## Bridge 02857 Inspection Report

Asset #02857(Routine)

US 62-20- LM 6.85 over DITCH NO. 18

Team Lead: Cory Shaw Inspection Date: 11/15/2024

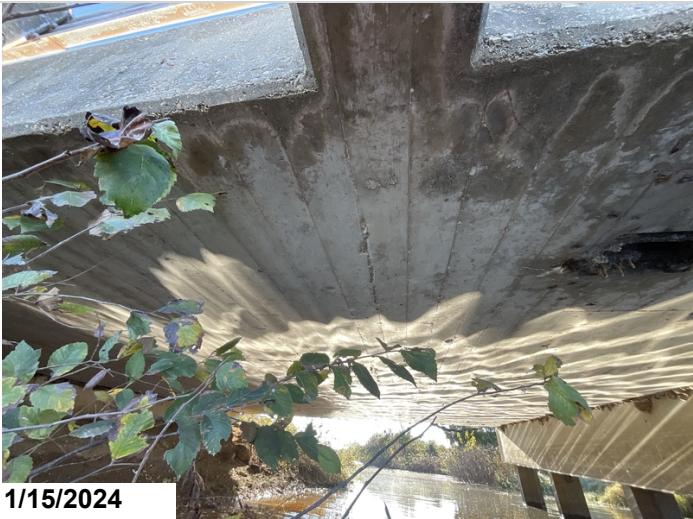
Span 2 undersurface 11-15-2024

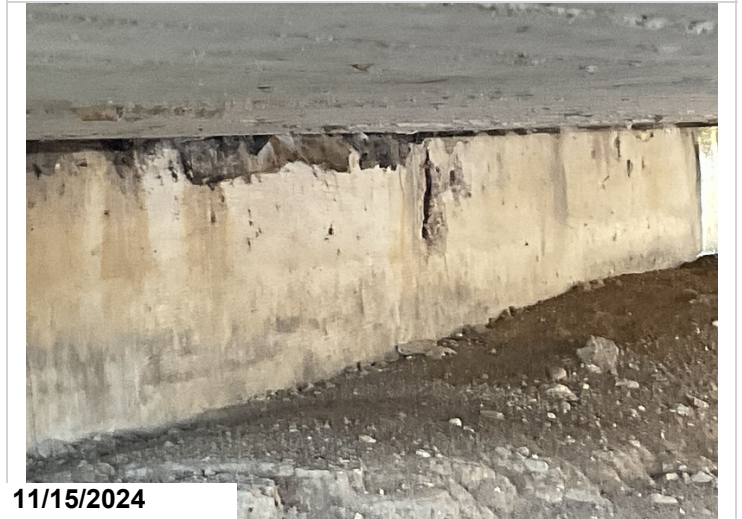
Bent 3 center line rebar 11-15-2024

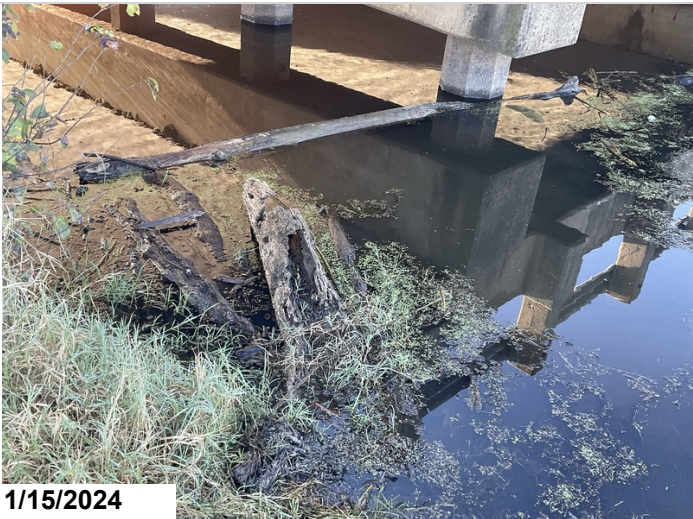
**61 - Channel/Channel Protection** (6 - Bank is beginning to slump. River control devices and embankment protection have widespread minor damage. There is minor stream bed movement evident. Debris is restricting the channel slightly.)  
Minor drift lodged against Bent 2.

Drift lodged against bent 2 11-15-2024

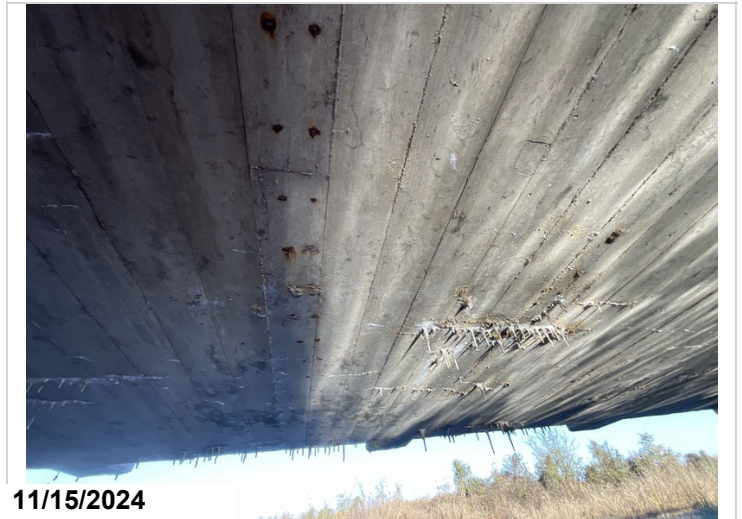
Span 1 left cracking with efflorescence 11-15-2024

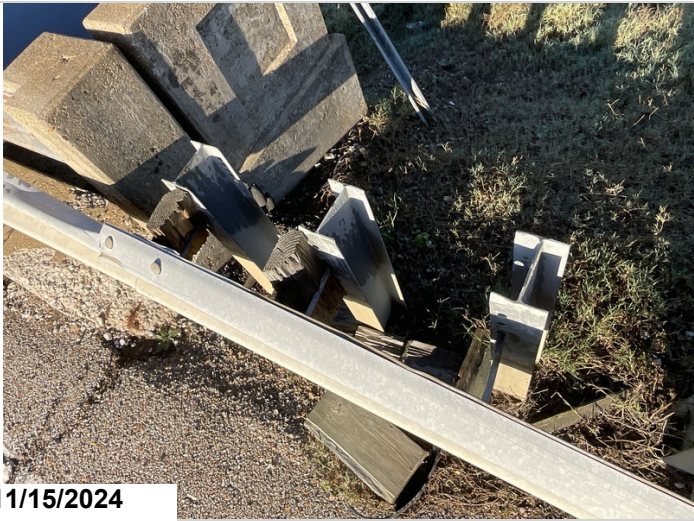
Bent 4 (East end) on left approach rail 3 wood spacer blocks damaged. 11-15-2024

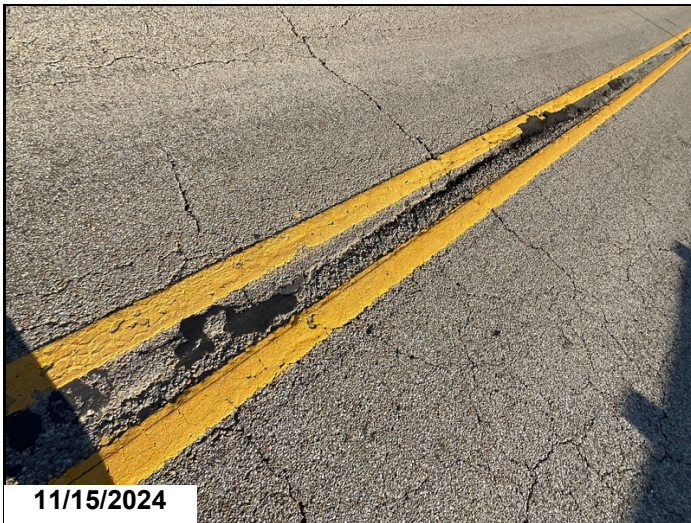
Asphalt wearing surface has numerous cracks and a few small spalls along center line.

Centerline deck 11-15-2024

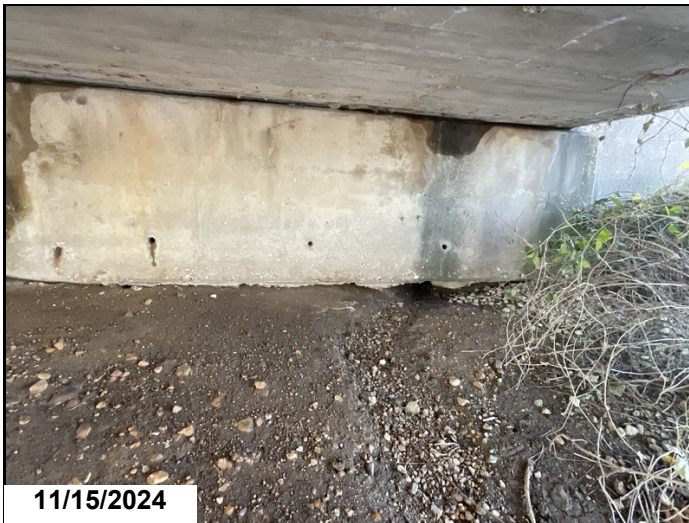
Bent 1 abutment is undermined for 4' on Lt end up to 6" below and 1' back under cap.

Bent 1 left end erosion 11-15-2024

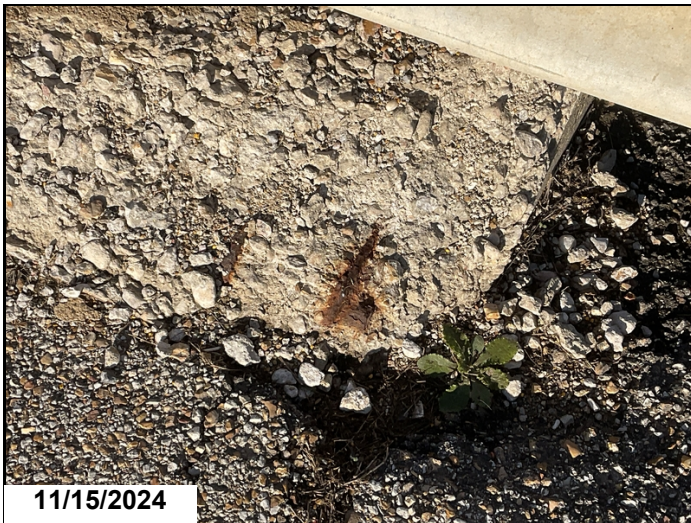
Curbs have areas of concrete disintegration with some rebar exposed.

Bent 3 left curb rebar 11-15-2024

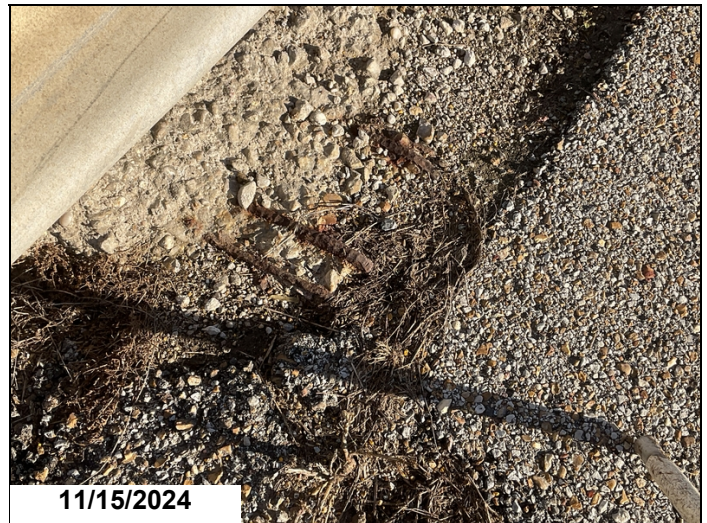
Bent 1 left curb rebar 11-15-2024

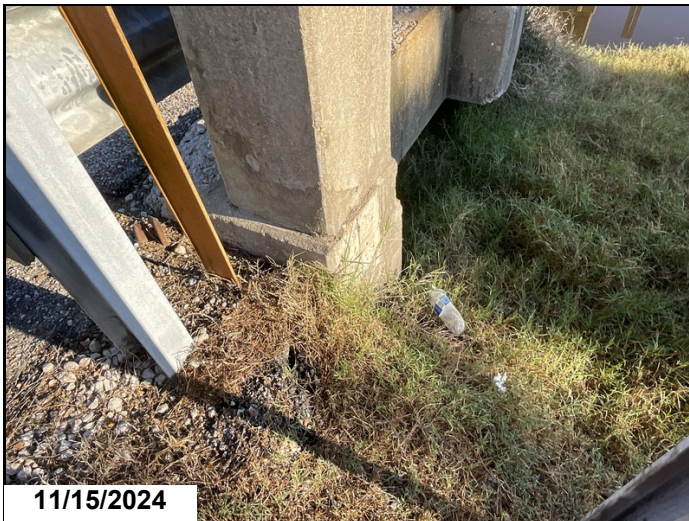
Bent 1 Rt wing is missing from past collision damage.

Bent 1 right wing is missing from past damage 11-15-2024
