Bridge 02858 Inspection Report

Asset #02858(Routine)

US 62- 20- LM 8.72 over DITCH NO. 19

Team Lead: Cory Shaw Inspection Date: 11/15/2024

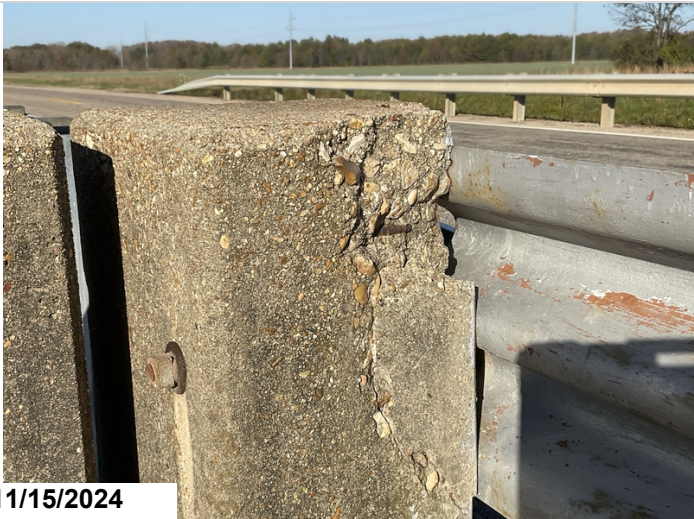
Bent 1 right post 11-15-2024

(215) Abutments have a few minor cracks. Cracking 6' CS2							
227	Reinforced Concrete Pile	EA	10	0	10	0	0
1190	Abrasion/Wear (PSC/RC)	EA	10	0	10	0	0
(227) Piles have minor abrasion. Abrasion 10 CS2							
234	Reinforced Concrete Pier Cap	LF	61	60	1	0	0
1080	Delamination/Spall/Patched Area	LF	1	0	1	0	0

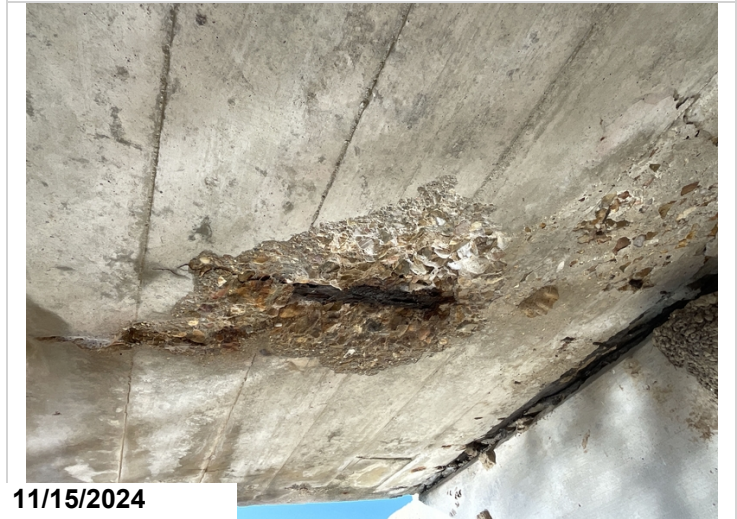
Span 2 undersurface at Bent 2 11-15-2024

(38) Undersurface has longitudinal and transverse cracks with some efflorescence along construction joints. Efflorescence 6' CS2, Cracking 20' CS2 & 65' CS3							
Undersurface has delaminated areas or spalls with rebar exposed near drains.							
Span 2 undersurface at Bent 2 has a spall with rebar. Rebar 2' CS3							
(510-38) Asphalt has several cracks. 597' CS3							
215	Reinforced Concrete Abutment	LF	77	71	6	0	0
1130	Cracking (RC and Other)	LF	6	0	6	0	0

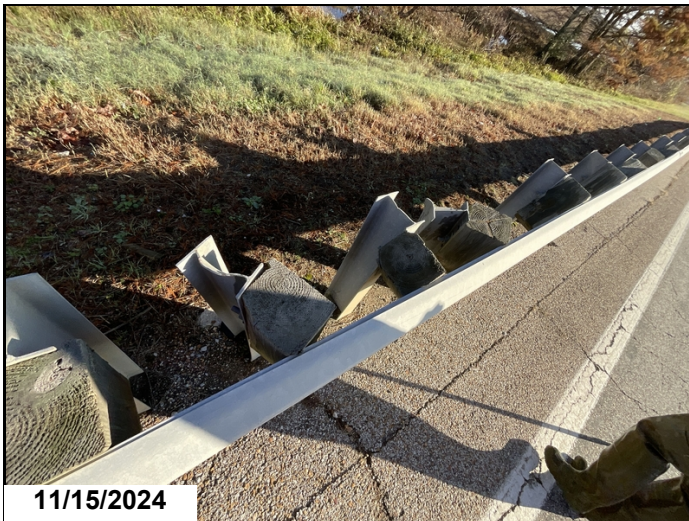
Approach rails have a few twisted posts and broken wood spacer blocks.

Bent 4 left approach rail wood spacer block damage 11-15-2024

Type of Work: Repair (General)

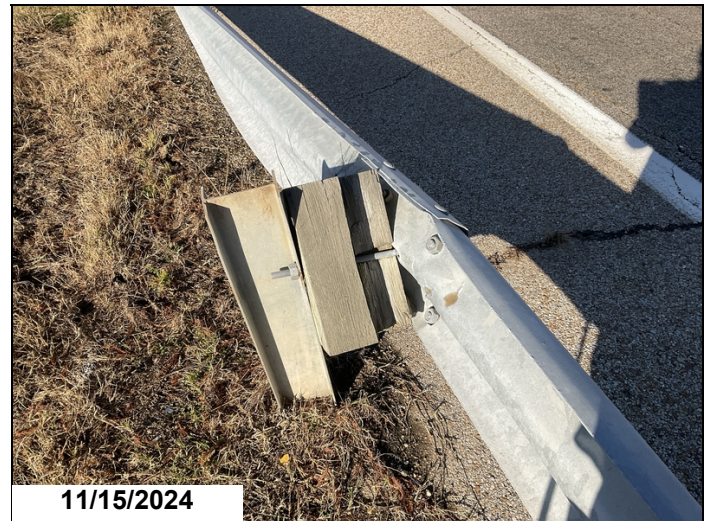
Bent 1 right approach rail wood spacer block damage 11-15-2024
