## Bridge 02859 Inspection Report

Asset #02859(Routine)

US 62-20- LM 11.71 over DITCH NO 13

Team Lead: James Adams Inspection Date: 11/25/2024

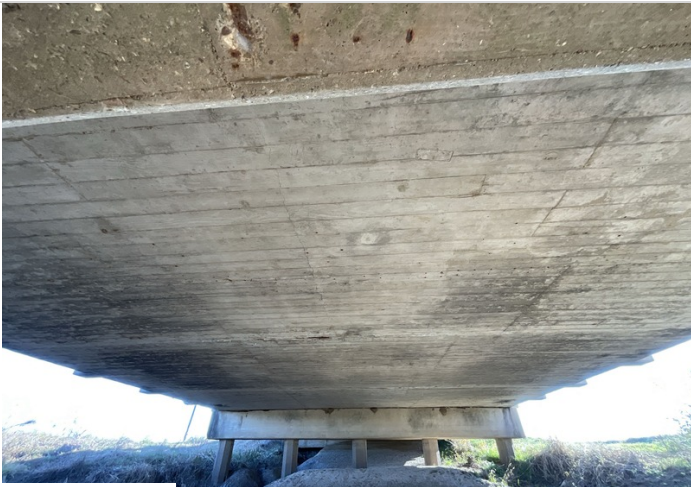
Span 2 undersurface

(38) Curbs have areas of concrete disintegration 52 SF Spalling (CS3) Curbs have some exposed rebar.4SF (CS3) Undersurface has a few longitudinal cracks. 55 LF (CS3), Delam. 8SF (CS3) Undersurface has transverse cracks with some efflorescence along construction joints. 98 SF (CS3) Undersurface has some efflorescence or spalls with exposed rebar near edges & drains. 16 SF (CS3) (510-38) Asphalt wearing surface has numerous cracks 229 SF (CS3) Asphalt wearing surface has a few small spalls along center line. 18SF (CS3).							
215	Reinforced Concrete Abutment	LF	77	54	0	23	0
1080	Delamination/Spall/Patched Area	LF	6	0	0	6	0
1090	Exposed Rebar	LF	2	0	0	2	0
6000	Scour	LF	15	0	0	15	0

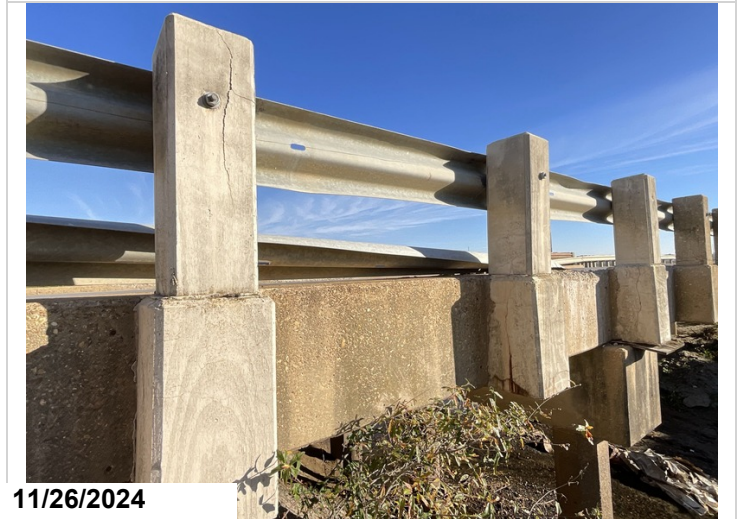
ELEMENTS	DESCRIPTION	UNITS	TOTAL	CS1	CS2	CS3	CS4
7000	Damage	LF	3	0	0	3	0
515	Steel Protective Coating	SF	563	281	282	0	0
3440	Effectiveness (Steel Protective Coatings)	SF	282	0	282	0	0
(330) Left rail has surface rust. Right rail was replaced sometime in the past 85 LF (CS2)							
Several posts were patched, 3 are cracked. 3LF (CS3) damage							
(515-330) Left rail has surface rust. 282 SF (CS2).

Span 1 has 3 Right posts cracks

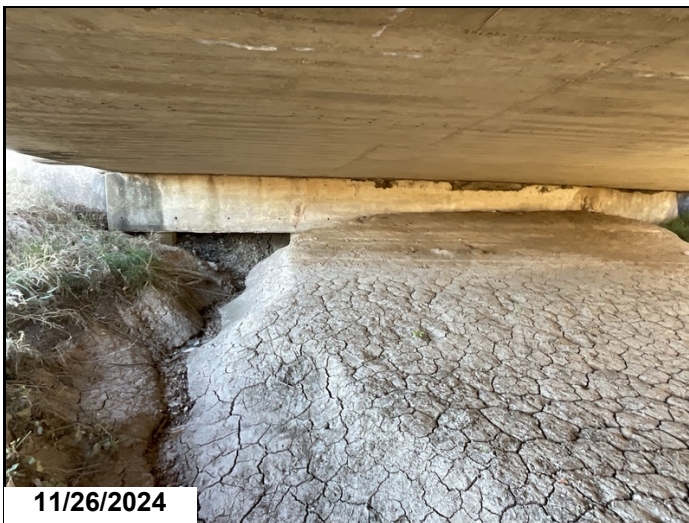
Bent 4 abutment is undermined on for 8' on Lt end up to 1.5' below and 2' back under cap. Pile 1 is exposed.

Type of Work: Repair (General)

Status: Monitor

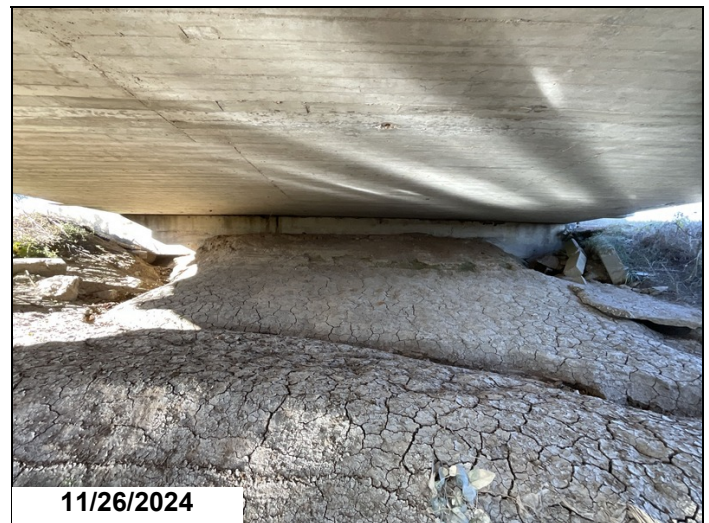
Bent 1 abutment is undermined on Lt and Rt ends up to 2' below and 1.5' back under cap.

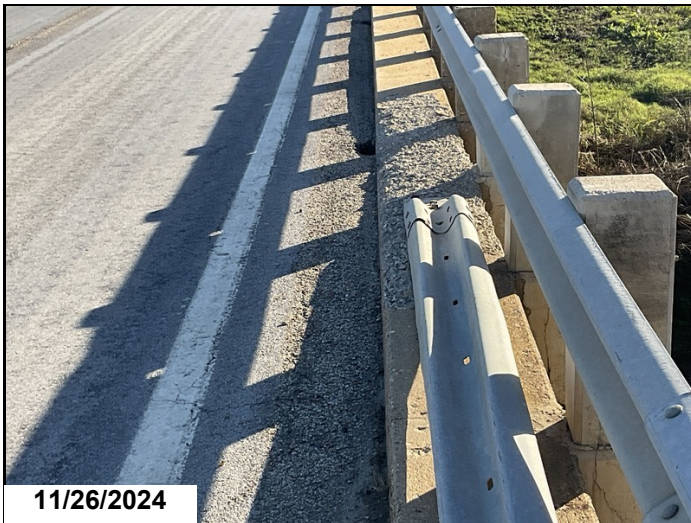
Right curb

Curbs have areas of concrete disintegration with some rebar exposed.

Type of Work: Repair (General)

Status: Monitor
