## Bridge 02860 Inspection Report

Asset #02860(Routine)

US 62-20- LM 13.47 over CACHE RIVER DITCH

Team Lead: James Adams Inspection Date: 11/25/2024

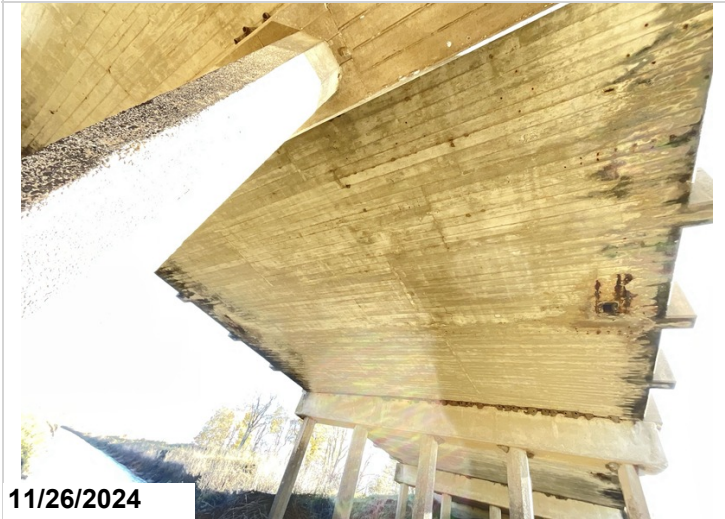
(38) Undersurface has a few longitudinal cracks. 120SF CS3 Undersurface has transverse & diagonal cracks with some efflorescence along construction joints. 30SF CS3 Undersurface has delaminated areas or spalls 42SF CS3 Undersurface has exposed rebar near drains and edges of slabs.48SF CS3 (510-38) Asphalt wearing surface has several cracks. Asphalt has a few small spalls or delaminated areas along center line and along gutters.								
215	Reinforced Concrete Abutment		LF	77	34	6	37	0
1080	Delamination/Spall/Patched Area		LF	3	0	0	3	0
6000	Scour		LF	40	0	6	34	0

Span 2 undersurface

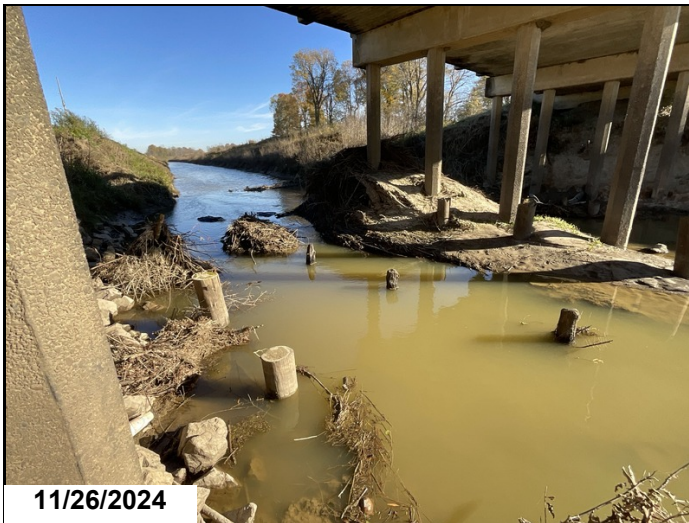
Drift and sediment are built up at bent 3.

Span 2&3 drift

**Type of Work:** Channel Work/Drift Removal

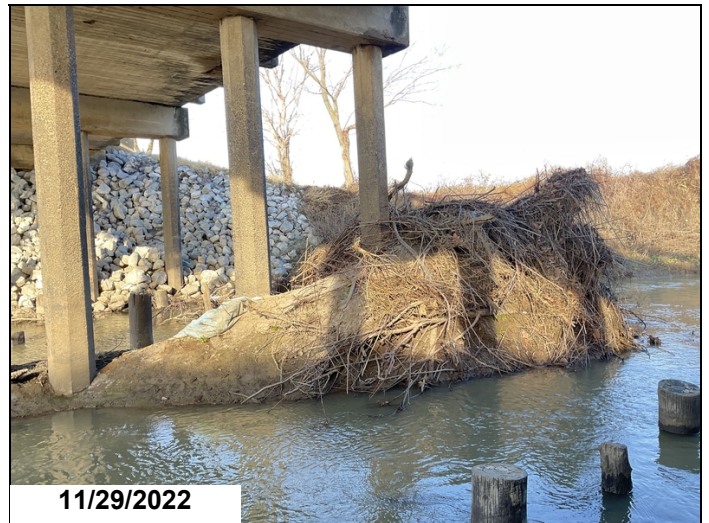
Bent 3 drift

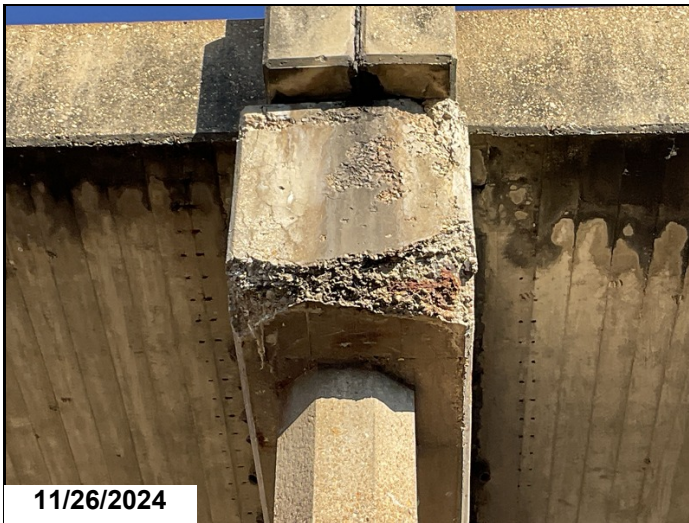
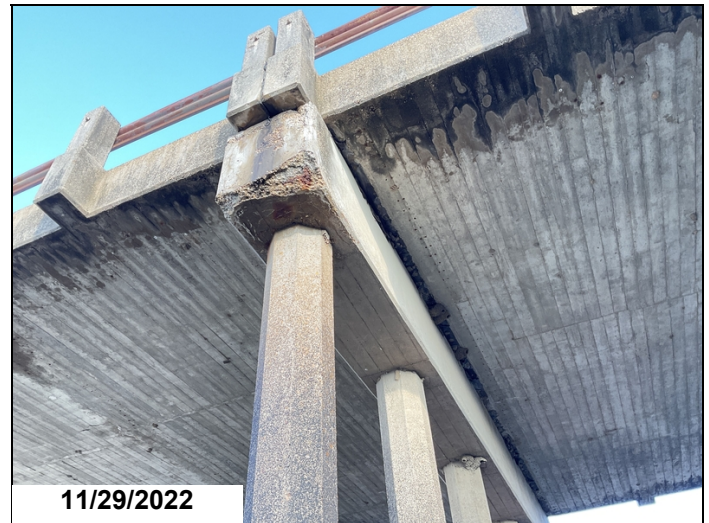
(234) Bent 3 cap has concrete disintegration with some rebar exposed on left and right ends. 3LF rebar CS3

Bent 3 cap has concrete disintegration with some rebar exposed on Lt and Rt ends.

**Type of Work:** Substructure Repair

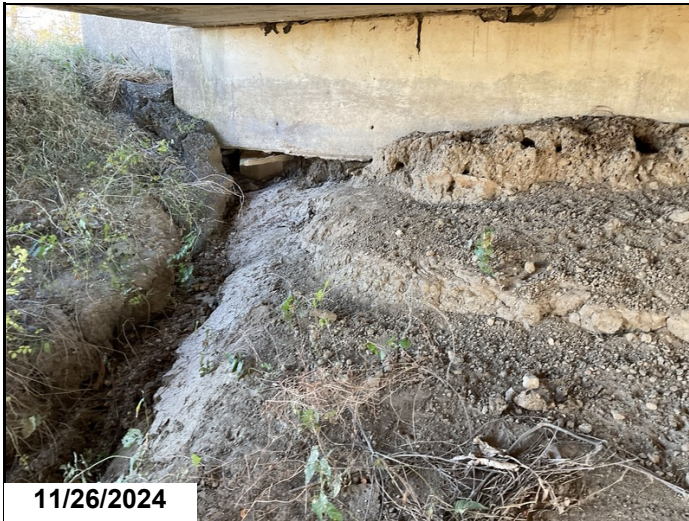
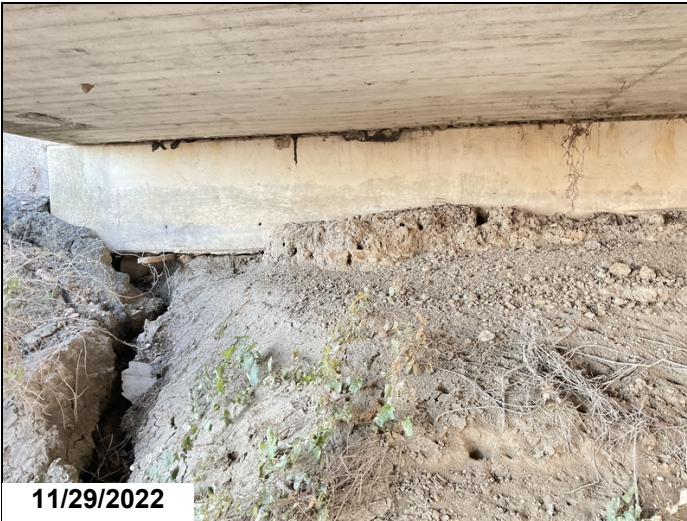
Bent 5 abutment is undermined on Lt end up to 1' below and 1' back under.

Bent 5 left 11-26-2024

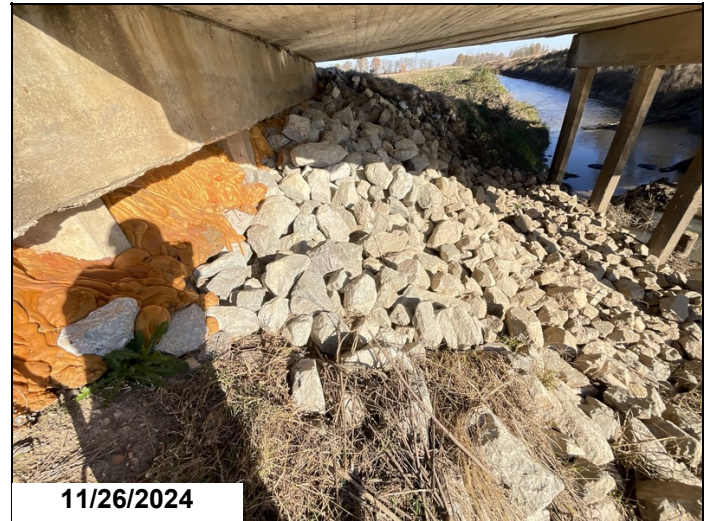
\*\*Bent 1 is undermined on Rt end up to 2.5' below and 2' back under. Approach roadway embankment has some erosion behind wing wall. Repaired with riprap and expandable foam. Observed 11-26-2024.

Bent 1 slope protection and expandable foam repair  
observed 11-26-2024

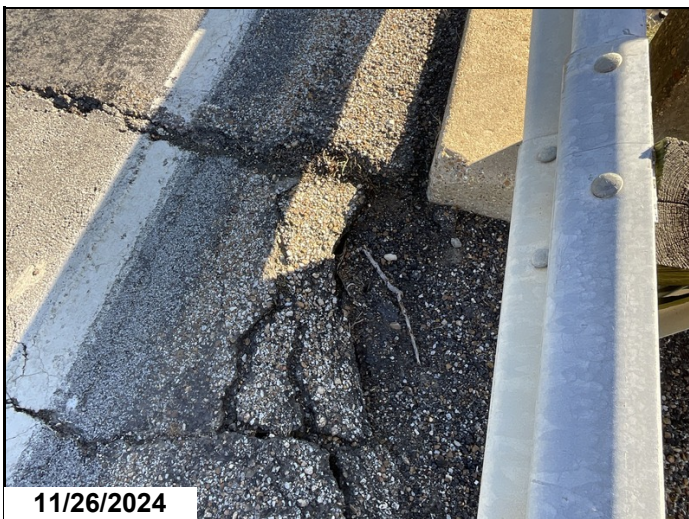
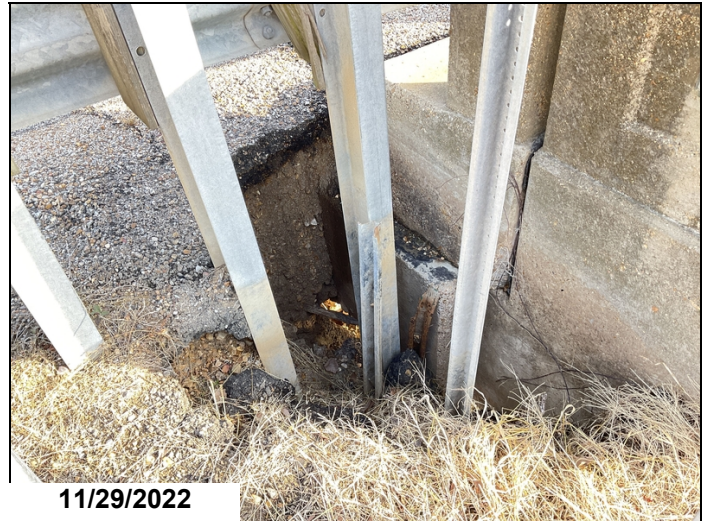
Bent 1 right approach roadway embankment repair  
observed 11-26-2024
