Bridge 03023 Inspection Report

Route:62 Section:20 Log:2.58

Arnold Road ID:11x62x20xA, Arnold Log mile:2.593

(4) Place Code	0
(6) Features Intersected	BLACK RIVER
(7) Facility Carried	US 62-20- LM 2.58
(9) Location	2.58 MI E US 67
(11) Mile Point	2.58 mi
(12) Base Highway Network	Yes

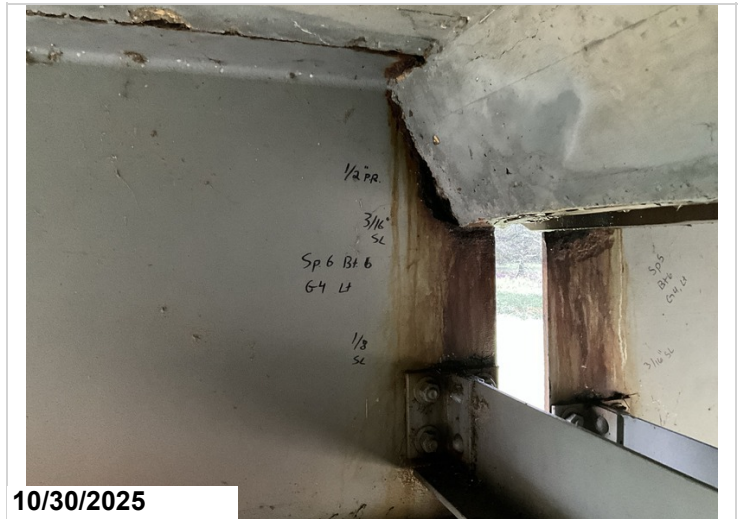
This defect is common throughout the structure at girder ends.

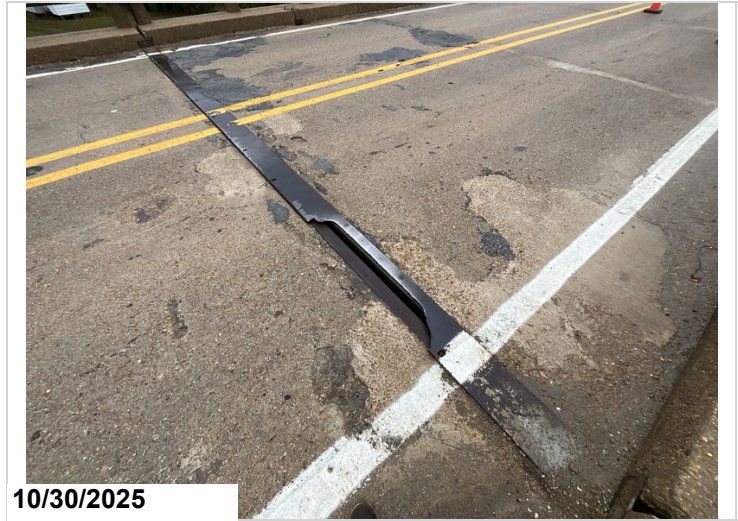
Bent 6, Joint: Joint armor missing. 4LF CS4 metal deterioration.

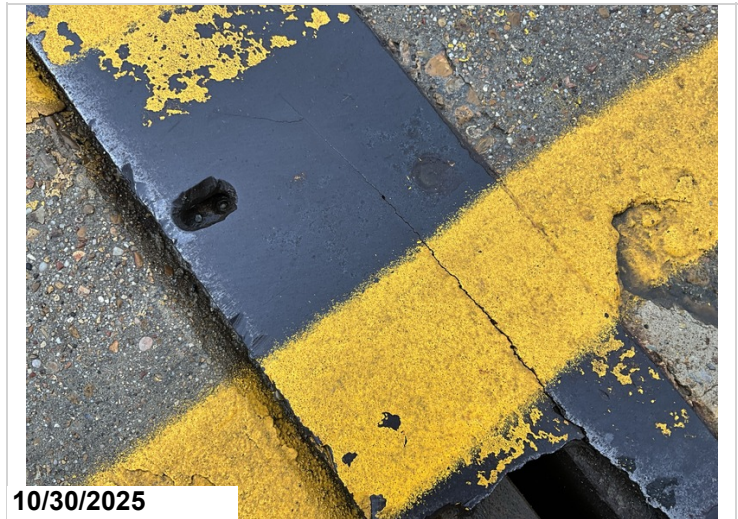
Bent 3, Joint. Cracking in the joint armor. 1LF CS3 metal deterioration.

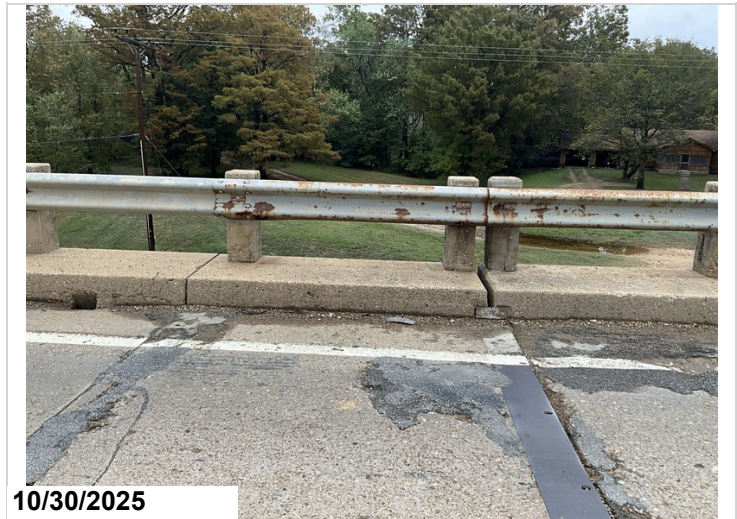
Span 10, Left: Active corrosion to the railing.

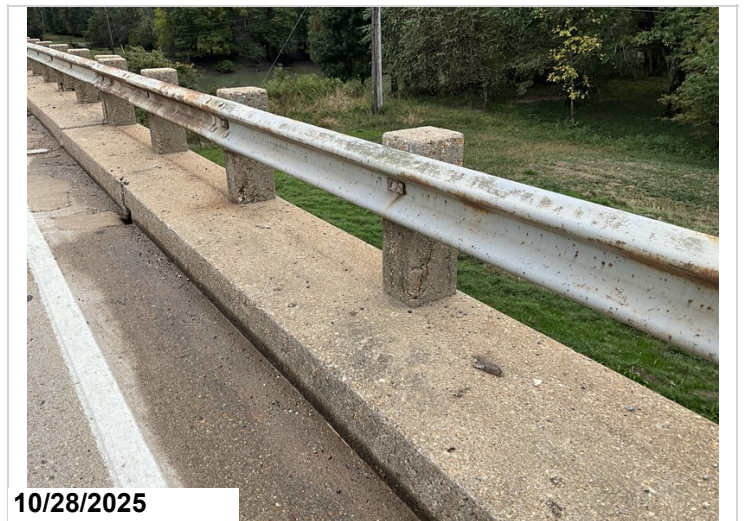
Typical condition of Bridge Railing.

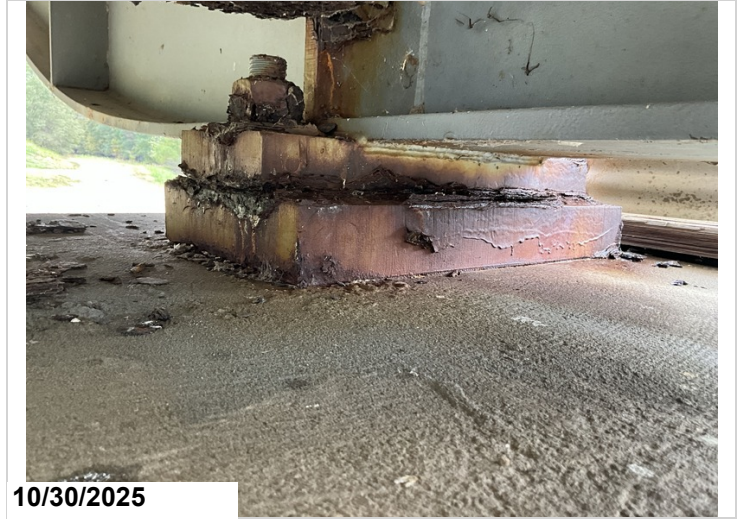
Pier 3, Bearings 1 - 4: Active corrosion with pack rust between the sole and masonry plate. 4EA CS3 corrosion.

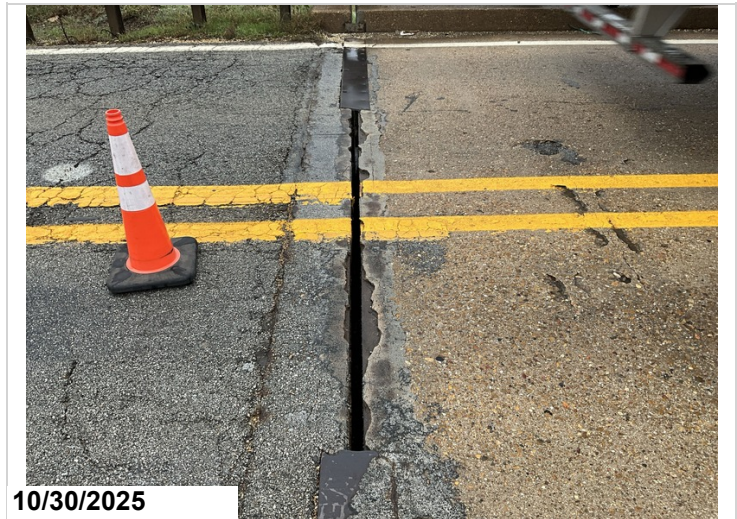
Bent 1, Joint: Armor missing. 12LF CS4 metal deterioration.

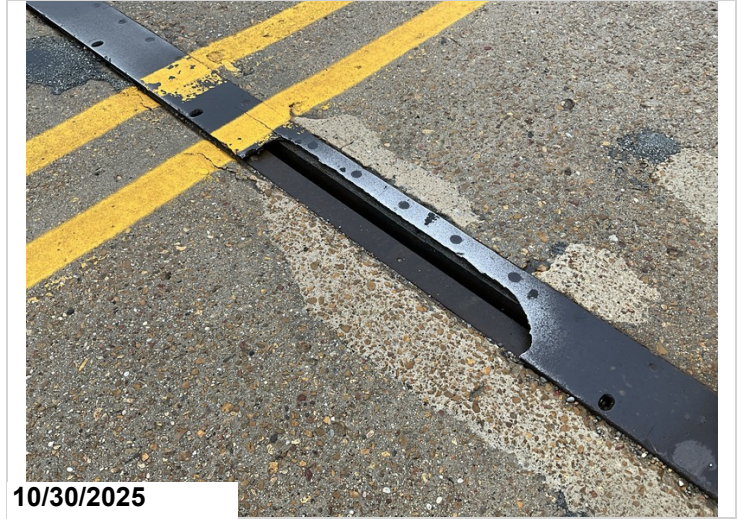
Bent 3, Joint: Armor missing. 4LF CS4 metal deterioration.

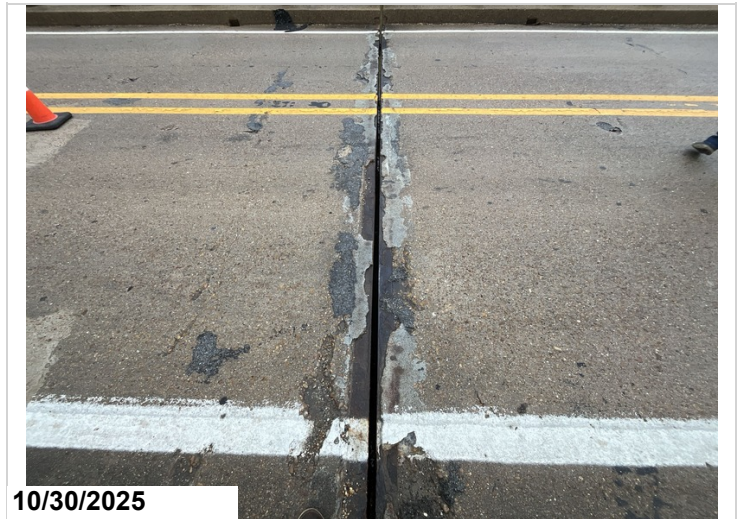
Bent 5, Joint: Armor missing for the full length. 26LF CS4 metal deterioration.

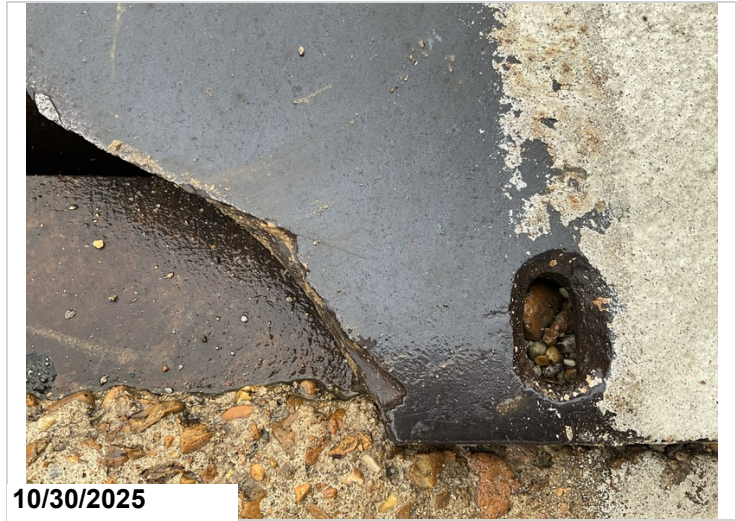
Bent 6, Joint: Cracking in the joint armor. 1LF CS3. metal deterioration.

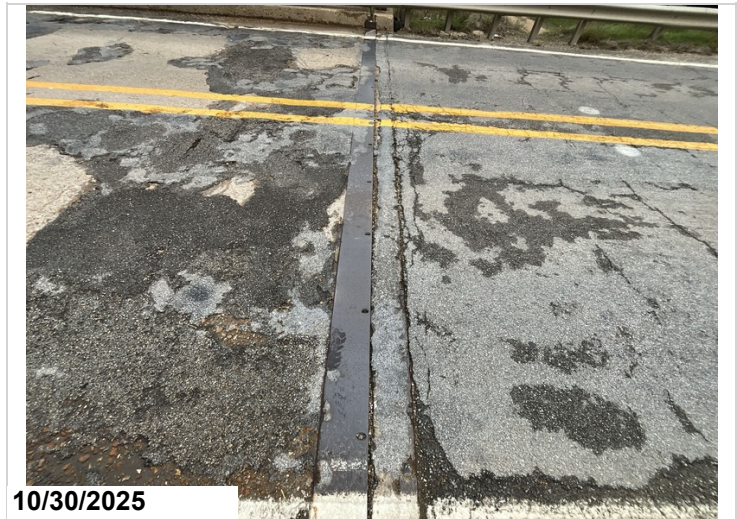
Bent 8, Joint: Debris impactation, full length. 26LF CS3 debris impactation.

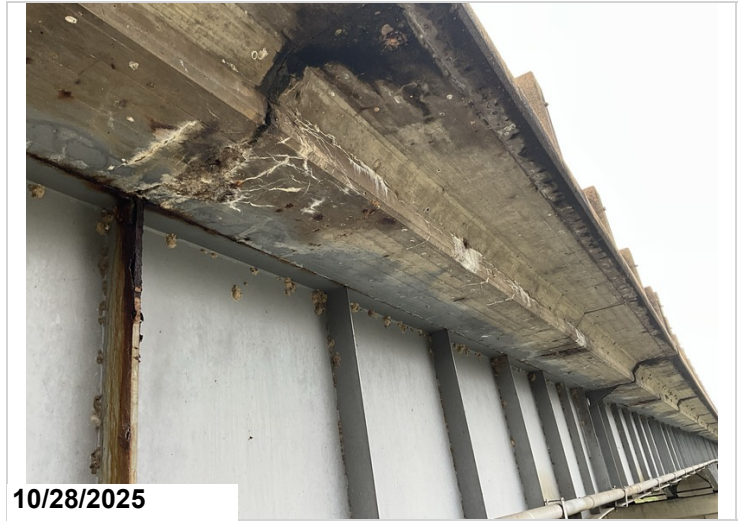
Span 8, Left overhang: Cracking with efflorescence. 14sf CS3 efflorescence.

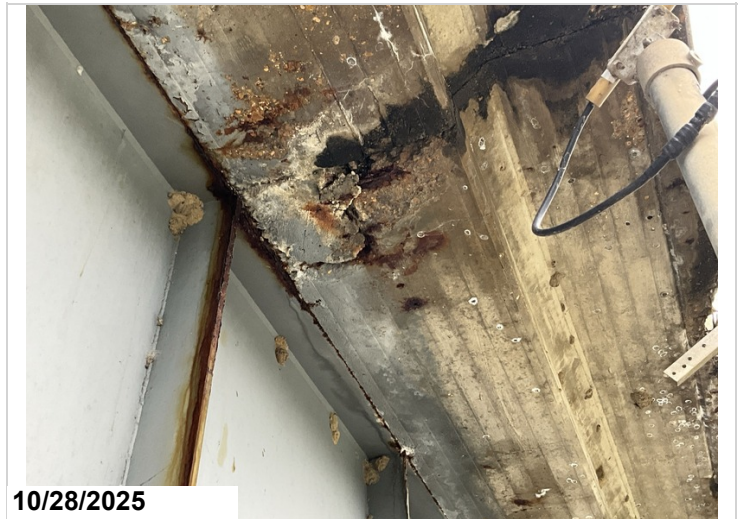
Span 9, Right overhang: Spalling with exposed reinforcing steel with section loss. 19sf CS3 corrosion.

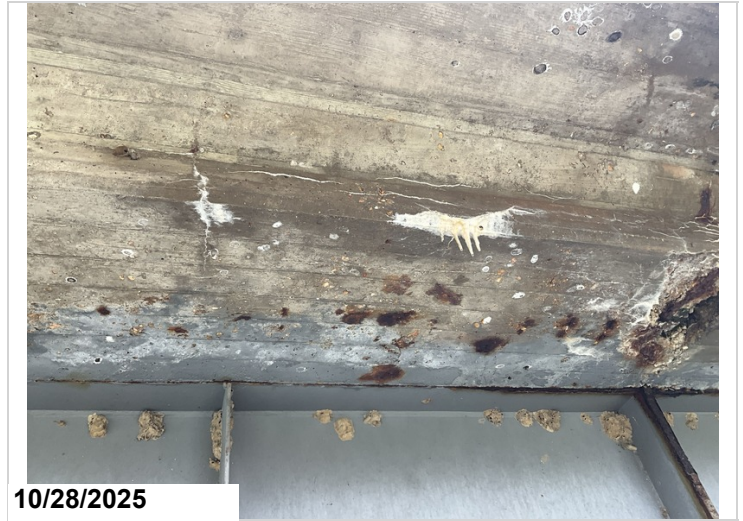
Span 8, Left overhang: Cracking with efflorescence build up.
8SF CS3 efflorescence.

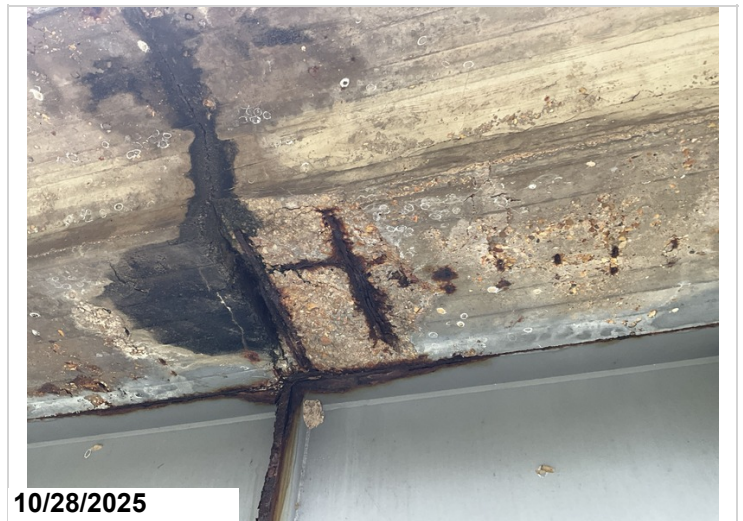
Span 8, Right Overhang: Spalling with exposed reinforcing
steel with section loss. 10SF CS3 exposed reinforcing steel.

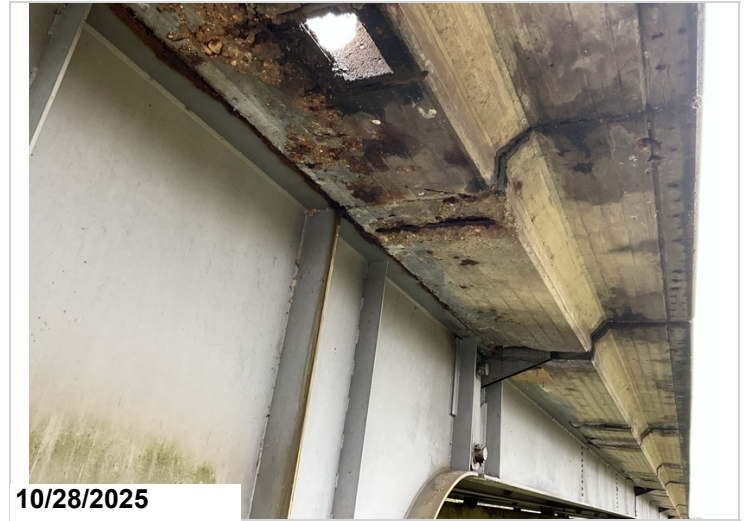
Span 7, Left overhang: Spalling with exposed reinforcing steel with section loss. 8SF CS3 exposed reinforcing steel.

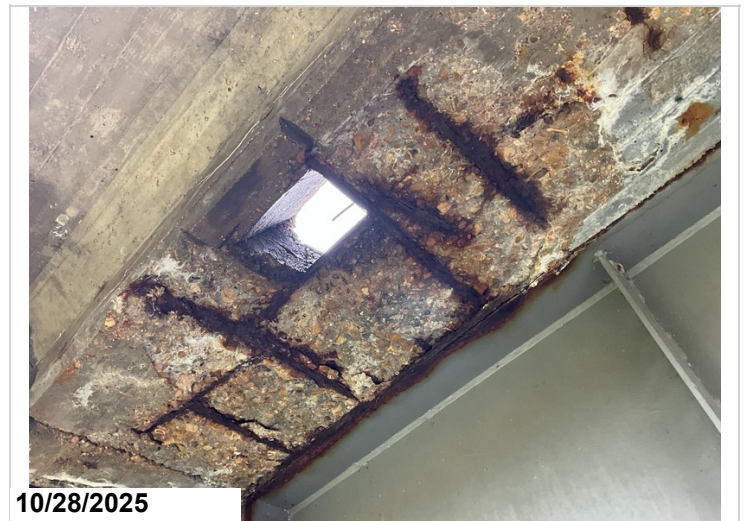
Span 7, Right overhang: Spalling with exposed reinforcing steel with section loss. 18SF CS3 exposed reinforcing steel.

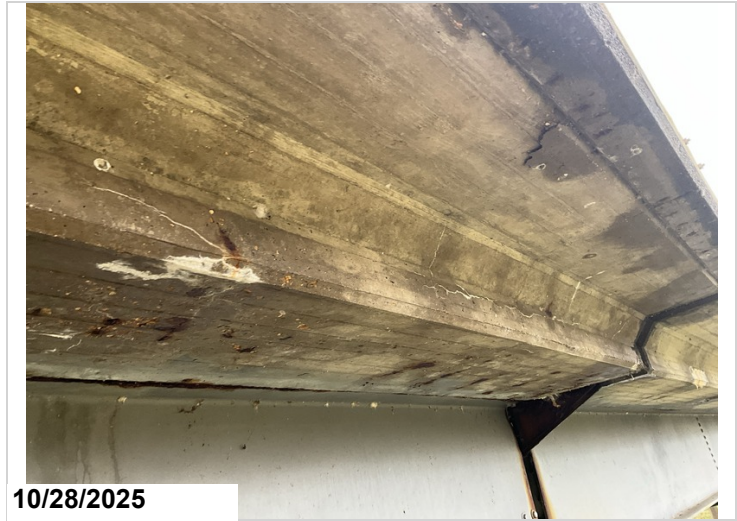
Span 6, Left overhang: Cracking with efflorescence and rust staining. 8SF CS3 efflorescence/rust staining.

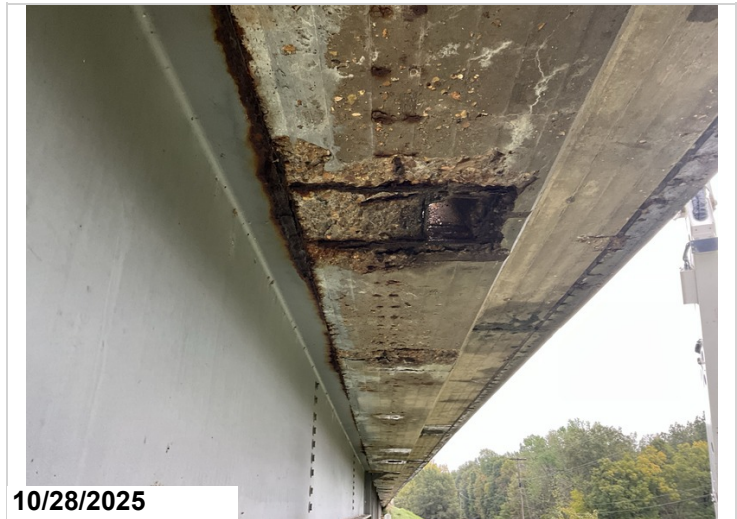
Span 6, Right overhang: Spalling with exposed reinforcing steel with section loss. 7SF CS3 exposed reinforcing steel.

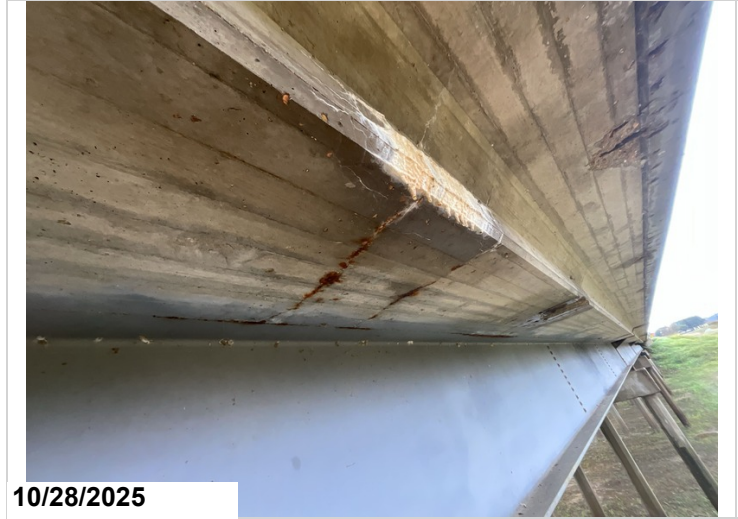
Span 5, Left overhang: Cracking with efflorescence and rust staining. 3LF CS3 efflorescence/rust staining.

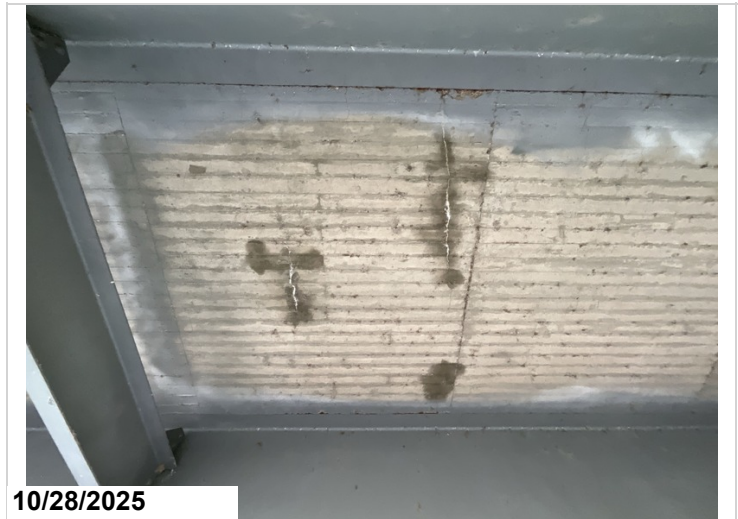
Span 4, undersurface: Cracking with efflorescence. 32sf CS2 efflorescence.

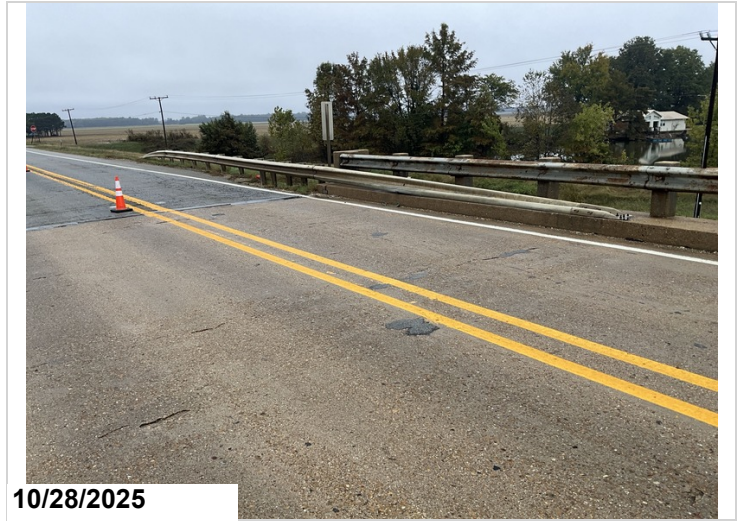
Span 1: Unsound patched and spalling. 28SF CS3 Spalling.
Span 2: 26SF CS3 Spalling.

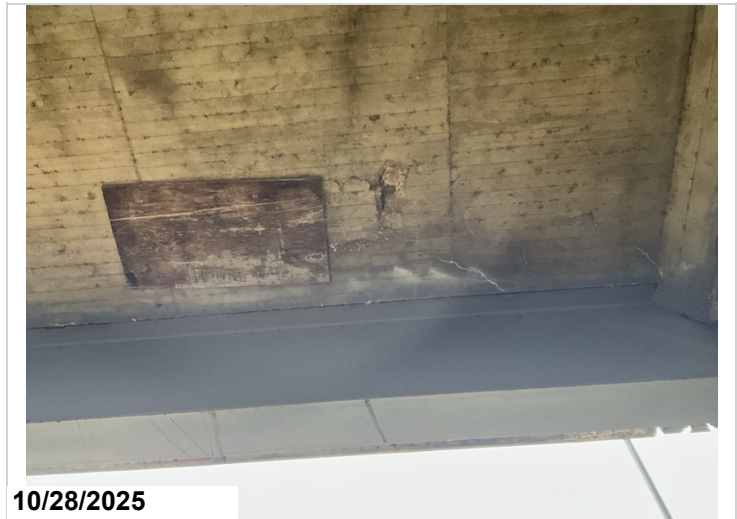
Span 11, Bay 3, Ahead of Bent 7: Spalling with exposed
reinforcing steel with section loss. 1SF CS3 exposed
reinforcing steel.

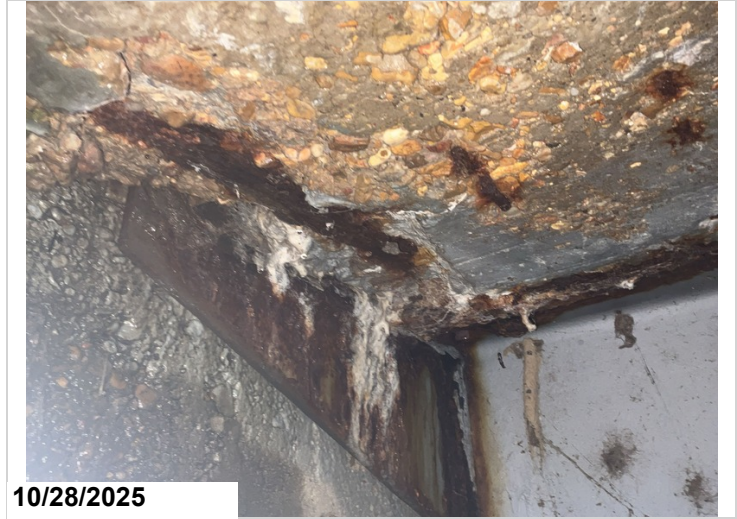
Span 11, Left overhang, Adjacent to Bent 8: Spalling with exposed reinforcing steel with section loss. 2SF CS3 exposed reinforcing steel.

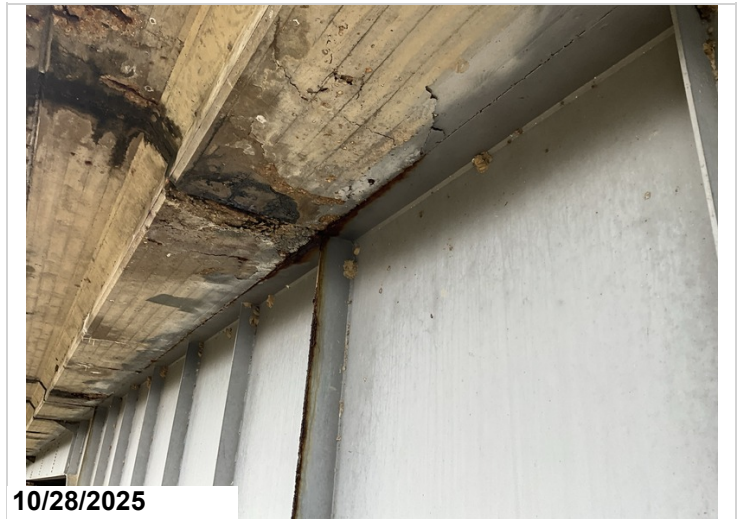
Span 9, Girder 1, Left, at third saw joint: Active corrosion with flaking rust along the Top Flange. 6LF CS3 corrosion.

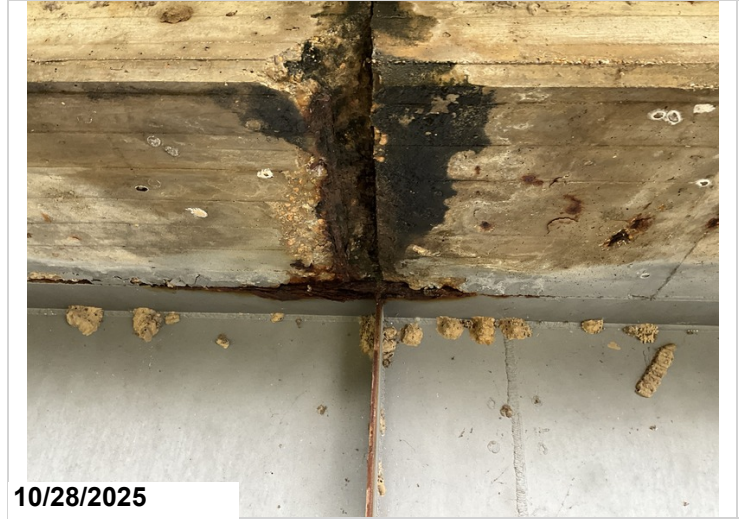
Span 9, Girder 1, Left: Active corrosion with flaking rust along the Top Flange below first saw joint.

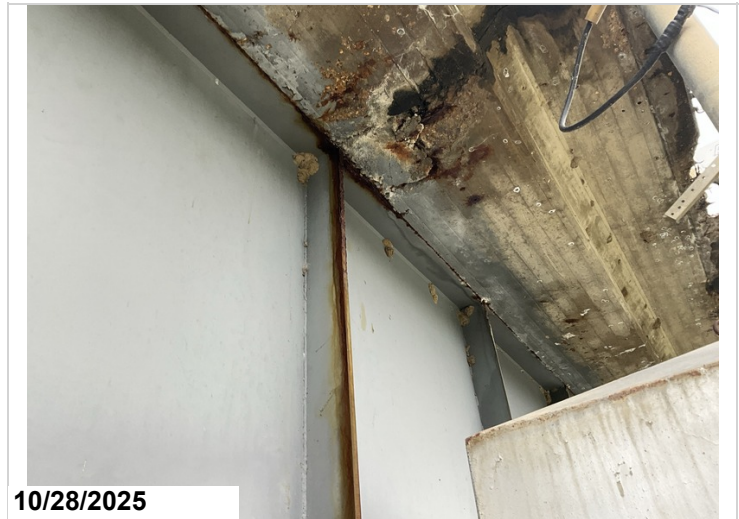
Span 8, Girder 4, Right: Active corrosion with flaking rust along the Top Flange and vertical bearing stiffener. 4LF CS3 corrosion.

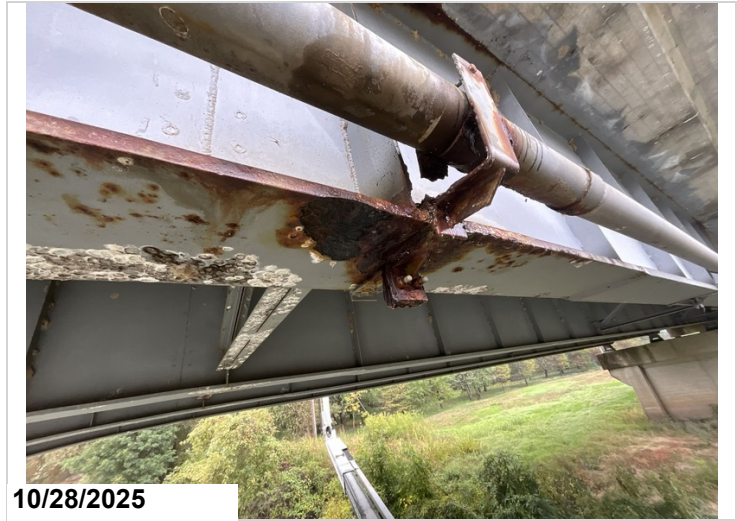
Span 7, Girder 1, Bottom Flange: Active corrosion with section loss up to 7/16" below the last saw joint before Pier 2.

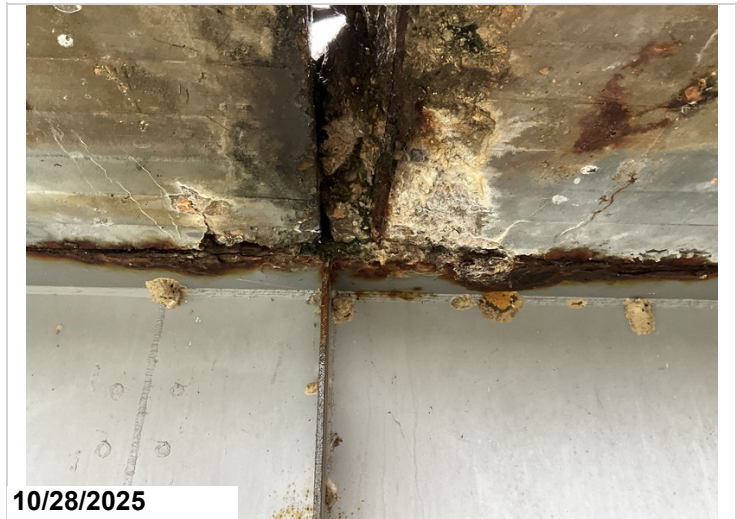
Span 7, Girder 1, Left, Top Flange: Active corrosion with flaking rust along the Top Flange below last saw joint before Pier 2. 8LF CS3 corrosion.

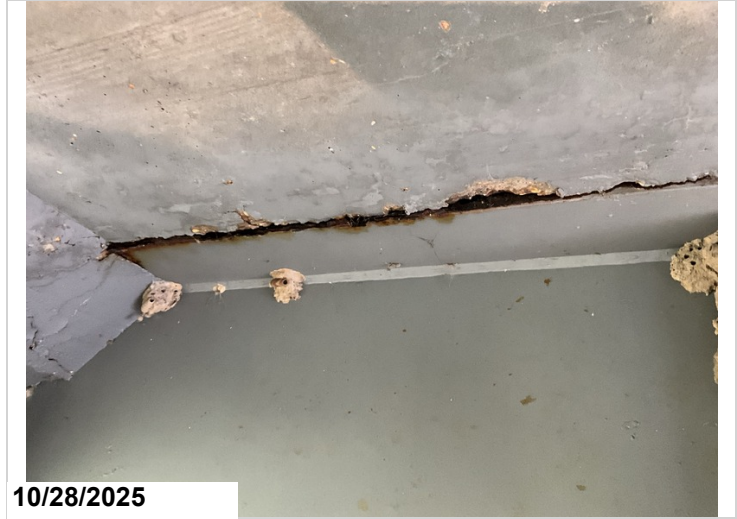
Span 7, Girder 2, Right: Active corrosion with flaking rust along the Top Flange. 7LF CS3 corrosion.

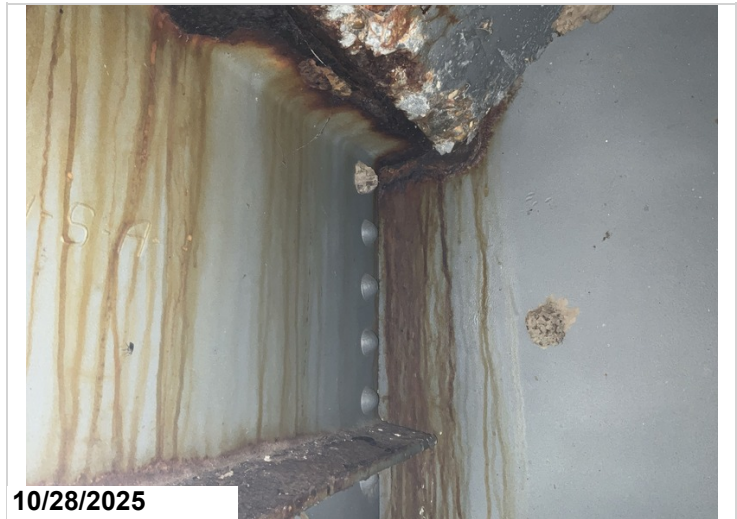
Span 6, Girders 1 - 4, at center Two diaphragms: Active corrosion with with flaking rust and section loss up to 3/16" to the web at the haunch areas. 8LF CS3 corrosion.

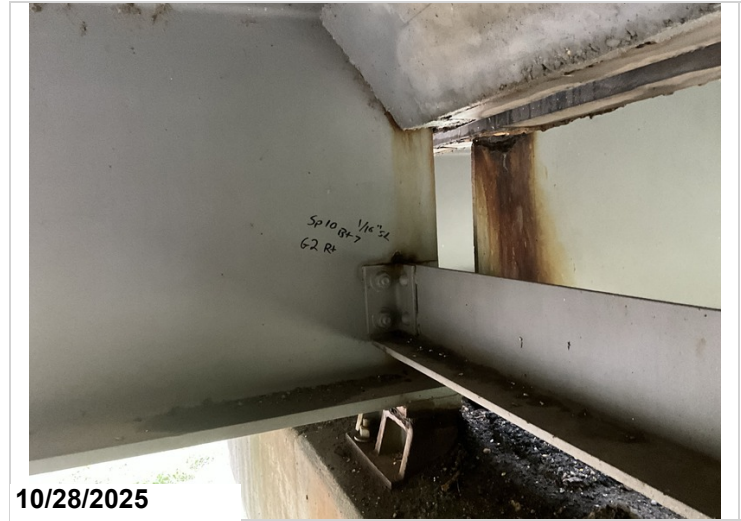
Span 10, Bent 7, Girder 2, Right: Active corrosion with section loss up to 1/16" to the web at the diaphragm connection. 1LF CS3 corrosion.

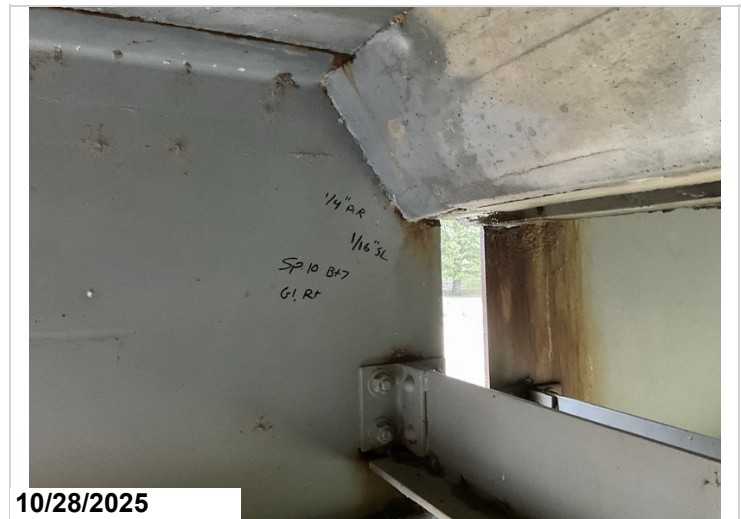
Span 10, Bent 7, Girder 1, Right: Active corrosion with section loss up to 1/16" to the web at the haunch area and pack rust up to 1/4" between the girder web and the concrete haunch. 1LF CS3 corrosion.

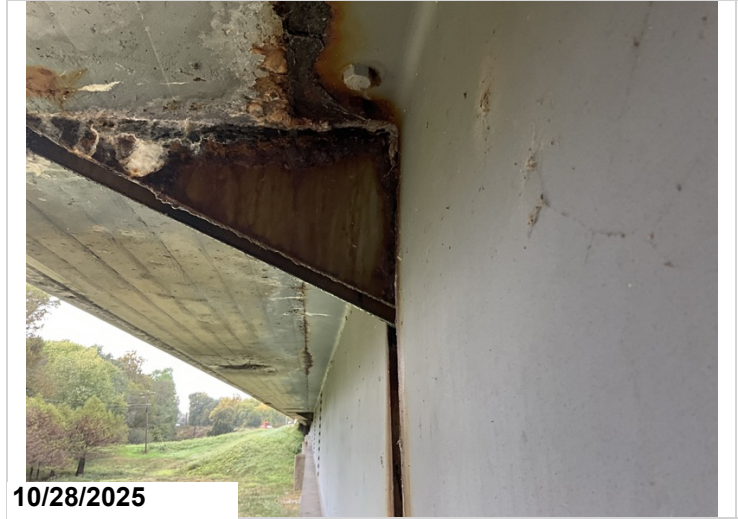
Span 6, Bent 6, Girder 4: Distortion in the web due to pack rust between the Girder web and the concrete haunch.

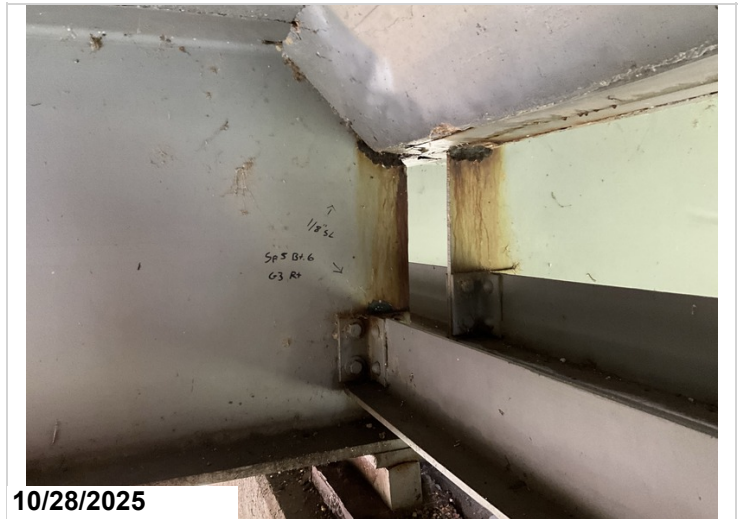
Span 5, Bent 6, Girder 3, Right: Active corrosion with section loss up to 1/8" to the web at the haunch and diaphragm connection areas. 1LF CS3 corrosion.

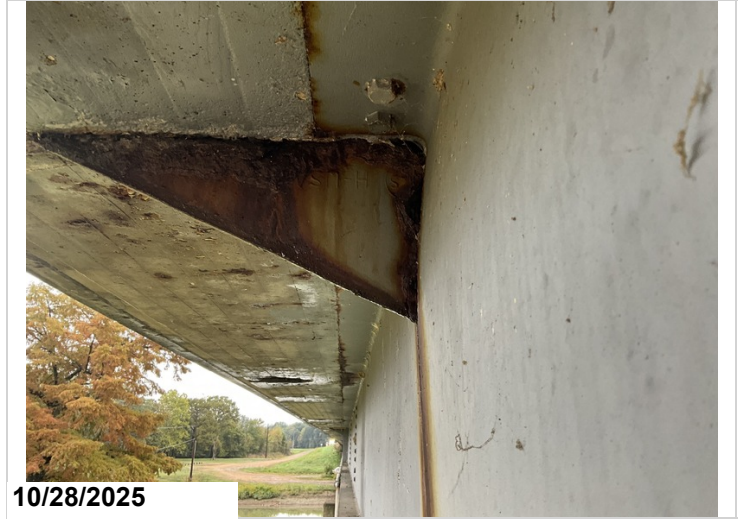
Span 5, Bent 6, Girder 1: Distortion in the web due to pack rust between Girder web and concrete haunch.

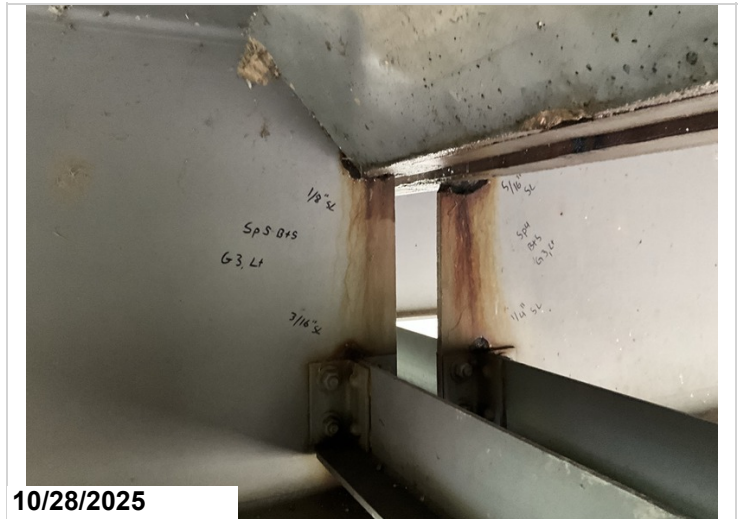
Span 5, Bent 5, Girder 3, Left: Active corrosion with section loss up to 1/8" to the web at the haunch area and section loss up to 3/16" to the web at the diaphragm connection. 1LF CS3 corrosion.

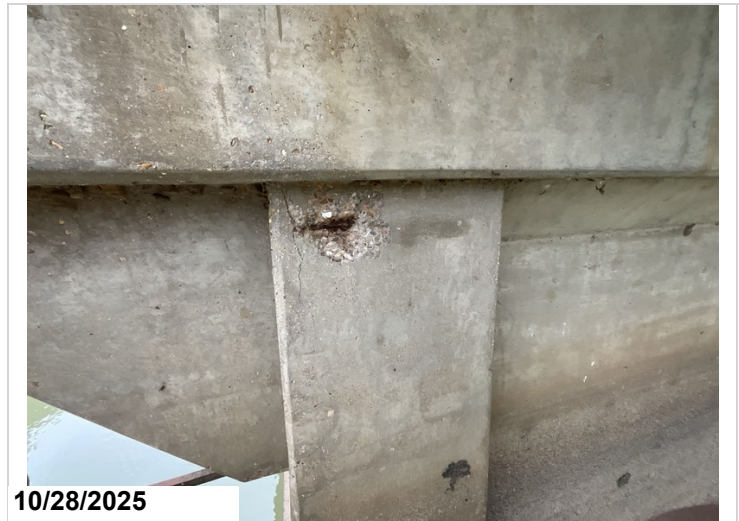
Pier 3, Column 2, Ahead: Spalling with exposed reinforcing steel with section loss near bottom of cap. 1EA CS3 exposed reinforcing steel.

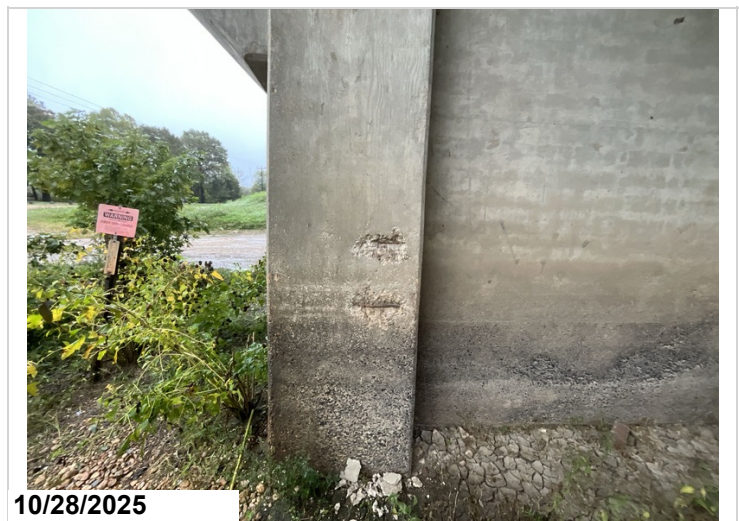
Pier 4, Column 1, Back: Spalling with exposed reinforcing steel. 1EA CS3 exposed reinforcing steel.

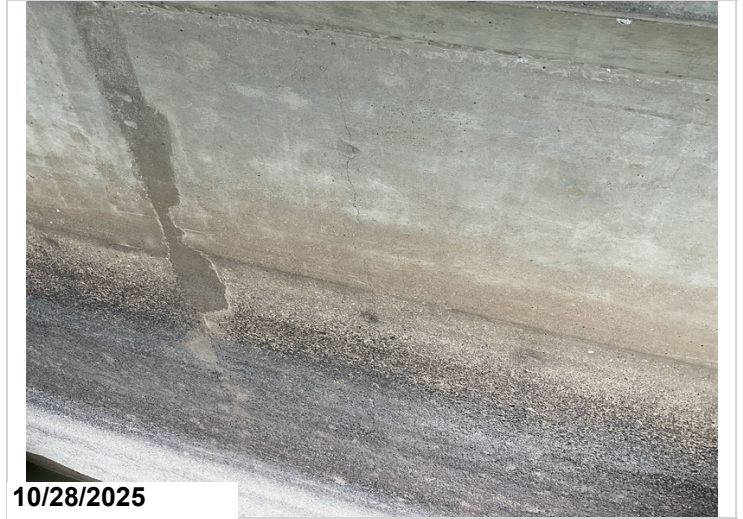
Pier 3, Back, Wall: Vertical cracking Right of centerline. 1LF CS2 cracking.

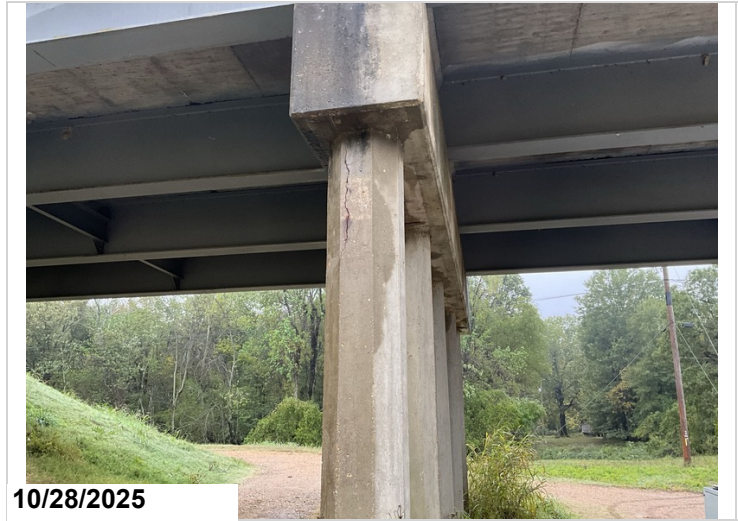
Bent 7, Pile 1, Ahead and Left: Vertical cracking with rust staining. 1EA CS3 rust staining.

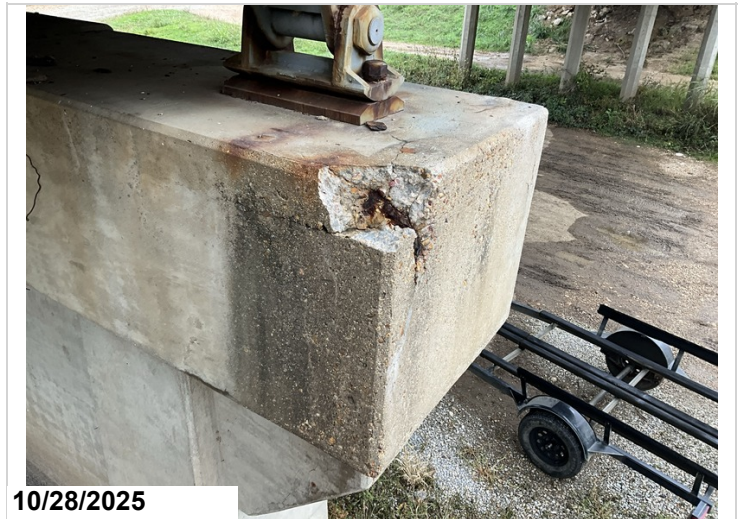
Pier 4, Right, back corner: Spalling with exposed reinforcing steel with section loss. 1LF CS3 exposed reinforcing steel.

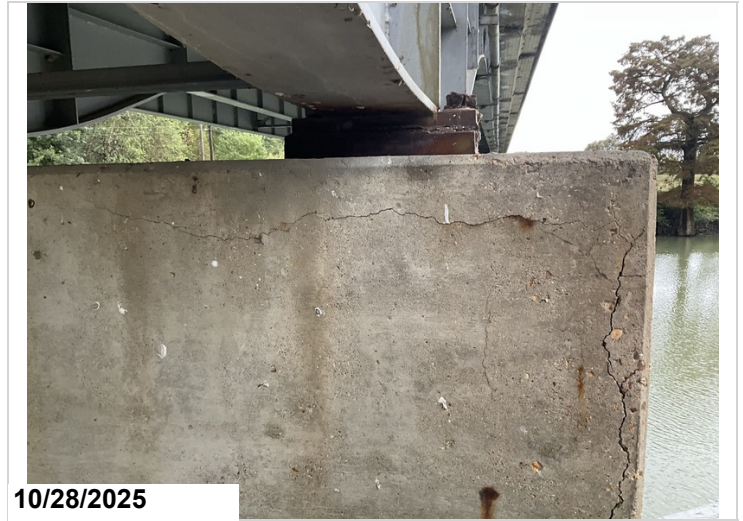
Pier 3, Ahead, Cap, below Girder 1: Horizontal cracking. 4LF CS3 cracking.

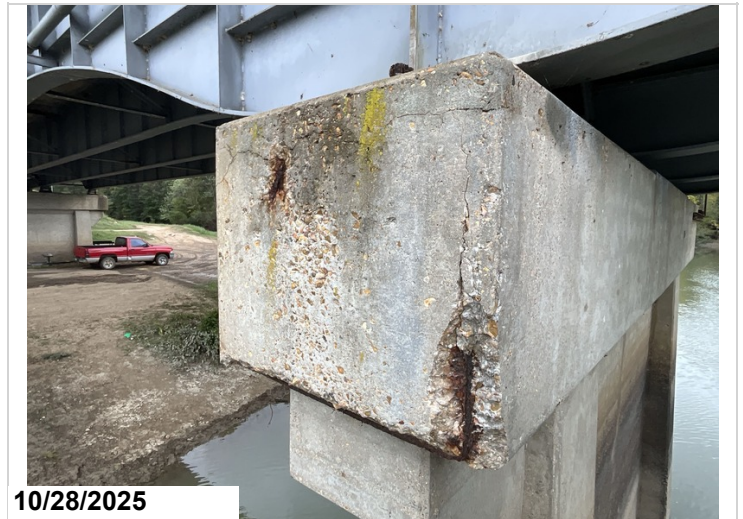
Pier 3, Cap, Left: Spalling with exposed reinforcing steel with section loss. 1LF CS3 exposed reinforcing steel.

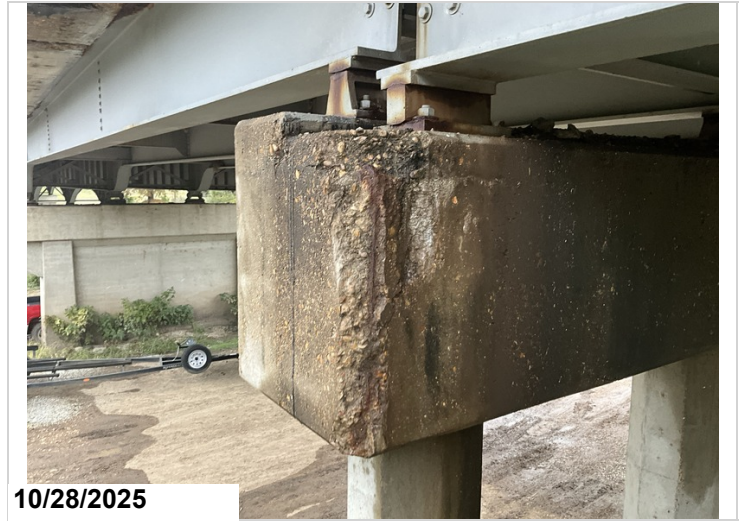
Bent 7, Ahead, Right: Spalling with exposed reinforcing steel with section loss. 1LF CS3 exposed reinforcing steel.

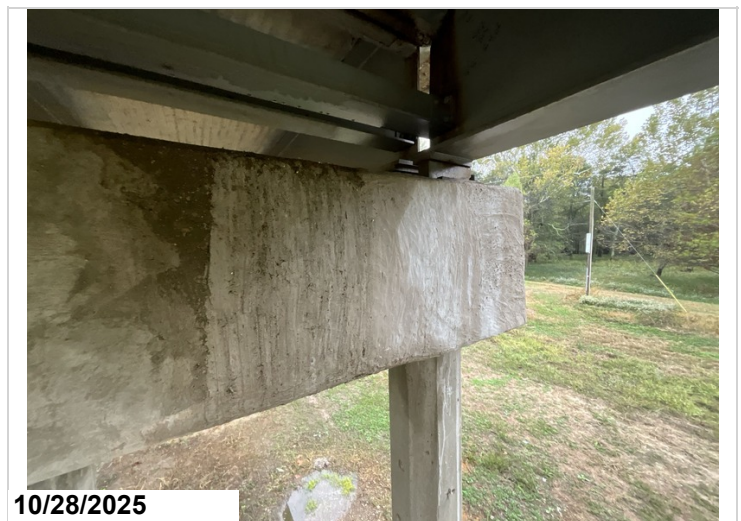
Bent 3, back, under Girder 4: Repair. 4LF CS2.

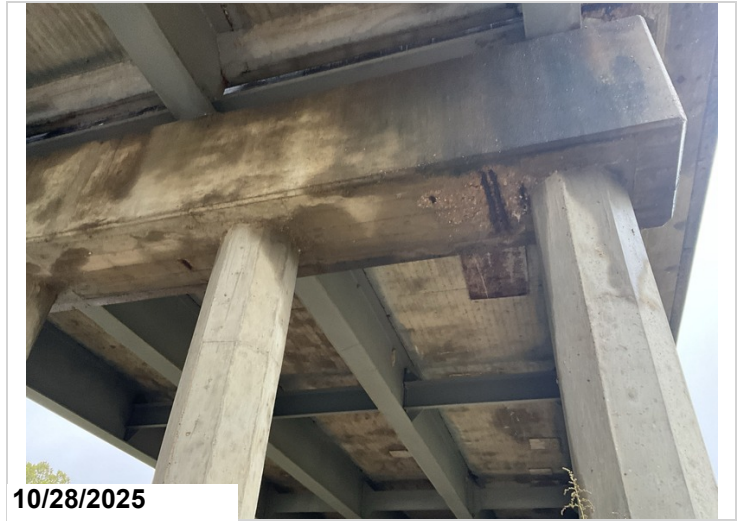
Bent 7, Cap: Spalling with exposed reinforcing steel with section loss. 8LF CS3 exposed reinforcing steel.

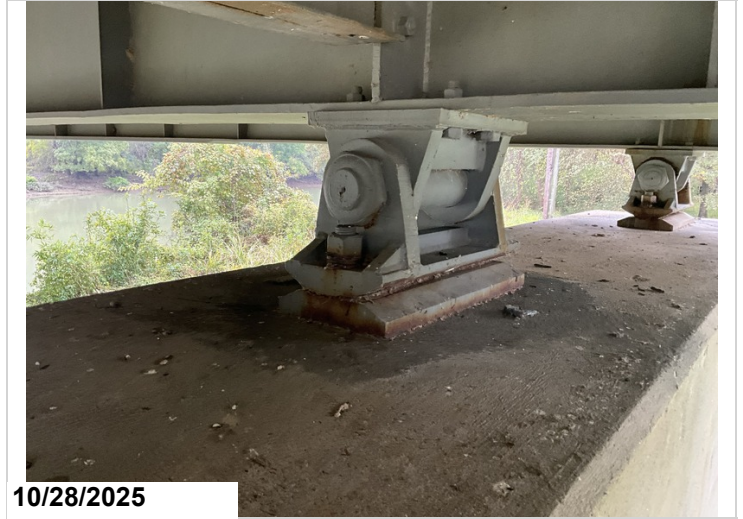
Pier 1: Typical bearings.

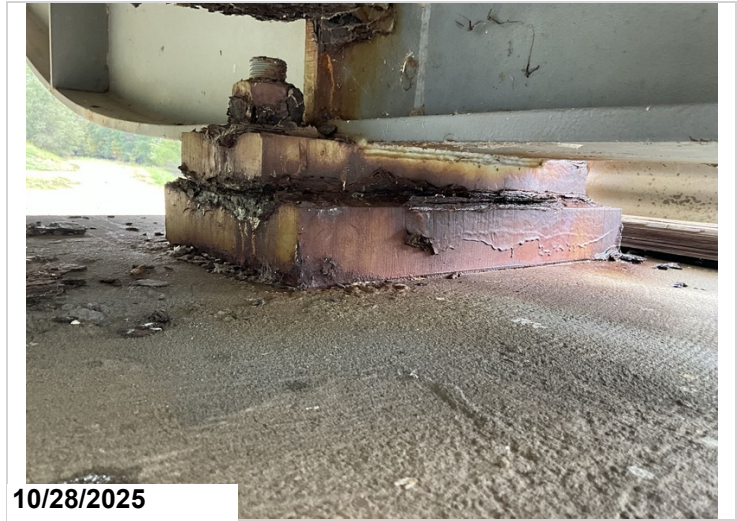
Pier 3, Bearings 1 - 4: Active corrosion with pack rust
between the sole and masonry plate. 4EA CS3 corrosion.

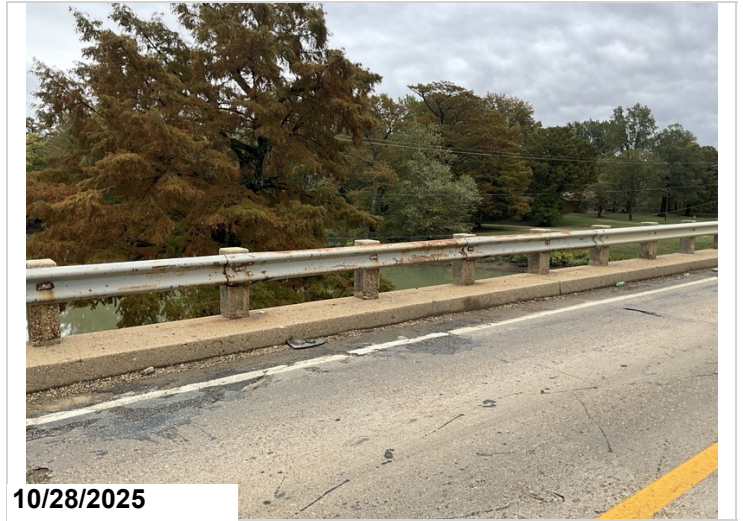
Spans 6 and 7: Typical bridge railing.

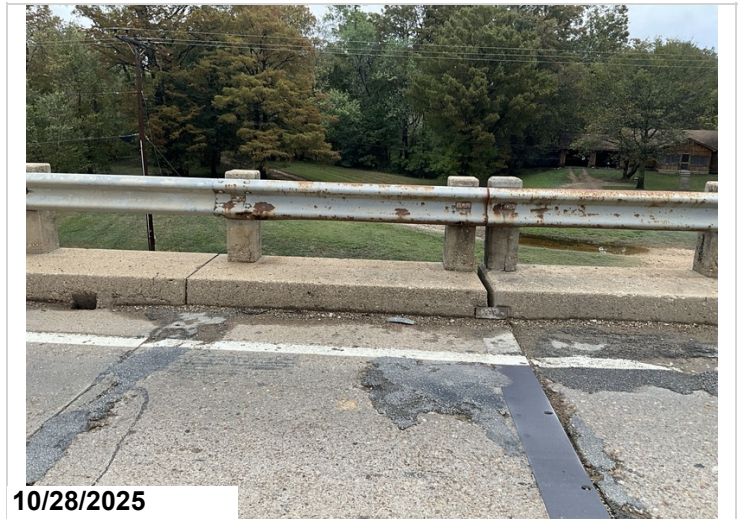
Span 10, Left: Active corrosion to the railing.
