Bridge 03024 Inspection Report

Route:62 Section:20 Log:3.55

District 10, 21 - Clay County

Team Lead: Brandon Sutton, Inspection Date: 10/30/2025

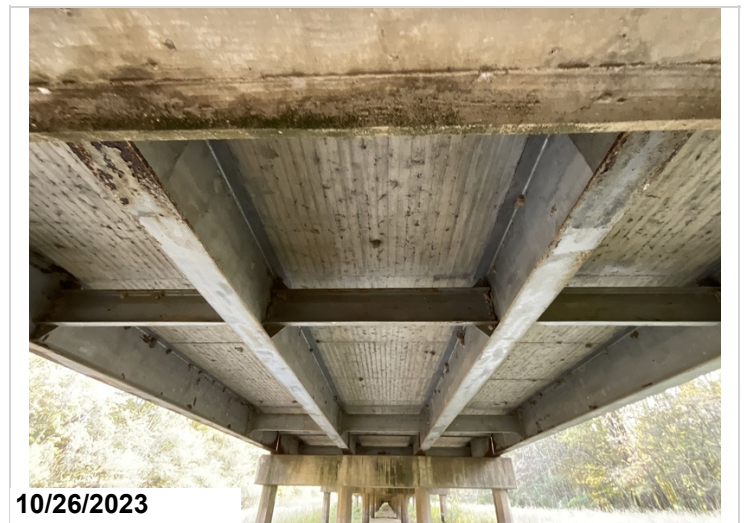
Span 2 under surface

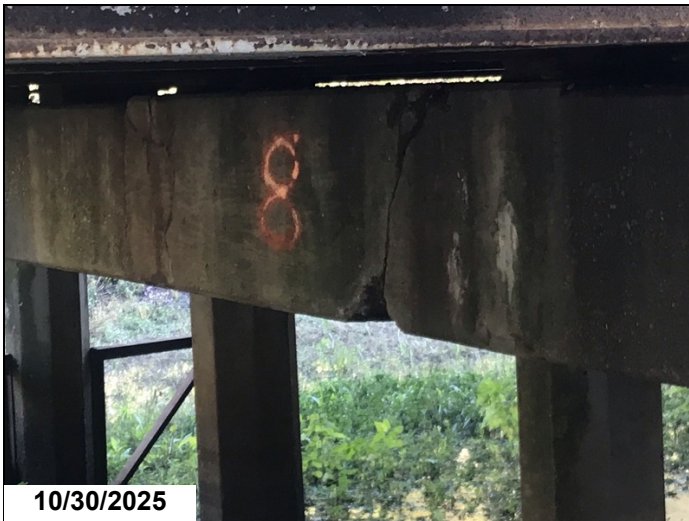
Bent 8 cap has possible settlement cracks near centerline and over piles 2 and 3. Cracks are up to 1/8" wide. Bottom of cap has efflorescence.

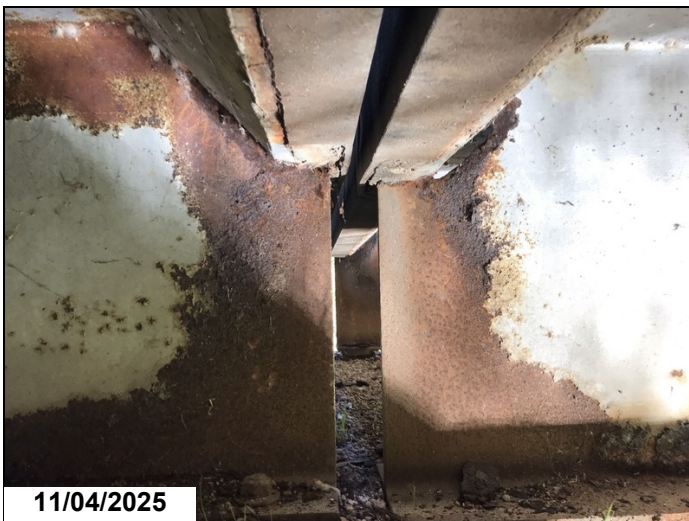
Span 18 bent 18 girder 2 has a 6" x 1" hole in web below haunch, with a 2" crack running back 1LF CS3.

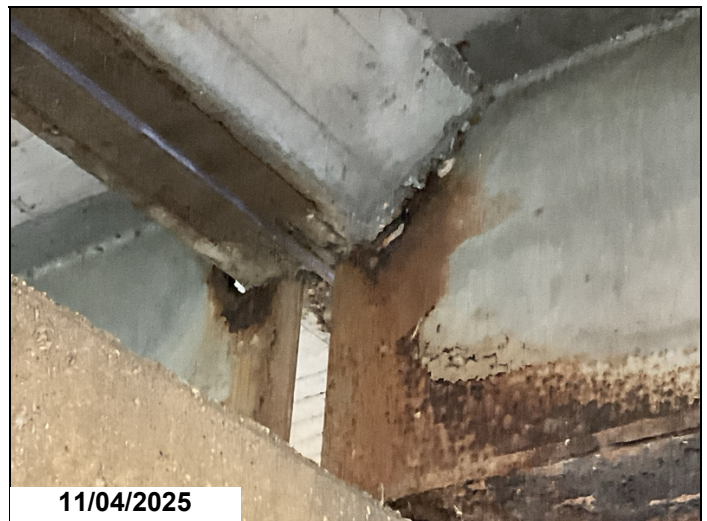
Span 6 bent 6 girder 3 has a 3" x 1" hole in web below haunch 1LF CS3.

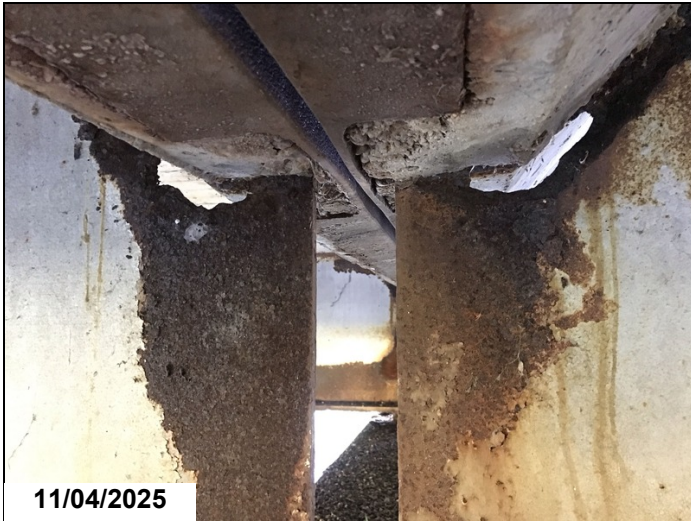
Span 11 bent 11 girder 3 has a 9" x 1" hole in web below haunch, with a 2.5" crack running ahead 1LF CS3.

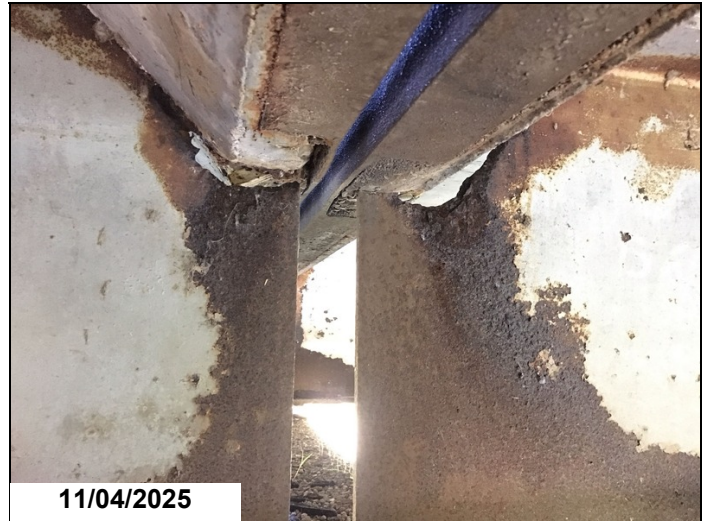
Span 14 bent 14 girder 2 has a 7" x 1.5" hole in web below haunch and girder is floating 1/16" 1LF CS3.

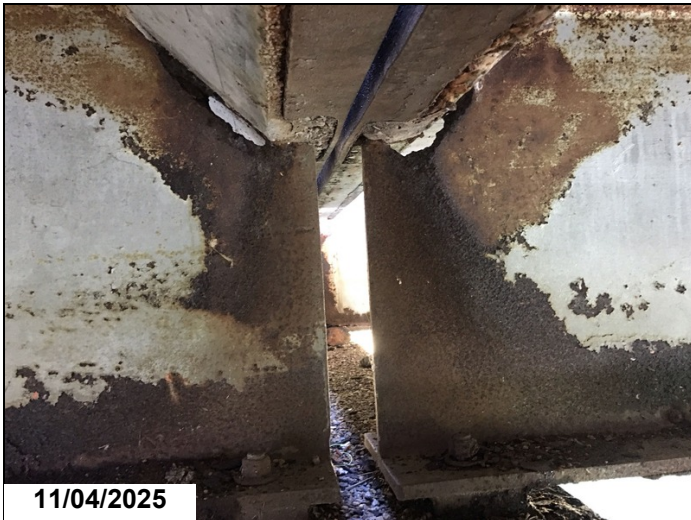
Span 15 bent 15 girder 2 has a 5" x 1" hole in web below haunch, with a 2" crack running ahead 1LF CS3.

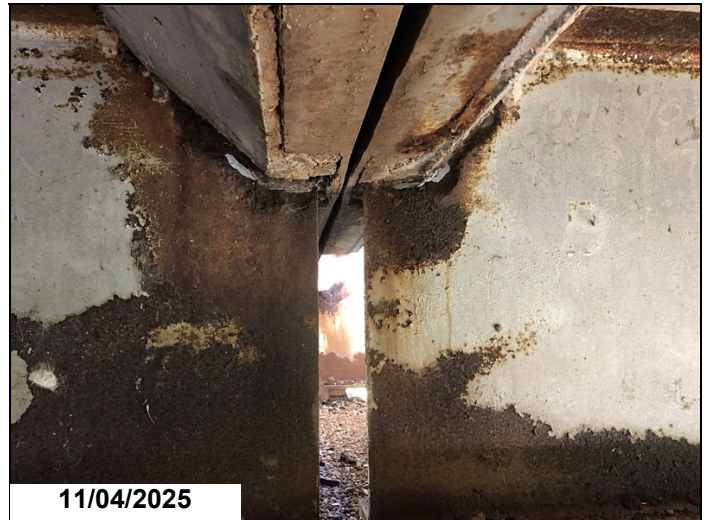
Span 16 bent 16 girder 2 has a 5" x 1in hole in web below haunch, with a 2" crack running ahead 1LF CS3.

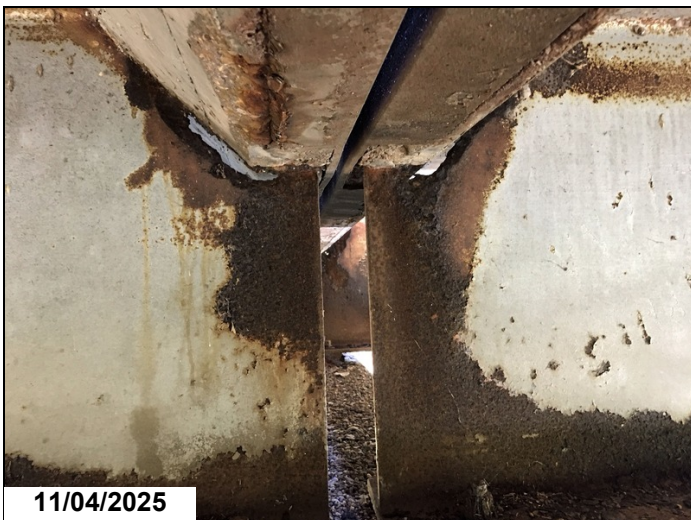
Span 17 bent 17 girder 2 has a 5" x 1" hole in web below haunch, with a 2" crack running ahead 1LF CS3.

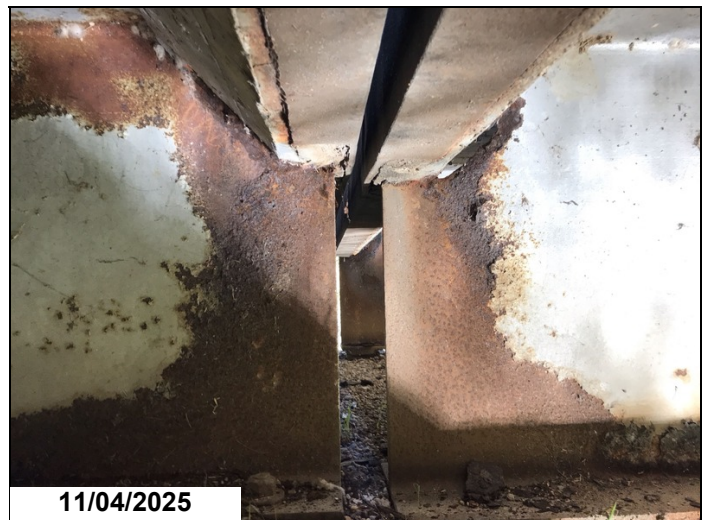
Span 18 bent 18 girder 2 has a 6" x 1" hole in web below haunch, with a 2" crack running back 1LF CS3.

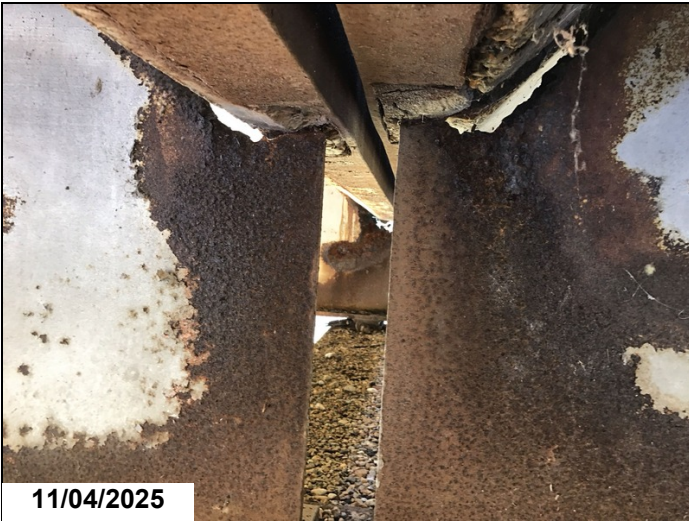
Span 18 bent 18 girder 3 has a 7" x 1" hole in web below haunch, with a 3" crack running back 1LF CS3.

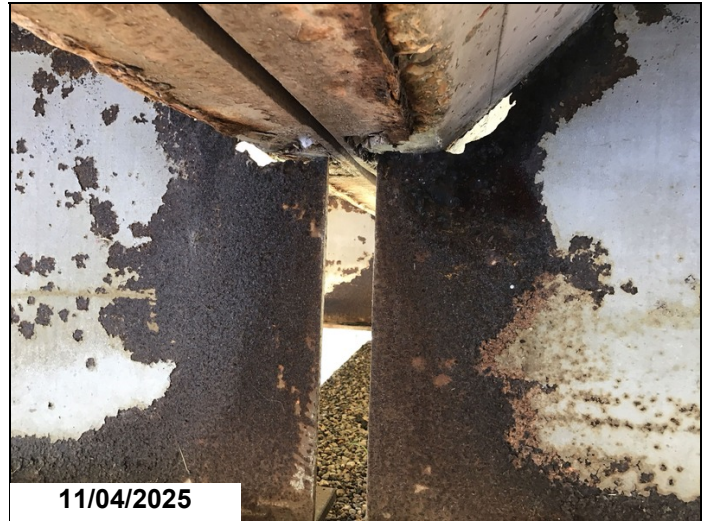
Span 19 bent 19 girder 3 has a 9" x 1" hole in web below haunch, with a 1" crack running back 1LF CS3.

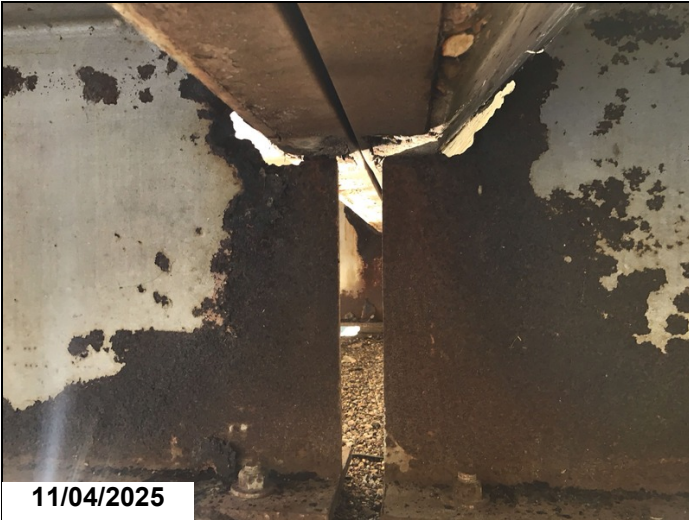
Span 20 bent 20 girder 3 has a 6" x 1" hole in web below haunch, with 2" crack running back 1LF CS3.

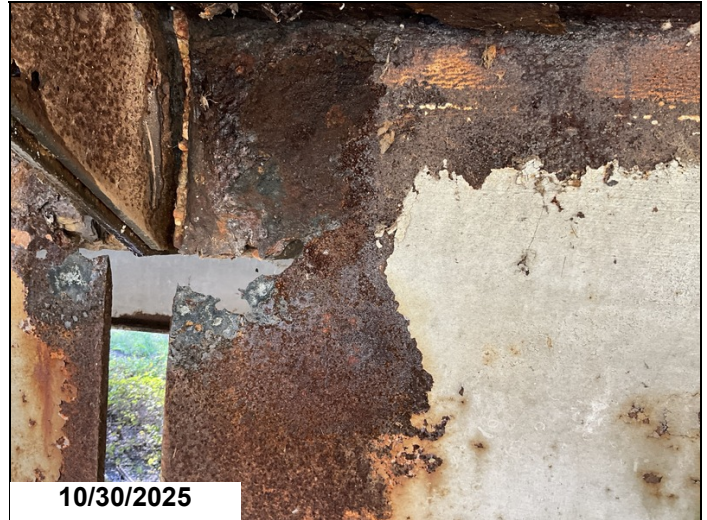
Span 16 bent 17 girder 1 has a 6" x 3" hole in web below haunch, with a 1" crack running back 1LF CS3.

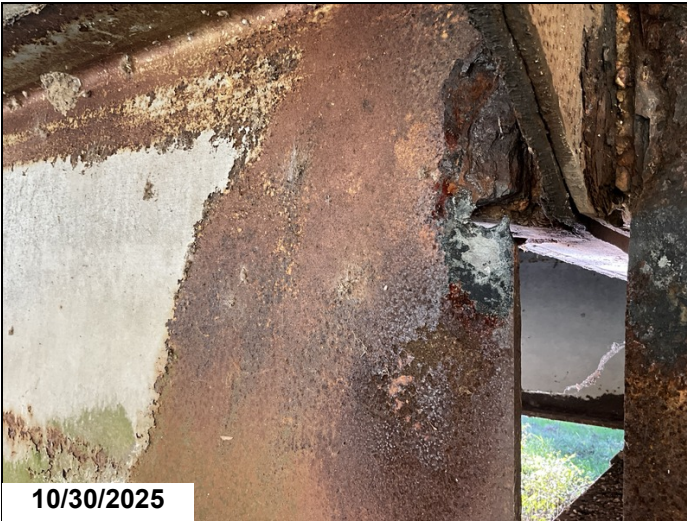
Span 16 bent 16 girder 1 has a 1" diameter hole in web below haunch, with a 1/4" crack running down and a 1/4" crack running ahead 1LF CS3.

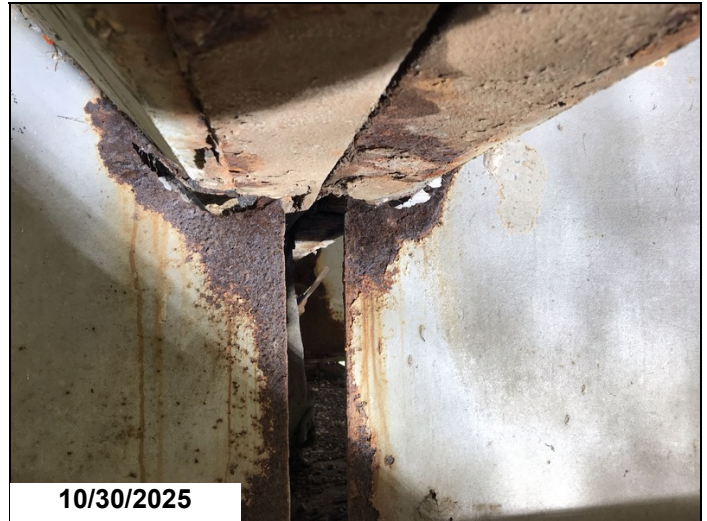
Span 19 bent 20 girder 2 has a 6" x 1" hole in web below haunch, with a 1" crack running ahead 1LF CS3.

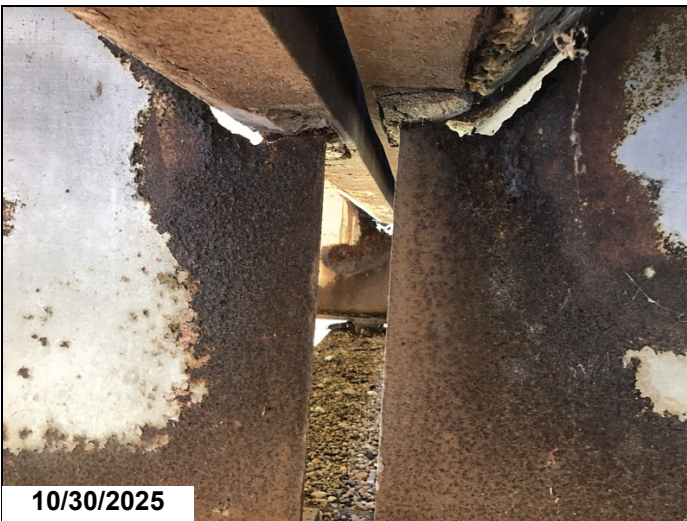
Span 17 bent 18 girder 3 has a 7" x 1" hole in web below haunch, with a 2" crack running ahead 1LF CS3.

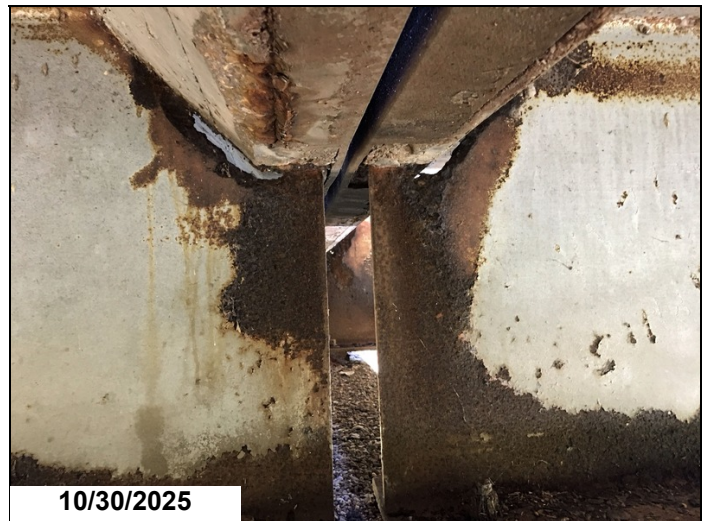
Span 16 bent 17 girder 2 has a 7" x 1" hole in web below haunch, with a 2" crack running ahead 1LF CS3.

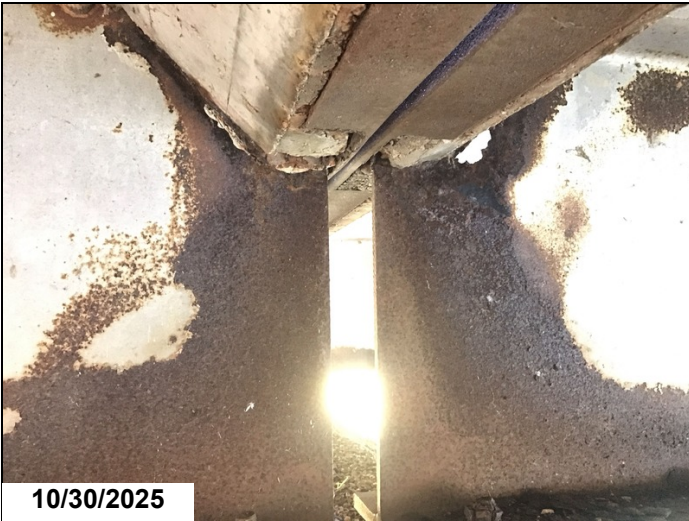
Span 9 bent 10 girder 2 has a 9" x 1" hole in web below haunch, with a 1" crack running ahead 1LF CS3.

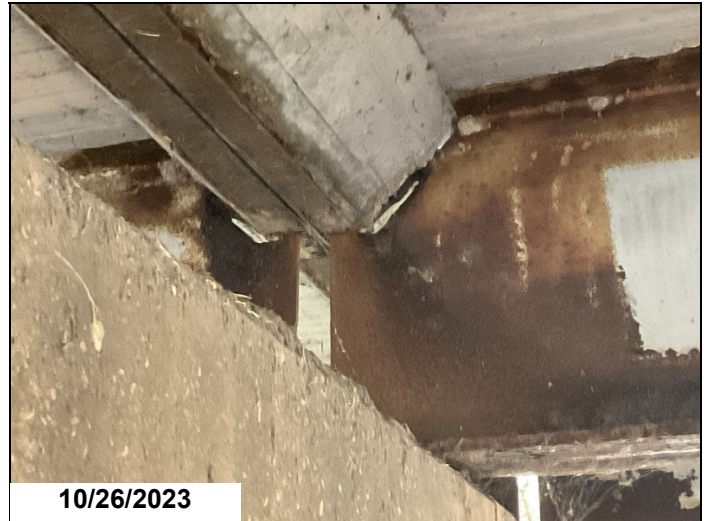
Span 7 bent 8 girder 2 has a 6" x 1" hole in web below
haunch, with a 2" crack running ahead 1LF CS3.

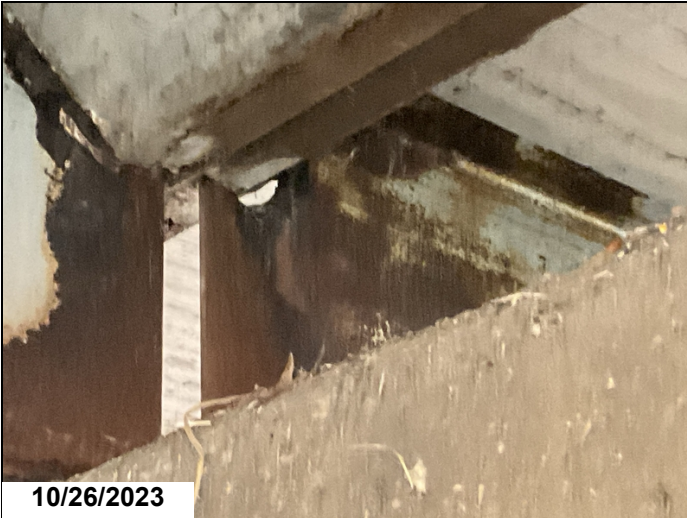
Span 7 bent 8 girder 3 has a 5" x 2" hole in web below
haunch 1LF CS3.

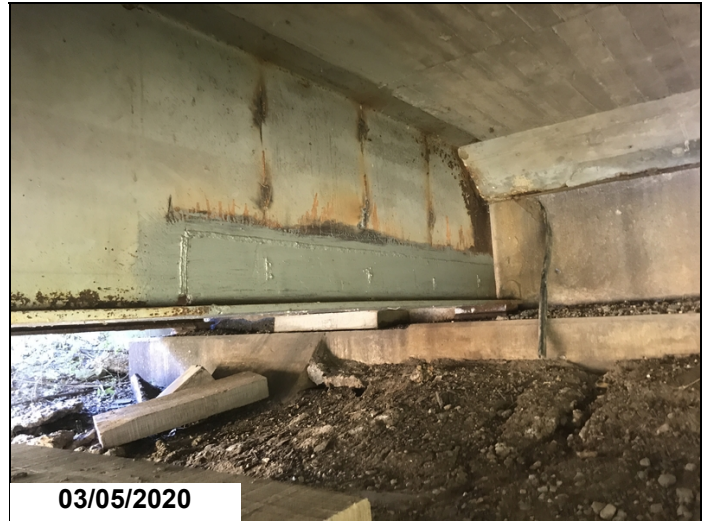
Span 21 bent 22 girder 2 was t-spliced in the past. Web below haunch has a 3" x ½" hole rusted through 1LF CS3. Girder is floating.

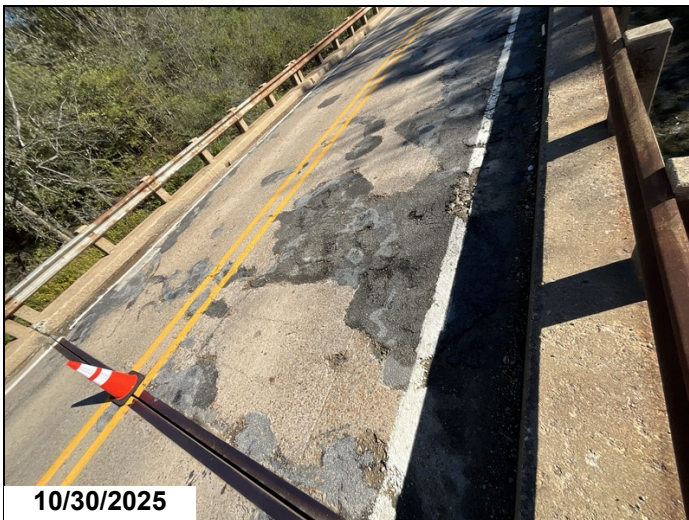
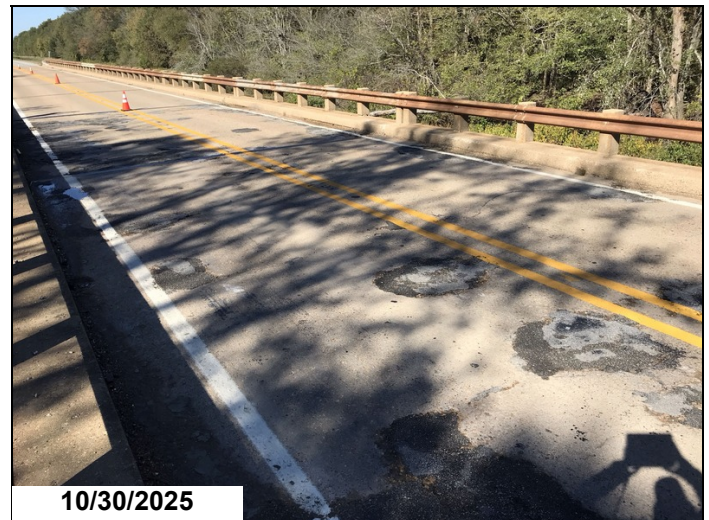
Span 9 top of deck
120 sq ft of spall CS3

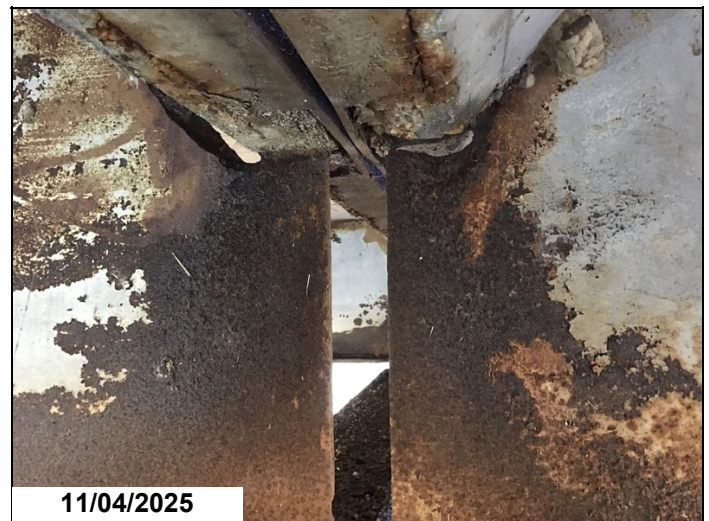
Span 7 bent 7 girder 2 has a 5" x 1" hole in web at haunch 1LF CS3.

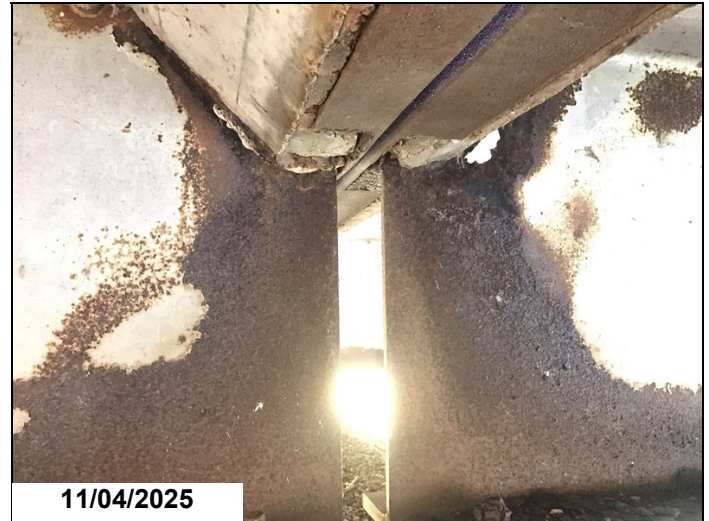
Span 10 bent 10 girder 2 has a 3" x 2" hole in web below haunch 1LF CS3.

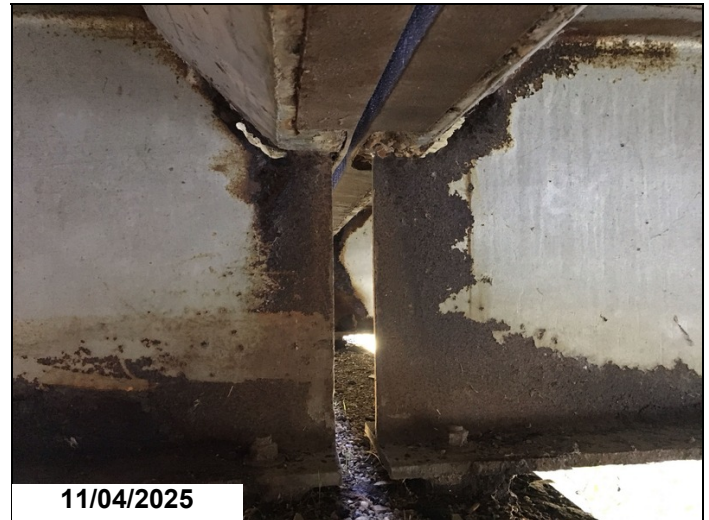
Span 11 bent 11 girder 2 has an 8" x 1" hole in web below haunch 1LF CS3.

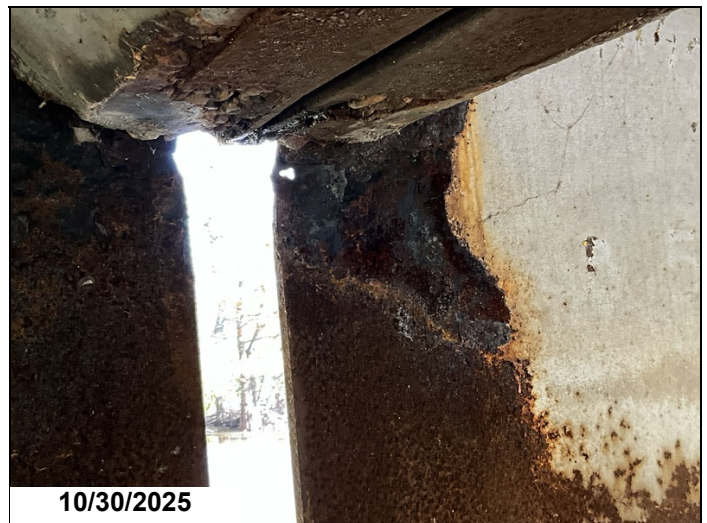
Span 20 bent 20 girder 1 has a 1" diameter hole in web below haunch 1LF CS3.

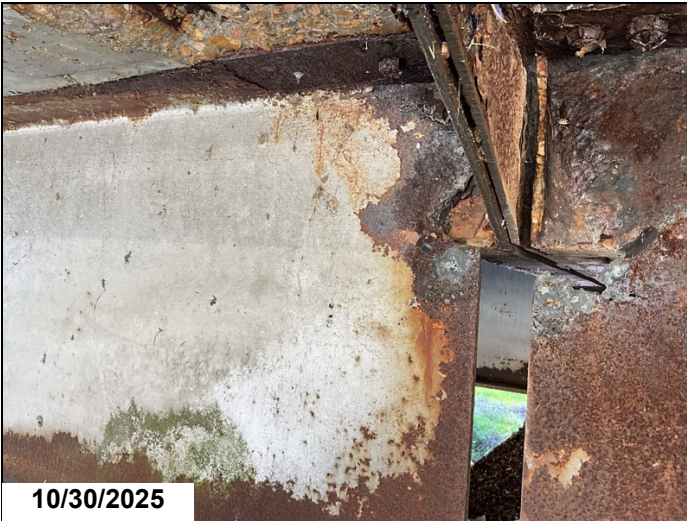
Span 17 bent 17 girder 1 has a 6" x 4" area in web below haunch, with holes rusted through 1LF CS3.

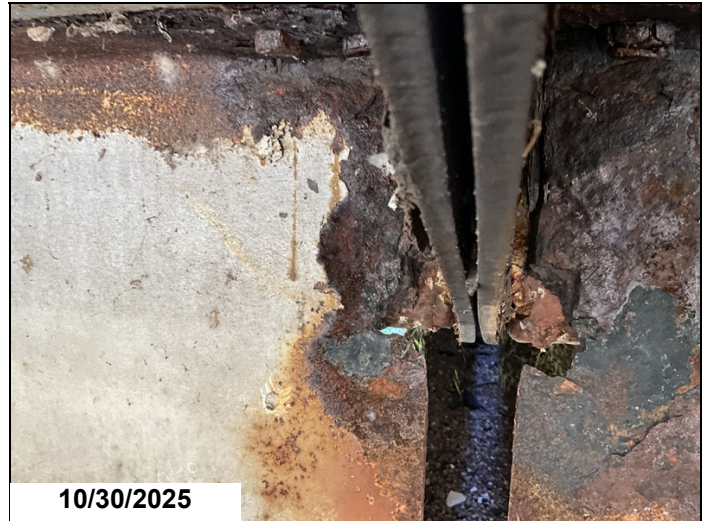
Span 14 bent 14 girder 1 has a 2" x 3" hole in web below haunch 1LF CS3.

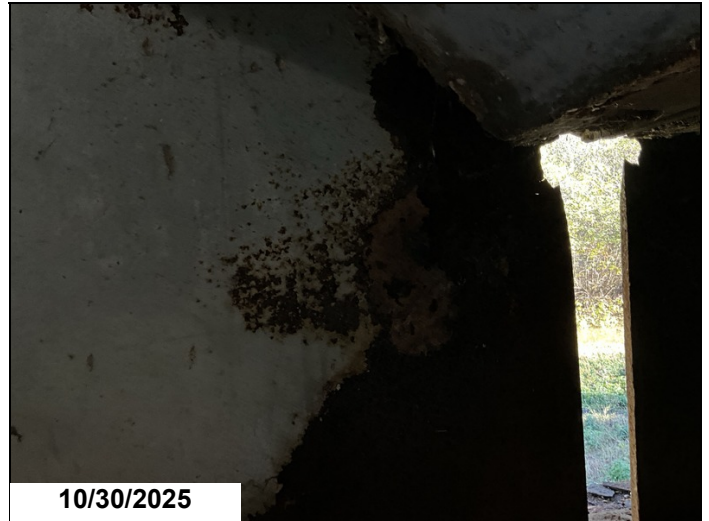
Span 9 bent 10 girder 1 has a 2" x 1" web below haunch 1LF CS3.

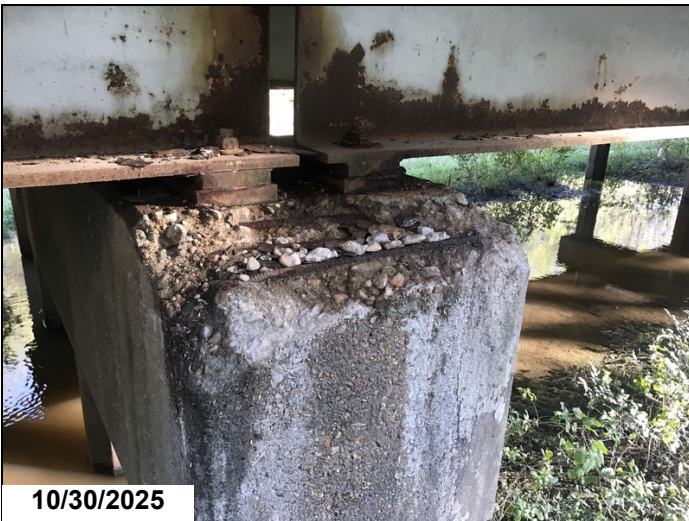
Bent 14 cap right end has a 1' spall near bearing area with exposed rebar CS3.

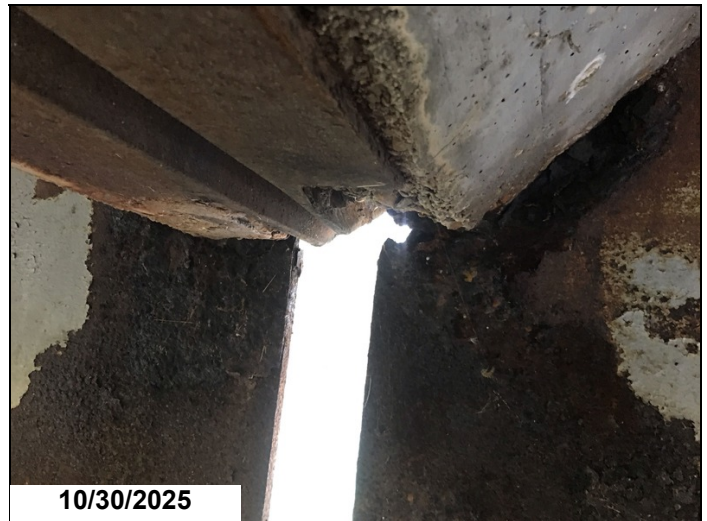
Span 12 bent 13 girder 4 has a 1" diameter hole in web below haunch 1LF CS3.

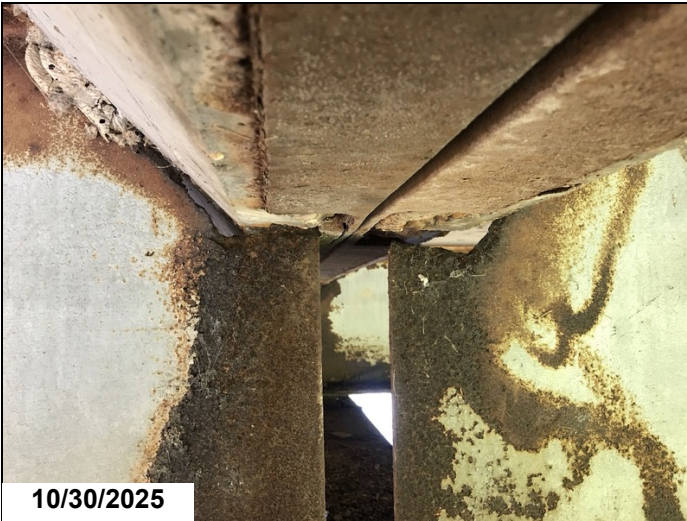
10/30/2025
Span 20 bent 21 girder 3 has a 4" x 1" hole in web below haunch, with a 2" crack running ahead 1LF CS3.

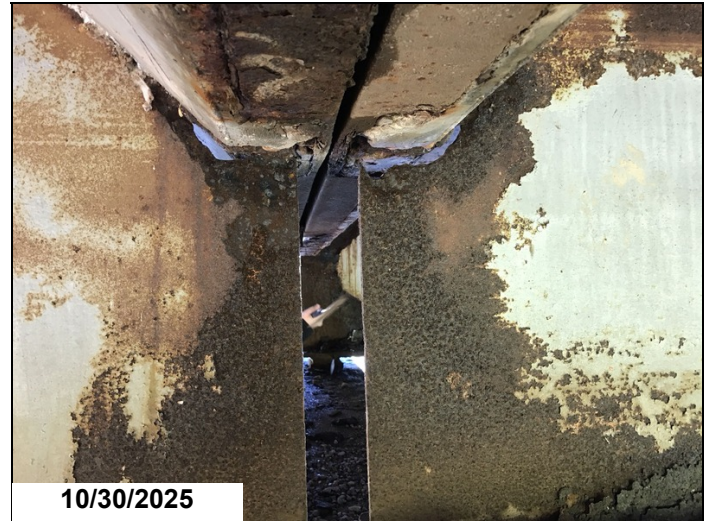
10/30/2025
Span 20 bent 21 girder 2 has a 4" x 1" hole in web below haunch, with a 2" crack running ahead 1LF CS3.

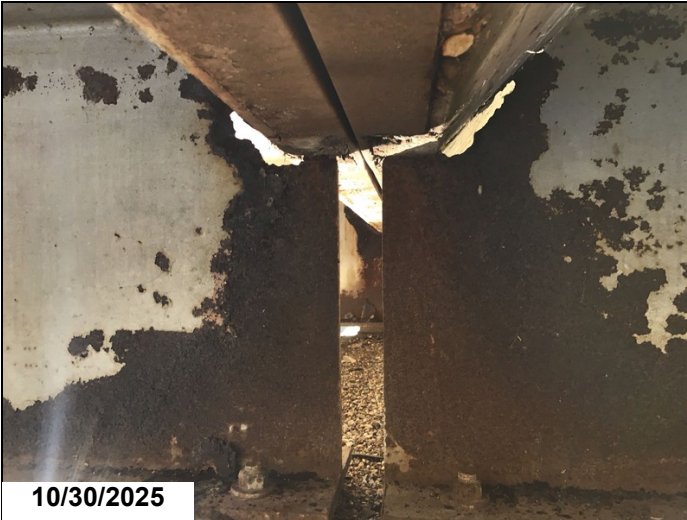
10/30/2025
Span 19 bent 20 girder 3 has a 7" x 1" hole in web below haunch 1LF CS3.

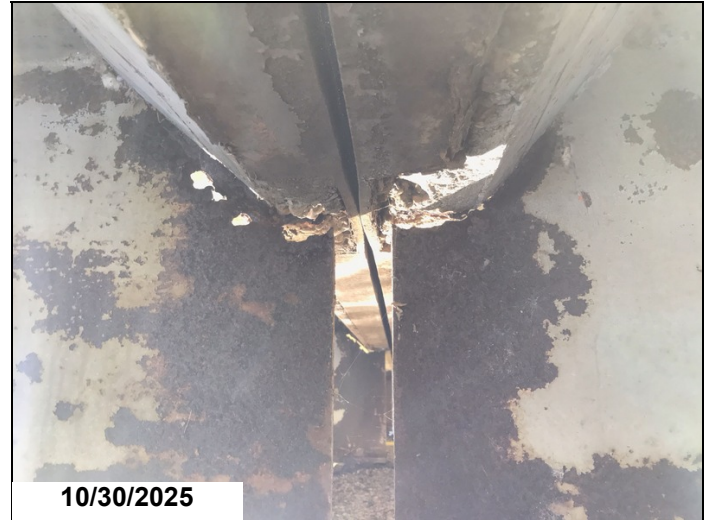
10/30/2025
Span 18 bent 19 girder 2 has a 5" x up to 1" hole in web below haunch 1LF CS3.

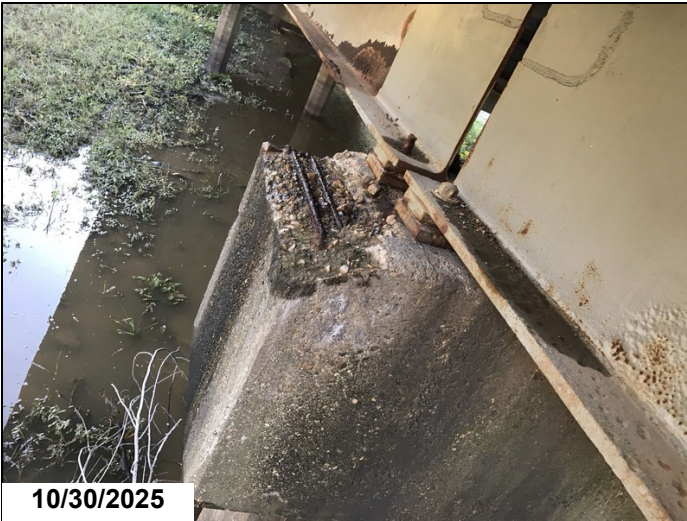
Bent 3 left has a 1' spall with exposed rebar.
rebar CS3.

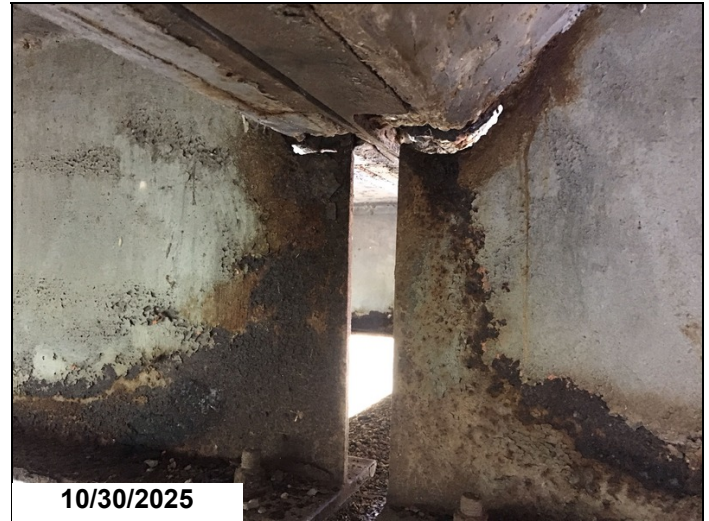
Span 1 bent 2 girder 2 has a 5" x 1" hole in web below
haunch 1LF CS3.

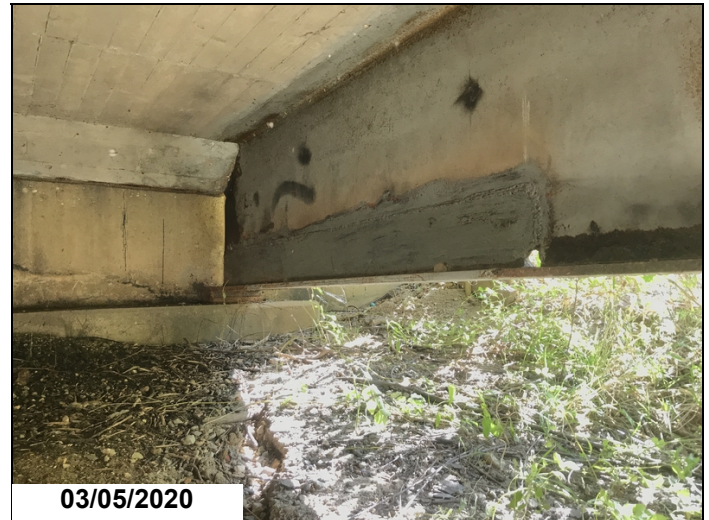
Span 21 bent 22 girder 4 bottom of web was t-spliced in
the past, web below haunch has a 1" diameter hole 1LF
CS3.

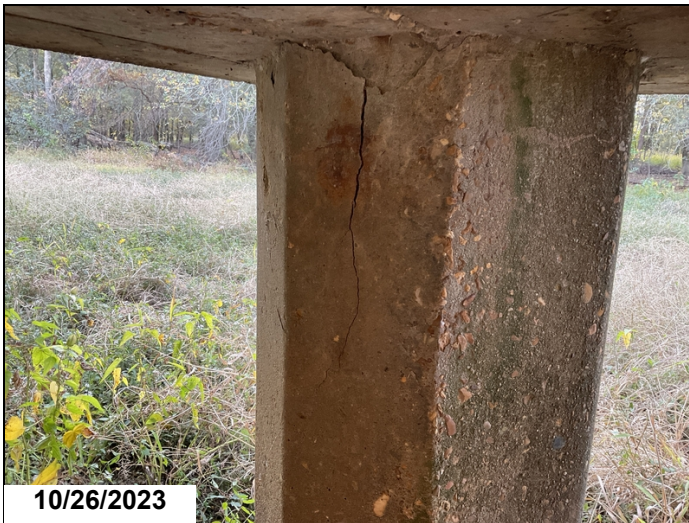
Bent 7 pile 4
10-26-2023

Bent 7 pile 4 has cracks with rust stains near top.
