## Bridge 03241 Inspection Report

SH 93-01- LM 4.73 over UPSHAW CR

Location: 1.05 MI E ELEVEN POINT RI

Team Lead: Richard Jones Inspection Date: 01/13/2025

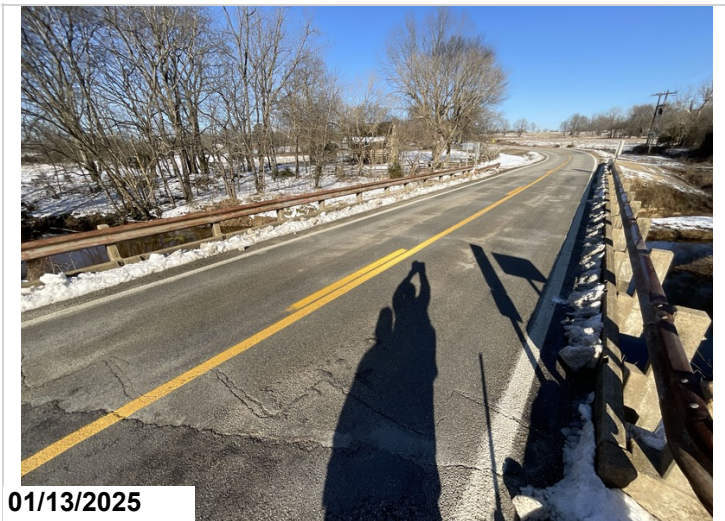
Wearing surface

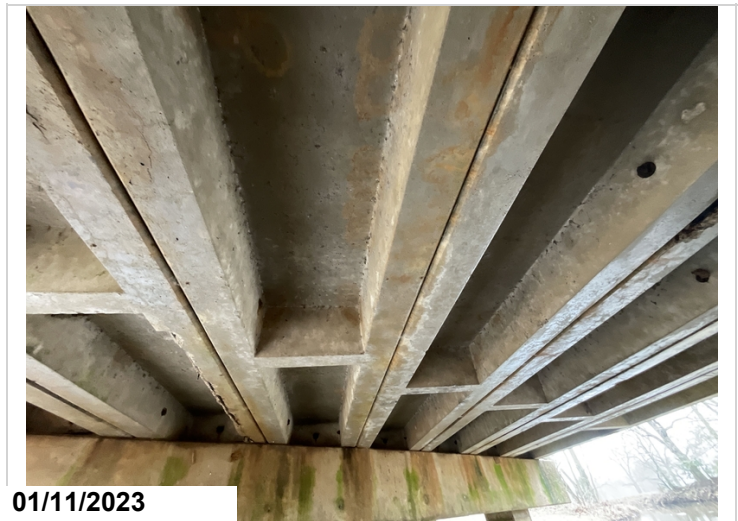
under surface

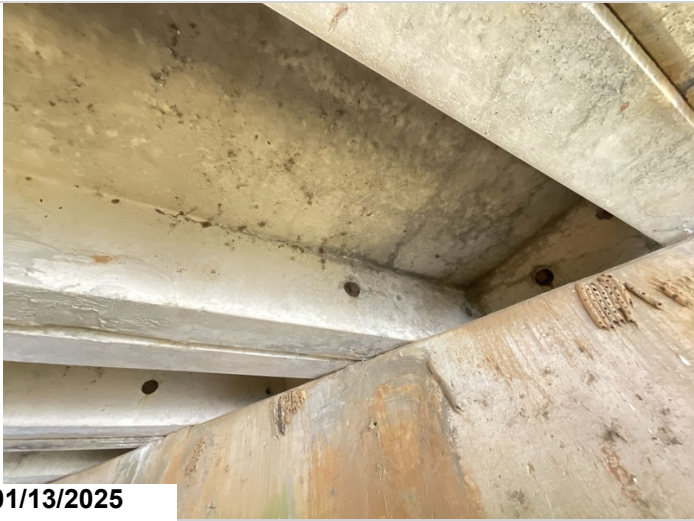
Span 1 bent 2 unit 5 Lt leg 2' patch CS2

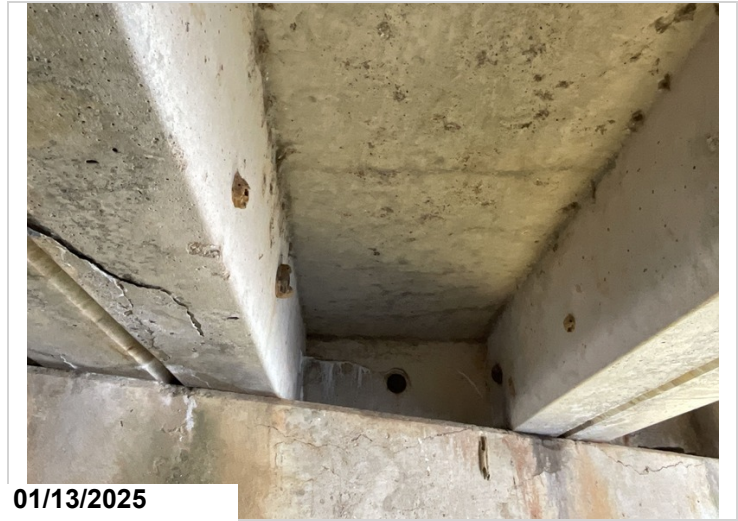
Span 1 bent 2 unit 6 cracks CS2 and 3

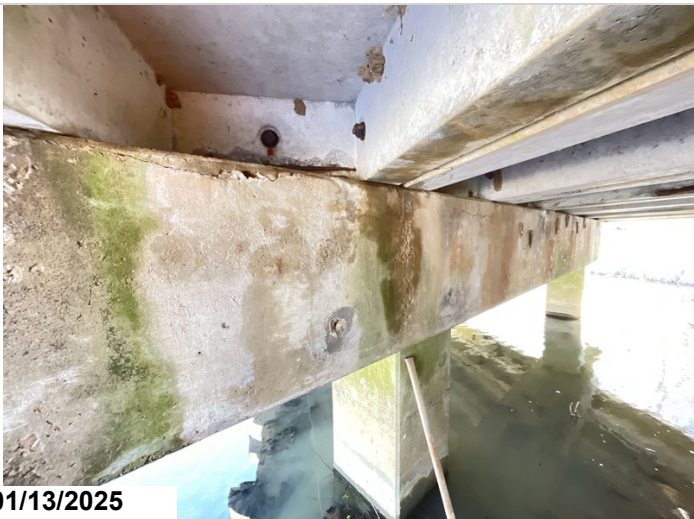
Bent 2 cap typical cracks/delaminated areas

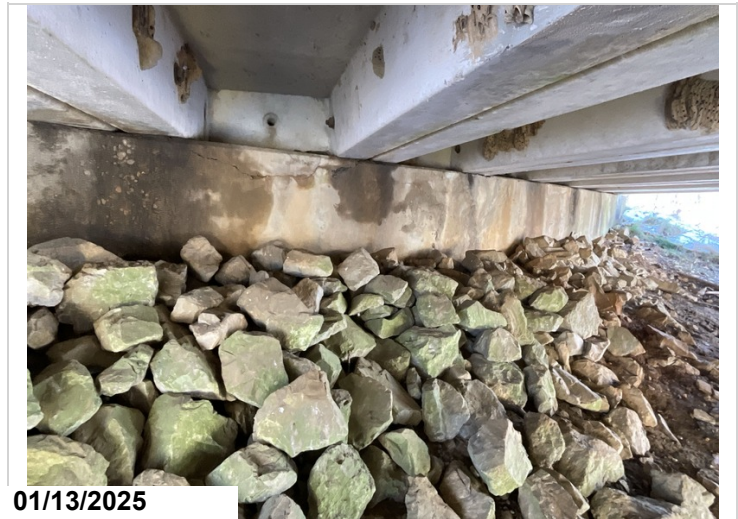
Bent 1 crack/delam CS3

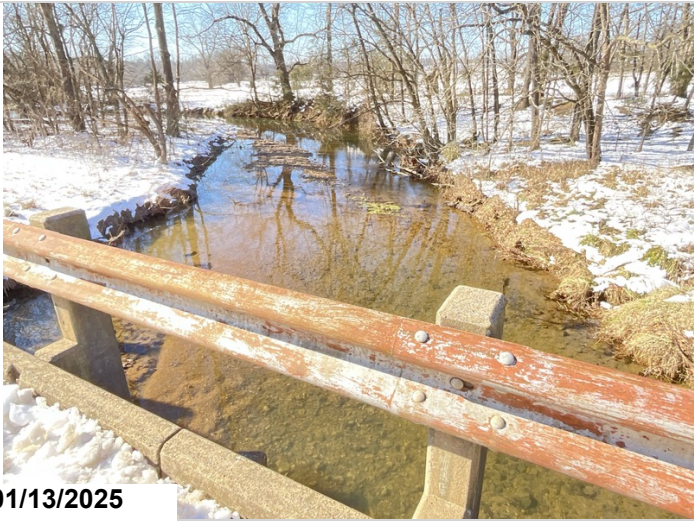
Channel Lt

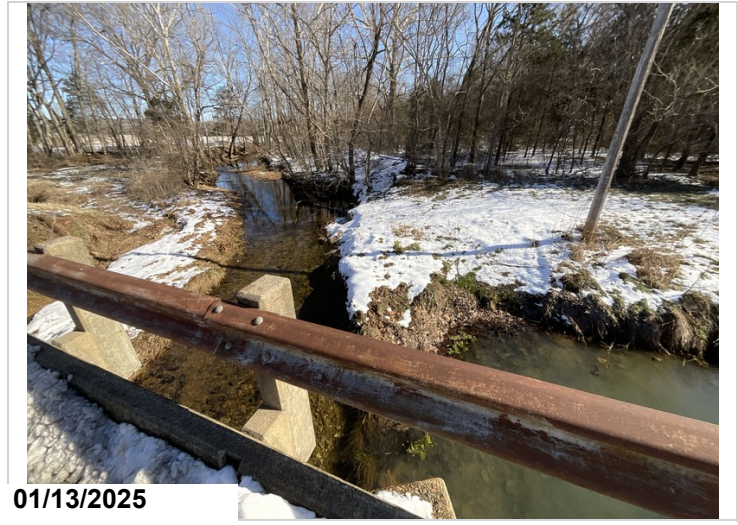
Channel has a minor scour hole at spans 2 and 3 to the Rt of structure.

Channel Rt

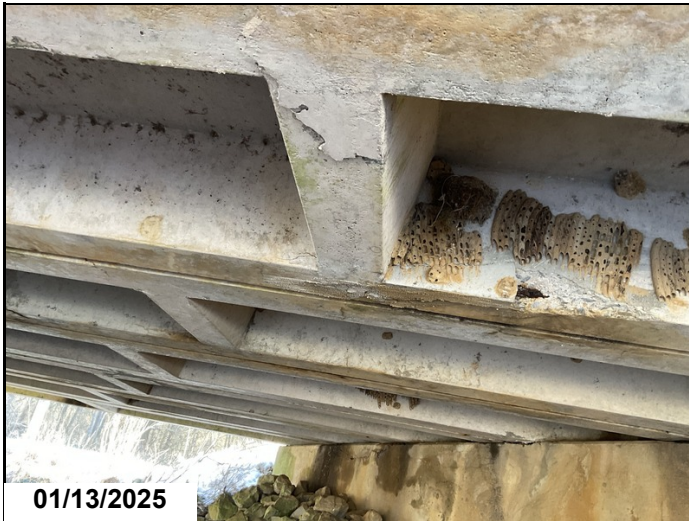
Girder portion of precast units have a few longitudinal cracks/delaminated areas, patched areas, and spalls with rebar exposed.

Span 1 unit 2 rebar CS3

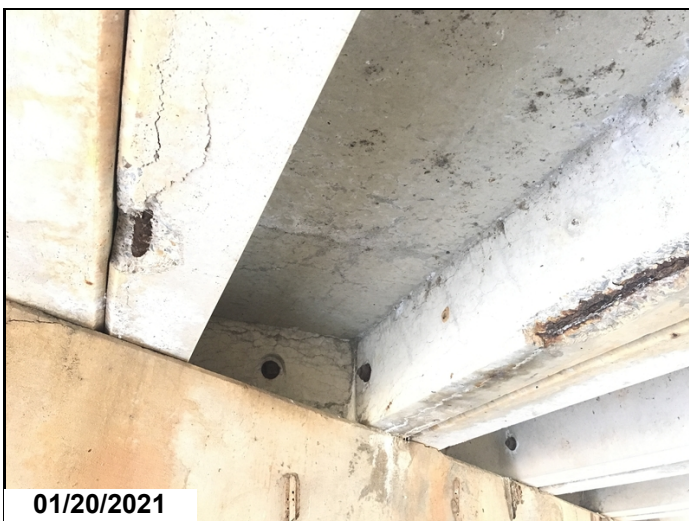
Span 1 unit 3 rebar CS3

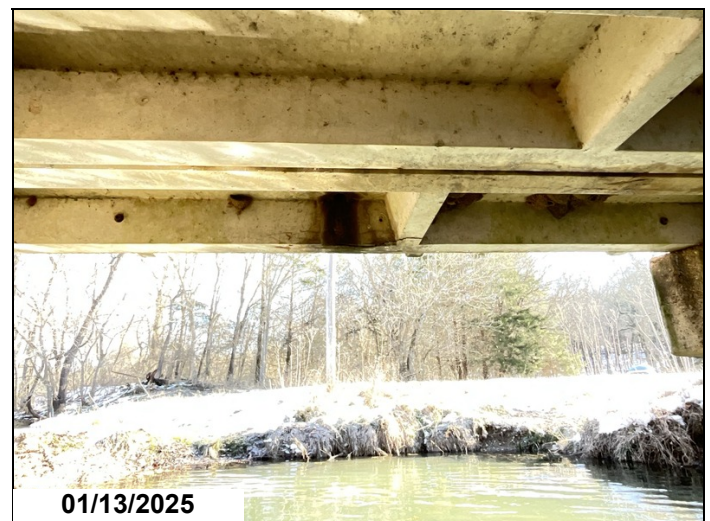
Span 2 unit 7 cracks CS3

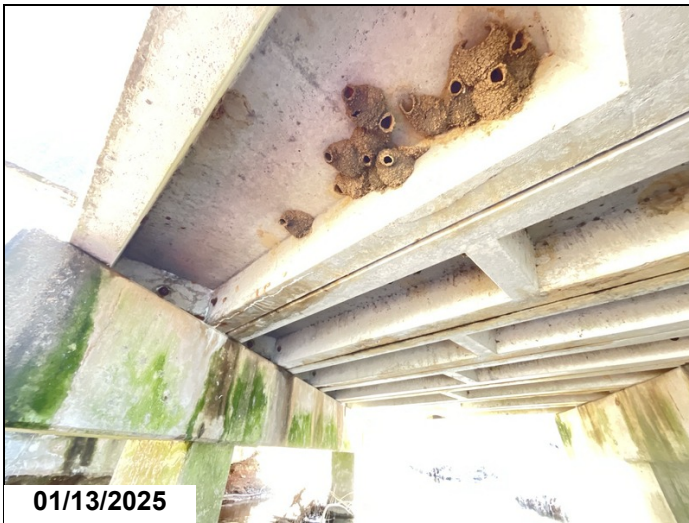
Ends of a few units have map cracking with some efflorescence and rust stains.

Span 3 unit 1 efflorescence/rust CS3

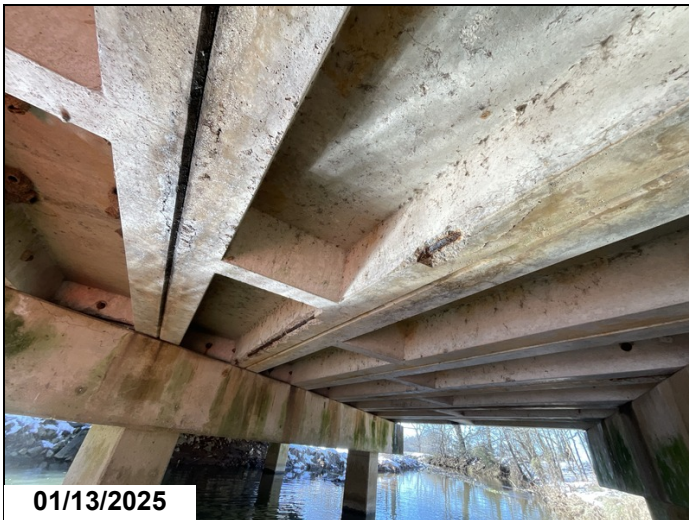
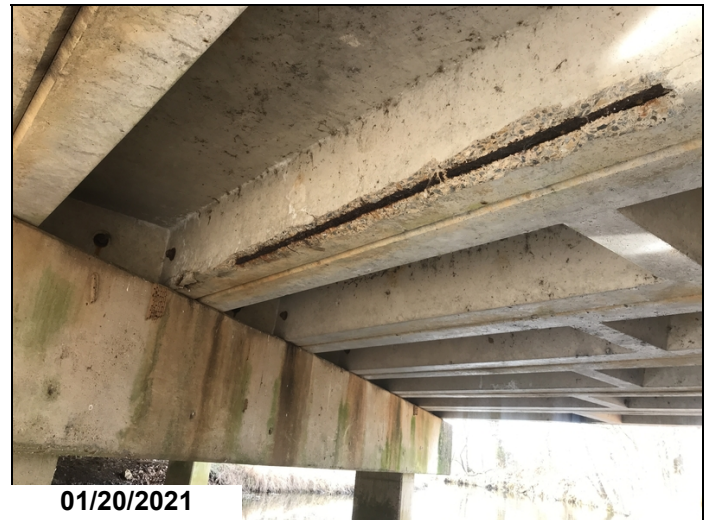
Span 3 unit 6 rebar CS3

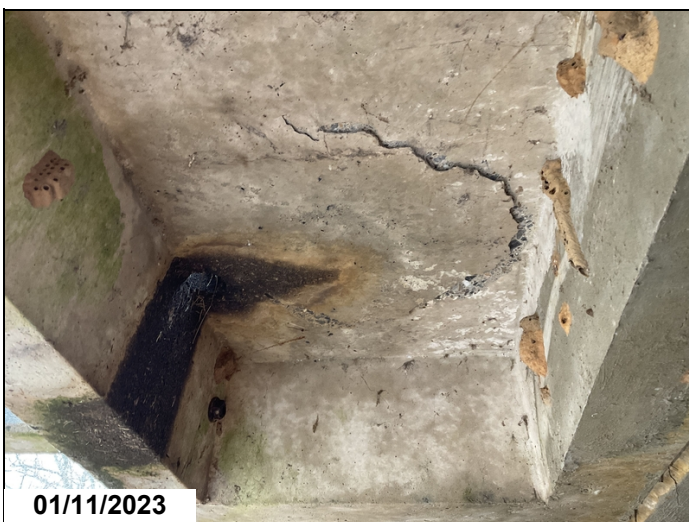
Span 4 unit 1 undersurface delam

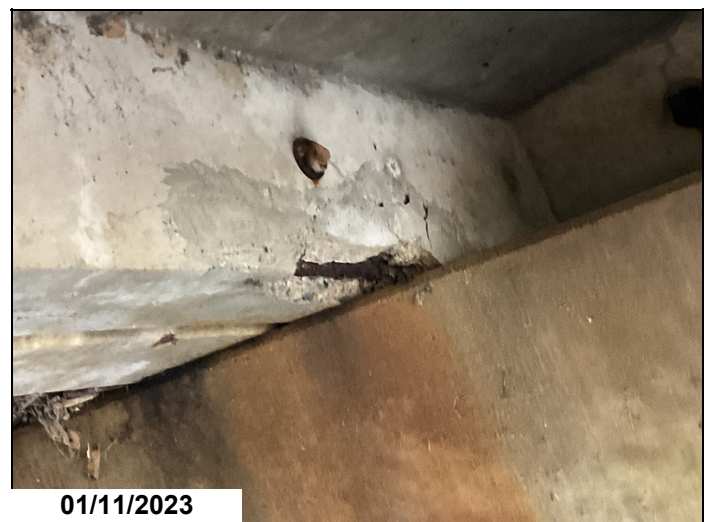
Span 4 unit 4 rebar CS3

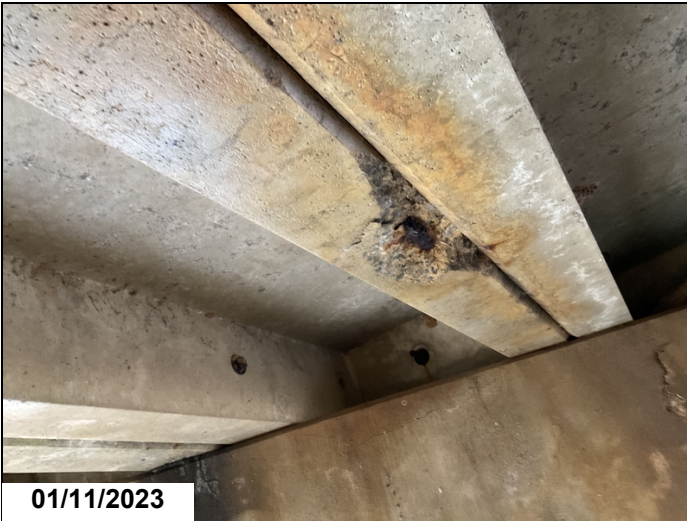
Span 4 unit 6 rebar CS3

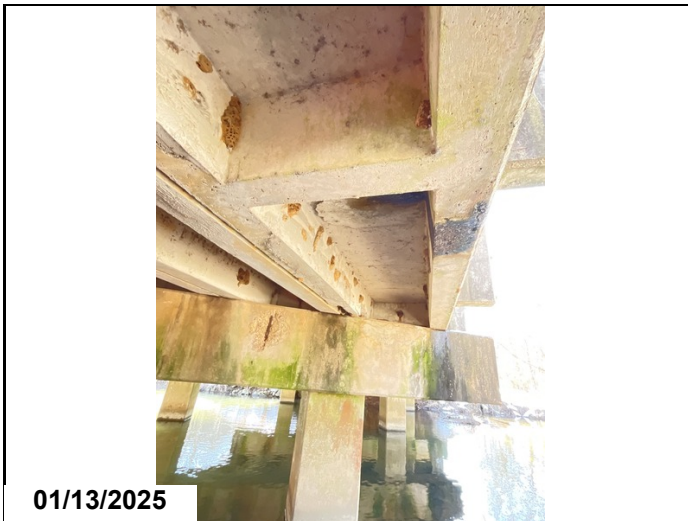
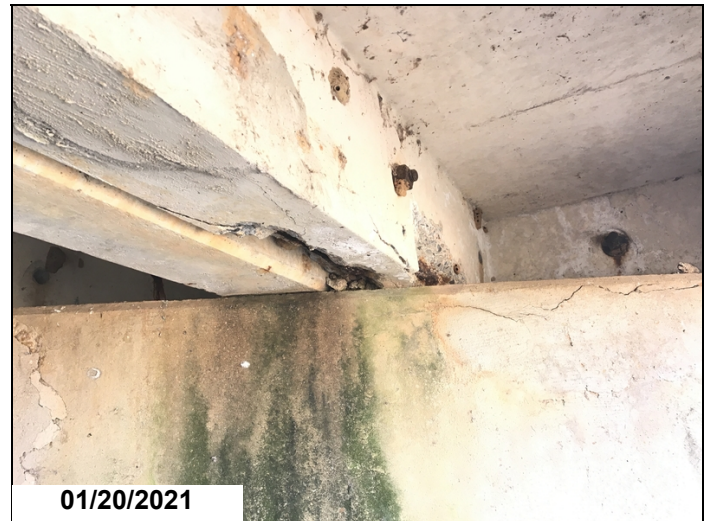
Span 4 unit 1

Span 4 bent 4 unit 1 Rt leg has a 1.5' spall with exposed rebar over cap.

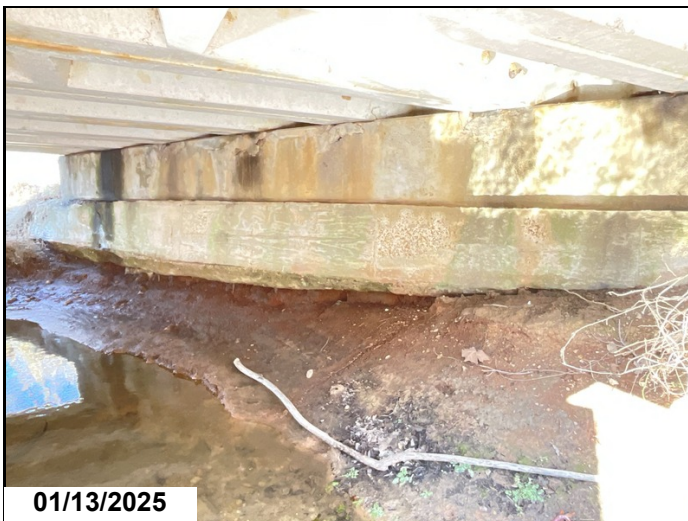
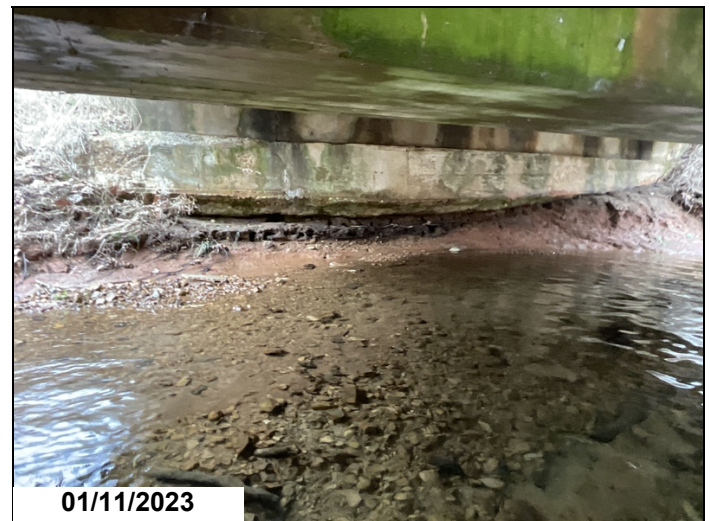
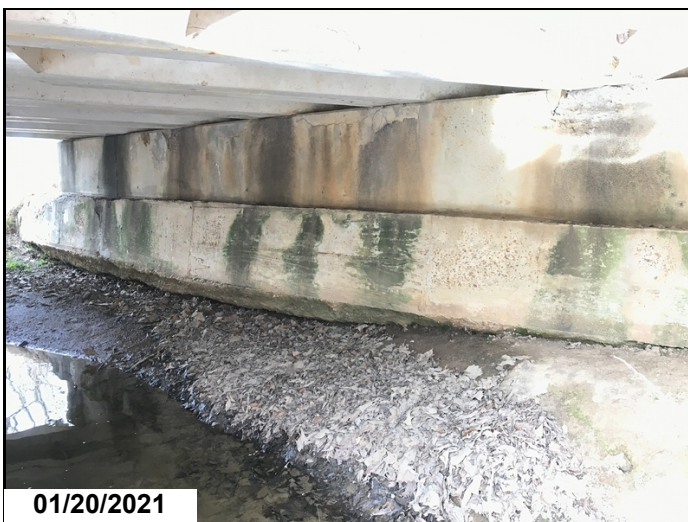
Bent 5 was built as an open abutment. A concrete scour repair was added under cap portion sometime in the past. Scour repair is undermined up to 1.5' below and 1' back under.

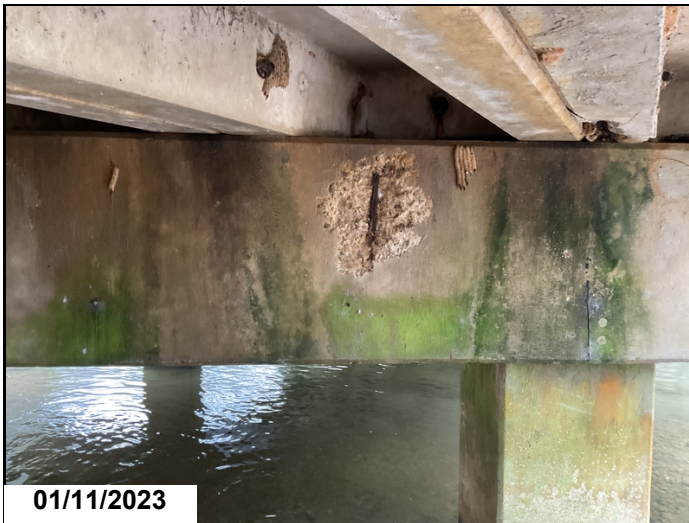
(234) Caps have horizontal cracks (3' CS2, 19' CS3) and delaminated or spalled areas under units. 3' CS2, 4' CS3 Bents 2 and 4 have shallow spalls with exposed rebar from lack of coverage. CS3							
330	Metal Bridge Railing	LF	160	0	160	0	0
1000	Corrosion	LF	160	0	160	0	0
515	Steel Protective Coating	SF	510	0	255	127	128
3440	Effectiveness (Steel Protective Coatings)	SF	510	0	255	127	128

Bent 4 ahead rebar CS3

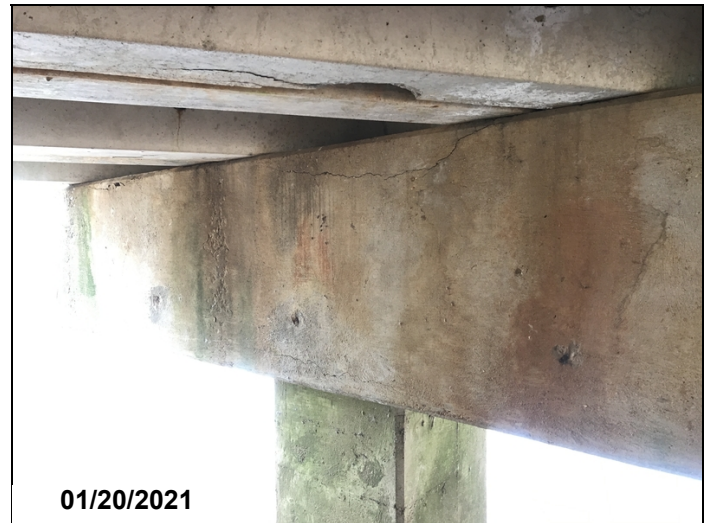
Caps and abutments have horizontal cracks and delaminated/spalled areas under units.

typ cap cracks/delam CS3

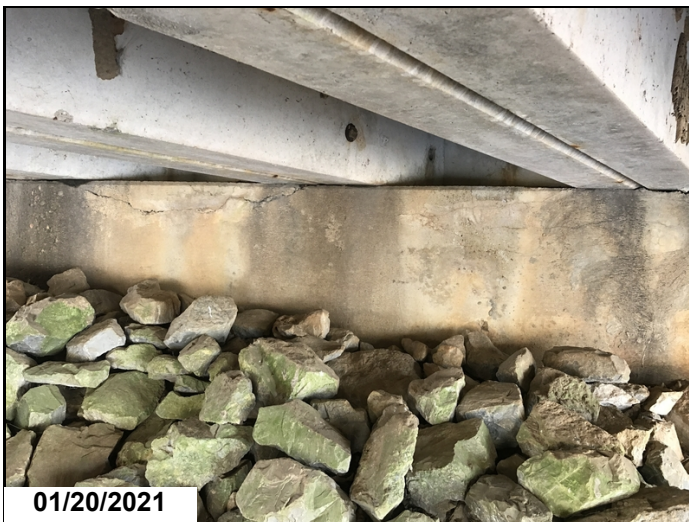
Bent 1 cracks/delam CS3

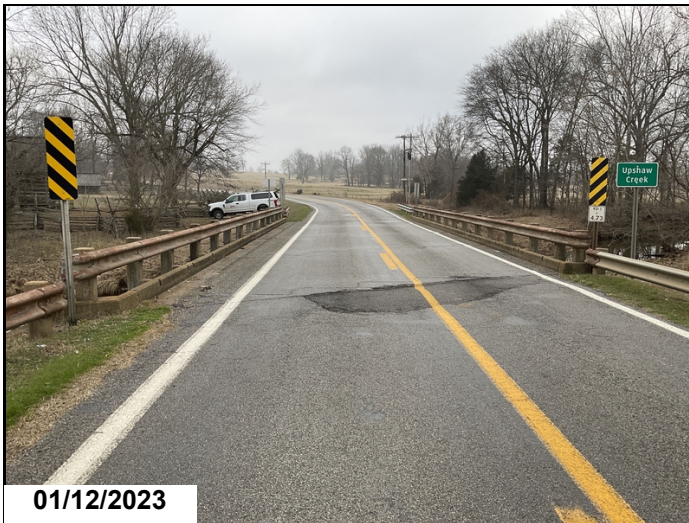
North

Bent 1 (south) approach roadway has up to 1 1/2in settlement, previously patched with asphalt but continuing to settle.

Approach roadway has an asphalt shim. RRJ
