Bridge 03254 Inspection Report

SH 93-01- LM 5.78 over ELEVEN POINT RIVER

Location: 5.78 MI NW JCT SH 93 & 90

Team Lead: Richard Jones Inspection Date: 09/10/2025

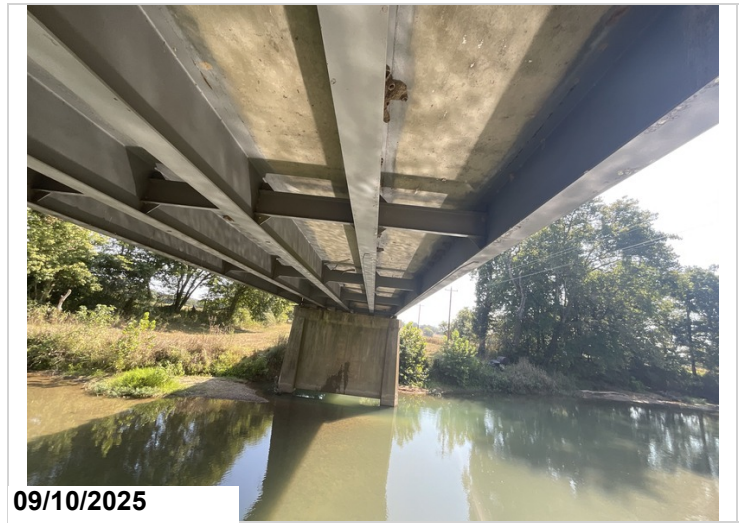
Main undersurface bay 1 efflorescence

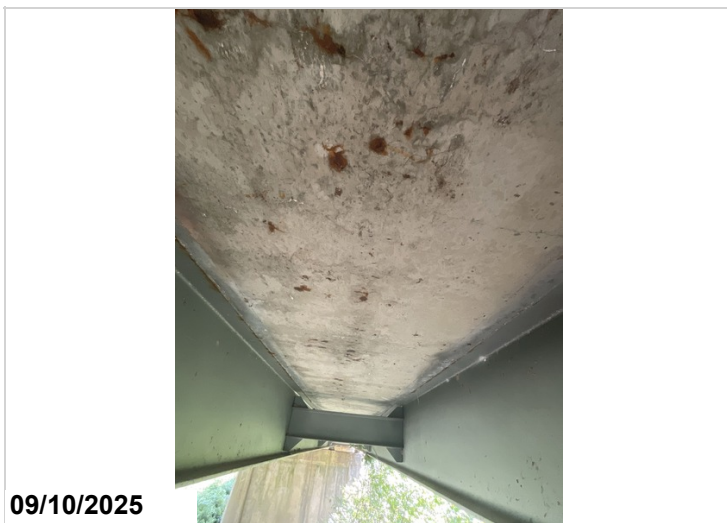
Span 14 bay 1 rust

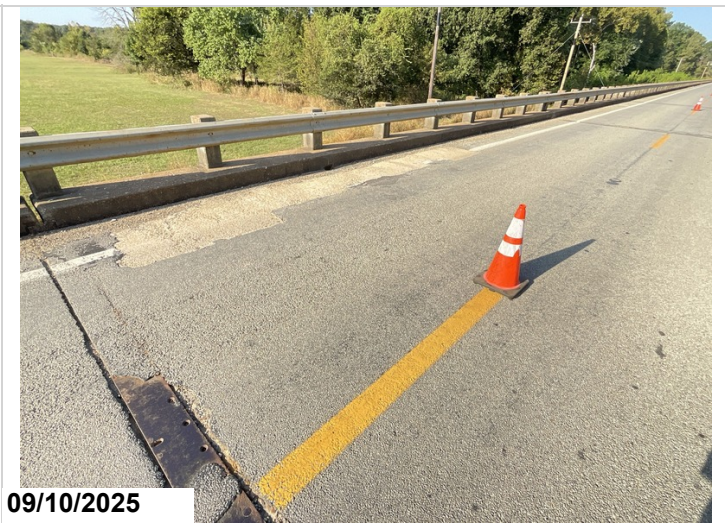
Span 5 Lt gutter typical of several patched areas

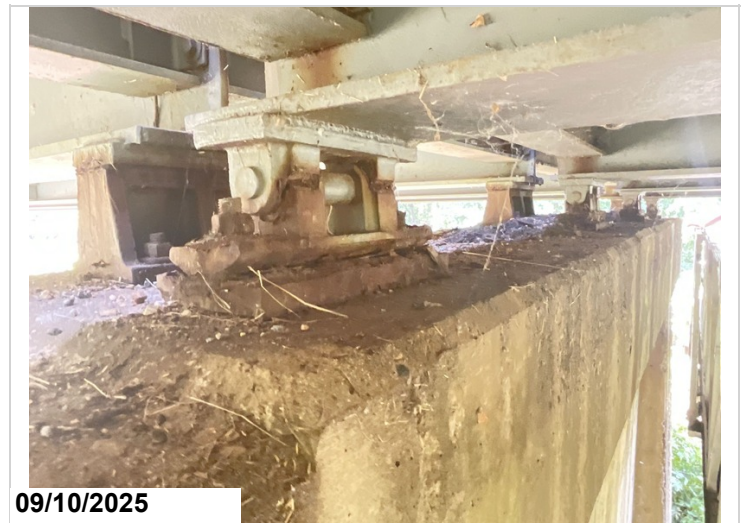
Bent 15 bearings corrosion and pack rust CS3

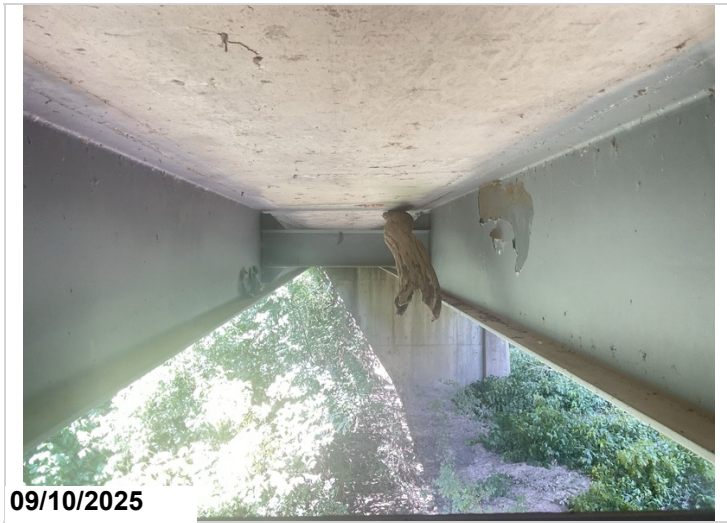
Span 14 paint 60' CS2

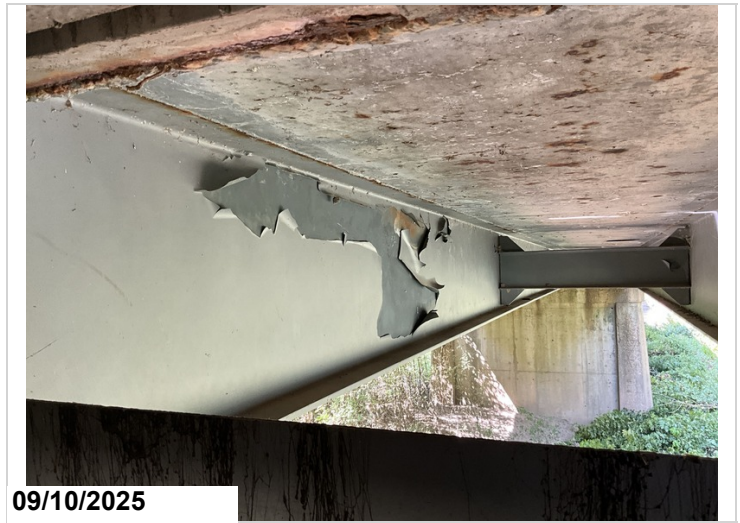
Span 14 Bent 14 Girder 4 Right side paint peeling. CS2 and CS3

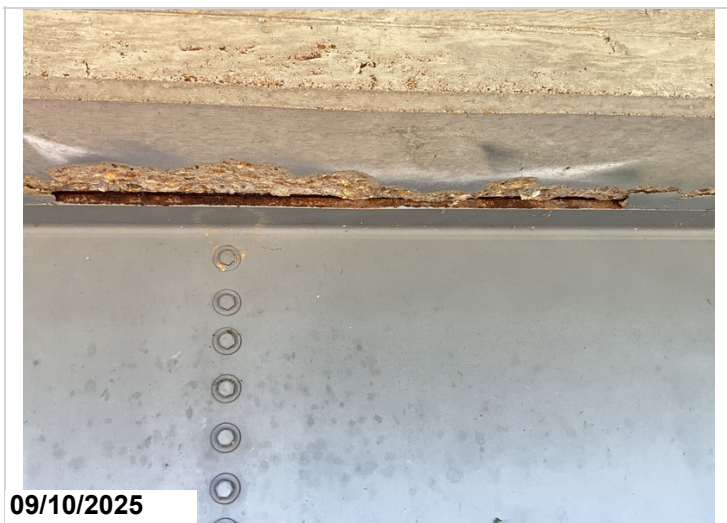
Span 7 Girder 5 Right side top flange is separating from deck

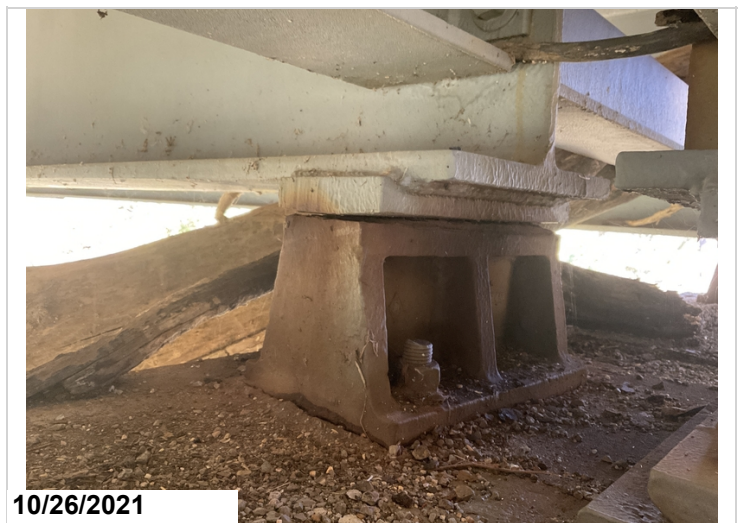
(313) Fixed bearings have pack rust and section loss, 50 CS3: Span 12 bent 12 bearing 4 has up to a 1/4" gap between bearing and masonry plate. Bent 16 and 17 ahead bearing 2 pushed back with 1/4" gap on ahead side. Span 17 bent 17 bearings 1, 2, and 3 pushed back with up to 1/4" gap on ahead side. Span 17 bent 17 bearing 3 has up to 1/8" gap between cap and bearing.

Span 12 bent 12 bearing 4 pack rust CS3

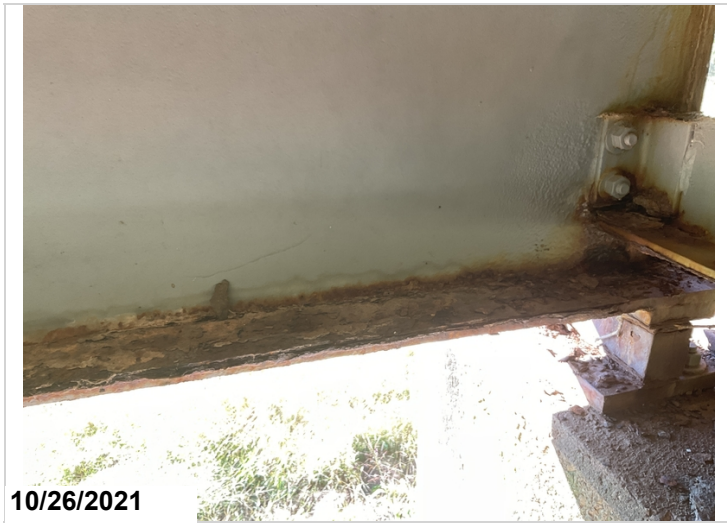
Span 4 bent 5 girder 1 active corrosion CS2

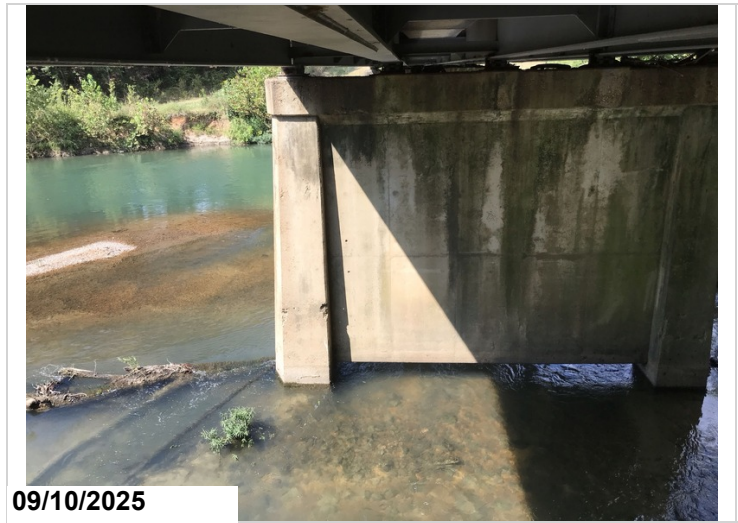
Bent 16 columns have spalls with exposed rebar CS3.

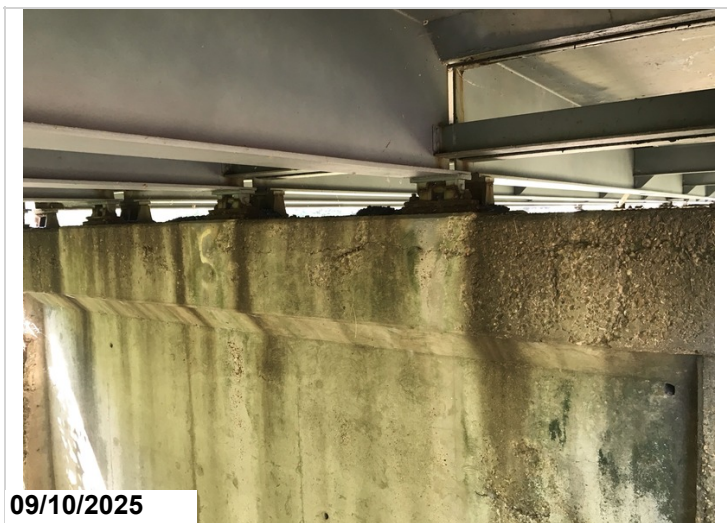
Bent 15 cap back right end has 12' horizontal cracking CS3, ahead has 6' horizontal cracking CS3.

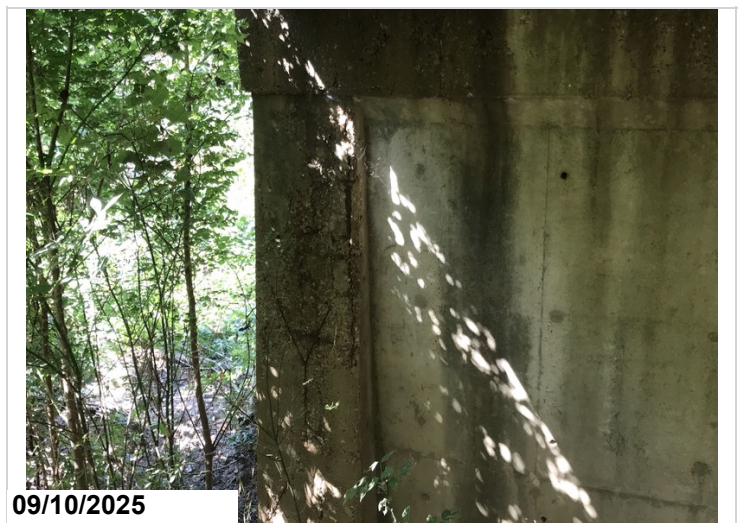
Bent 15 left column has large spall with exposed rebar CS3. Right has spall with exposed rebar CS3.

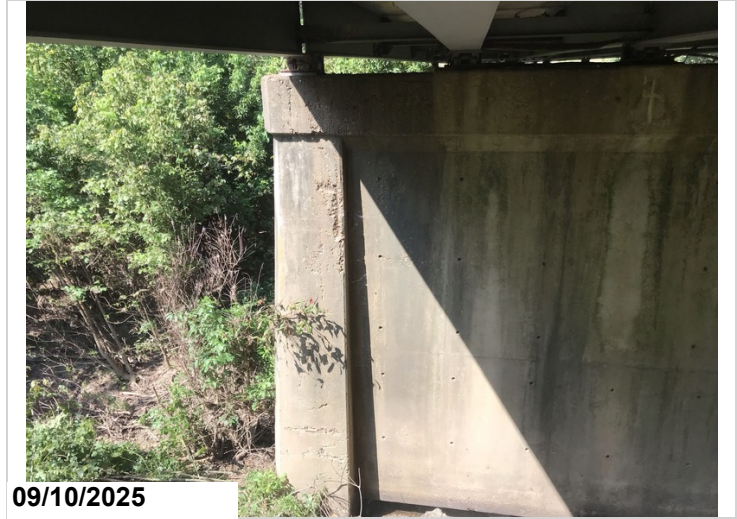
Bent 14 columns have spalls with exposed rebar CS3.

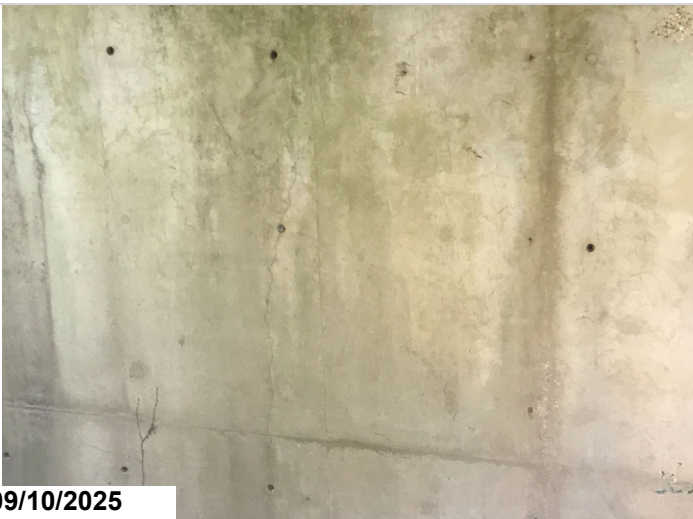
(210) Bent 13 pier wall near mid vertical cracks. 2' CS3. Bent 14 pier wall has 1' spall with exposed rebar CS3.							
215	Reinforced Concrete Abutment	LF	66	66	0	0	0

Bent 13 pier wall near mid vertical crack CS3.

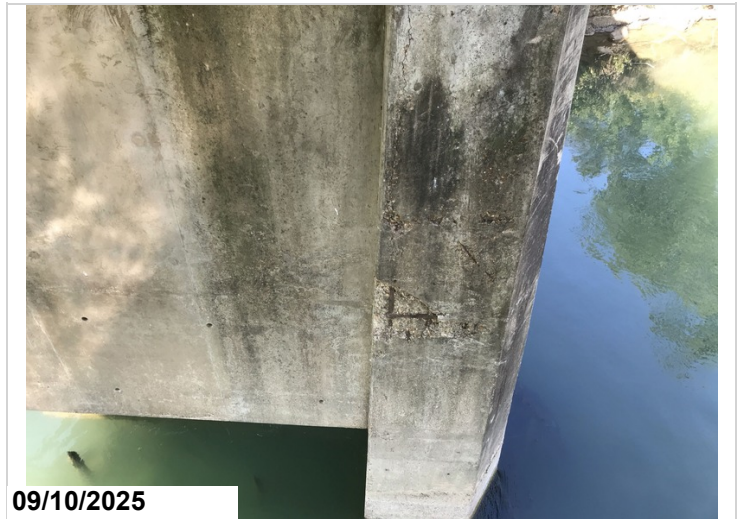
Bent 11 right and left columns have spalls with exposed rebar CS3.

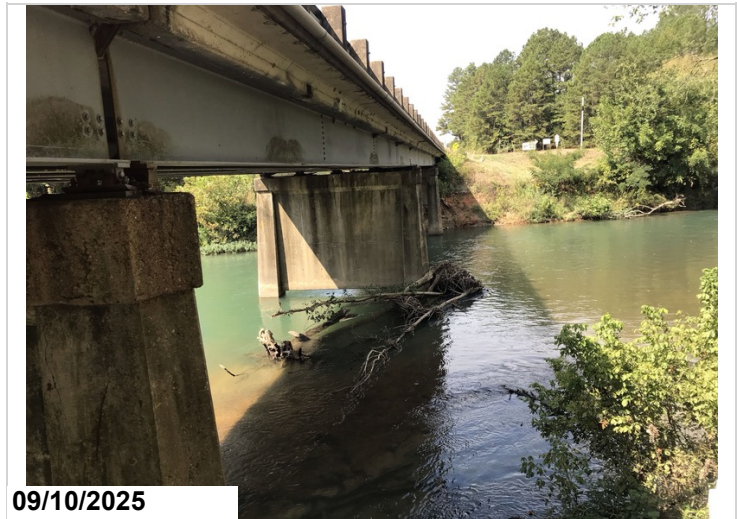
Bent 17 has drift buildup.

Bent 17 right side drift

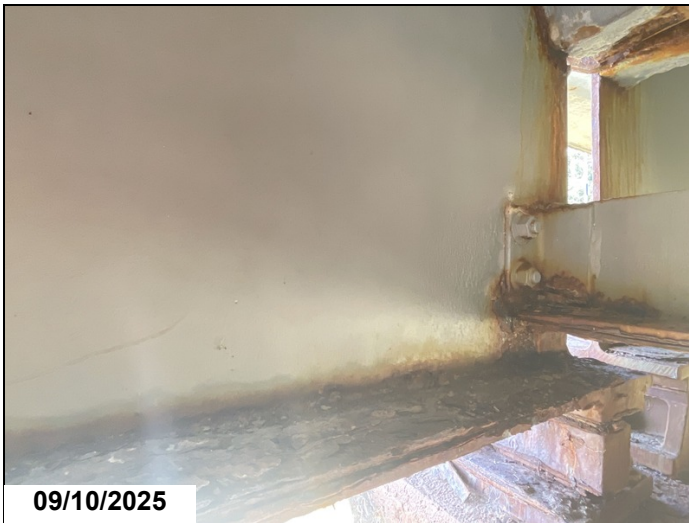
Span 4 bent 5 girder 1 corrosion with areas of section loss

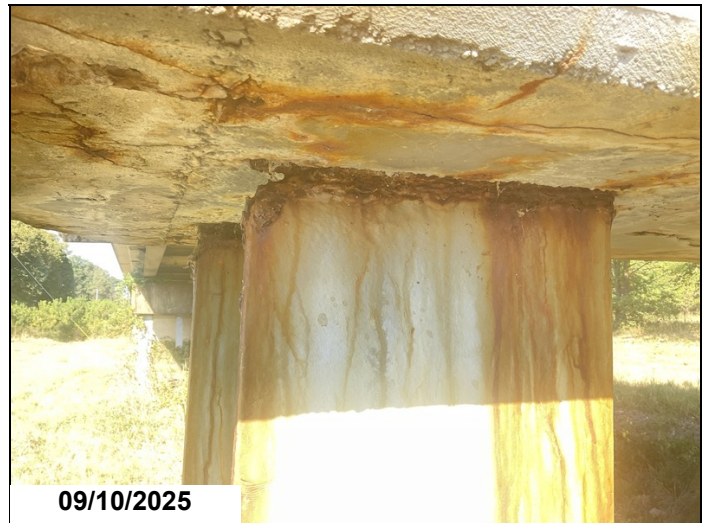
Bent 5 pile 1 has 1" hole on edge of back Lt flange CS3

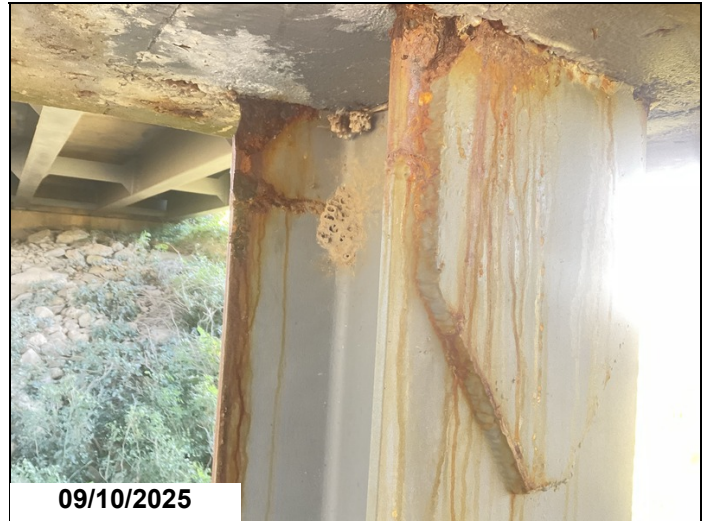
Bent 2 pile 3 back Rt flange knife edged at connection to cap CS3

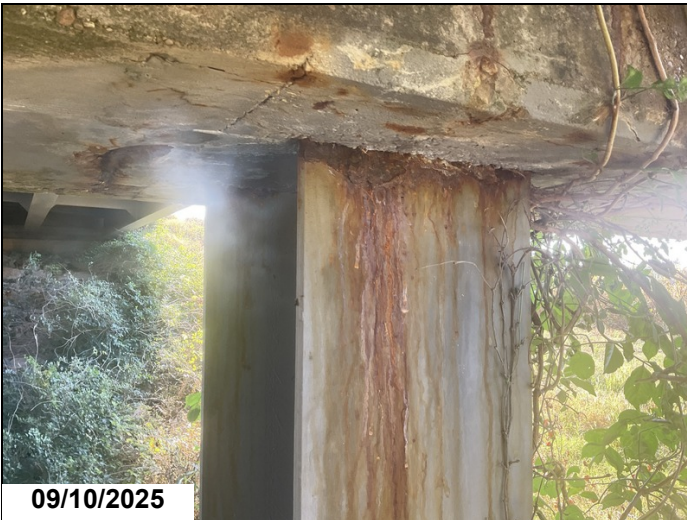
Bent 2 pile 2 ahead corrosion CS3

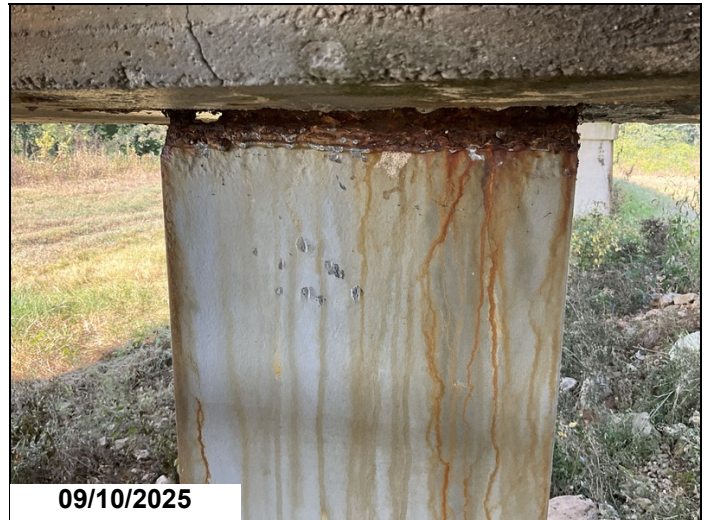
Bent 7 Pile 4 back flange has a 1" x 1/2" hole CS3

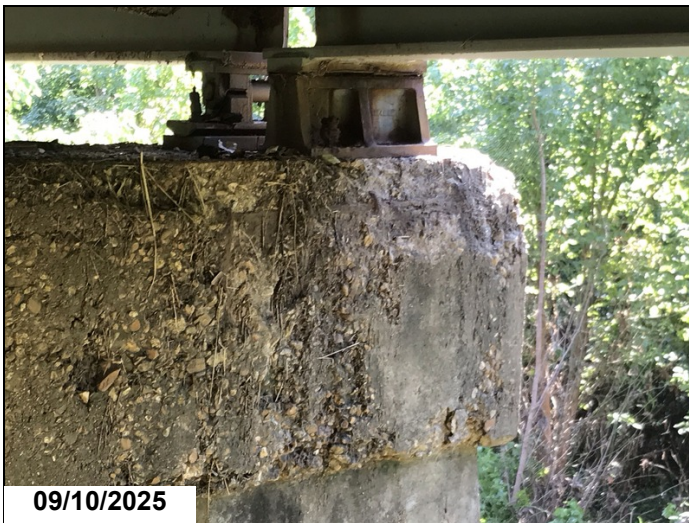
Bent 14 cap ahead right end has 3' spall with exposed rebar CS3

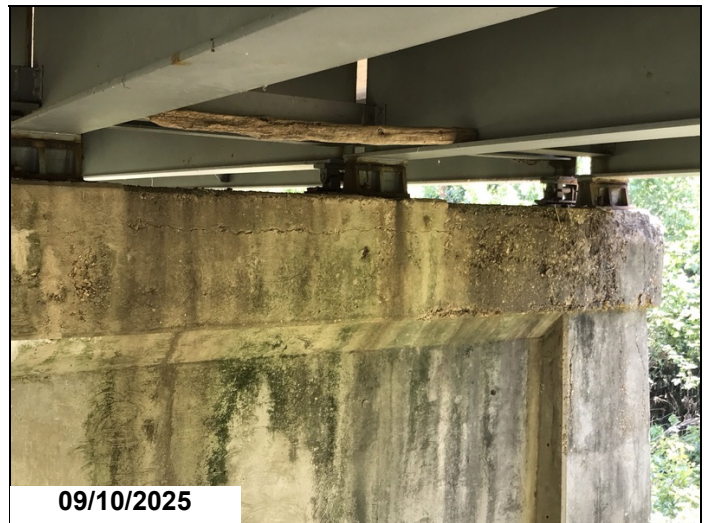
Bent 14 cap ahead face has 8' horizontal cracking CS3.

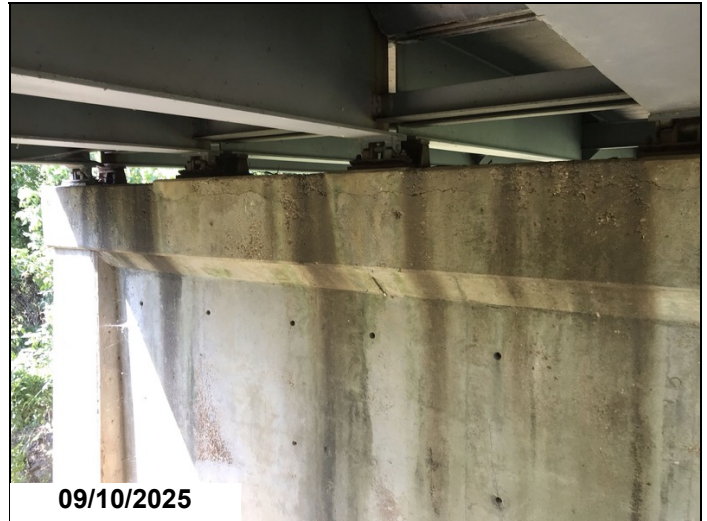
Bent 13 cap has full length horizontal cracking CS3 1' is spall with exposed rebar CS3.

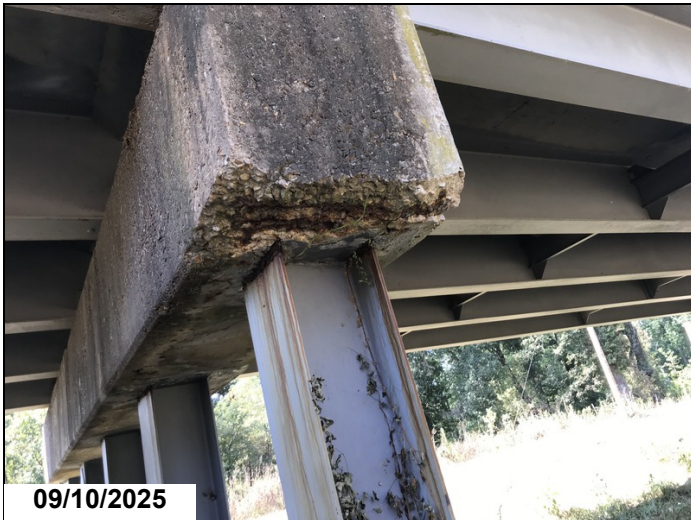
bent 7 cap right end has 1' spall with exposed rebar CS3, over piles 2 and 3 has 4' cracking CS3, 3' spall with exposed rebar CS3.

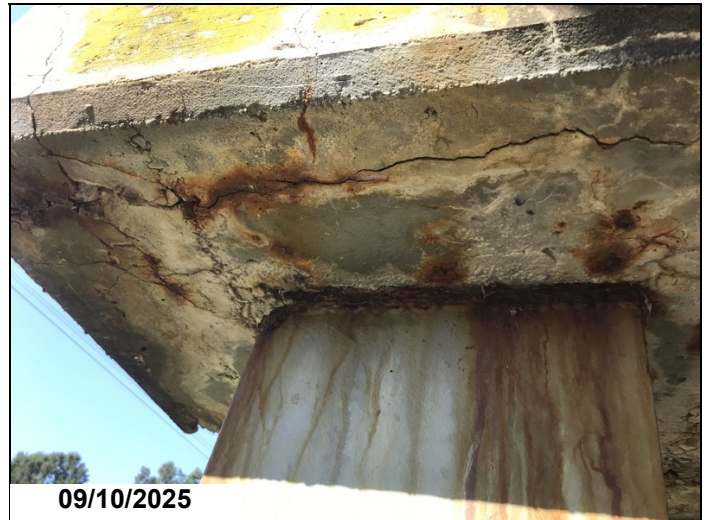
Span 4 bent 5 left end has 1' spall with exposed rebar CS3, and 4' cracking with rust staining CS3.

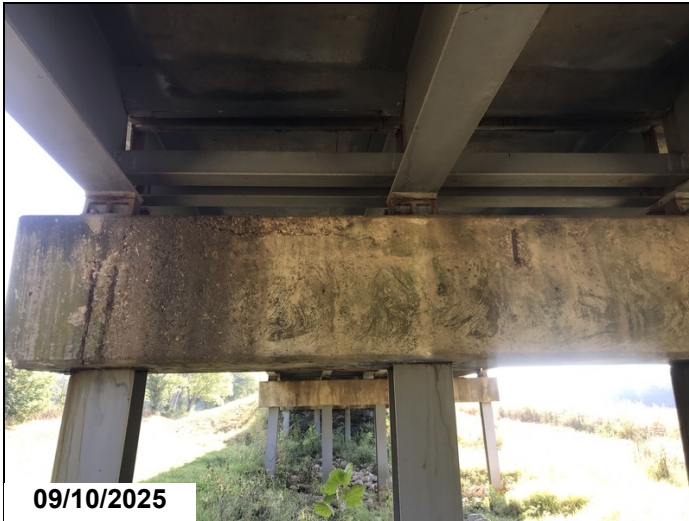
Span 4 bent 4 cap from mid to right end has 6' cracking CS2 and 3' spalls with exposed rebar CS3.

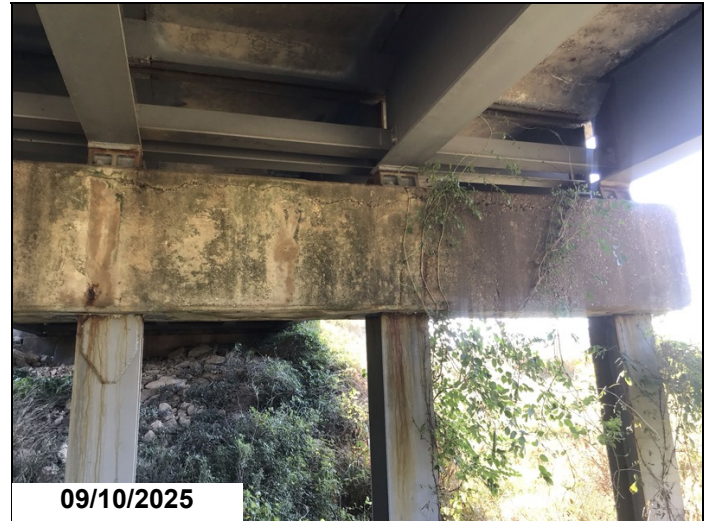
Span 2 bent 2 mid to left end top of cap has an 10' delaminated area CS3.

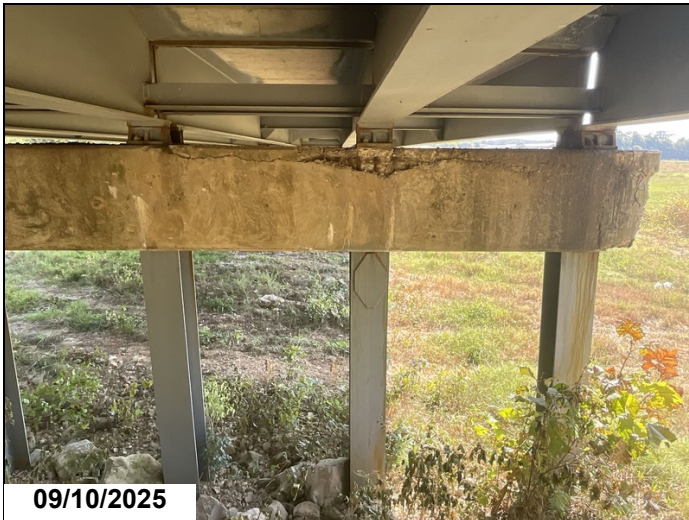
Bent 7 ahead spall/rebar CS3

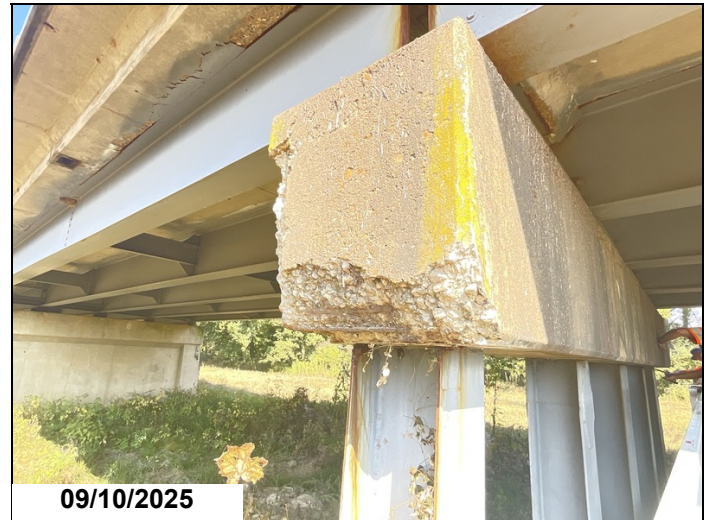
Bent 7 Lt spall/rebar CS3

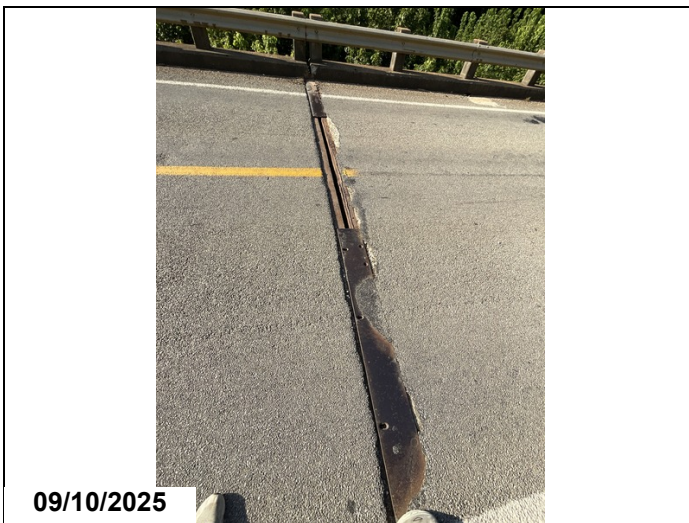
Bent 13 6 missing, 8' loose

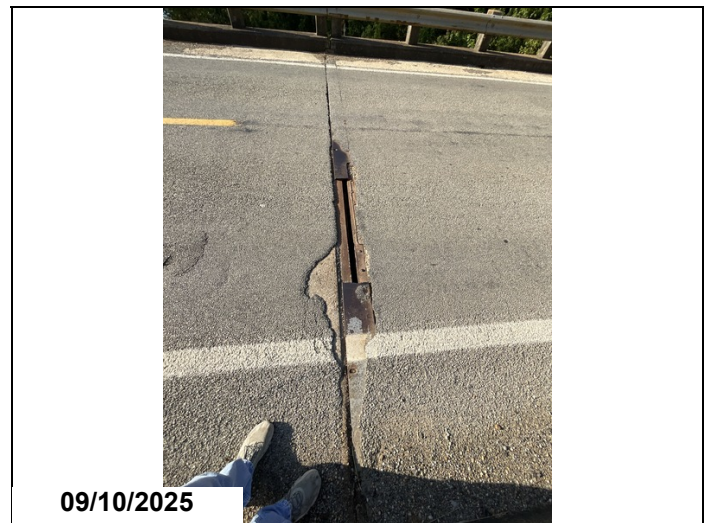
Bent 11 4' missing rest loose

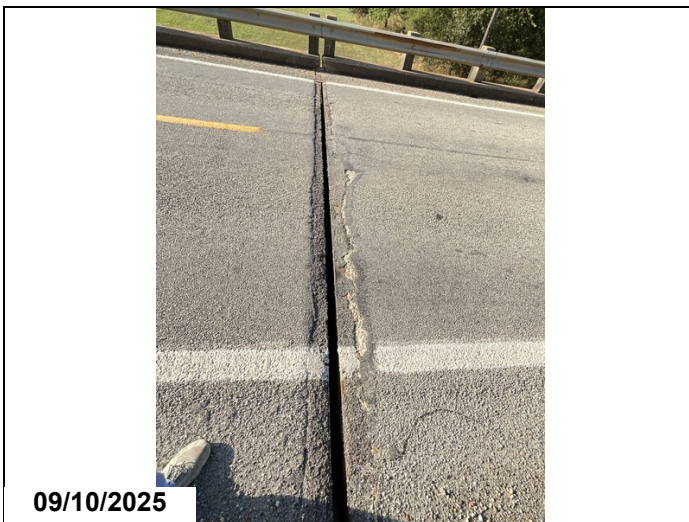
Bent 6, 7, 9, 14, 15, 16 missing

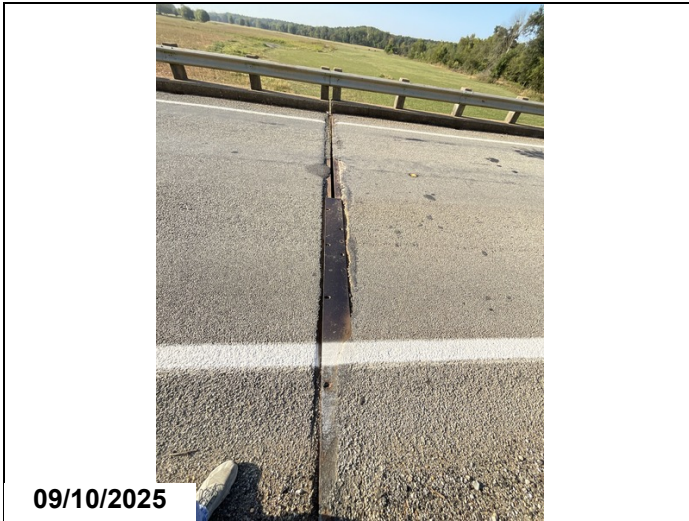
Bent 3 joint slide plate loose

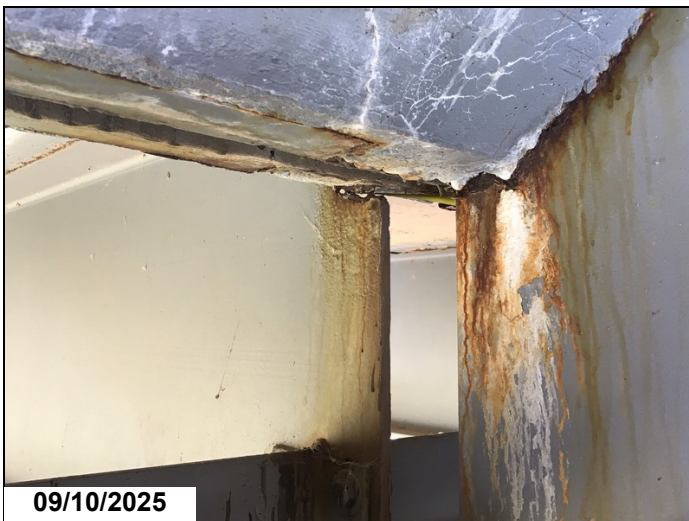
Span 18 bent 18 girder 3 has a 4" x 1" hole below haunch CS3

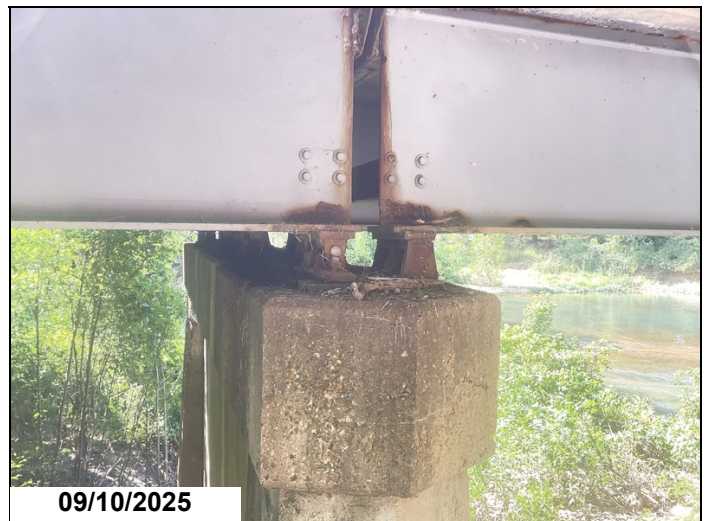
Span 15 bent 15 girder 5 corrosion CS2 and CS3

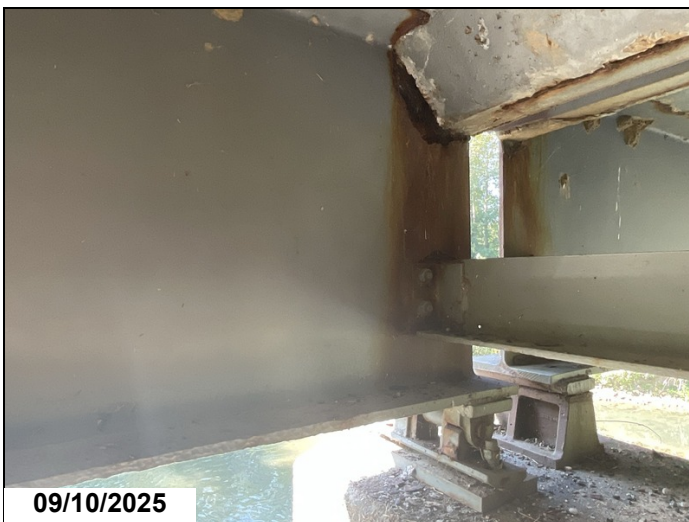
Span 9 bent 10 girder 1 moderate loss CS3

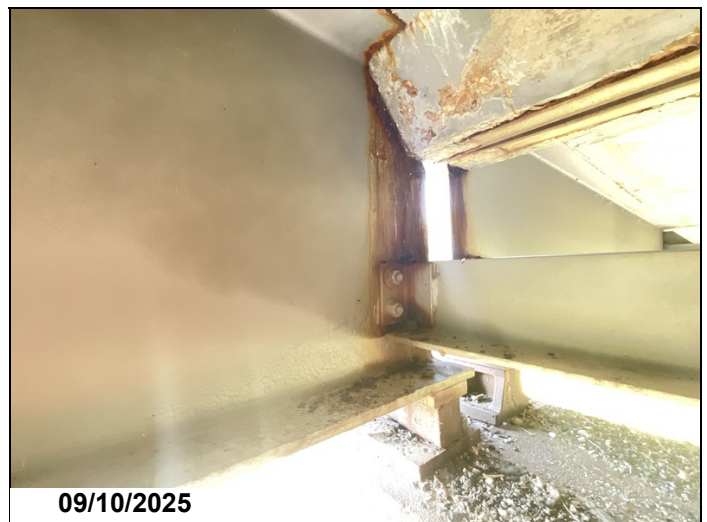
Span 2 bent 3 girder 1 section loss at haunch CS3

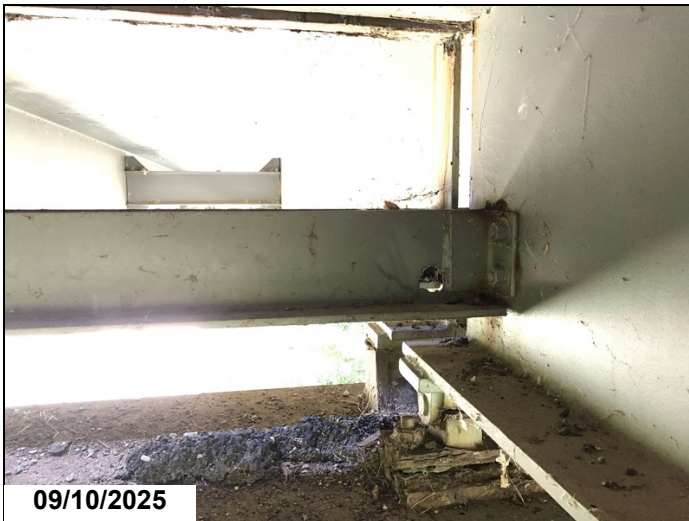
Span 14 bent 15 bay 3 diaphragm has a 2" diameter hole

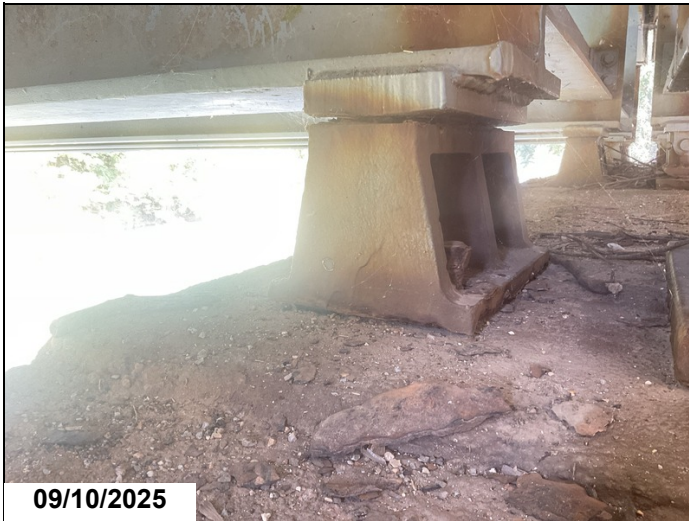
Bent 16 and 17 ahead bearing 2 pushed back with 1/4 gap on ahead side
