## Bridge M1675 Inspection Report

Asset #M1675(Routine)  
SH 93-01- LM 1.29 over HOLDER CREEK  
Location: 1.3 MI N JCT SH 90

Team Lead: Brandon Sutton Inspection Date: 01/10/2024

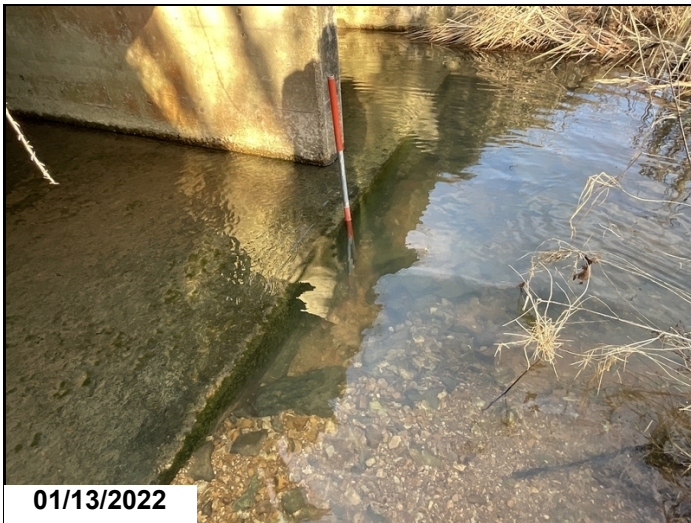
**61 - Channel/Channel Protection** (6 - Bank is beginning to slump. River control devices and embankment protection have widespread minor damage. There is minor stream bed movement evident. Debris is restricting the channel slightly.) Channel has scoured up to 2' below flowline at inlet end. Scour is beginning to undermine flowline. Scour at outlet end was filled with rip rap in the past. Trees and brush in channel.

Channel has scoured up to 2' below flowline at inlet end. Scour is beginning to undermine flowline.

Inlet scour

**Type of Work:** Channel Work/Drift Removal

**Status:** Monitor
