## Bridge M1676 Inspection Report

SH 93-01- LM 2.79 over WAR EAGLE CREEK

Location: 2.79 MI NW JCT 90 & 93

Team Lead: Brandon Sutton Inspection Date: 01/10/2024

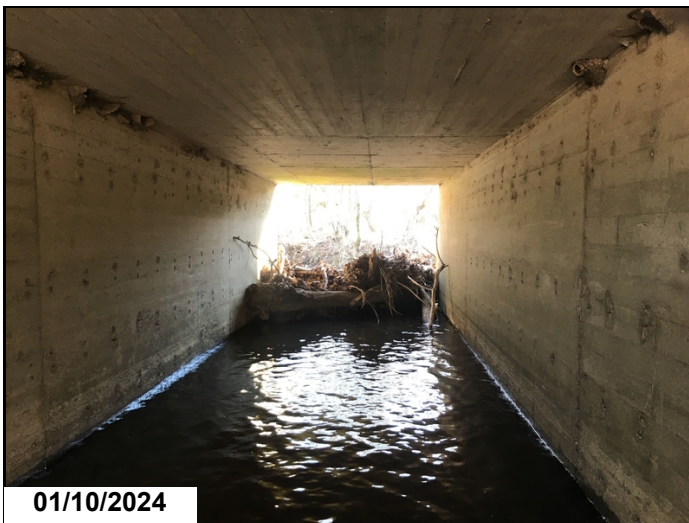
Barrels 1, 2 and 3 have moderate drift buildup on inlet end, restricting flow. Barrel 2 has moderate sediment buildup.

Drift in barrel 2

Type of Work: Channel Work/Drift Removal

to Randolph Co Crew for removal KAW 1/16/20

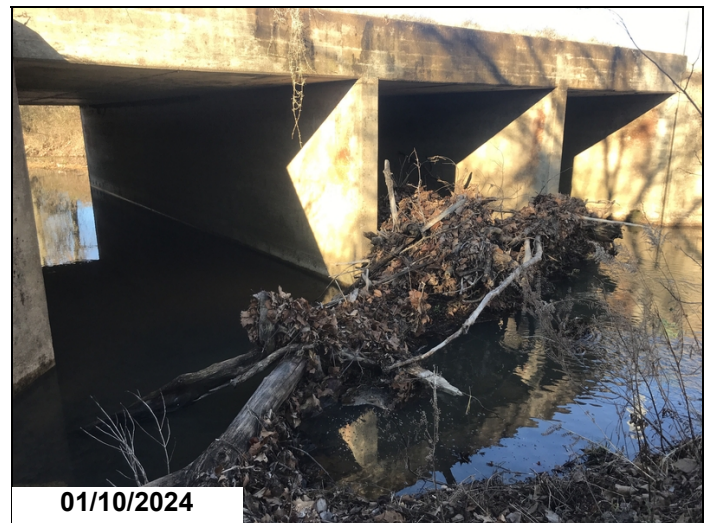
Drift on inlet, right end

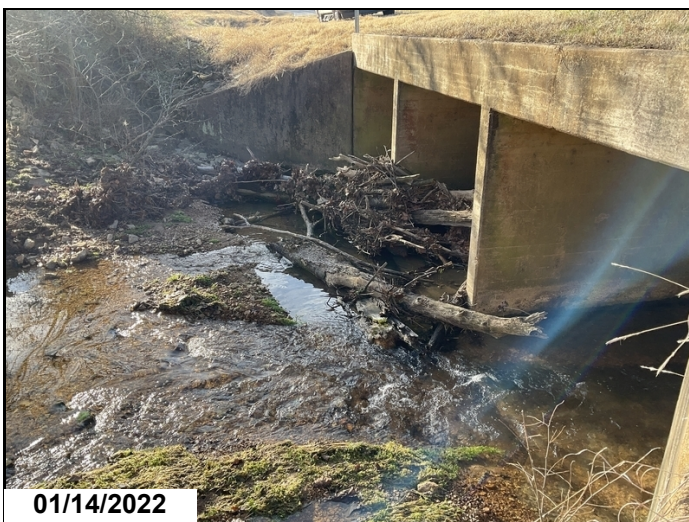
Inlet drift

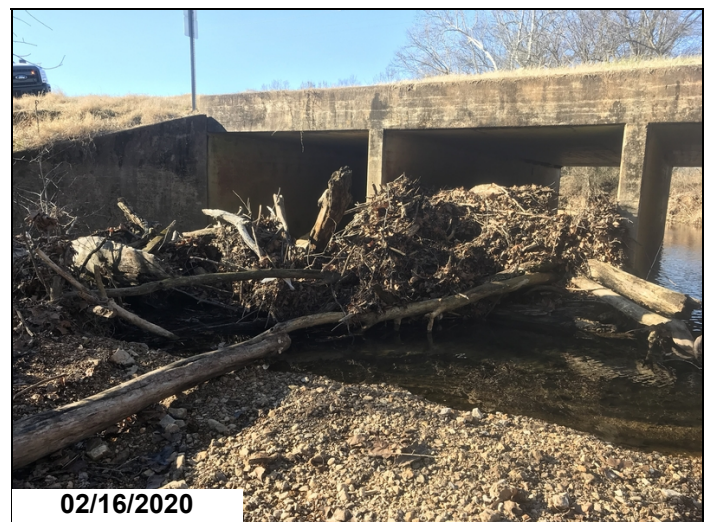
2020 drift
