Bridge M1677 Inspection Report

SH 93-01- LM 3.54 over CREEK

Location: 3.5 MI NW JCT SH 90 & 93

Team Lead: Brandon Sutton Inspection Date: 01/10/2024

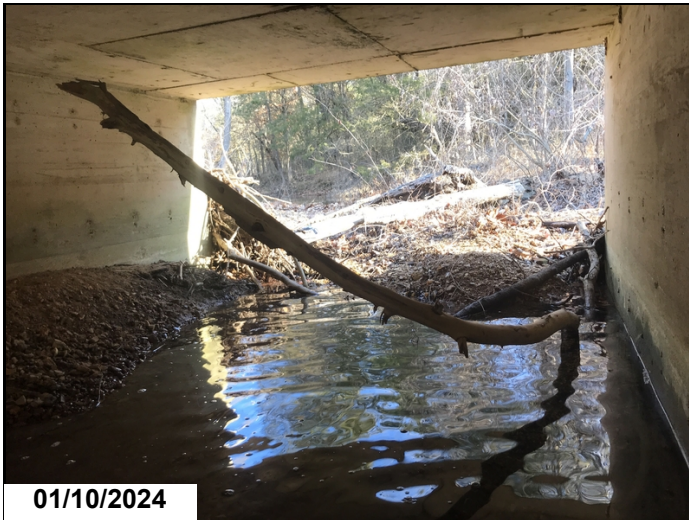
Barrels 1-3 have up to 2.5' of sediment and gravel buildup.
Barrels 2 and 3 have moderate drift buildup.

Drift and sediment in barrel 2

Type of Work: Channel Work/Drift Removal

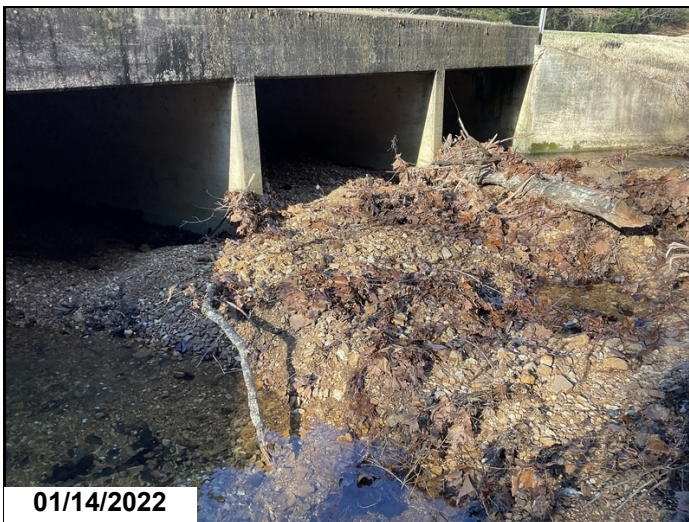
drift

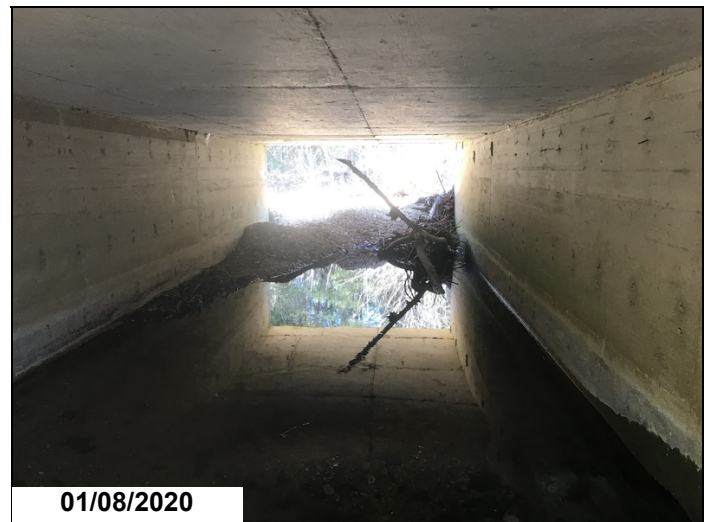
drift
