## Bridge X0758 Inspection Report

SH 231-06- LM 4.62 over CREEK

Team Lead: Brandon Sutton Inspection Date: 01/10/2024

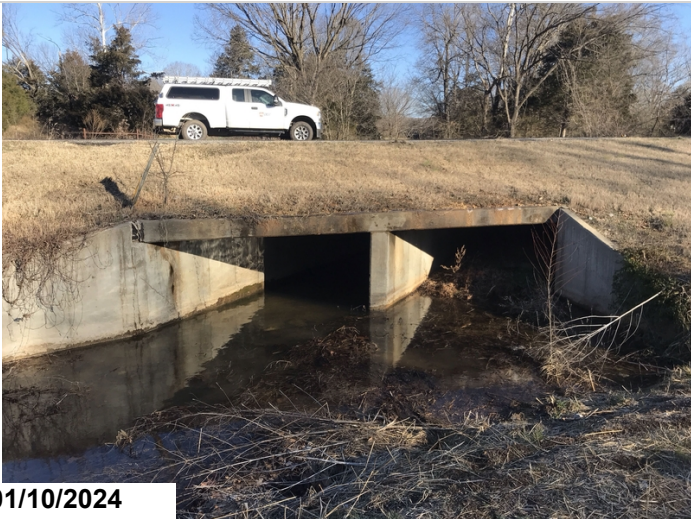
Elevation view

**62 - Culverts** (7 - Shrinkage cracks, light scaling and insignificant spalling which does not expose reinforcing steel. Insignificant damage caused by drift with no misalignment and not requiring corrective action. Some minor scouring has occurred near curtain walls, wingwalls or pipes. Metal culverts have a smooth symmetrical curvature with superficial corrosion and no pitting.) RCBC is in overall good condition.

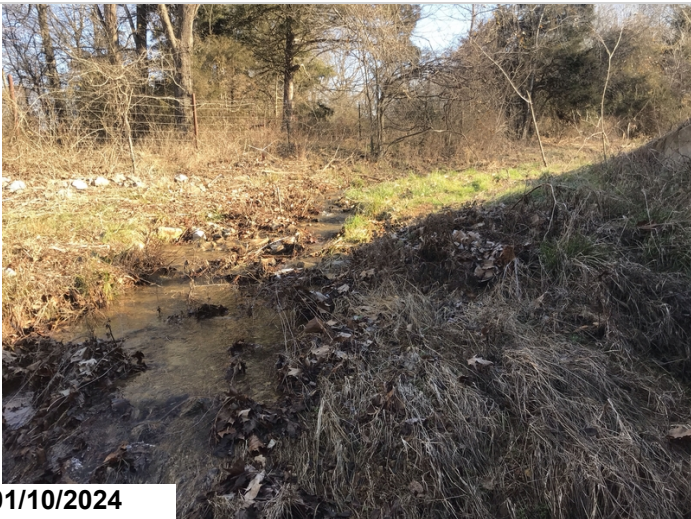
Upstream view

**61 - Channel/Channel Protection** (7 - Bank protection is in need of minor repairs. River control devices and embankment protection have a little minor damage. Banks and/or channel have minor amounts of drift.) Channel has some debris and vegetation restricting flow.

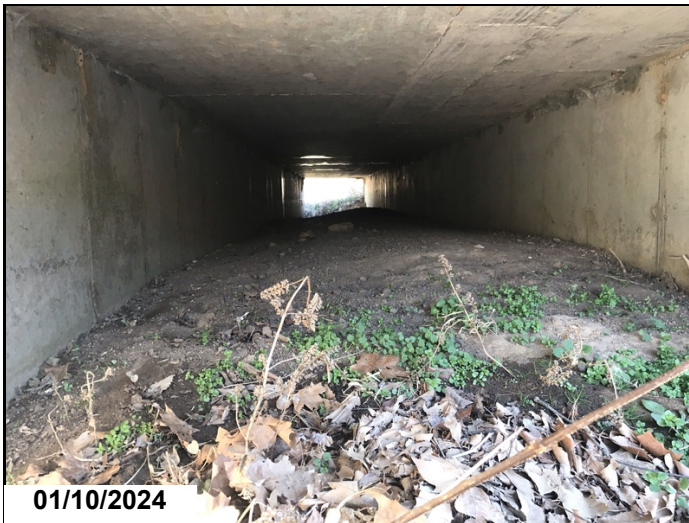
Barrels 1 and 2 have up to 2' of sediment buildup.

Sediment build up in barrel 1

**Type of Work:** Channel Work/Drift Removal
