## Bridge X1702 Inspection Report

AR Hwy 135 over Ditch No. 4

Location: 1 MI S JCT of SH 158

Team Lead: Richard Jones Inspection Date: 11/05/2025

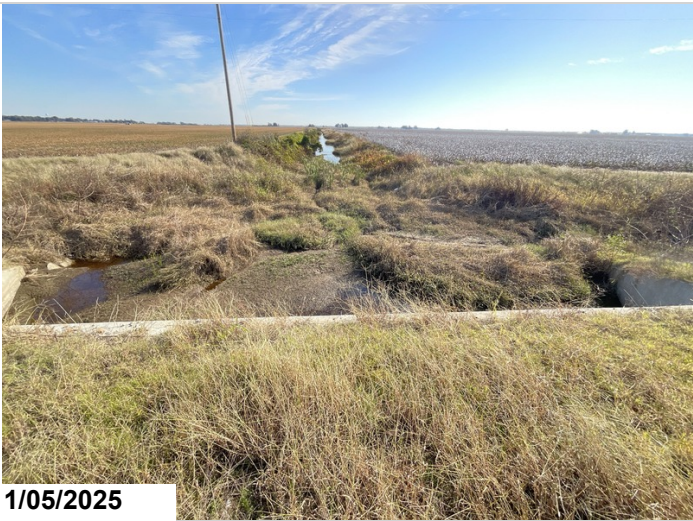
Channel Right

**61 - Channel/Channel Protection** (7 - Bank protection is in need of minor repairs. River control devices and embankment protection have a little minor damage. Banks and/or channel have minor amounts of drift.)  
Channel is in overall good condition.

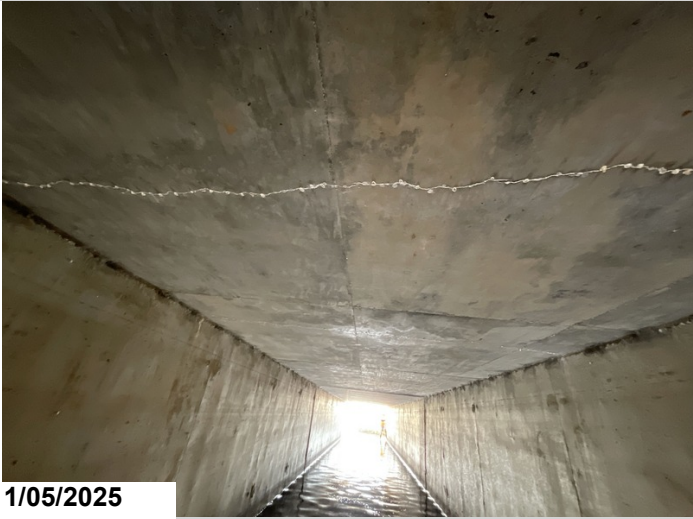
ELEMENTS	DESCRIPTION	UNITS	TOTAL	CS1	CS2	CS3	CS4
241	Reinforced Concrete Culvert	LF	404	360	37	7	0
1120	Efflorescence/Rust Staining	LF	33	0	31	2	0
1130	Cracking (RC and Other)	LF	11	0	6	5	0
(241) RCBC top slab has a few minor cracks with efflorescence. 31' CS2, 2' CS3. Walls have a few minor to moderate cracks, especially near wings. 6' CS2, 5' CS3.

Typical crack with efflorescence. CS2

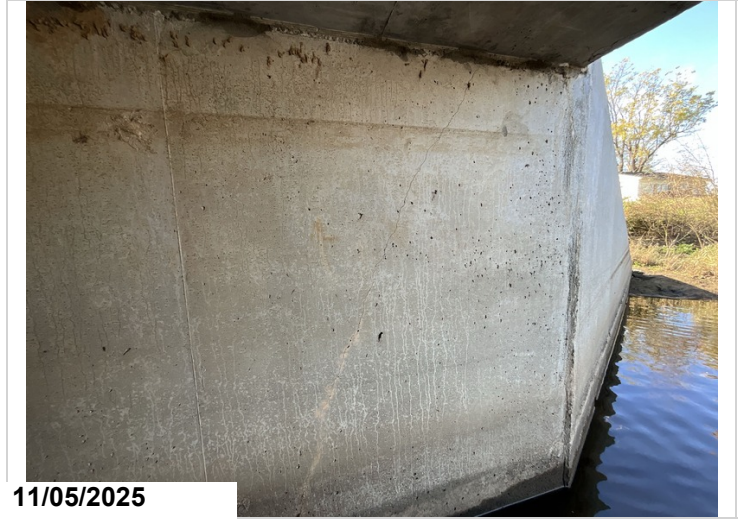
Barrel 1 Left Side Back wall diagonal crack CS3
