Bridge 06890 Inspection Report

Asset #06890(Routine)

SH 141-01- LM 5.51 over Mud Creek

Team Lead: James Adams Inspection Date: 04/04/2022

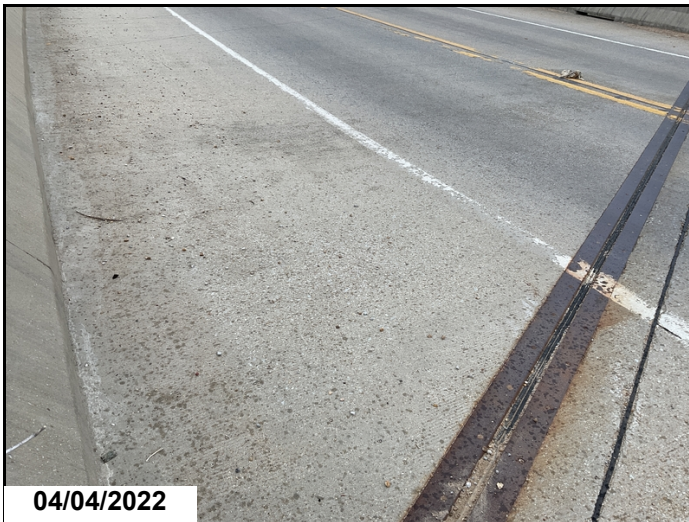
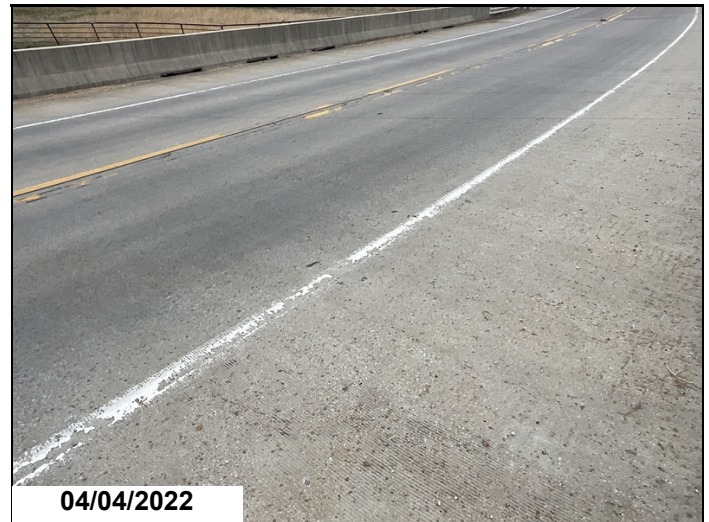
Deck has longitudinal and transverse cracking. Deck has areas of minor abrasion with scattered areas of missing coarse aggregate.

Type of Work: Repair (General)
