Bridge 06891 Inspection Report

Asset #06891(Routine)
SH 141-01-LM 5.78 over Mud Creek Relief

Location: 5.78 MI N JCT US 63B

Team Lead: James Adams Inspection Date: 04/04/2022

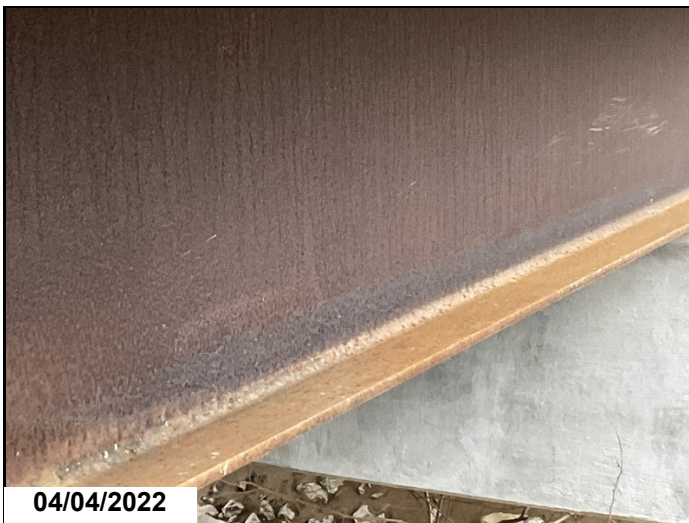
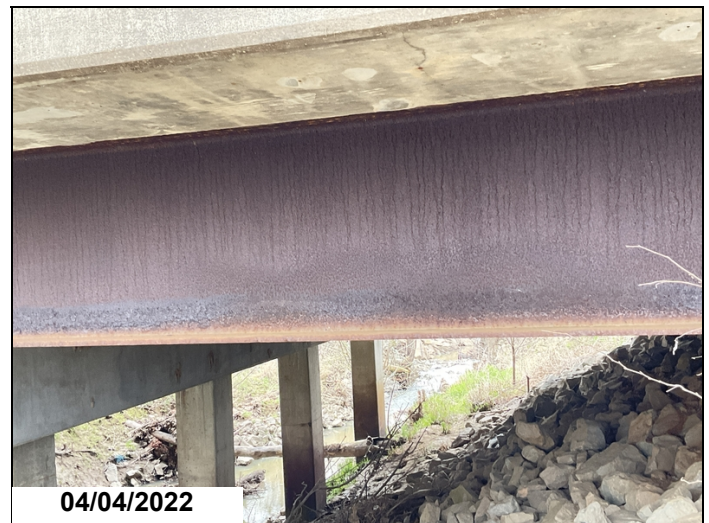
Ends of girders have areas of granular texture.

Exterior girders have a few areas of granular texture on outside face. Bottom flange has areas of flaking rust.

Outside girders

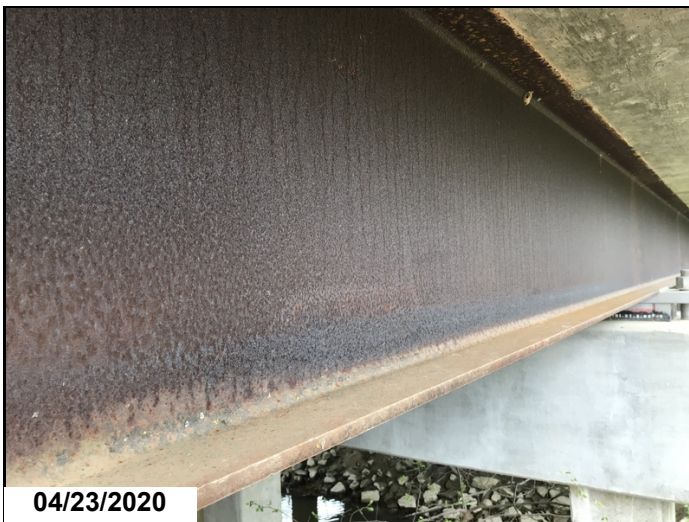
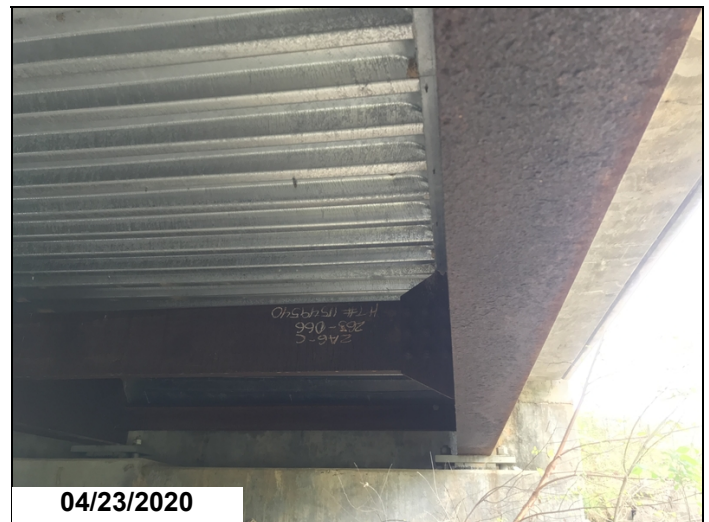
Exterior girders

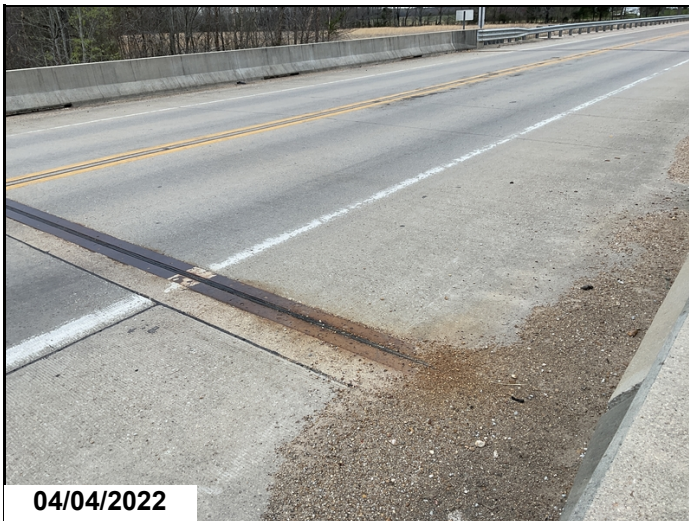
Looking North

Deck has a few minor longitudinal and transverse cracks.

Deck has minor traffic wear in wheel paths and a few areas of minor abrasion. Deck has areas of missing coarse aggregate.
