Bridge M3983 Inspection Report

SH 141-02- LM 3.85 over POPLAR CREEK

Location: 2.25MI SW OF WALCOTT

Team Lead: Cory Shaw Inspection Date: 11/05/2025

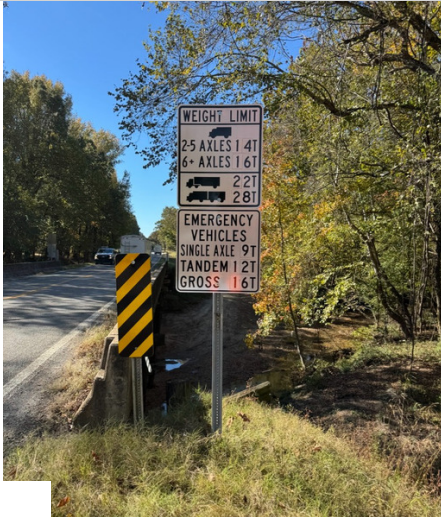
Load postings

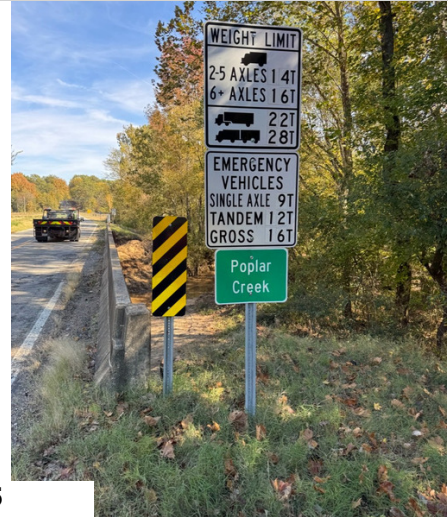
Load postings

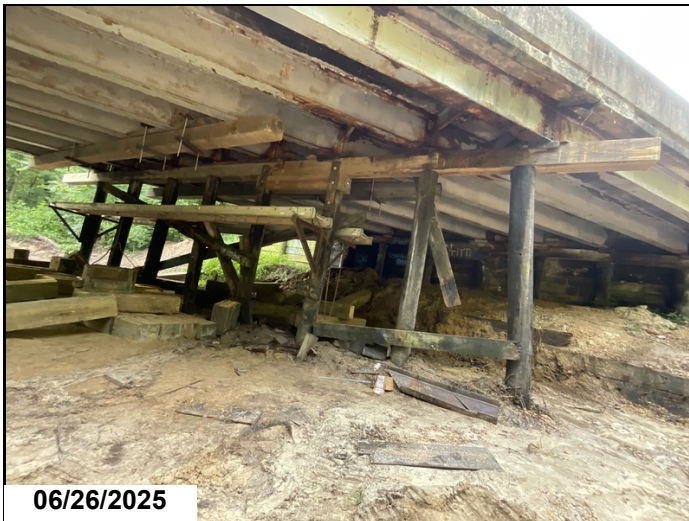
**Repaired: Bent 2 cap has a splice over pile 4 and sub cap over piles 3 and 4. Sub cap is decayed and hollow over pile 4 with some minor crushing. Ahead face has deep checks and is partially hollow. Bent 2 cap is decayed and partially hollow with checks from pile 1 to pile 3, and from pile 4 - 6. **D10 bridge crew replaced with 51' length cap, 6-25-2025.

Bent 2 cap ahead side. Replaced by D10 bridge crew 6-26-2025.

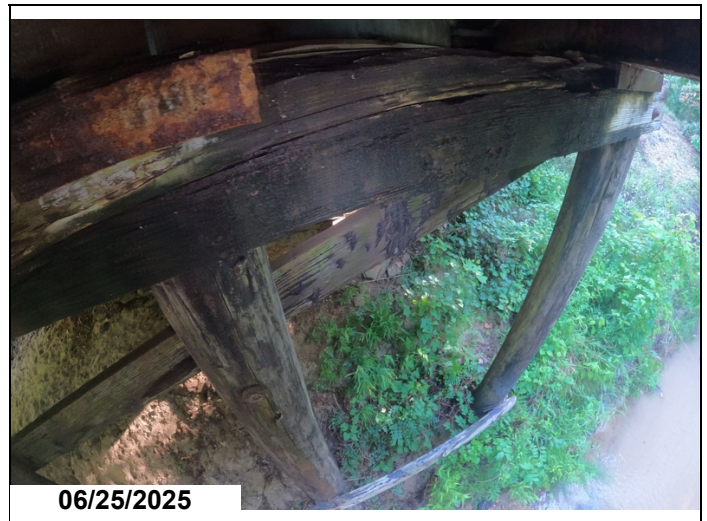
***Bent 5 cap is split and hollow from pile 5 to Right end. Top of cap is crushing under girders 7 and 8. ***Repaired by local D10 bridge maintenance crew on 8-20-2025.

Bent 5 cap back side between girder 7&8

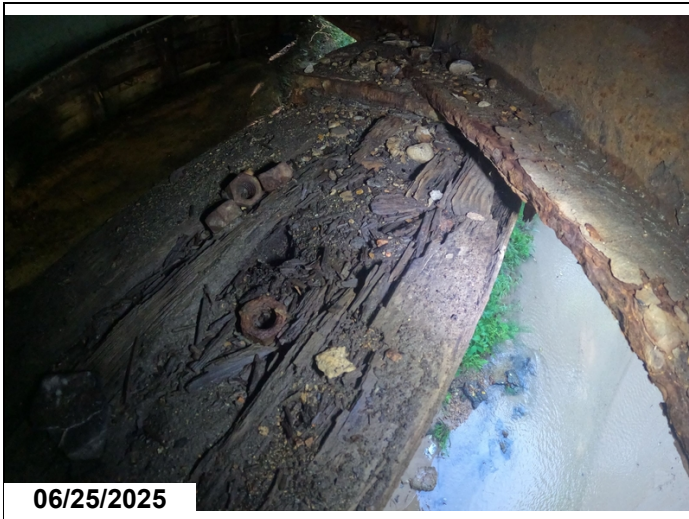
Bent 5 cap back side (girder 7 on Right)

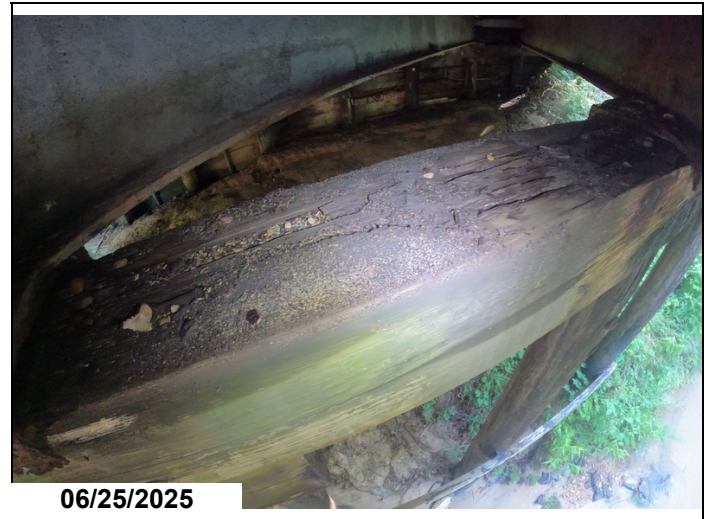
Bent 5 cap back side between girder 6&7

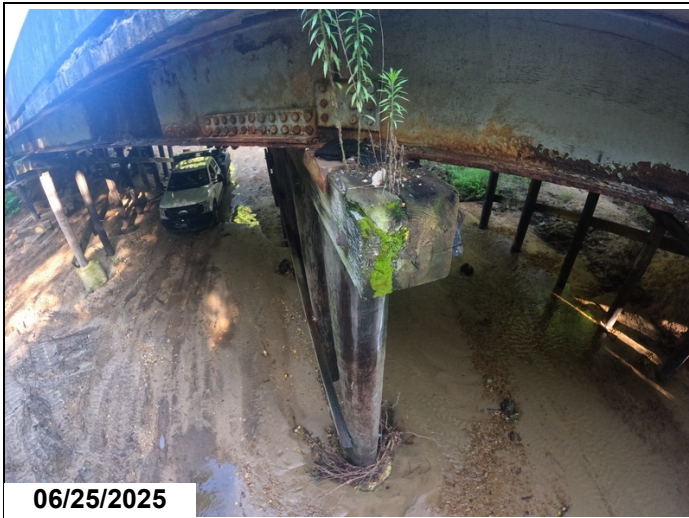
Bent 4 cap is partially hollow with deep checks and some crushing over piles 2 and 5 - 7. Cap is decayed and partially hollow on both Left and Right ends.

Bent 4 cap Right end

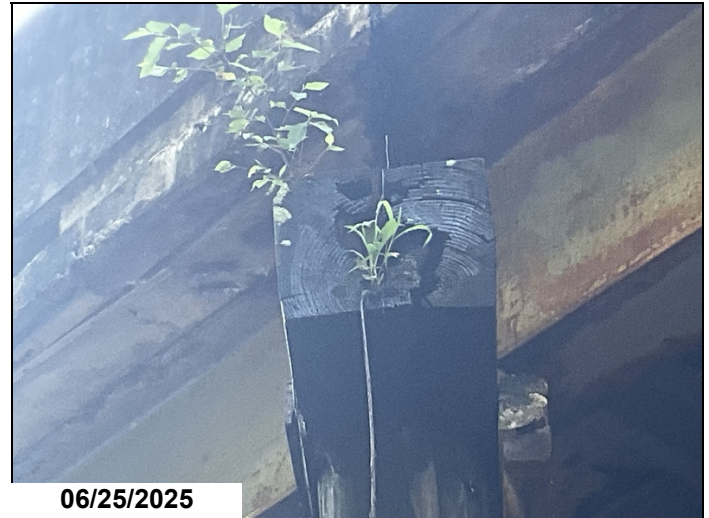
Bent 4 cap Left end

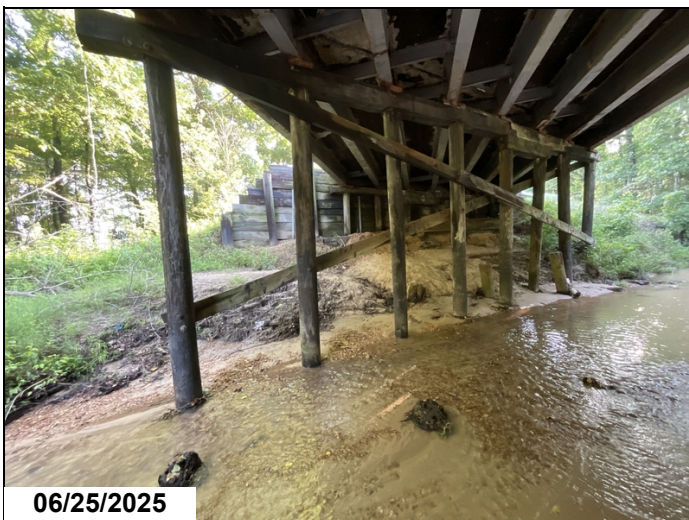
Bent 5 cap back side

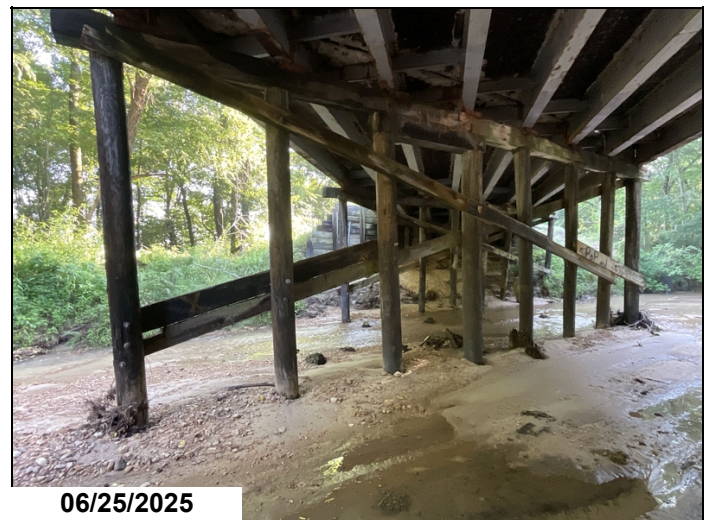
Bent 4 cap back side

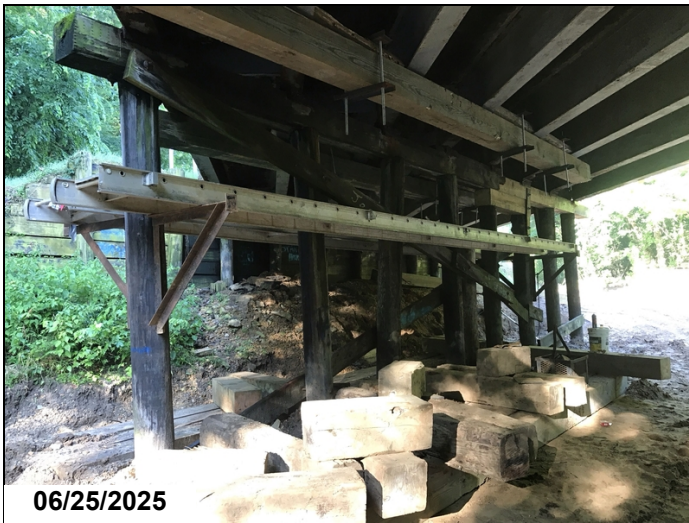
Bent 2 cap ahead side

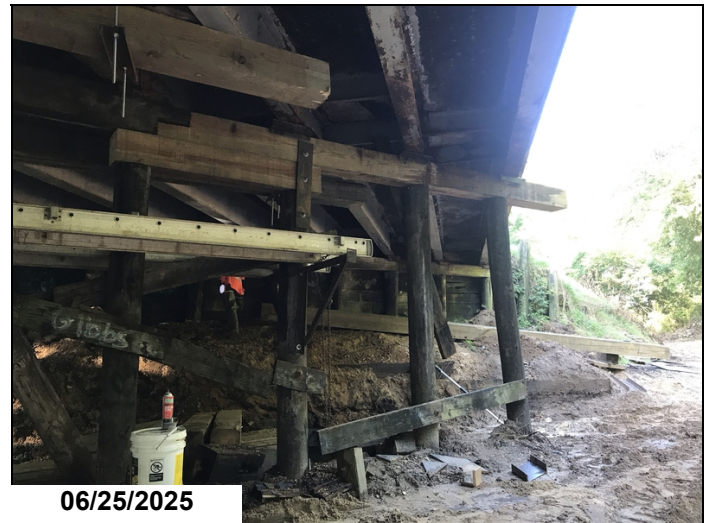
Bent 2 cap Left Splice over pile 4

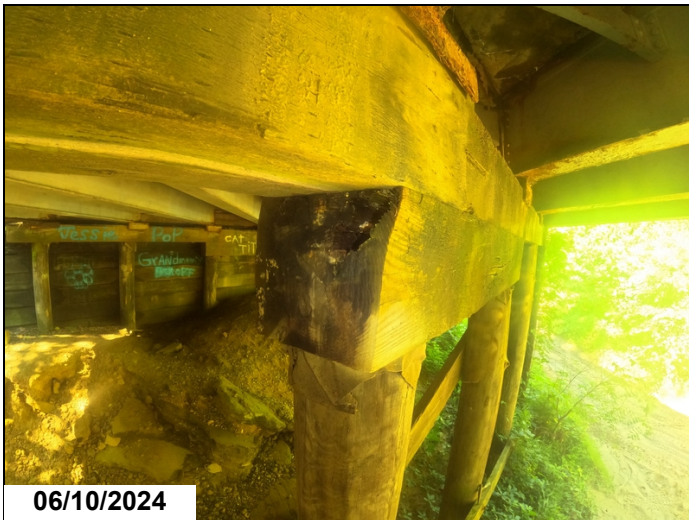
Bent 2 sub cap over pile 4

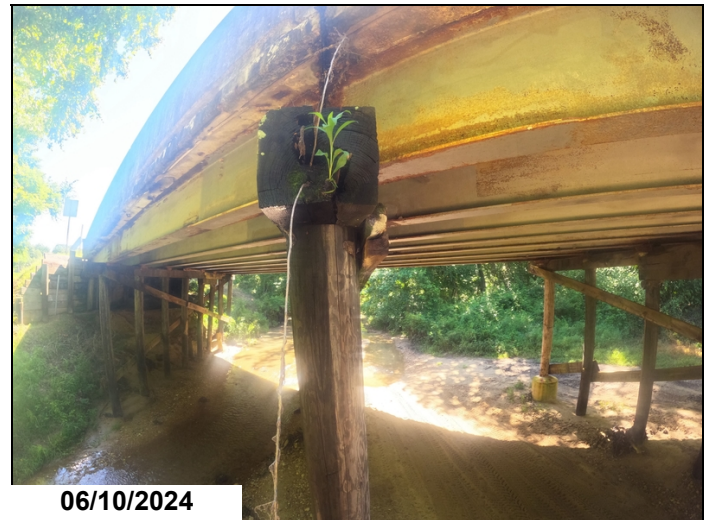
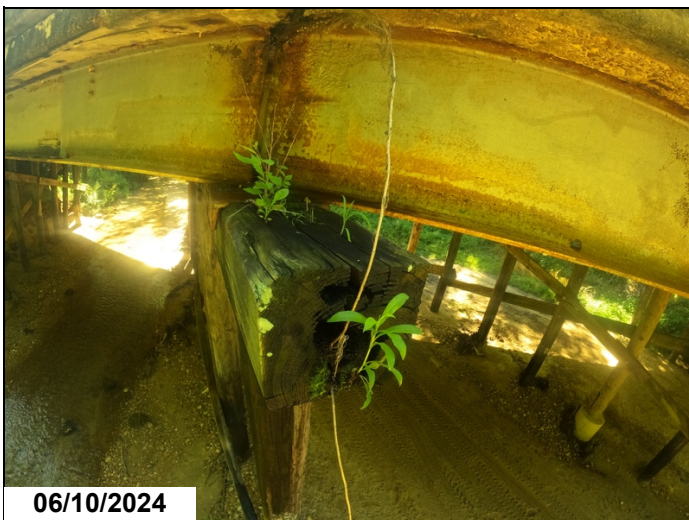
Bent 4 cap left

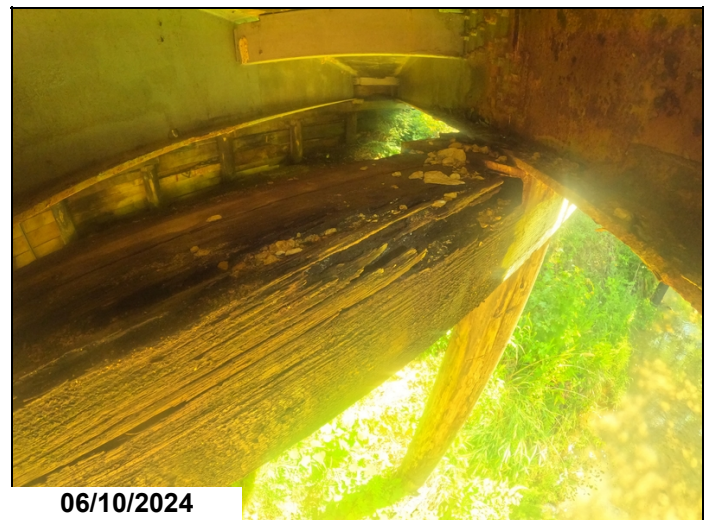
Bent 5 cap back side under girder 8

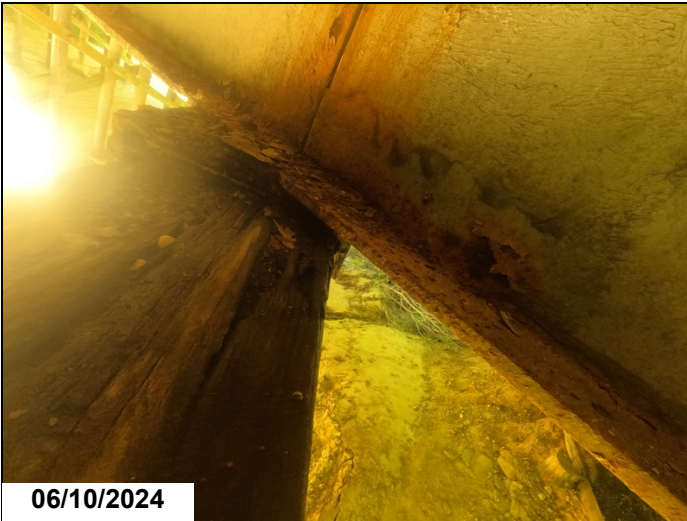
Bent 5 top of cap between girders 7&8

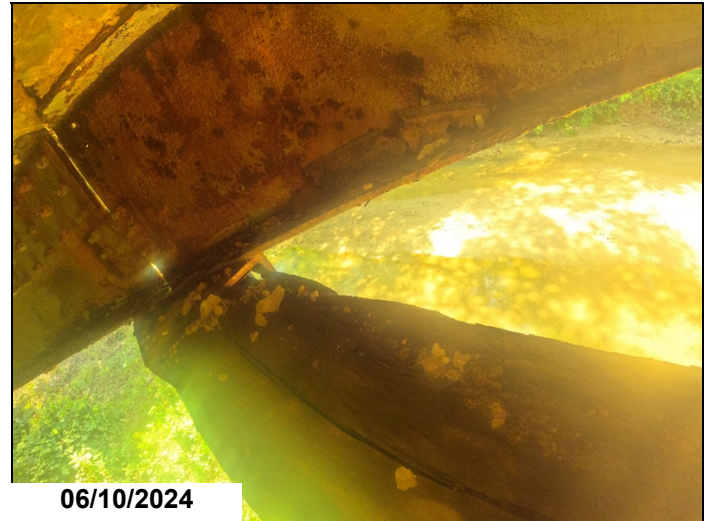
Bent 5 cap under girder 8

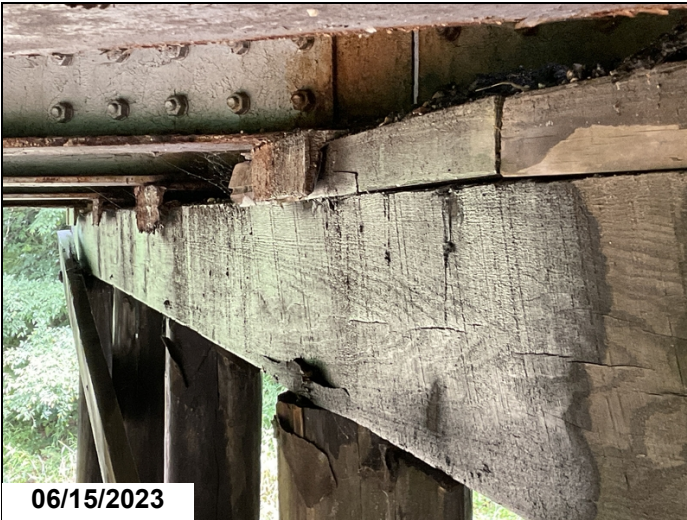
2023 - Bent 5 spacer under girder 4

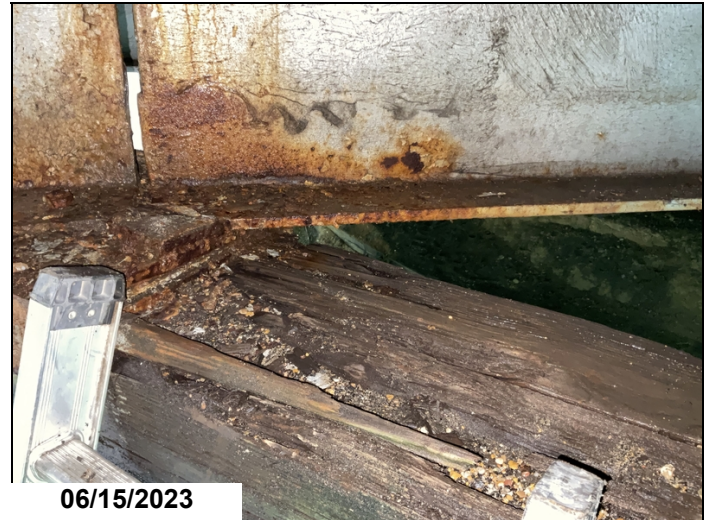
2023 - Bent 5 cap under girder 7

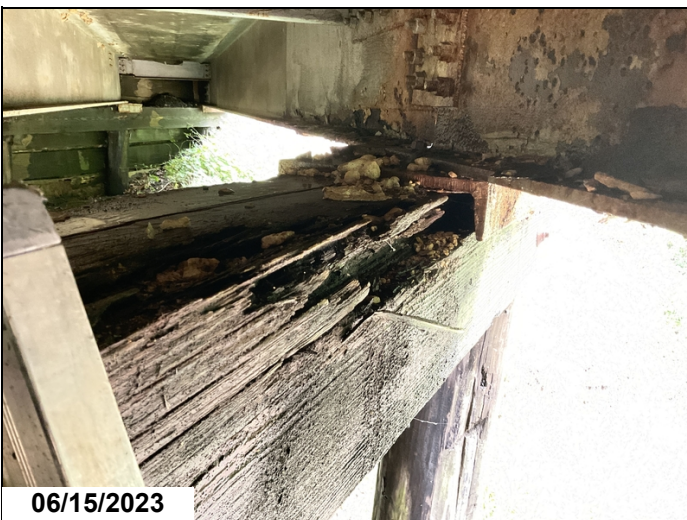
2023 - Bent 5 cap under girder 8

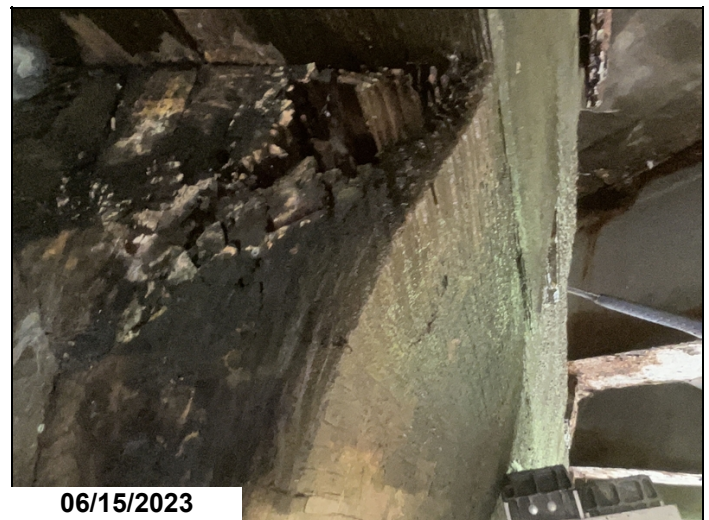
2023 - Bent 2 sub cap over pile 4

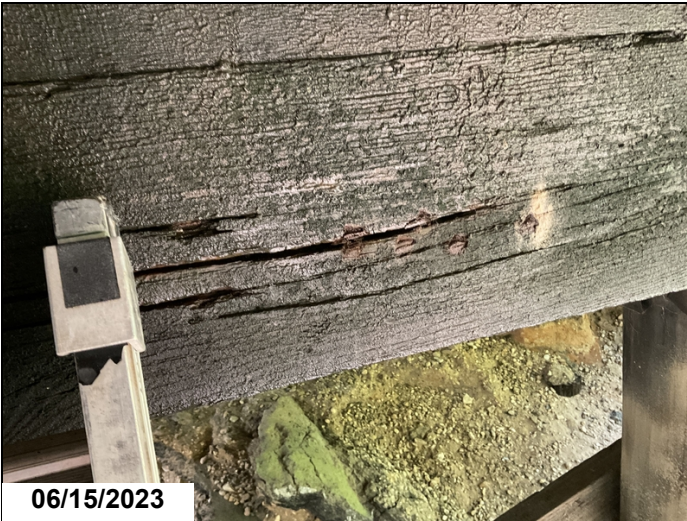
2023 - Bent 2 sub cap ahead face

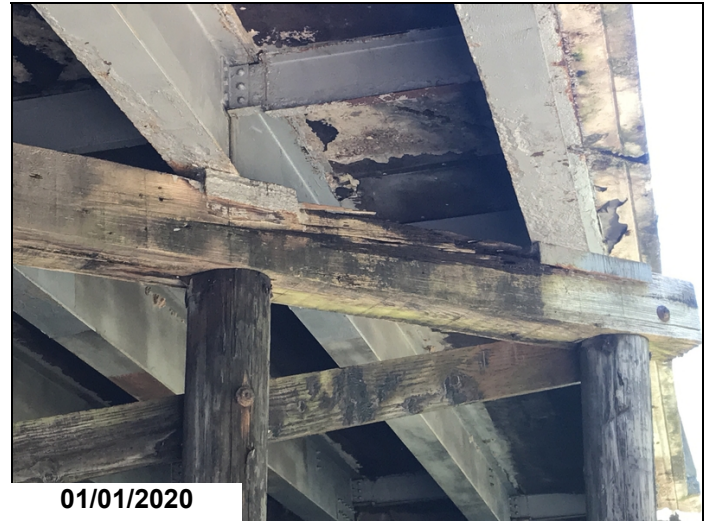
Bent 5 cap between piles 7 and 8 2019

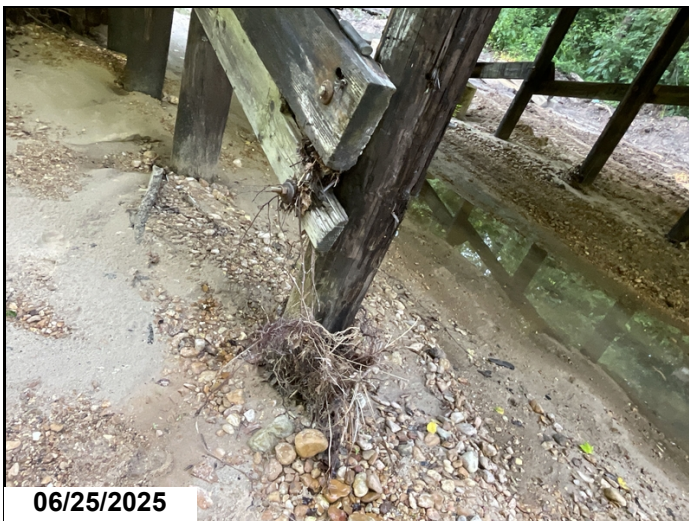
Bent 4 pile 1 decayed and partially hollow at x brace connection.

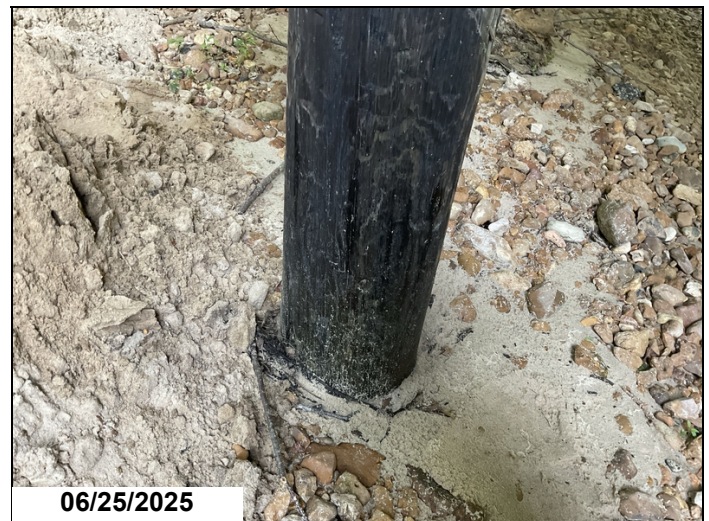
Bent 3 pile 7 has up to 1.5" outside decay at ground line.

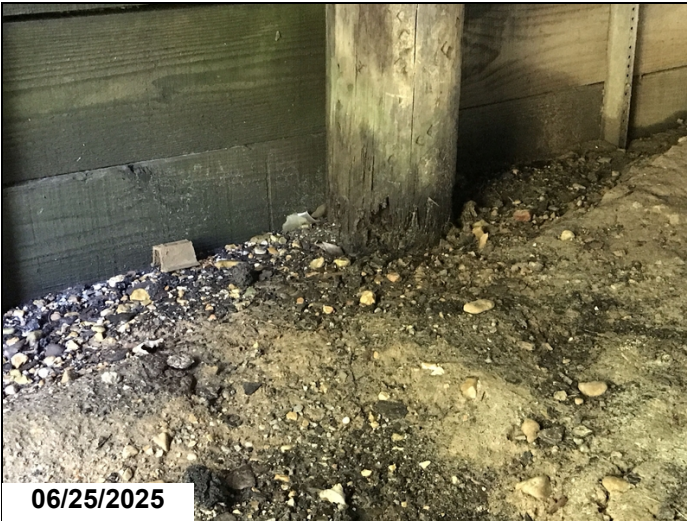
Bent 6 Pile 2

Bent 6 pile 2 has 1.5" of outside decay at ground line.

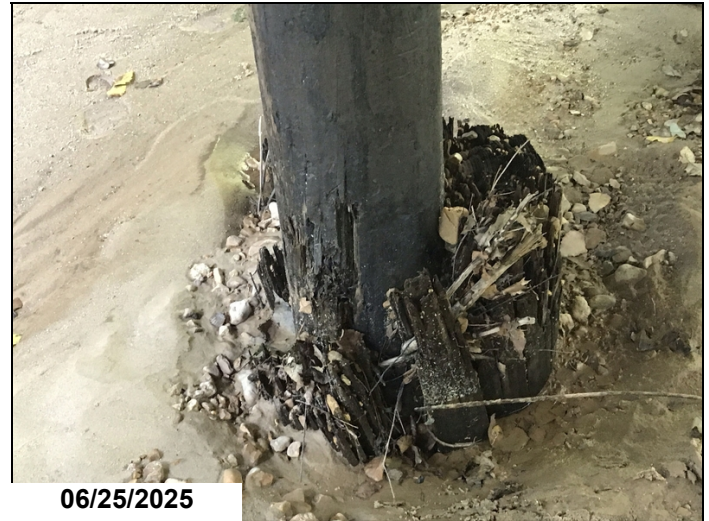
Bent 4 Pile 5

Bent 4 pile 5 has 2" of outside decay at ground line.

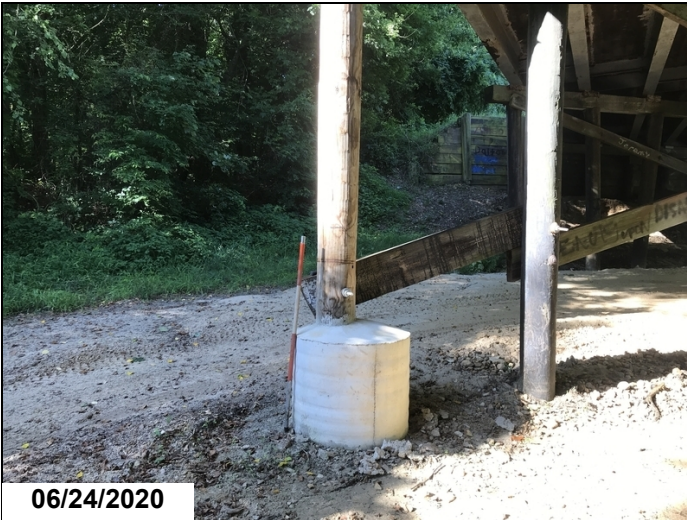
Bent 3 pile 8 has 1" of outside decay at ground line. Bent 3 pile 8 has been repaired. Observed at 06-24-2020 inspection. JFA/CWS

Bent 3 pile 8 replaced

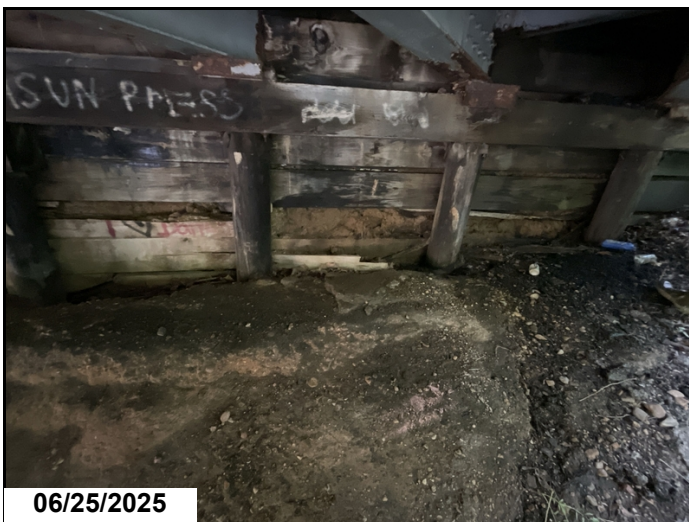
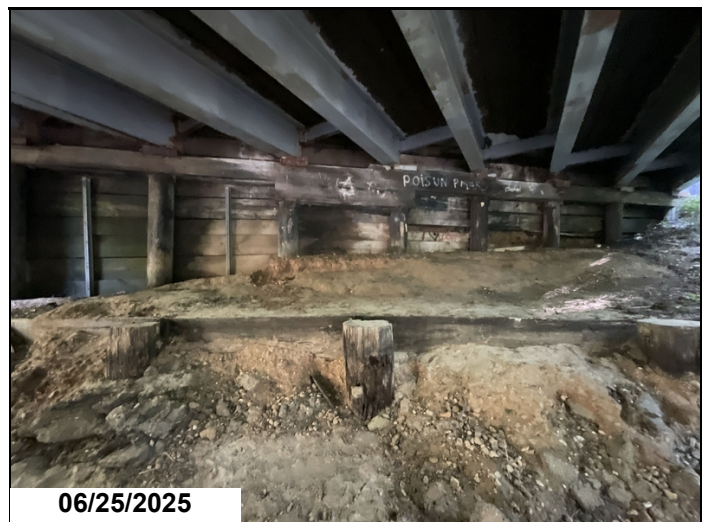
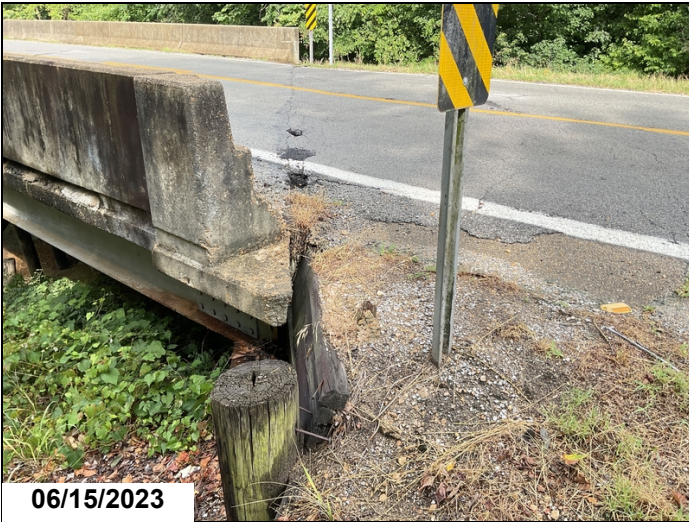
Bent 6 back wall is decayed and hollow. Roadway is losing some embankment through wall.
Bent 6 top of back wall on the right side has settled and rotated away from bridge end.

Bent 6 backwall

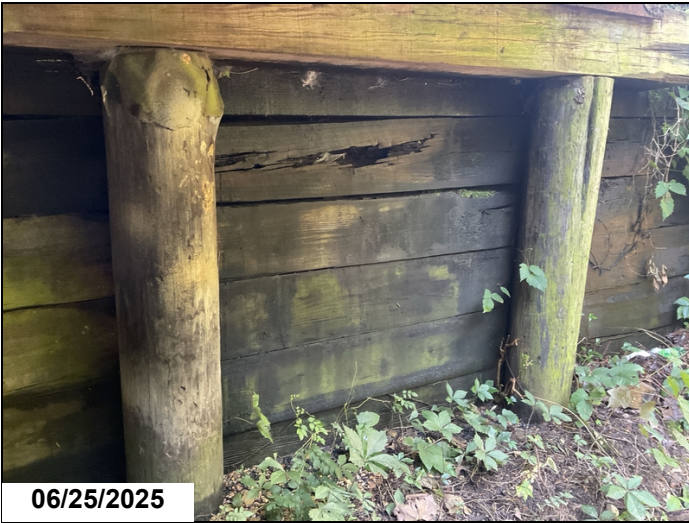
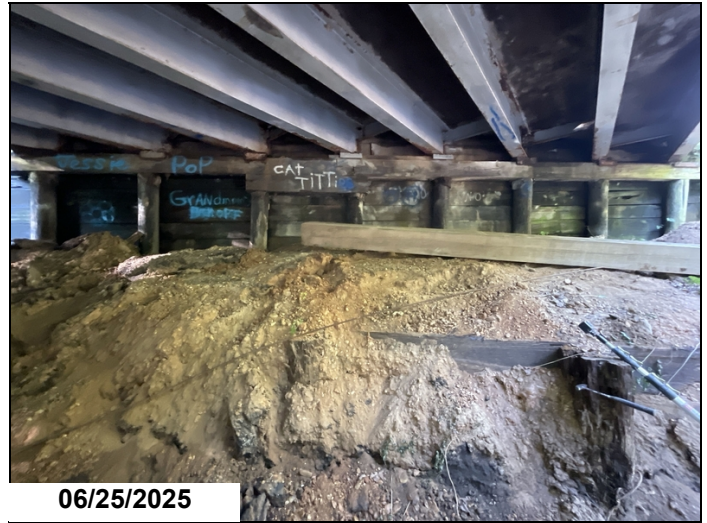
Bent 1 back wall is decayed and hollow.
Bent 1 back wall is caving in on girder 6.

Bent 1 backwall

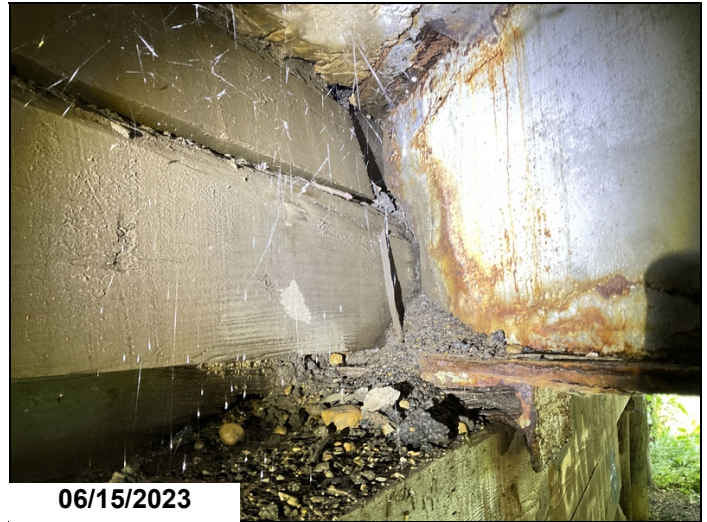
Bent 1 back wall at girder 6

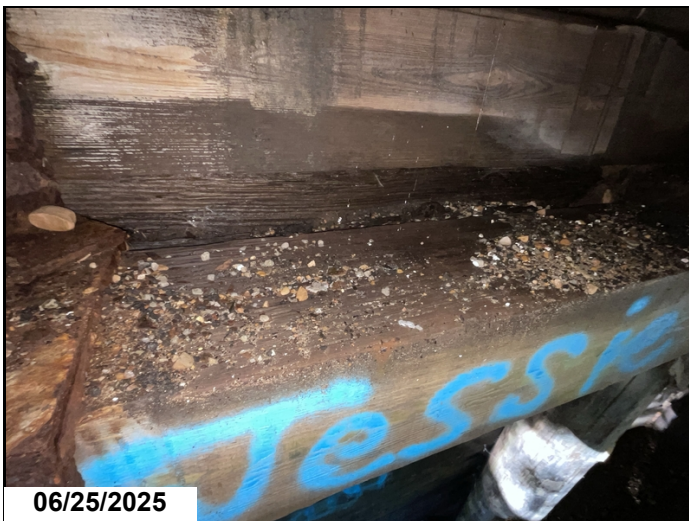
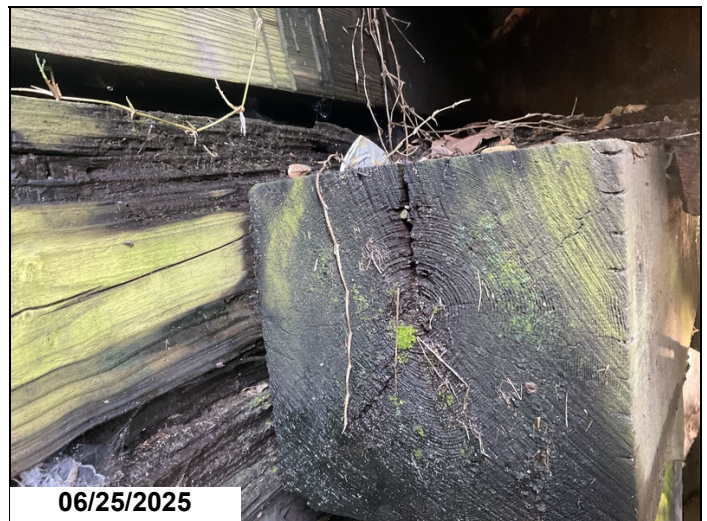
Bent 1 cap on Right end has a deep check halfway through cap. Cap is partially hollow on top between girders 7 & 8.
Bent 5 Cap Left end has a corner split on bottom ahead side.

Bent 1 cap between girders 7&8

Bent 1 cap Right end

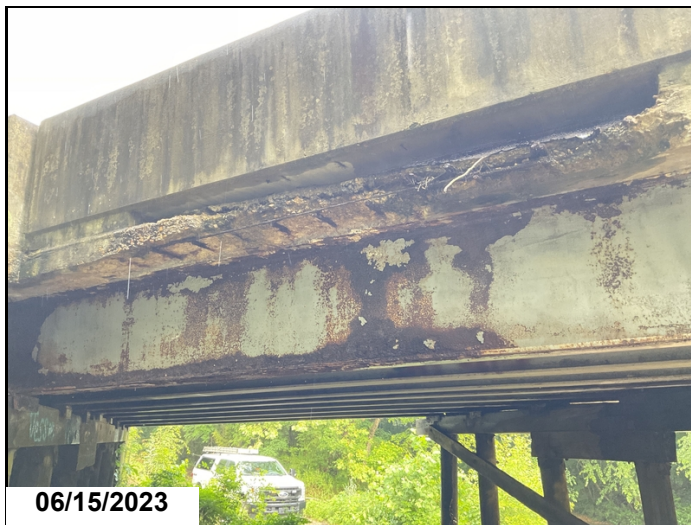
Span 1 Rt

Overhangs have areas of concrete disintegration with rebar exposed under drains, especially at end spans.

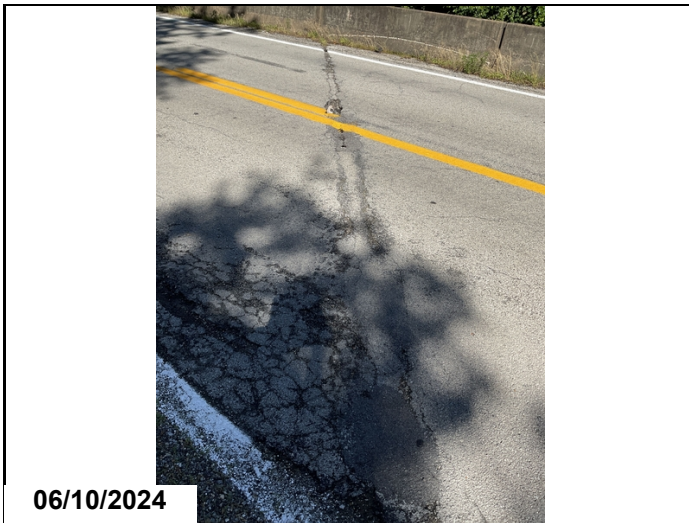
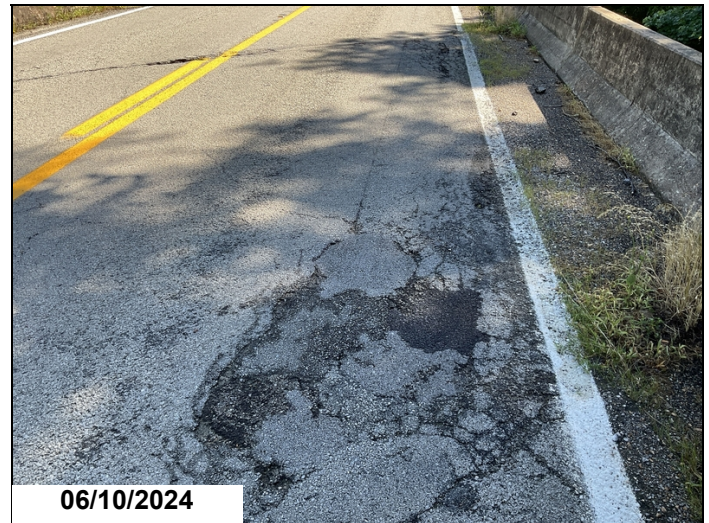
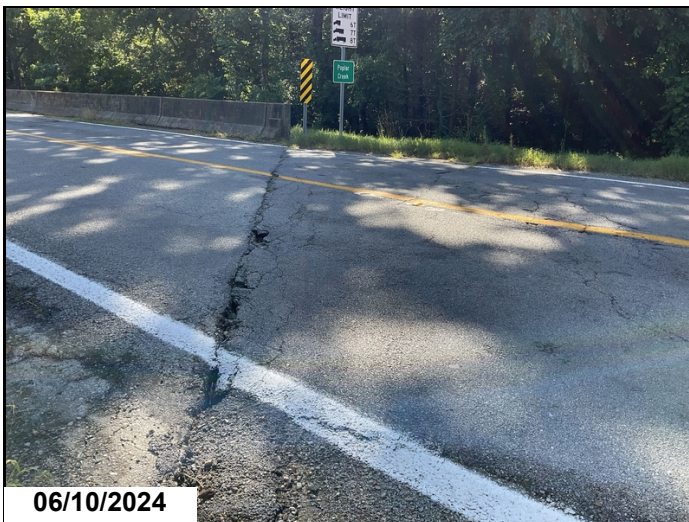
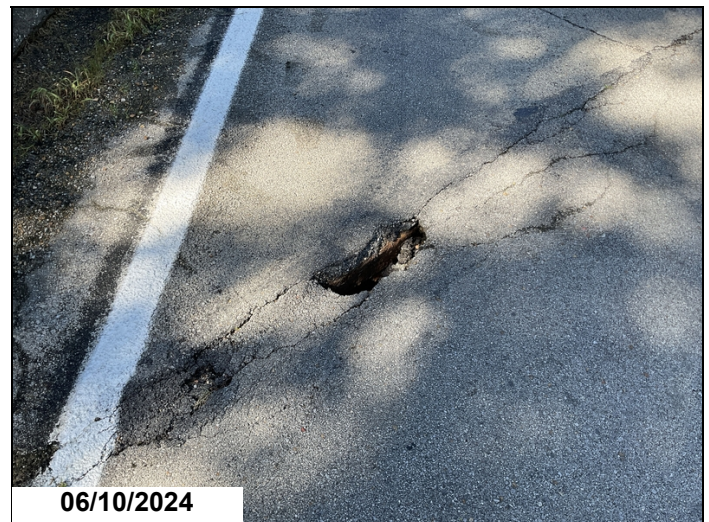
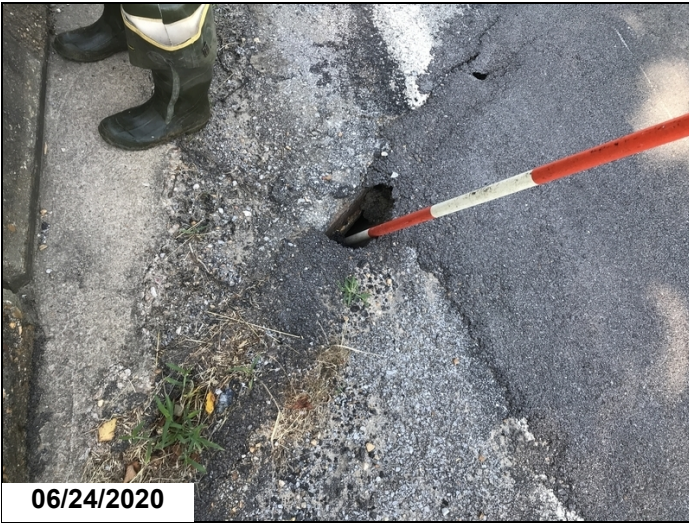
Approach roadways have settlement at each end of bridge. Asphalt is cracked and raveling out along joints.

to Greene Co Crew for repair KAW 7/6/2020
