# Bridge Inspection Report

**A3614**  
**I-40WB/Se51/L237.8**  
**over**  
**Spring Creek**

**Executive Summary**

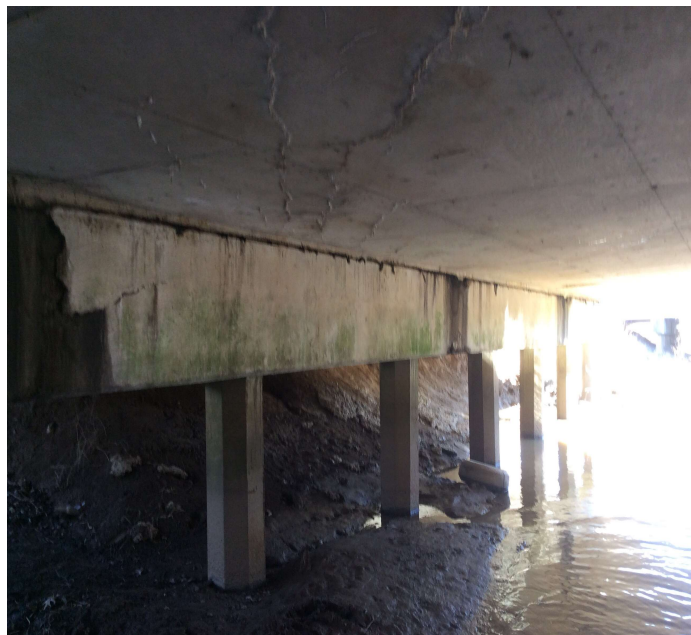
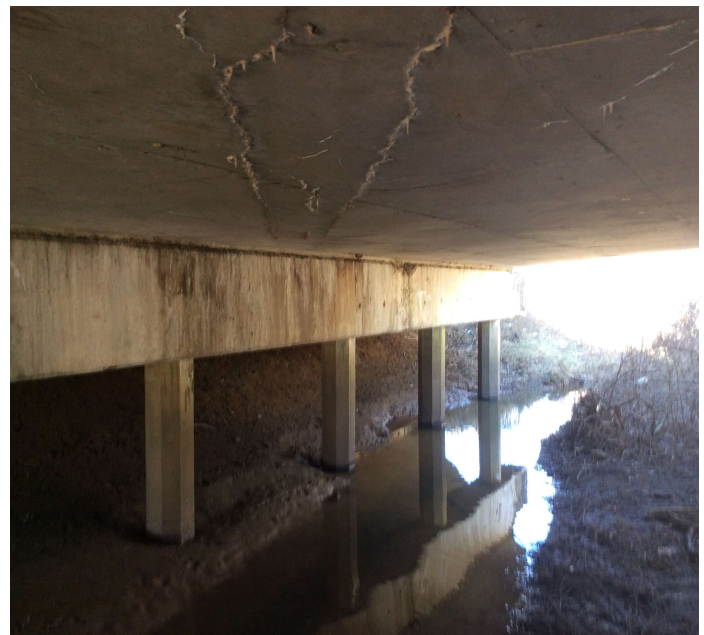
Bent #2 cap left and right ends have multiple cracks with spalling on top with no rebar exposed.

Bent #2 cap ahead face has a two foot spall between piles #2,3 with no rebar exposed.

Bent #3 cap back face has a three foot delamination between piles #2,3.

Bent #3 cap back face has a two foot spall at keyway between piles #6,7 with no rebar exposed.

Bent #4 cap 15' from right end at top has a 3' X2' six inch deep spall with no rebar exposed.

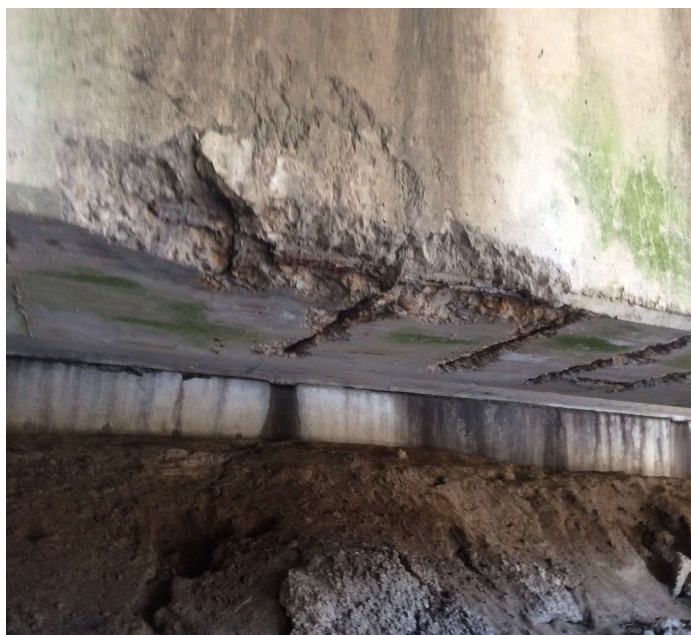
Bent #3 cap bottom chord between piles #4, 5 back face has a two foot spall with exposed rebar with 5% section loss.

PHOTO 3      Description      Bent #3 cap back face and bottom  
between piles #4,5.

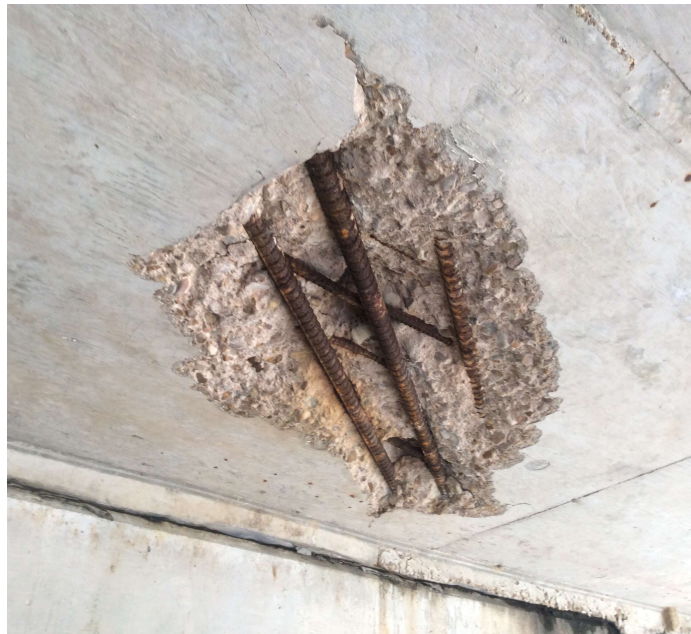
Soffit has open longitudinal cracks with areas of heavy efflorescence and small rust stains all spans.  
Span #1 soffit has four two foot spalls at sona--void drains with exposed rebar with 5% section loss.  
Span #2 soffit has a three foot spall near bent #3 pile #6 with exposed rebar with 5% section loss.

PHOTO 1      Description      Span #2 soffit between piles # 5,6.

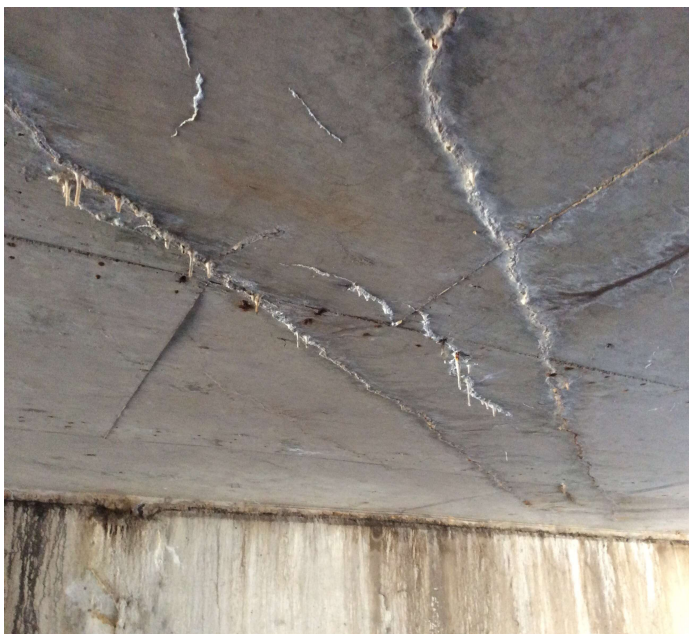
PHOTO 4 Description Typical soffit cracks with efflorescence and staining.

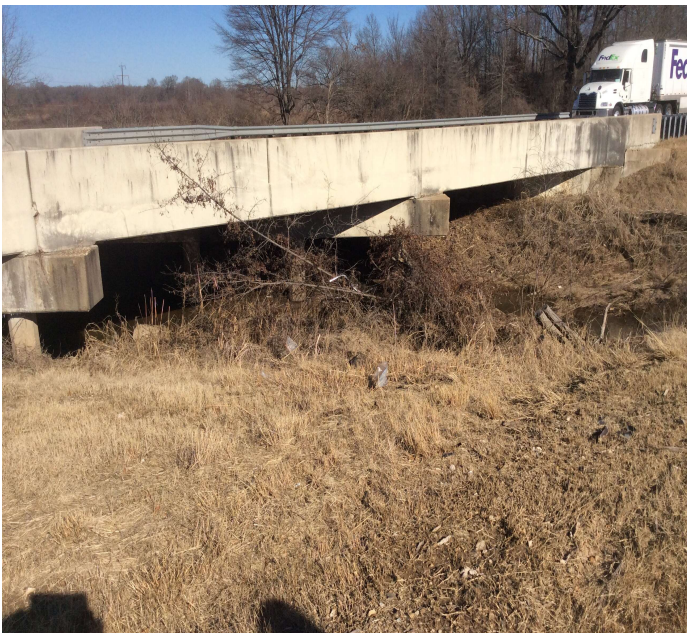
Small trees and vegetation are growing besides bridge.

PHOTO 1    Description    Typical brush

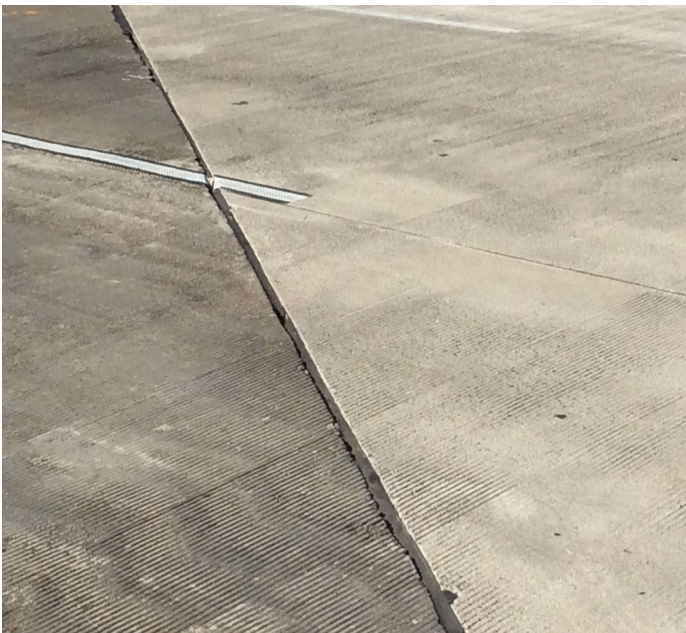
Several feet each pourable joint has loss of adhesion.

PHOTO 1    Description    Typical loss of adhesion.
