# Bridge Inspection Report

**B3614**  
**I-40EB/Se51/L237.8**  
**over**  
**Spring Creek**

Structure Number: B3614

Facility Carried: I-40EB/Se51/L237.8

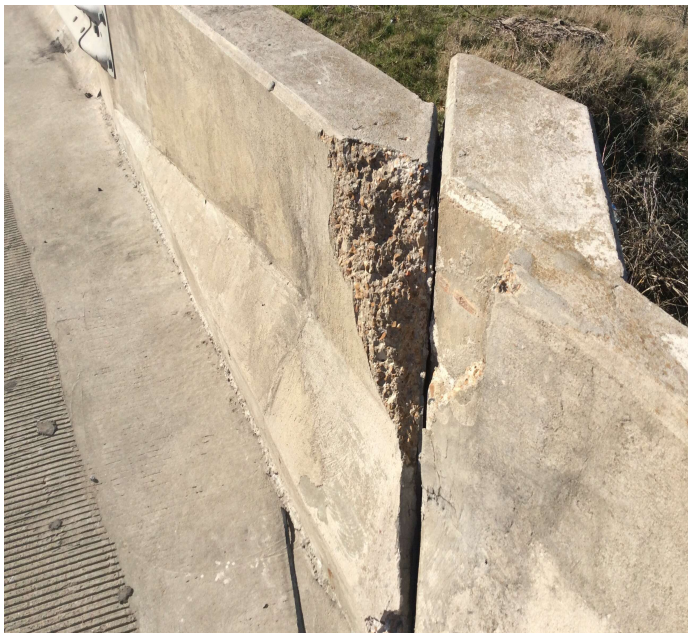
Abutment #1 left transition rail has 2' X 2' spall with exposed rebar no section loss.

PHOTO 1      Description      Concrete transition wall abutment #1 left side

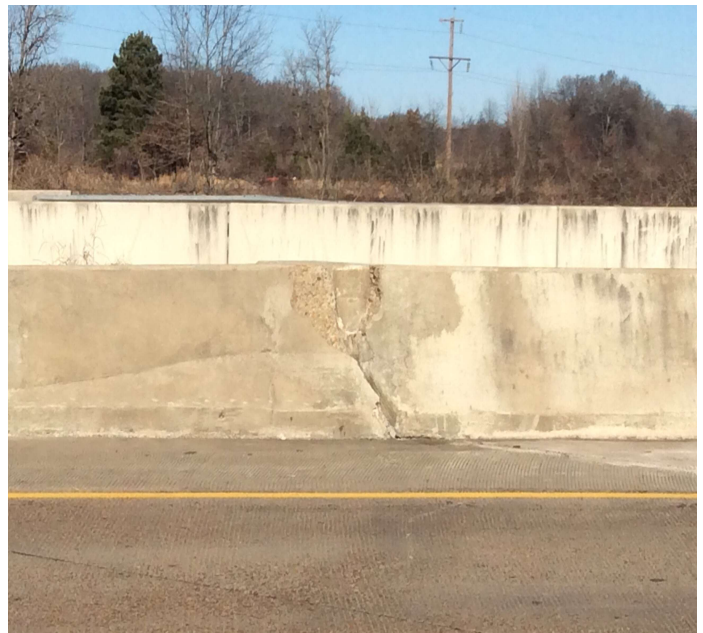
PHOTO 2      Description      Abutment #1 left rail spall.

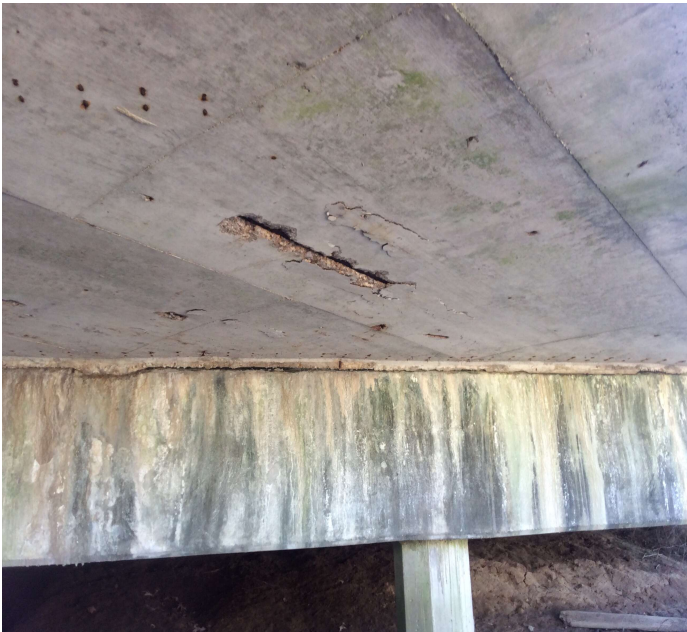
Span #2 soffit has 1' delamination 2' from bent #3 and 10' from right side of bridge, and left side has two 3' spalls with exposed rebar with 5% section loss.

PHOTO 1      Description      Spall in soffit span #2 left side.

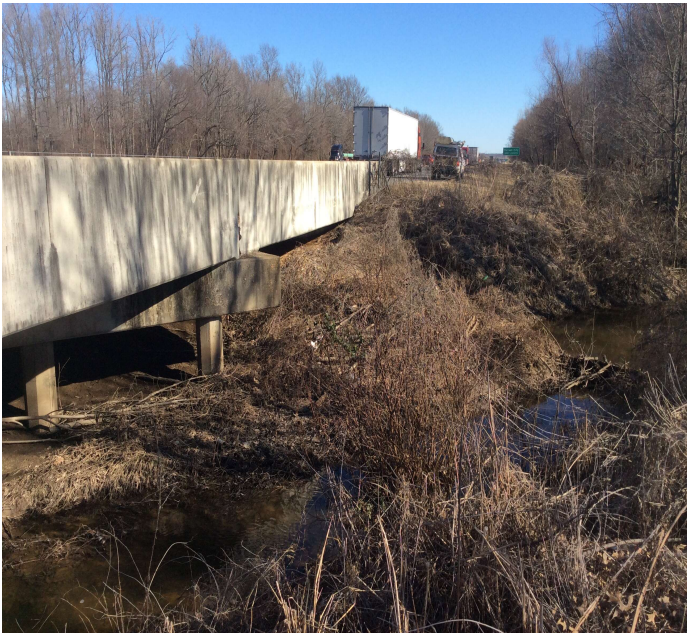
Small trees and vegetation are growing under and beside bridge.

PHOTO 1    Description    Typical vegetation

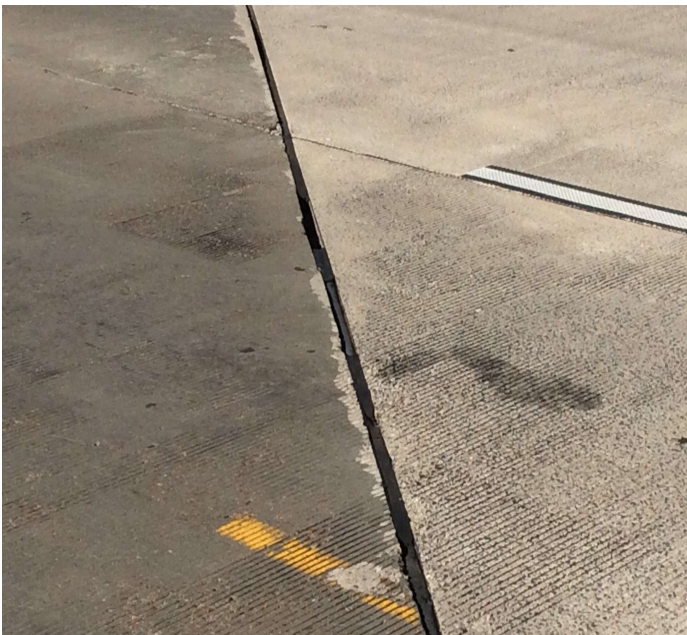
Each poured joint has several areas where material has lost adhesion.

PHOTO 1    Description    Typical joint lost adhesion.

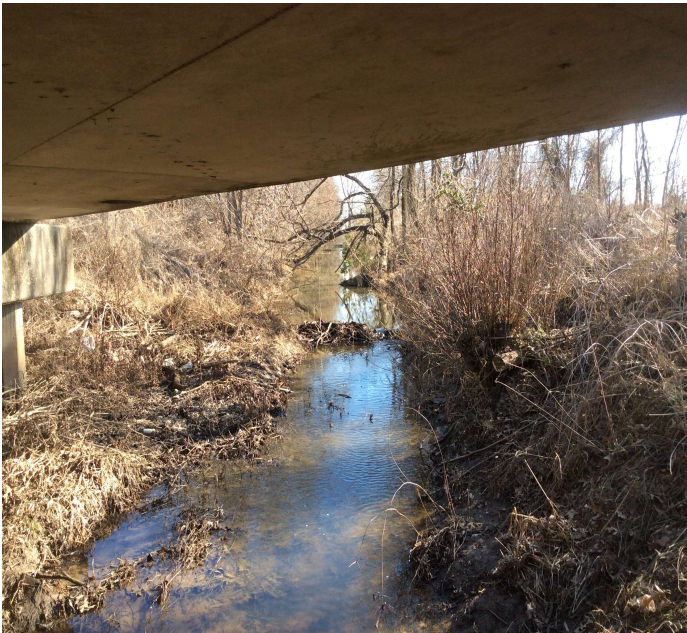
Right side of bridge has small beaver dam blocking channel.

PHOTO 1      Description      Right side of bridge has small beaver dam blocking channel.
