Bridge Inspection Report

A3617
I-40WB/Se51/239.52
over
Drainage Ditch

Structure Number: A3617

Facility Carried: I-40WB/Se51/239.52

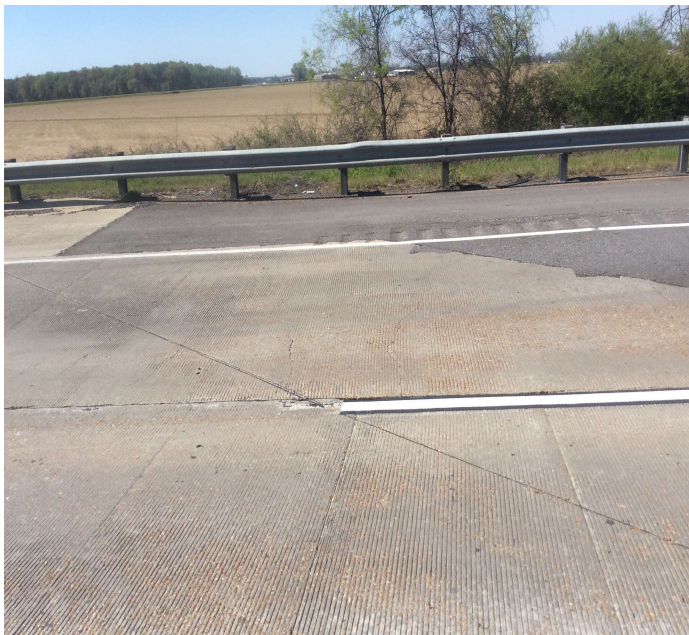
PHOTO 1 Description

Both approach slabs have open transverse cracks.

Priority: C - Important

Stage: Monitor

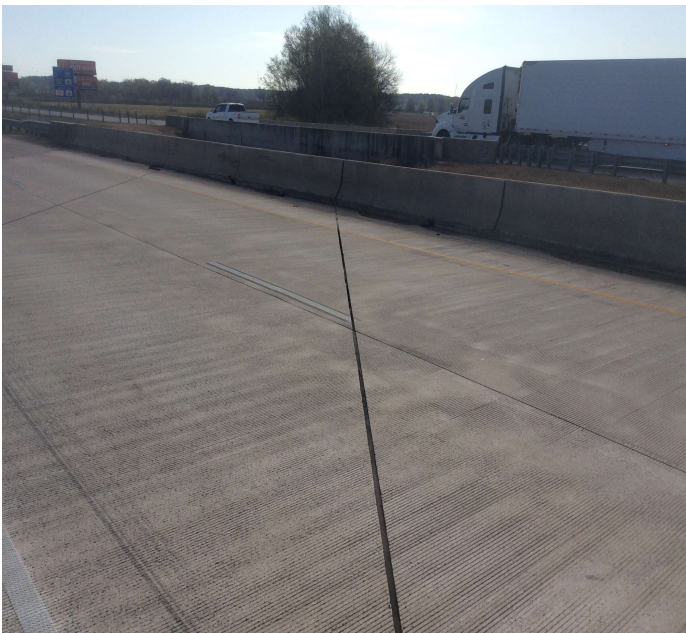
Bent #2,3 poured joint seal has a few spots of loss of adhesion ten feet total.

PHOTO 1 Description Bent #2,3 poured joint seal has a few spots of loss of adhesion ten feet total.

Priority: D - Routine

Stage: Open
