Bridge Inspection Report

B3617
I-40EB/Se51/239.52
over
Drainage Ditch

Structure Number: B3617

Facility Carried: I-40EB/Se51/239.52

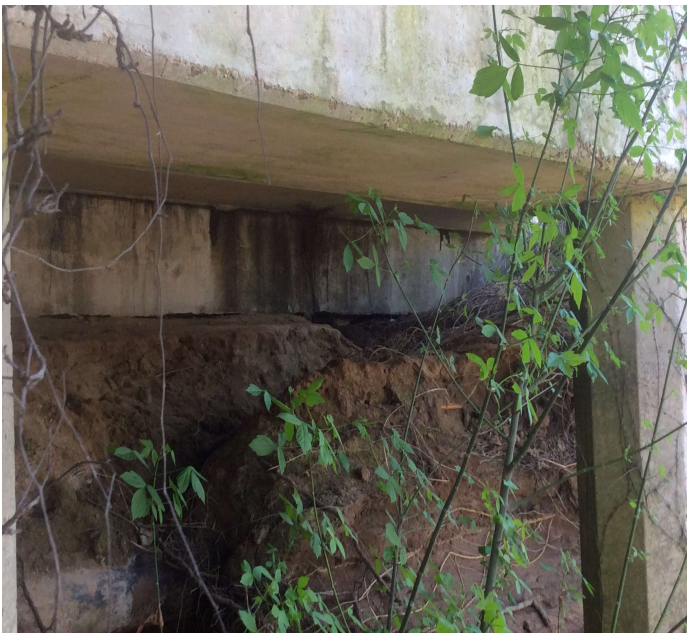
PHOTO 1 Description

Abutment #1 slope is eroded undermining cap and exposing pile #2.

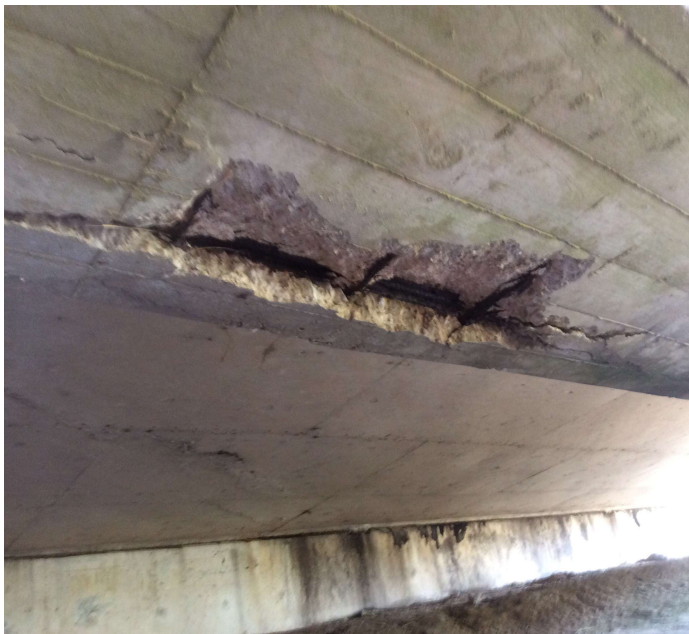
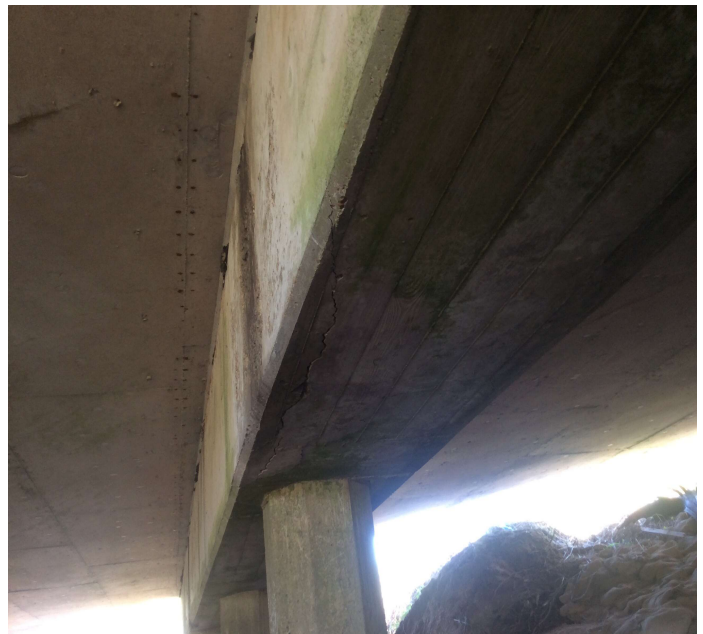
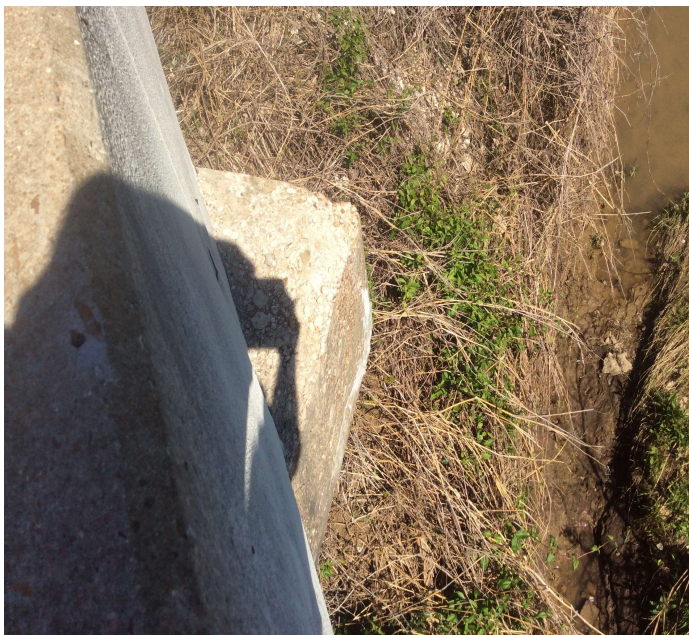
Bent #3 cap ahead face lower corner between piles #5,6 is spalled with exposed rebar with 5% section loss and delamination crack extending for 8'.

Bent #3 cap back face between piles #4,5 has crack and delamination on lower corner.

Top of caps on ends at bents #2,3 are scaling.

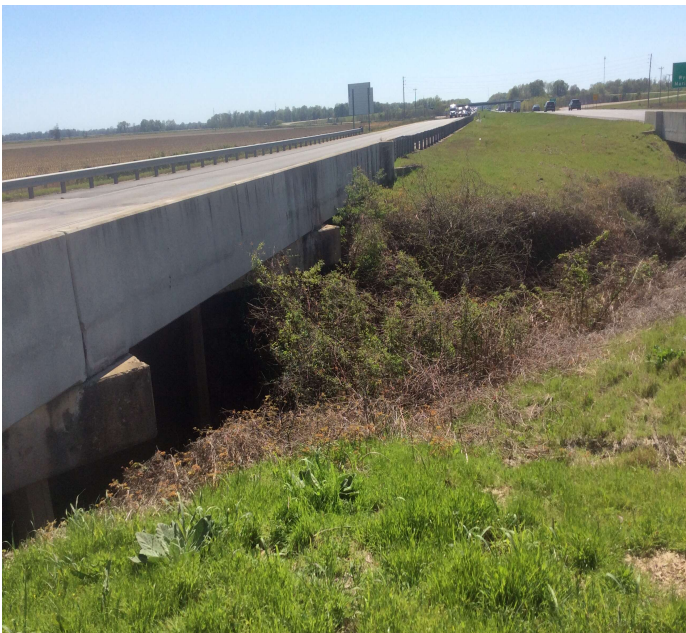
PHOTO 1 Description

Trees and vegetation is growing under and beside bridge.

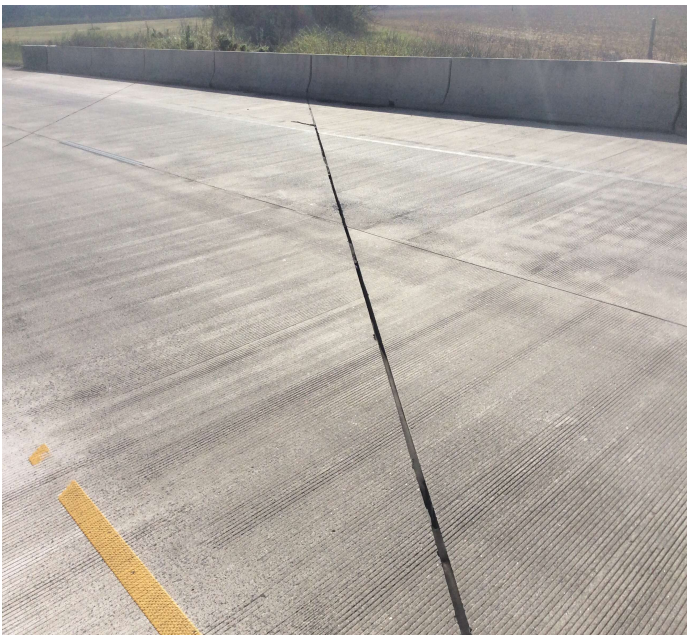
Bent #2,3 pourable joint has a few feet each bent with loss of adhesion 20 feet total.

PHOTO 1	Description	Bent #2,3 pourable joint has a few feet each bent with loss of adhesion 20 feet total.
---------	-------------	--
