# Bridge Inspection Report

**A6518**  
**I-40WB/Se51/234.04**  
**over**  
**Languille River**

Structure Number: A6518

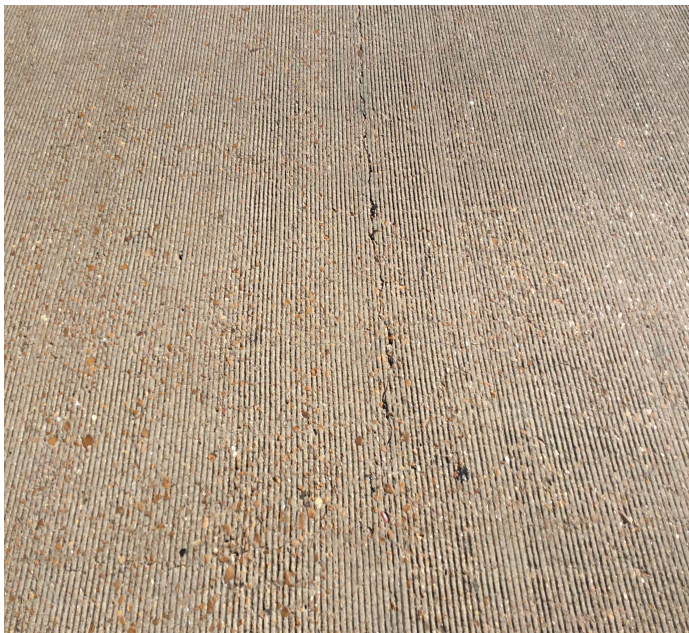
PHOTO 1 Description

Deck has transverse and longitudinal cracks open and sealed spaced three feet apart.

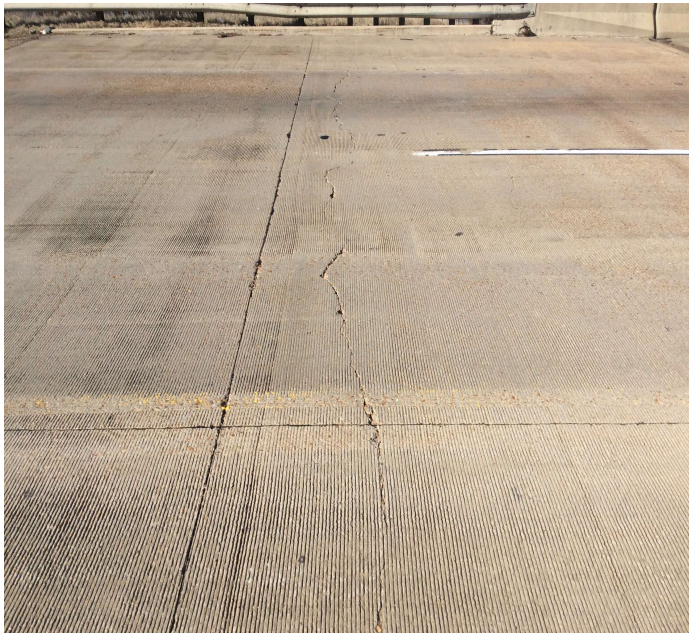
PHOTO 1 Description

All approach slabs have unsealed transverse and longitudinal cracks.

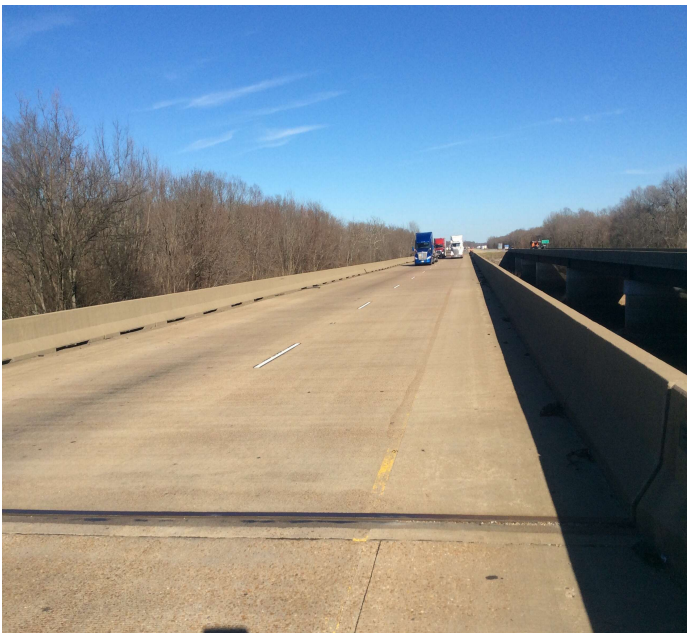
PHOTO 1 Description

Both gutters have large amounts of debris.

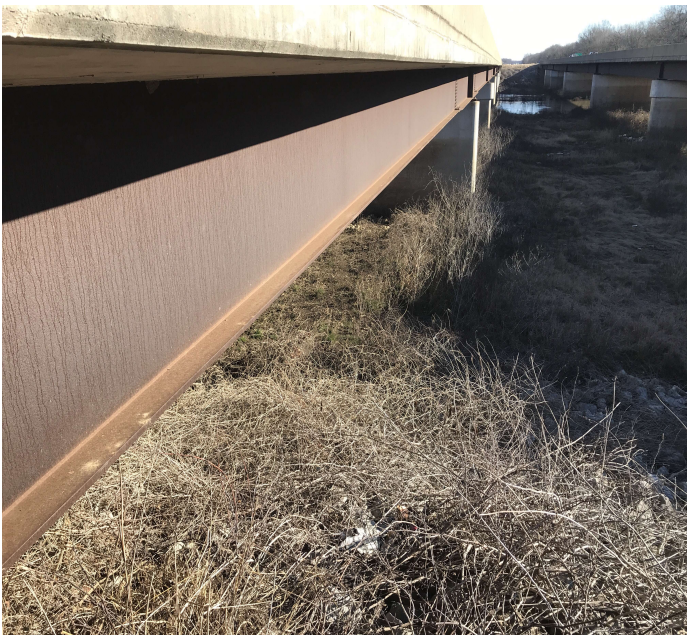
Small trees and vegetation are growing beside and under bridge.

PHOTO 1      Description      Small trees and vegetation are growing beside and under bridge.
