Bridge Inspection Report

B6518
I-40EB/Se51/234.04
over
Languille River

Structure Number: B6518

Facility Carried: I-40EB/Se51/234.04

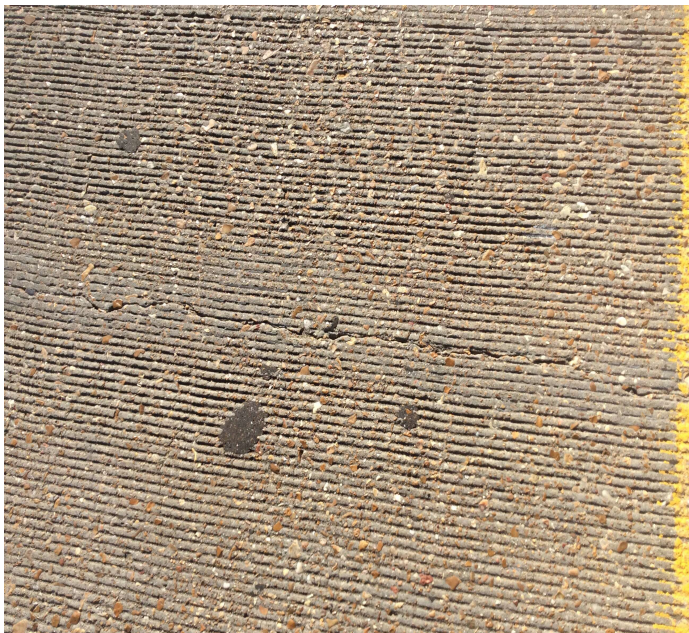
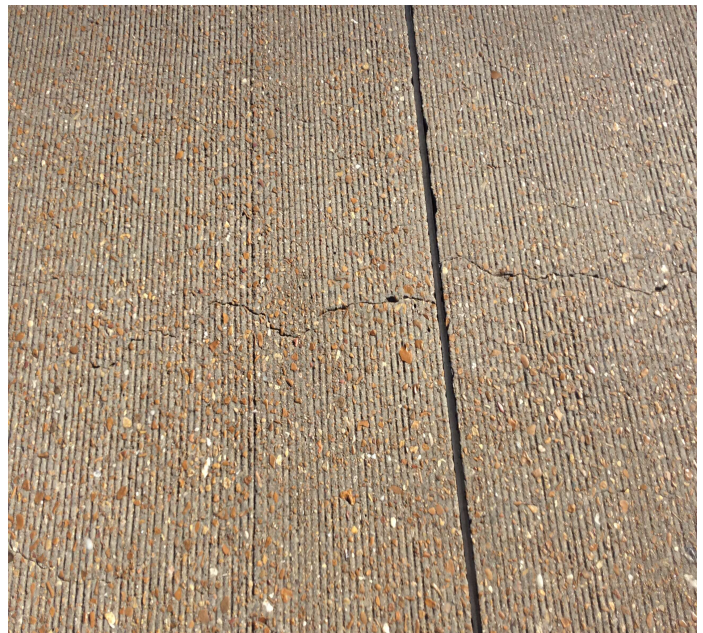
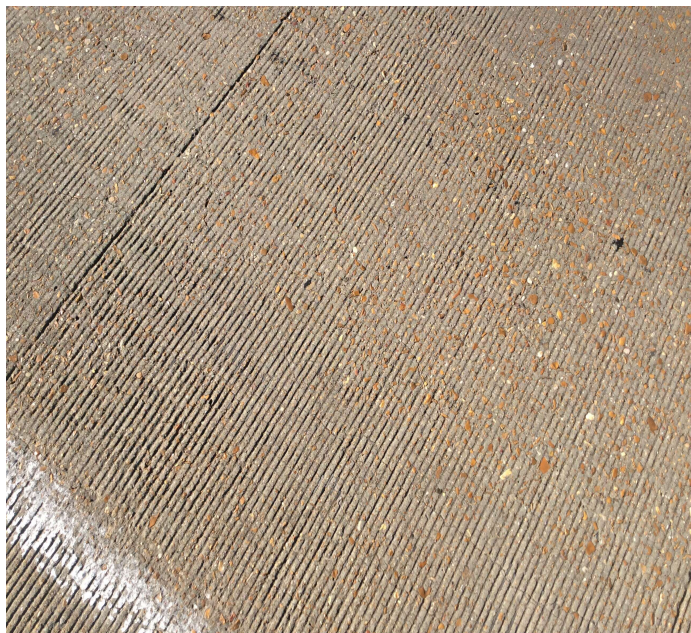
Deck has transverse and longitudinal cracks some have been sealed with epoxy spaced four to five feet apart.

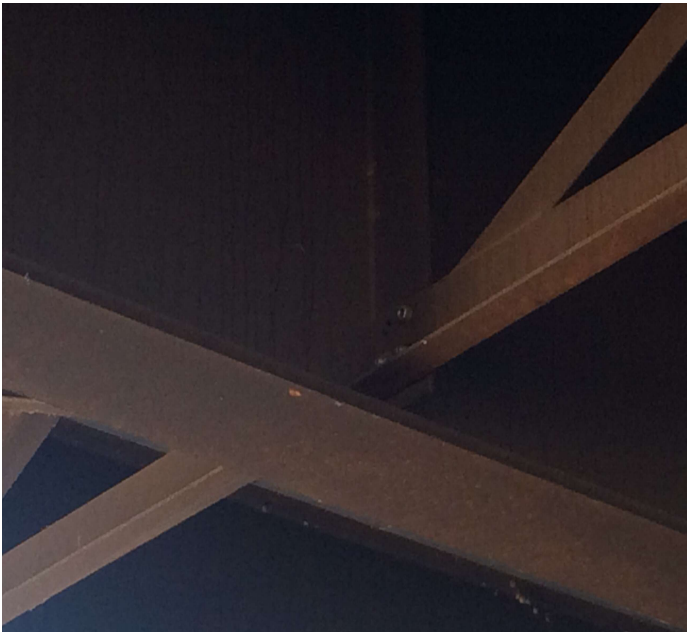
Span #1 girder #4 diaphragm bolts are loose.

Span #3 bent #4 girder #5 lower diaphragm connection has several loose bolts.

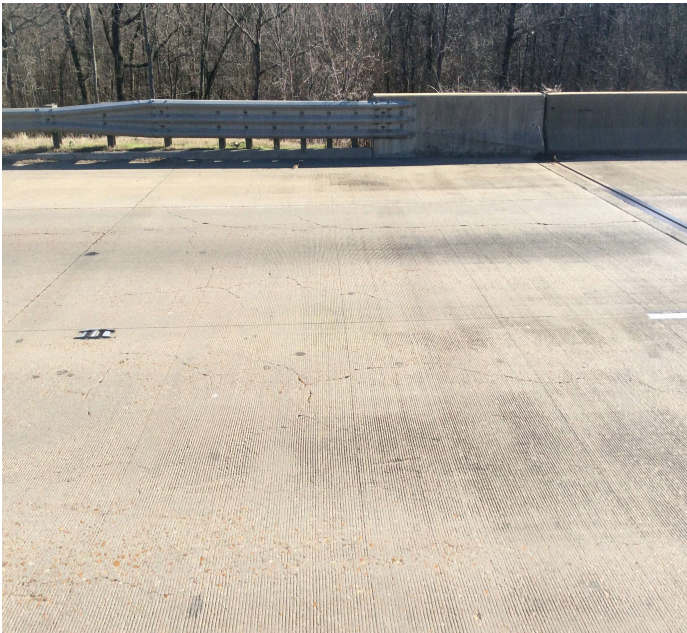
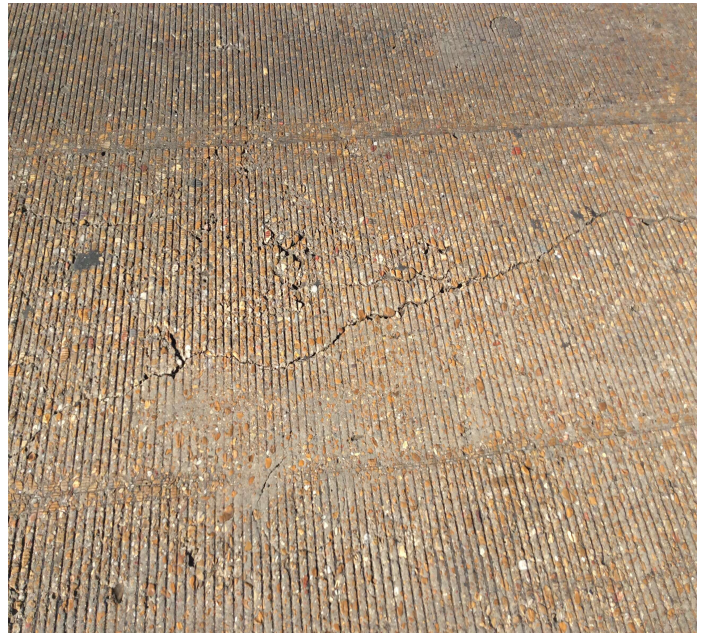
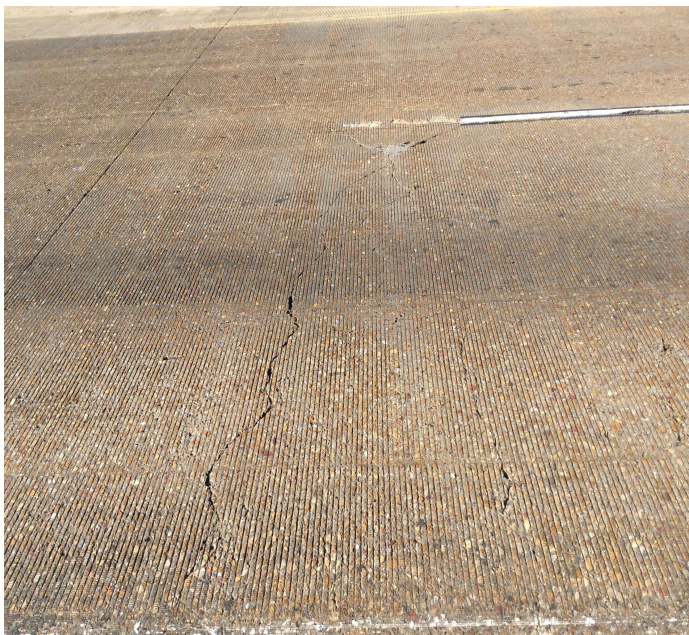
All slabs have open transverse and longitudinal cracks.

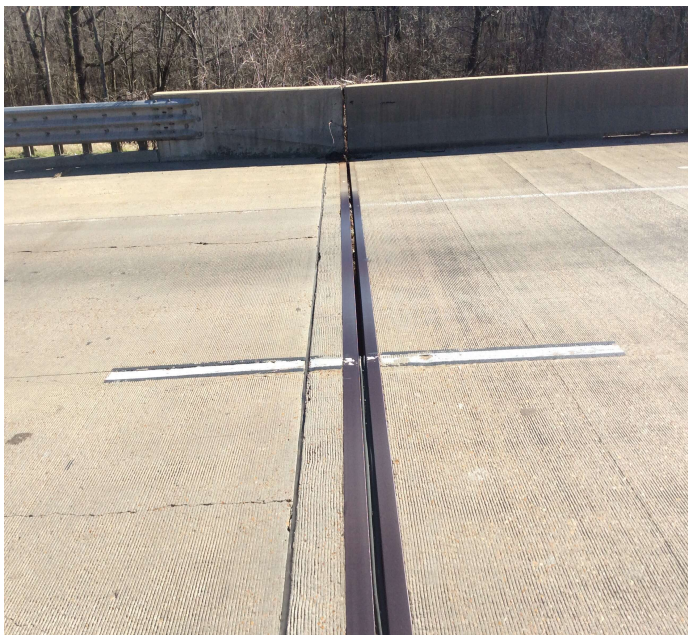
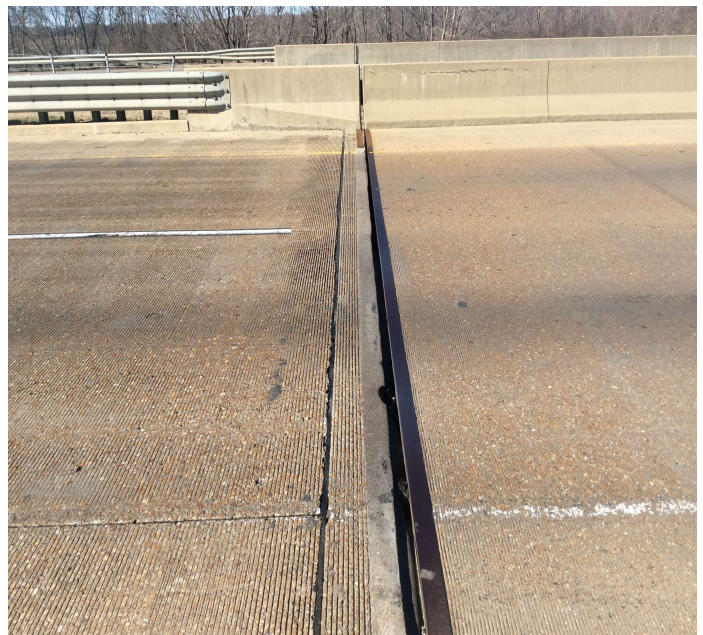
Abutment #1 right lane seal has fallen out and has a pourable seal in left lane only with loss of adhesive.
Abutment #2 right lane seal has fallen out and is a compressible joint seal.

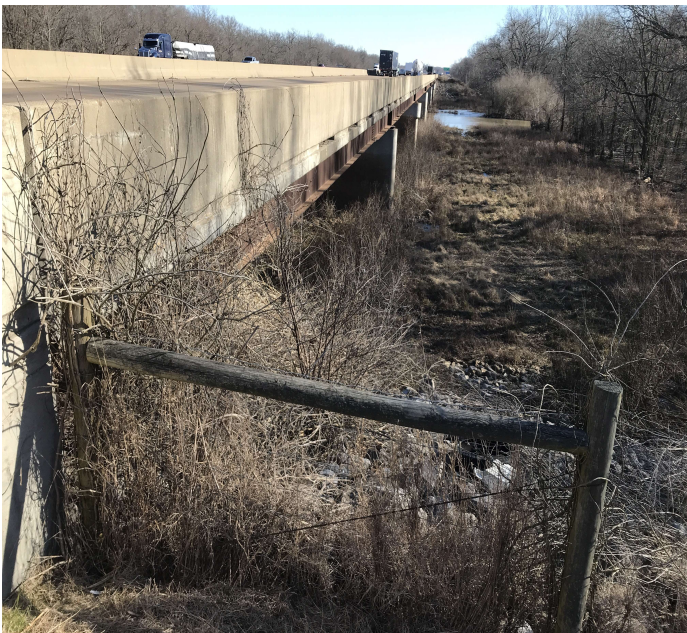
Small trees and vegetation are growing beside and under bridge.

PHOTO 1 Description Small trees and vegetation are growing beside and under bridge.
