Bridge Inspection Report

A6522
I-40WB/Se51/240.02
over
Dawson-RR/Z-F/L-1.88

Structure Number: A6522

Facility Carried: I-40WB/Se51/240.02

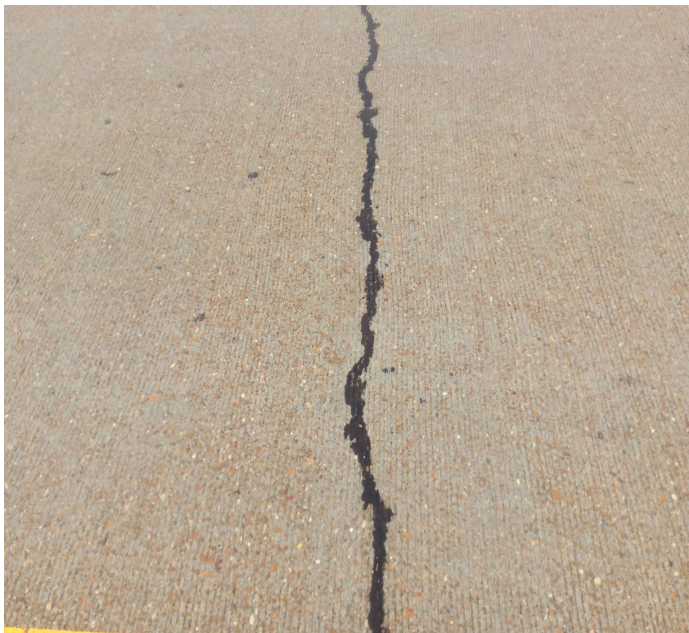
Deck has open and sealed longitudinal and transverse cracks each span majority are sealed various spaced.

PHOTO 1 Description Typical sealed transverse deck cracks

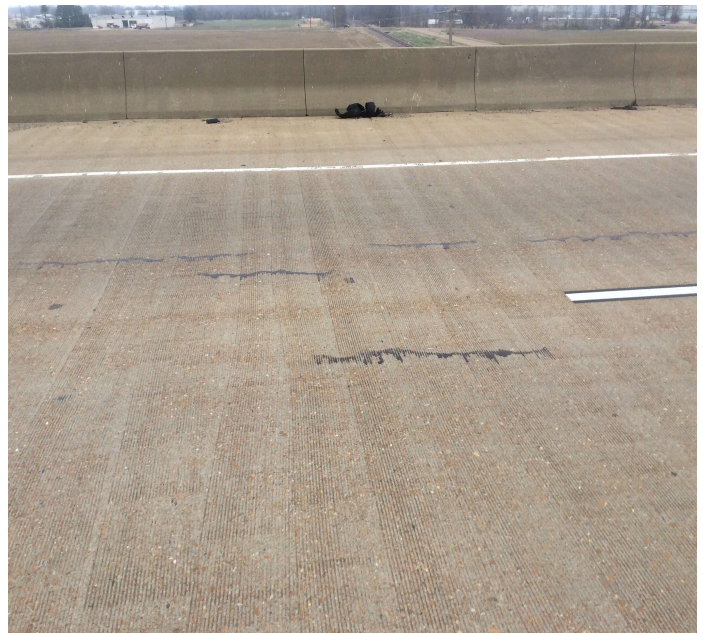
PHOTO 2 Description Typical sealed longitudinal deck cracks (3 sealed 3 unsealed) full length

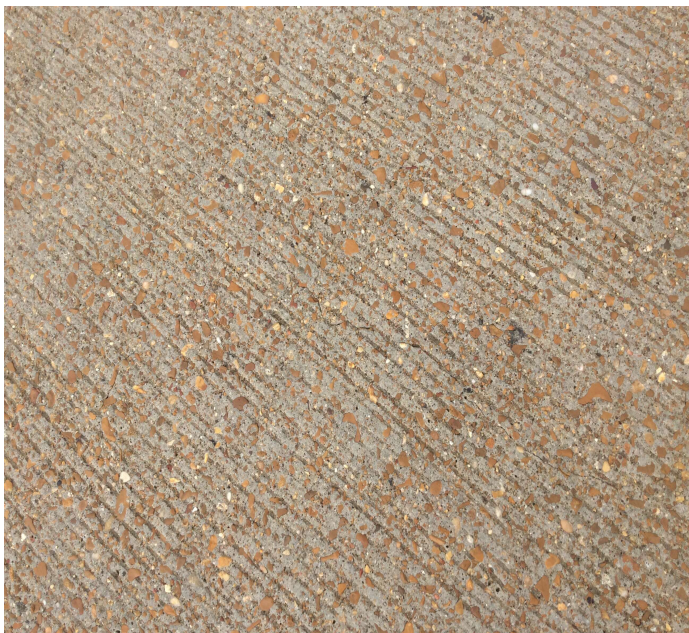
PHOTO 3 Description Typical unsealed transverse deck crack spaced 4'+-

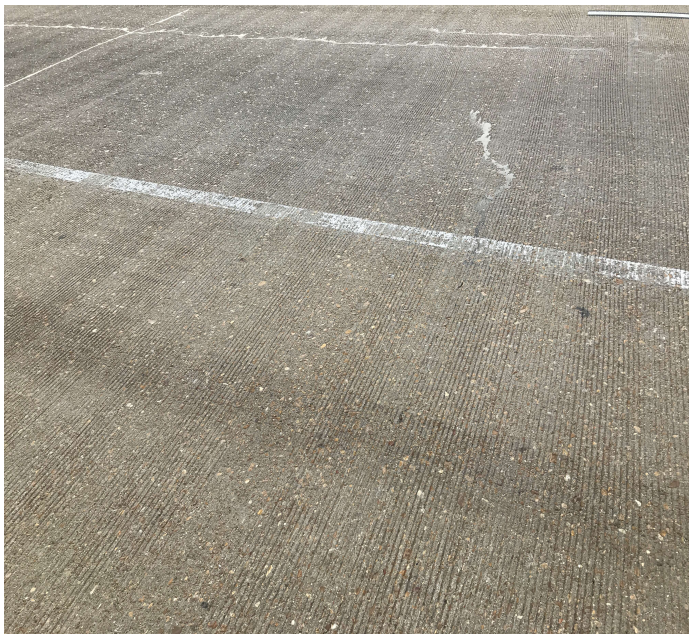
PHOTO 4 Description Typical deck.

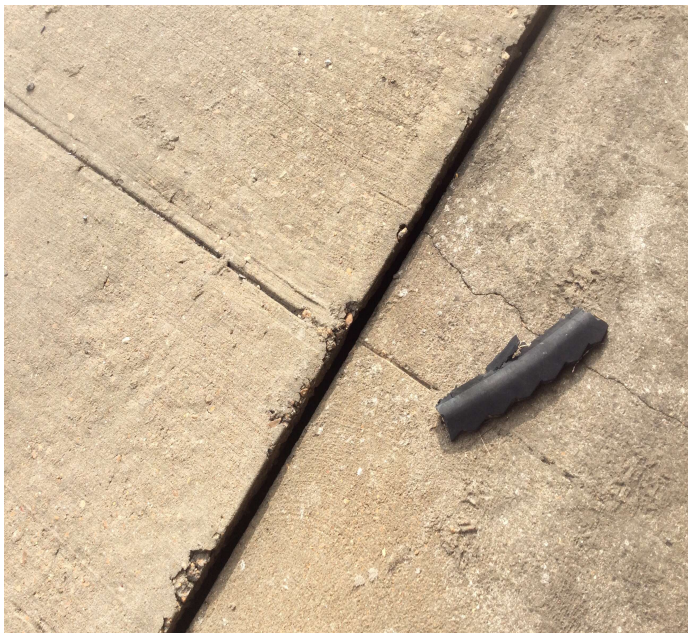
Abutment #1 slope right side has a voided area under slope pavement one and a half feet deep.

PHOTO 1 Description Abutment #1 slope pavement right side

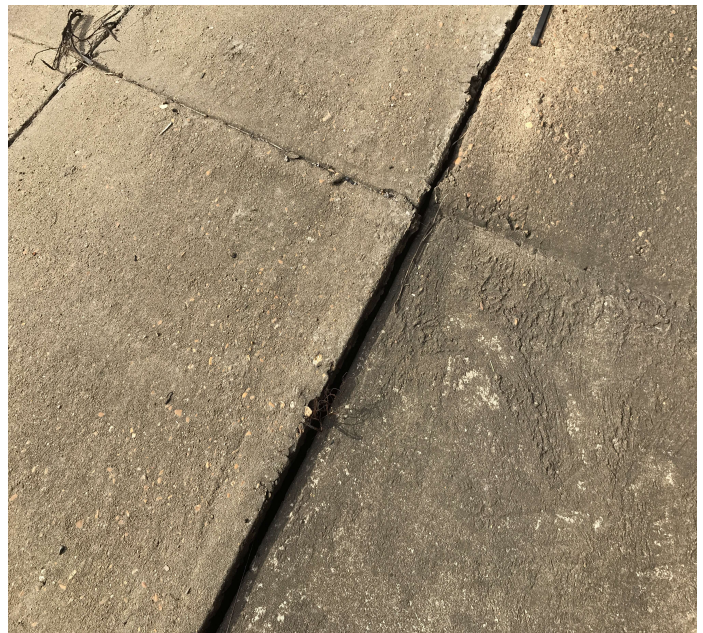
PHOTO 2 Description Abutment #1 slope right side has a voided area under slope pavement.

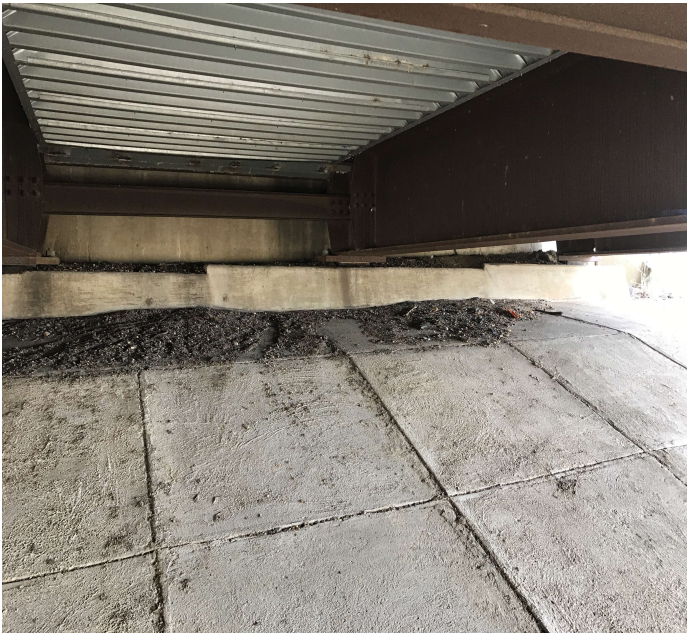
PHOTO 1 Description Abutment #1 cap has dirt and debris on it.

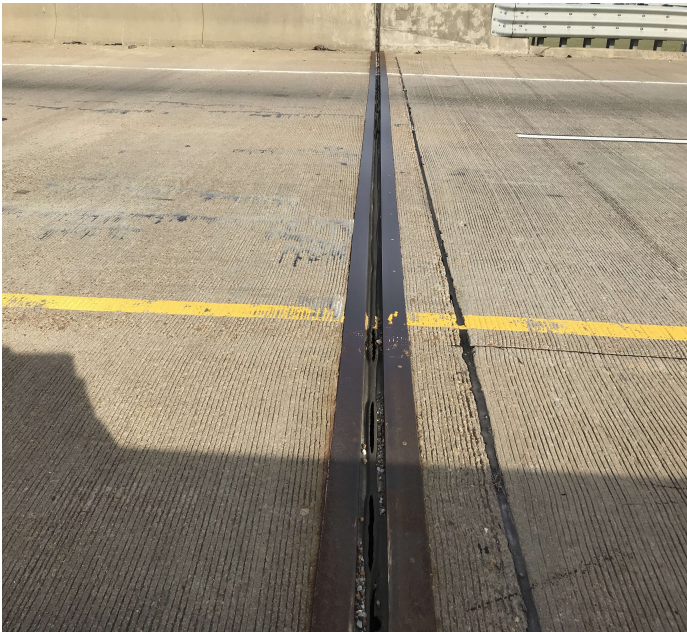
PHOTO 1 Description Abutment #2 joint material has 50% torn.

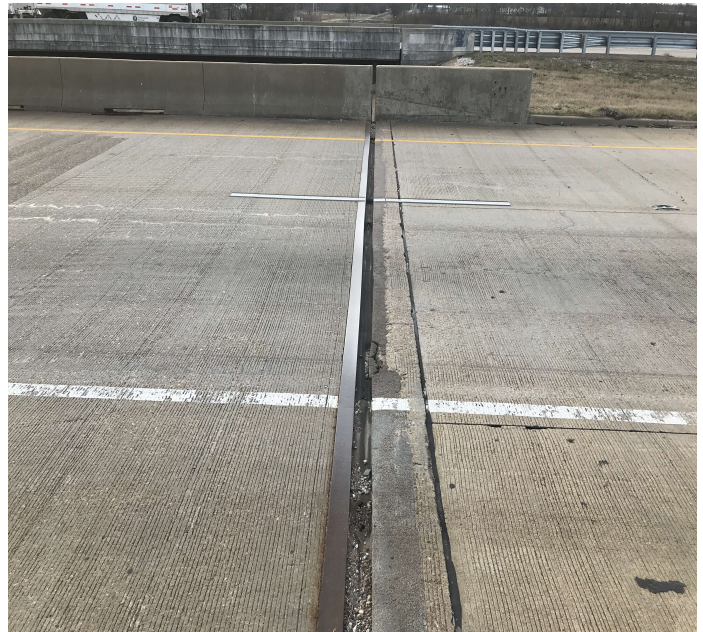
PHOTO 2 Description Abutment #1 joint material has six small torn areas.

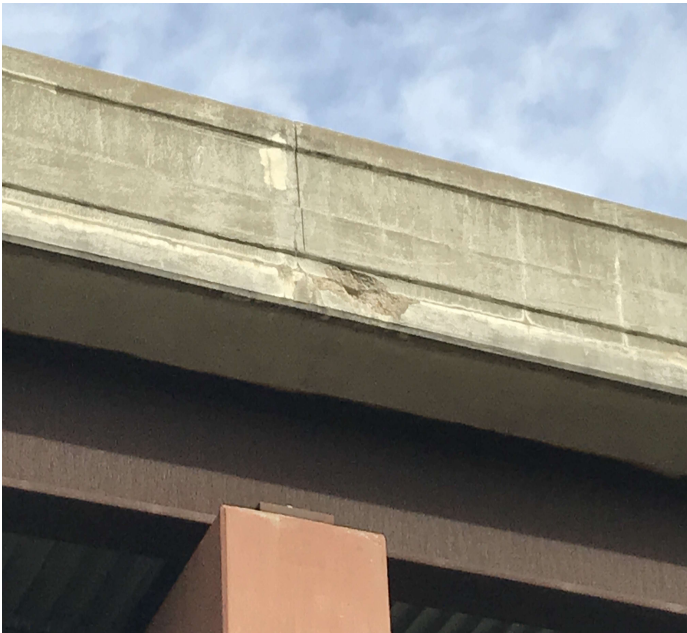
Right bridge rail out side at bent #3 has a one foot spall with no exposed rebar.

PHOTO 1 Description Spall at bent #3 right side outside of wall.
