Bridge Inspection Report

B6522
I-40EB/Se51/239.97
over
Dawson/Z-F/L-0.01

Structure Number: B6522

Facility Carried: I-40EB/Se51/239.97

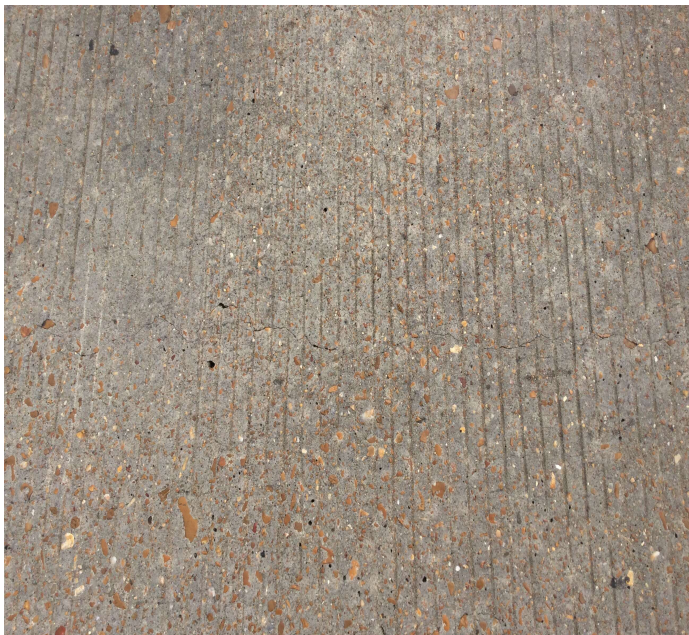
PHOTO 1 Description

Deck has open and sealed longitudinal and transverse cracks each span majority are sealed various spaced.

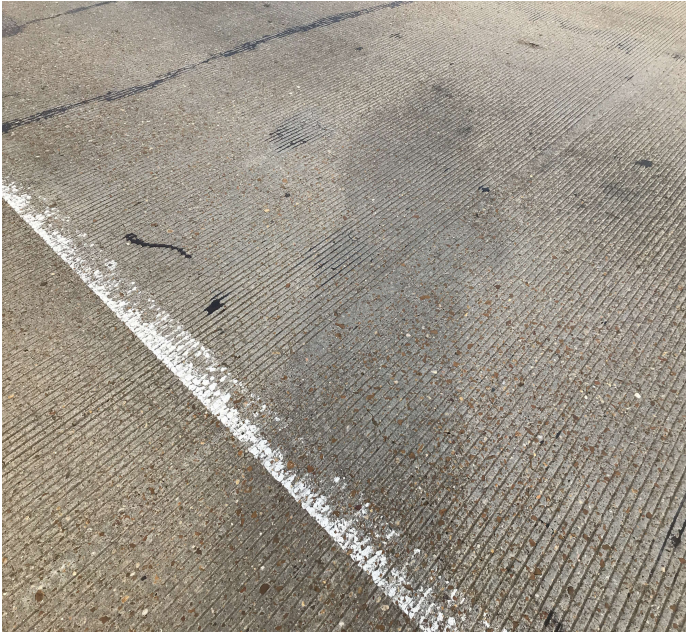
PHOTO 3 Description Typical deck

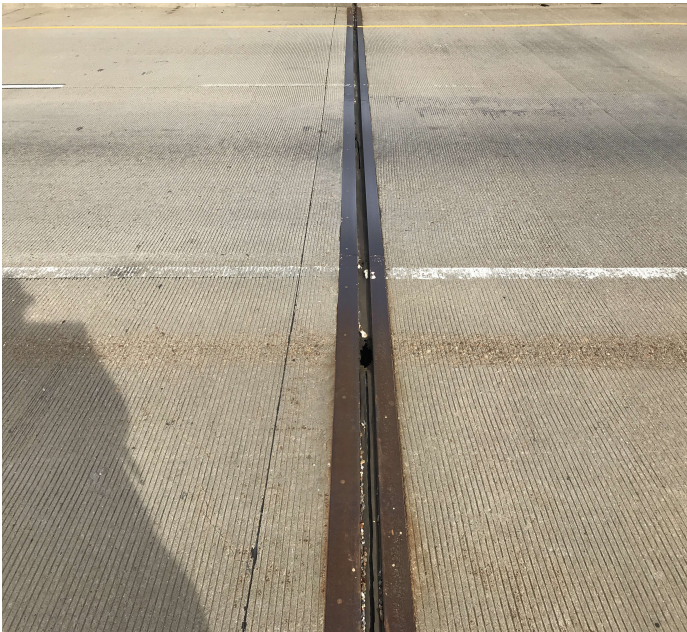
Abutment #1 joint material has twenty five feet that is torn.

PHOTO 1 Description Abutment #1 joint material has twenty five feet that is torn.

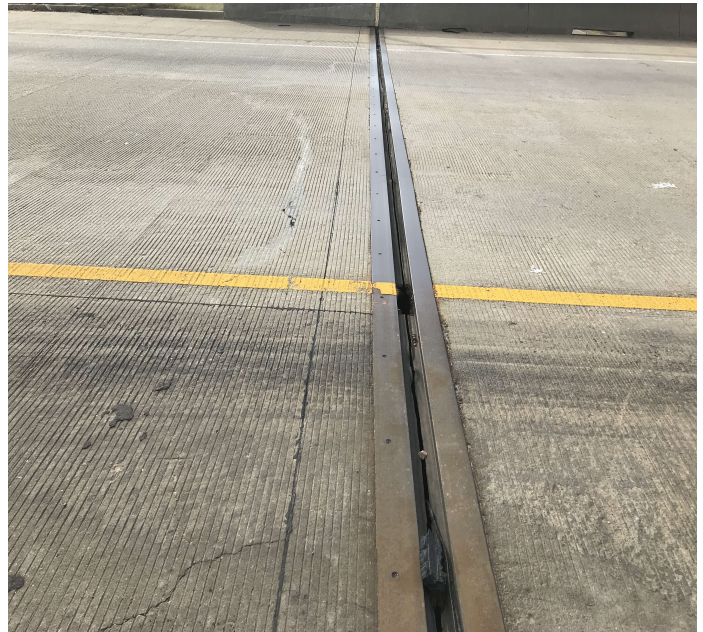
Abutment #2 joint material is torn full length.

PHOTO 2 Description Abutment #2 joint material is torn full length.
