Bridge #02808(Routine)
I-55N/Sec11/L12.67 over 15 Mile Bayou
Location: 2.50 Mi N Of Marion Ark

Team Lead: Drew Melton Inspection Date: April 13, 2020

IDENTIFICATION	
(1) State Names	Arkansas
(8) Structure Number	02808
(5) Inventory Route	55
(2) Highway Agency District	01
(3) County Code	35-Crittenden County, Arkansas

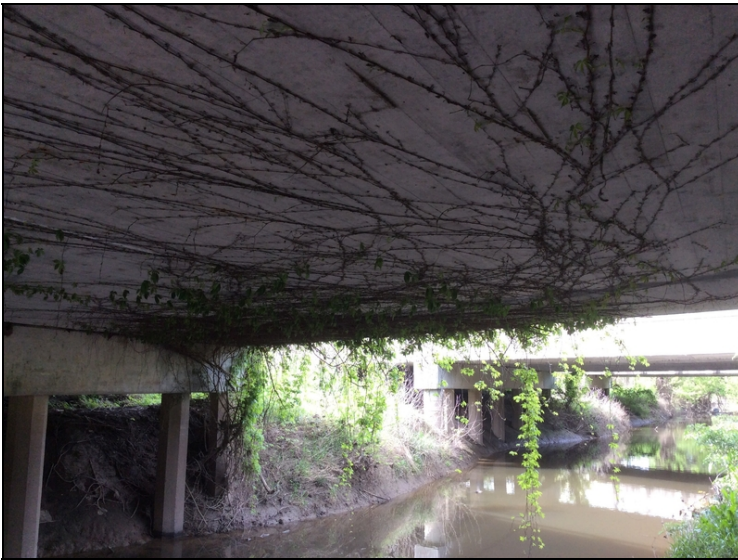
Date Reported: 04/18/2012
Priority: D- Routine
Type of Work: Clean
Status: Monitor
Component: Channel

Vegetation is growing under and beside bridge, and onto soffit and piles.

Span 2 vegetation.

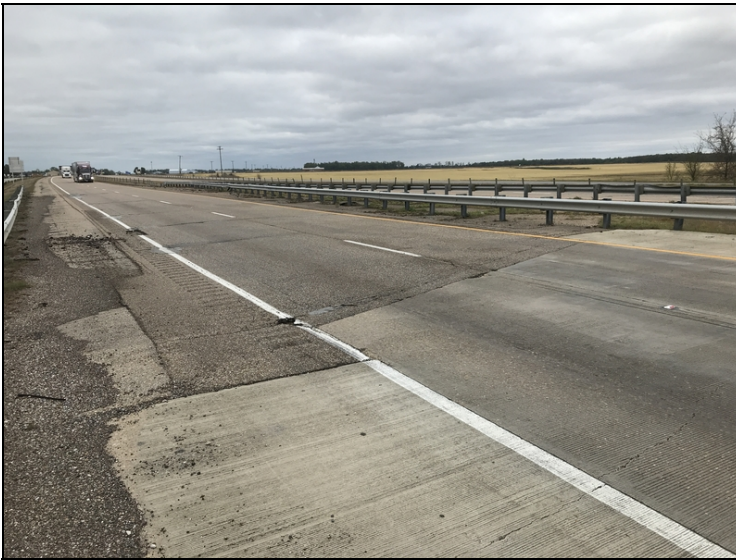
Date Reported: 04/21/2014
Priority: D- Routine
Type of Work: Repair
Status: Monitor
Component: Approach

Abutment #1 left and right approach rails have collision damage.

Abutment #1 left approach rail

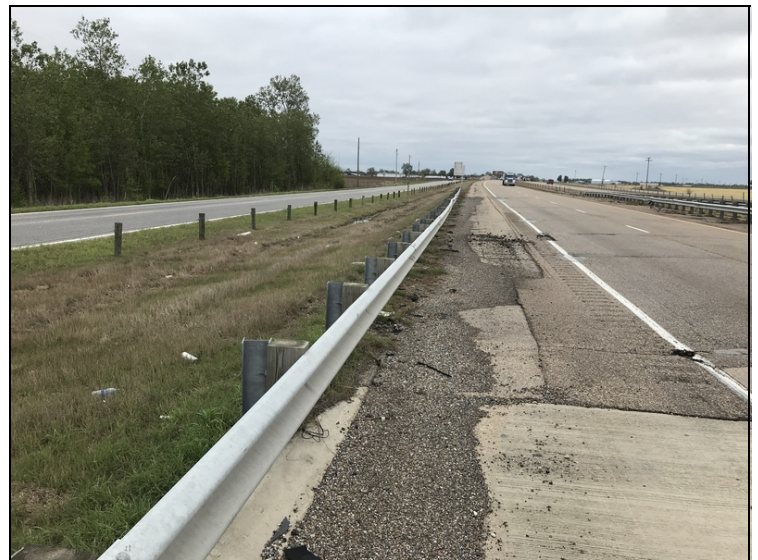
Abutment #1 right approach rail

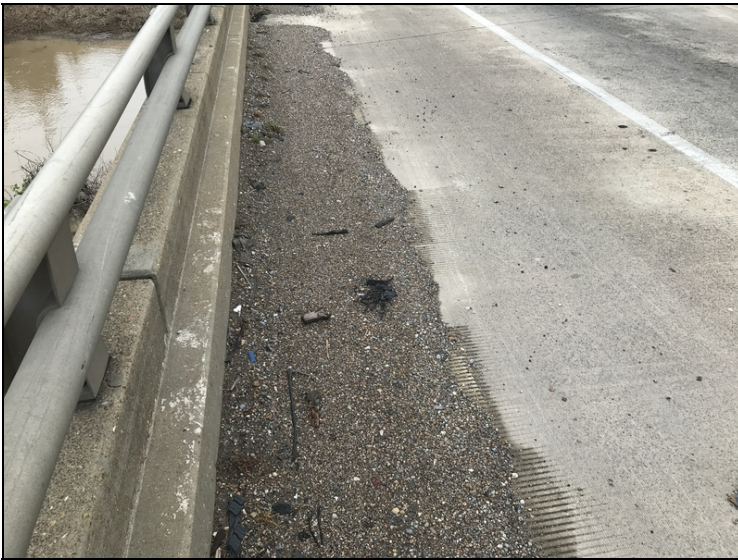
Date Reported: 04/18/2016
Priority: D- Routine
Type of Work: Clean
Status: Monitor
Component: Deck

Gutters are full of dirt and debris.

Typical debris in gutter.
