Bridge #02809(Routine)

I-55N/Sec11/L20.55 over Big Creek

Location: 1.0 Mi S Jct Of Sh 42

Team Lead: Drew Melton Inspection Date: April 13, 2020

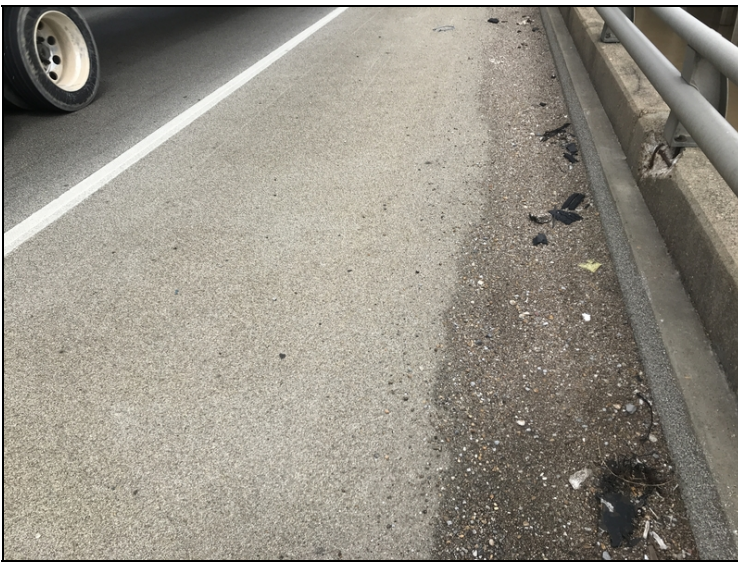
Gutters are full of dirt and debris full length.

Typical debris in gutters

Type of Work: Clean
