Bridge #02810(Routine, Underwater type 2)

I-55N/Sec11/L22.26 over Dry Bayou

Team Lead: Drew Melton Inspection Date: April 08, 2020

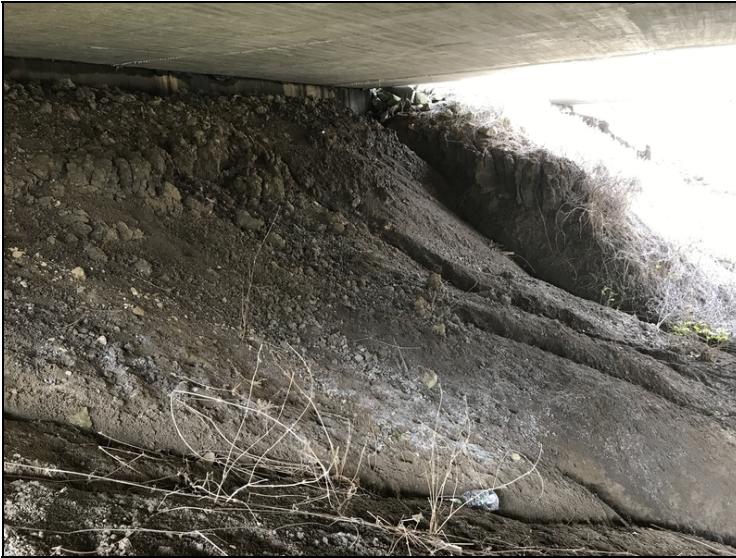
Date Reported: 04/11/2012
Priority: C - Important
Type of Work: Repair
Status: Monitor
Component: Channel

Abutments #1,2 slopes are eroded To vertical face within four feet of abutment caps.

Abutment #1 slope erosion.

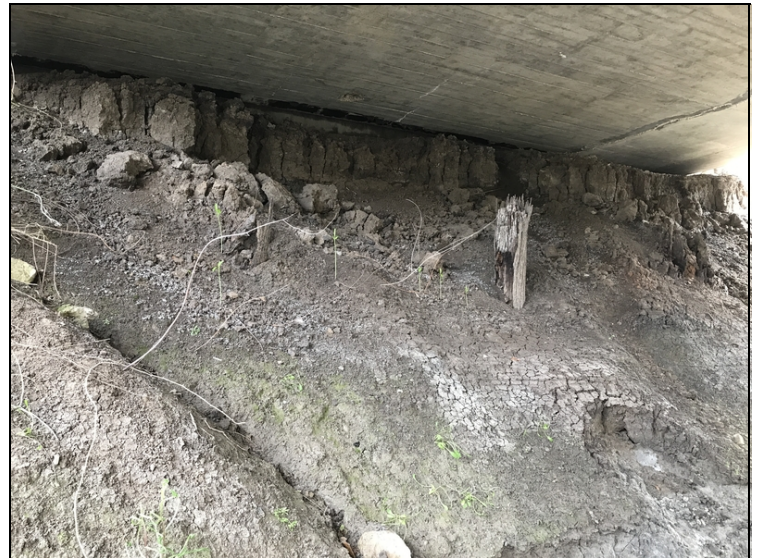
Abutment #2 slope erosion

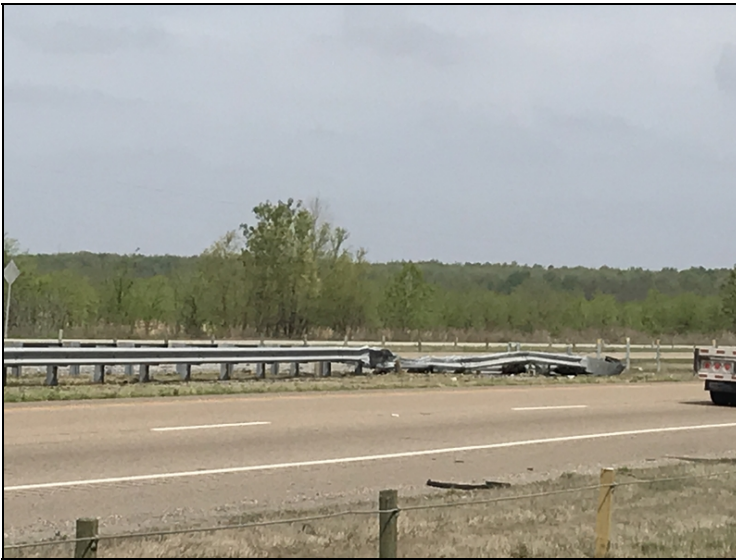
Date Reported: 04/08/2020
Priority: C - Important
Type of Work: Replace
Status: Open
Component: Approach

Abutment #2 left terminal end is destroyed.
