Bridge #06102(Record Change)

I-55/Sec-11/L-7.19 over I-40/Sec-52/L-277.13

Location: W Memphis Interchange

Team Lead: Drew Melton Inspection Date: September 10, 2020

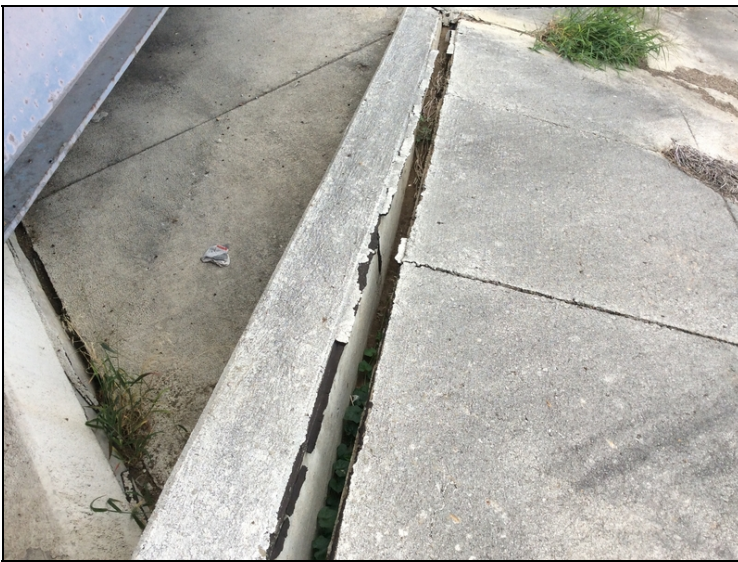
Abutment slope pavements on sides have separated up to 4" and have slide down.

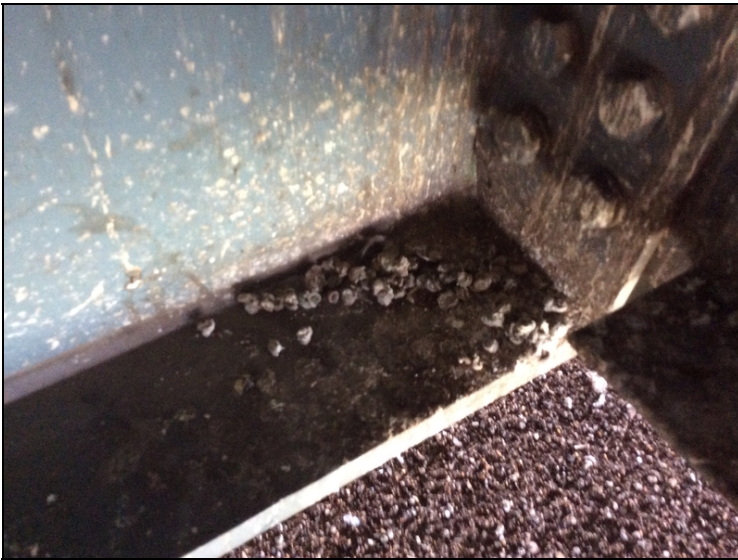
PIGEON WASTE ACCUMULATED IN LARGE QUANTITIES ON BOTTOM FLANGES OF GIRDERS.

Typical pigeon wast.

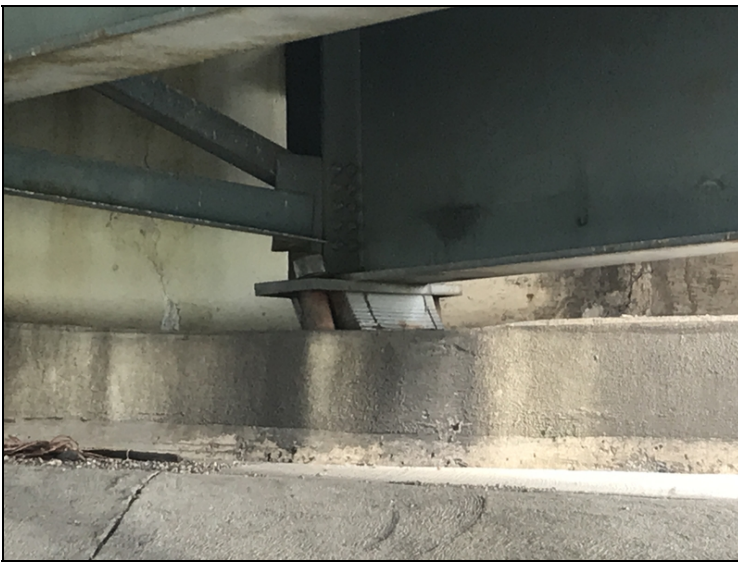
Abutment #1,2 - Bearing pads pushed back (+/-) 2 inches.

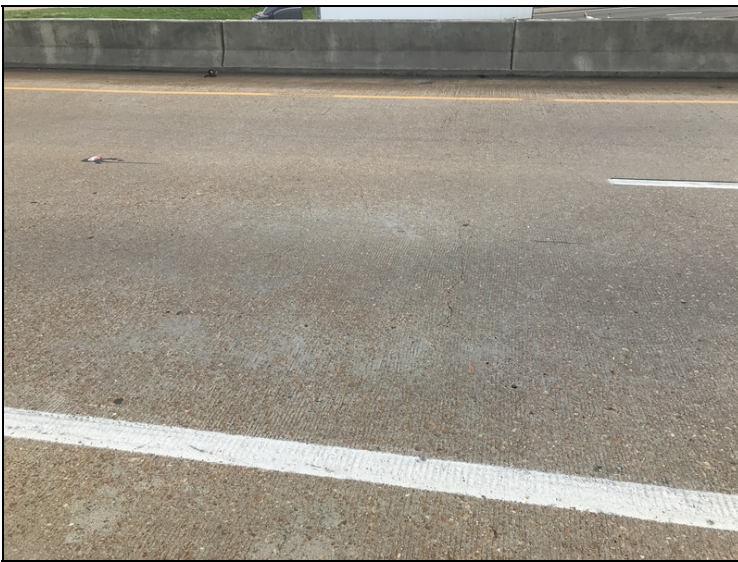
All spans have transverse cracks spaced at 3' - 4' up to 1/32" wide.

Typical deck cracks

8/31/2020 lowered deck from 7 to 6 due to excessive number of open cracks.

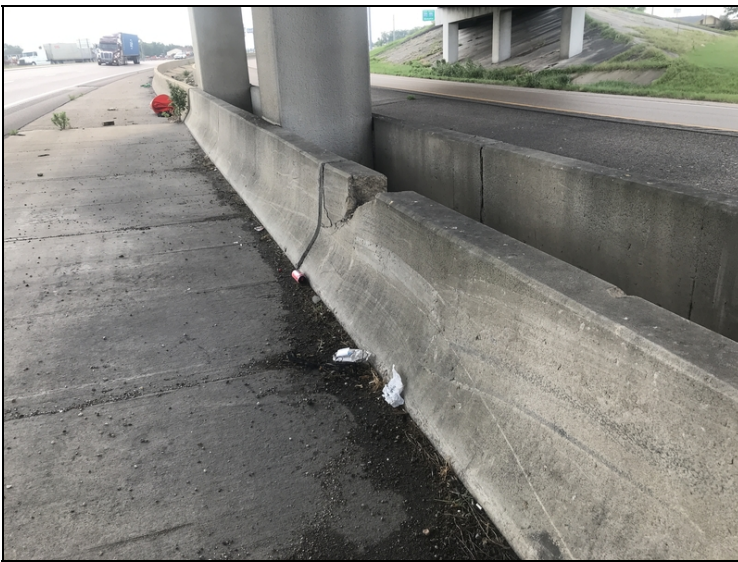
West bound left concrete pier protection has 2' spall and is cracked and broken due to collision.

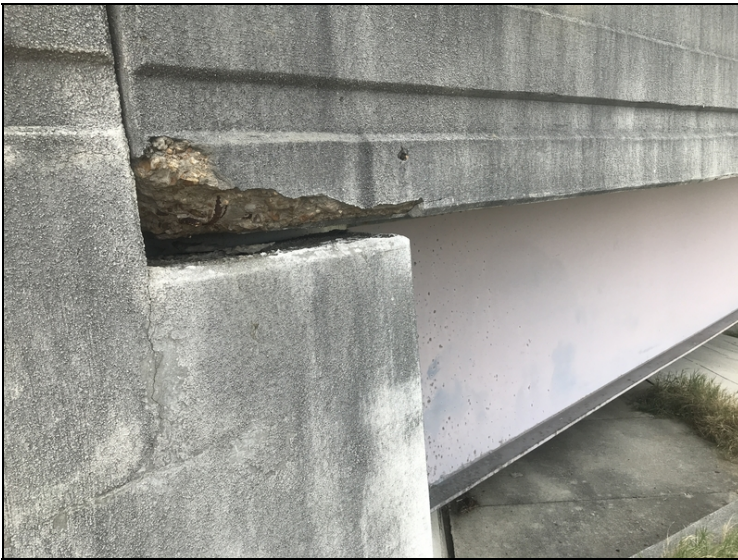
Abutment #2 right side at bridge end has one-foot spall exposed rebar with no section loss on soffit/under surface.

Abutment #2 right side at bridge end has one foot spall exposed rebar no section loss on soffit/under surface.

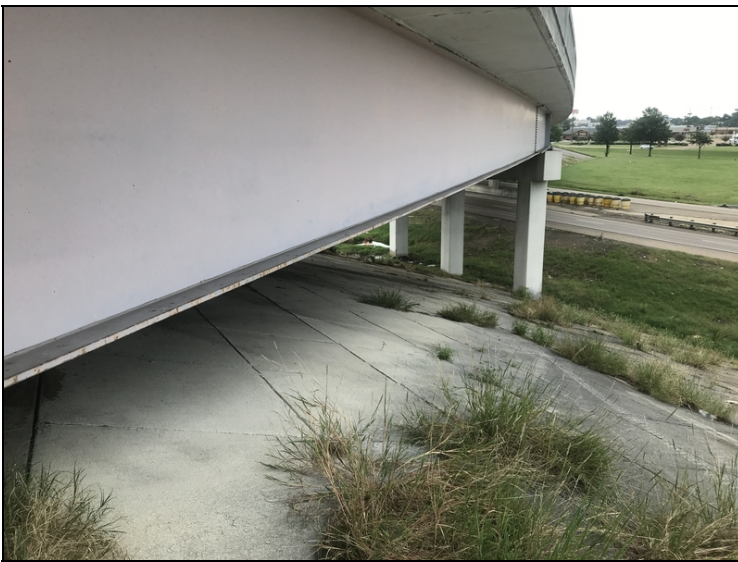
Paint has become chalky and has 5% bare metal exposed surface rust only.

Typical outside girder paint condition.

08/31/2020 lowered superstructure from 8 to 7 due to surface rust without section loss.

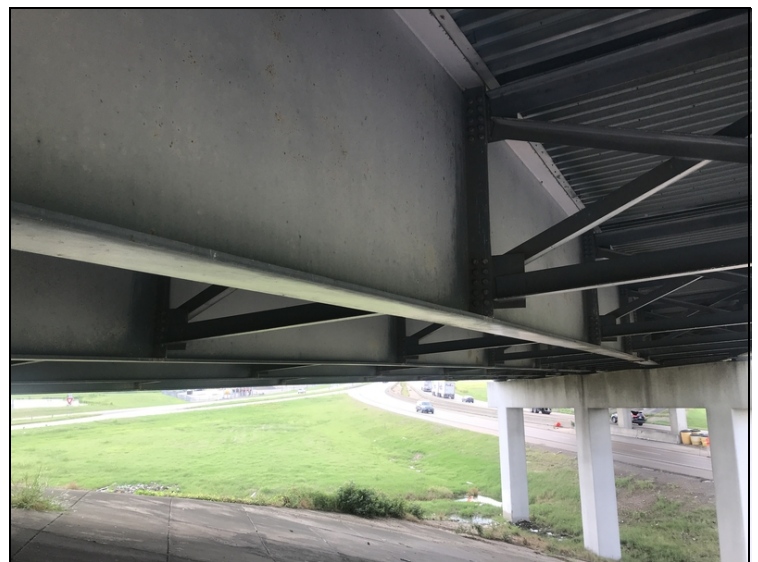
Typical paint condition interior girder
