Bridge #06103(Record Change)

I-55/Sec-11/L-7.39 over I-40/Sec-52Y/L-277.19

Team Lead: Drew Melton Inspection Date: September 10, 2020

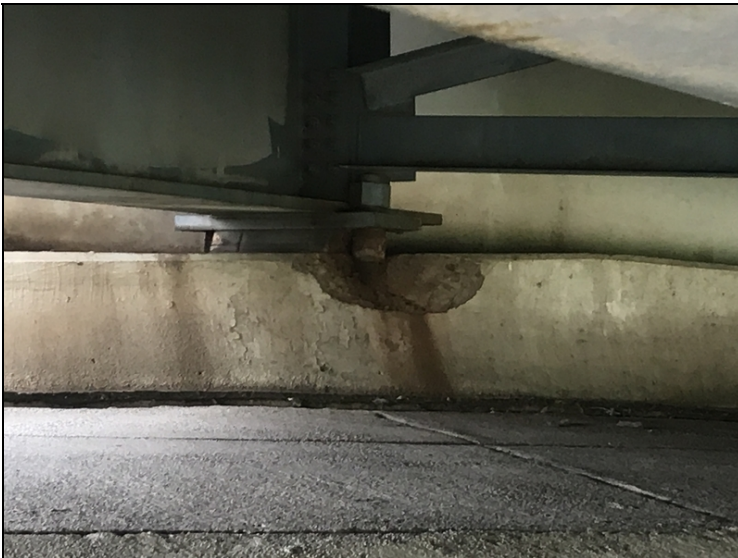
(215)							
Back wall's have vertical cs2 cracks spaced 4' apart. Bearing bolt abutment #2, girder #2 concrete spalled out under bearing approx. 4" on inside anchor bolt. anchor bolt is exposed.							
234	Reinforced Concrete Pier Cap	LF	115	115	0	0	0
301	Pourable Joint Seal	LF	28	0	28	0	0
2340	Seal Cracking	LF	28	0	28	0	0

Bearing bolt abutment #2, girder #2 concrete spalled out under bearing approx. 4" on inside anchor bolt. anchor bolt is exposed.

Date Reported: 09/10/2012
Priority: C - Important
Type of Work: Repair
Status: Monitor
Component: 215 - Reinforced Concrete Abutment

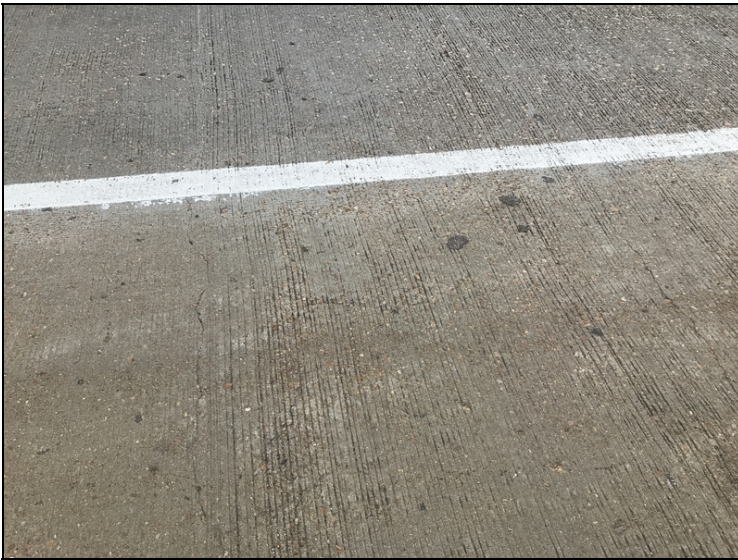
ELEM	DESCRIPTION	UNITS	TOTAL	CS1	CS2	CS3	CS4
12	Reinforced Concrete Deck	SF	15634	7906	7728	0	0
1130	Cracking (RC and Other)	SF	7728	0	7728	0	0
(12)							
Transverse and longitudinal cracking every 2' - 3' up to 1/32" wide. Soffit overhangs have transverse hairline cracks spaced 4' apart.							
107	Steel Open Girder/Beam	LF	1825	0	1825	0	0
1000	Corrosion	LF	1825	0	1825	0	0
515	Steel Protective Coating	SF	25964	0	23365	0	2599
3410	Chalking (Steel Protective Coatings)	SF	23365	0	23365	0	0
3440	Effectiveness (Steel Protective Coatings)	SF	2599	0	0	0	2599

Transverse and longitudinal cracking every 2' - 3' up to 1/32" wide.

08/31/2020 lowered deck from 7 to 6 due to excessive number of cracks.

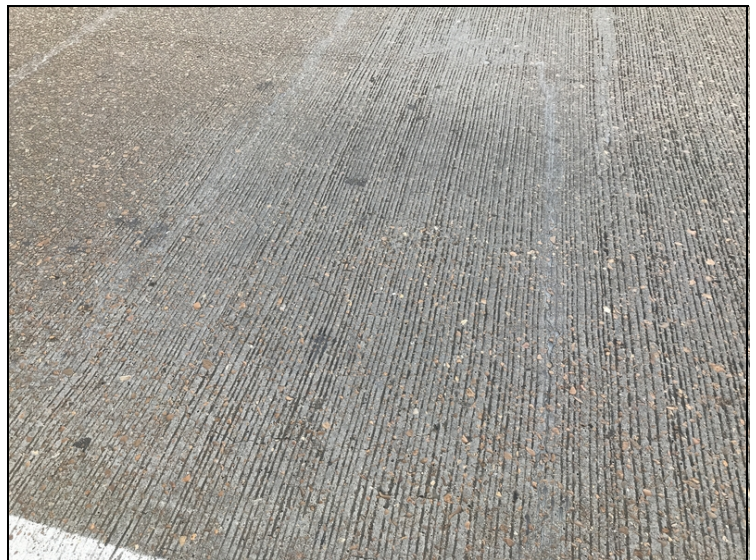
Transverse and longitudinal cracking every 2' - 3' up to 1/32" wide.

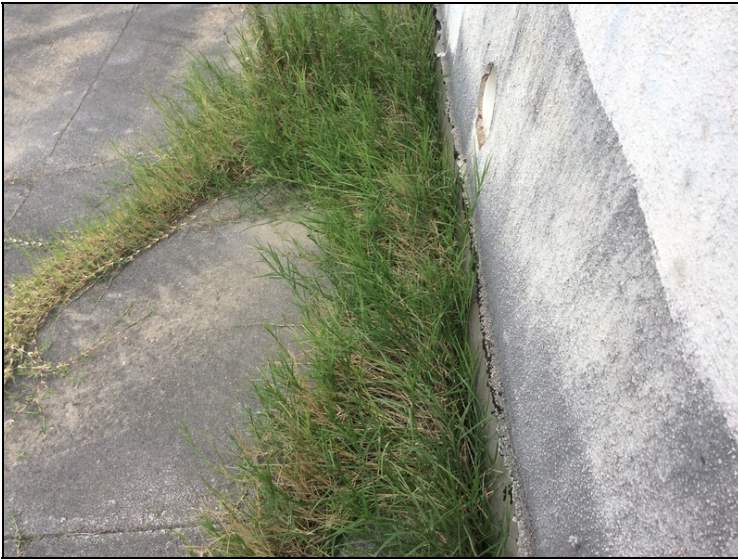
SIDE SLOPE AT BOTH ABUTMENTS BOTH SIDES HAVE SLID DOWN SLOPE CAUSING 3" WIDE OPENING AT COLD JOINT.

Typical side slope joint.

Slope pavement has sank 6"+/- at abutment #2 left and right side and abutment #1 both sides.

Abutment side slopes have slid down causing 3" wide opening between pavements.

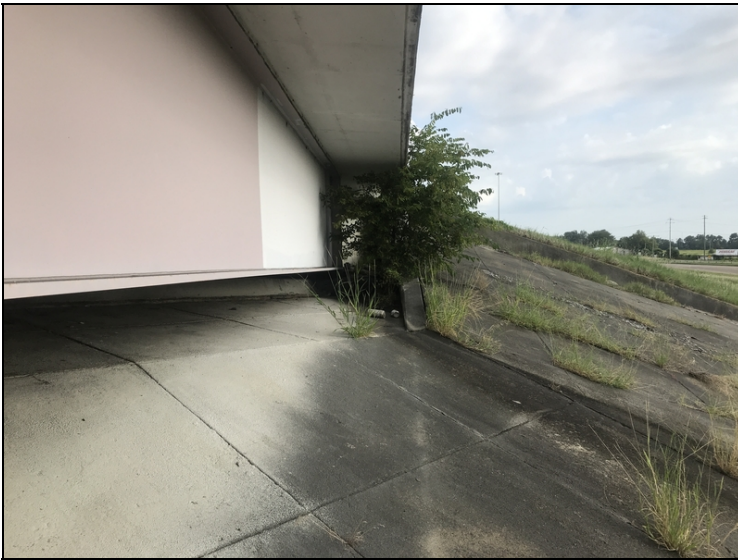
Abutment #2 right side has small tree growing beside bridge.

Abutment #2 right side has small tree growing
beside bridge.

Date Reported: 09/01/2020
Priority: D- Routine
Type of Work: Clean
Status: Monitor
Component: Approach

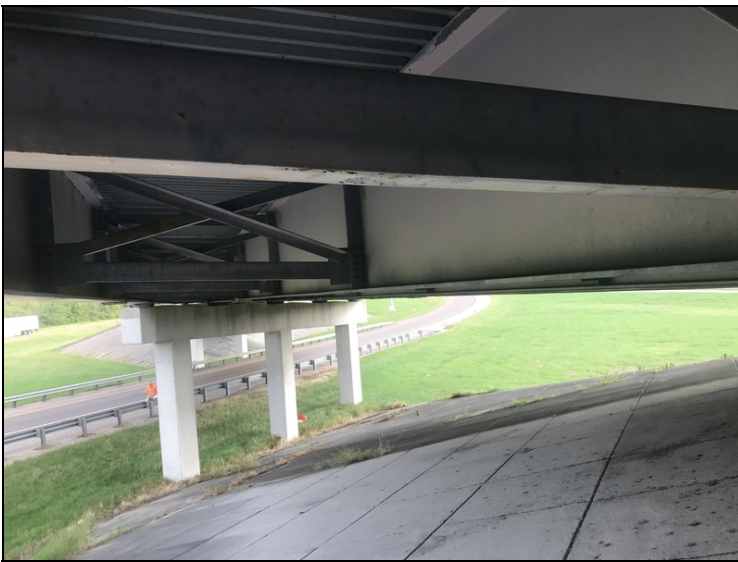
(107)							
Paint is chalky and peeling with up to 10% bare steel and some minor surface rust.							
205	Reinforced Concrete Column	EA	6	6	0	0	0
215	Reinforced Concrete Abutment	LF	200	149	50	1	0
1080	Delamination/Spall/Patched Area	LF	1	0	0	1	0
1130	Cracking (RC and Other)	LF	50	0	50	0	0

Paint is chalky and peeling with up to 10% bare steel and some minor surface rust.

Typical paint condition interior girder

Date Reported: 09/01/2020
Priority: D- Routine
Type of Work: Clean
Status: Monitor
Component: 107 - Steel Open Girder/Beam

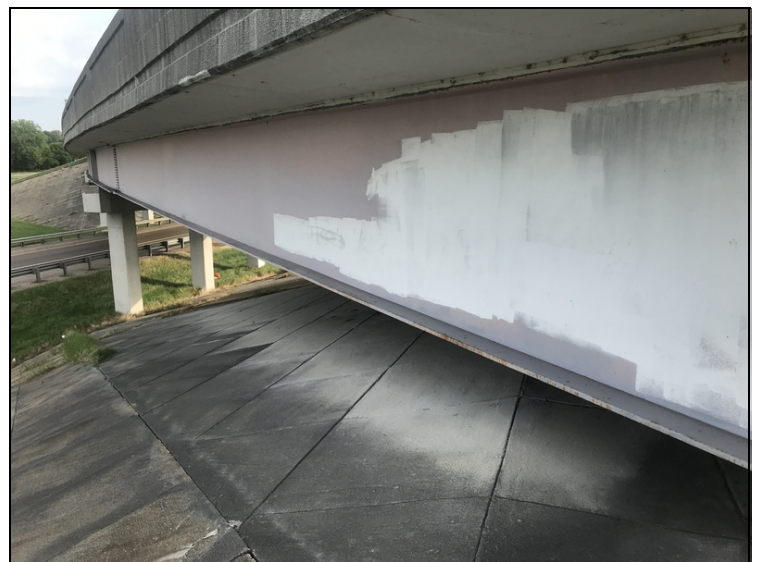
Typical paint outside girder
