**Bridge #02671 (Routine)**  
**I 55 NO BND LNS over FLETCHER RD/I55 FR/BN RR**  
**Location: .30 MI N JCT OF I-40**  
**Team Lead: Rhett Franks Inspection Date: June 17, 2019**

IDENTIFICATION	
(1) State Names	Arkansas
(8) Structure Number	02671
(5) Inventory Route	55
(2) Highway Agency District	01
(3) County Code	35-Crittenden County, Arkansas

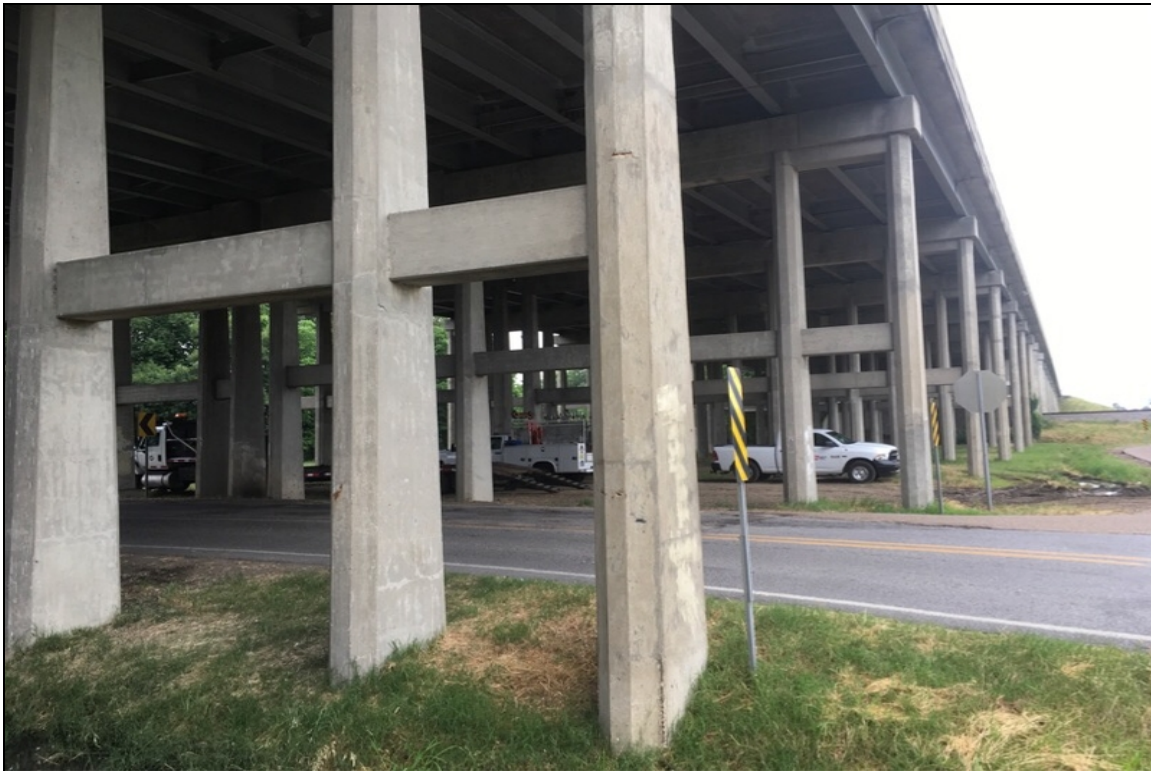
Bent 4, Girder 6: Spalling with exposed reinforcing steel.

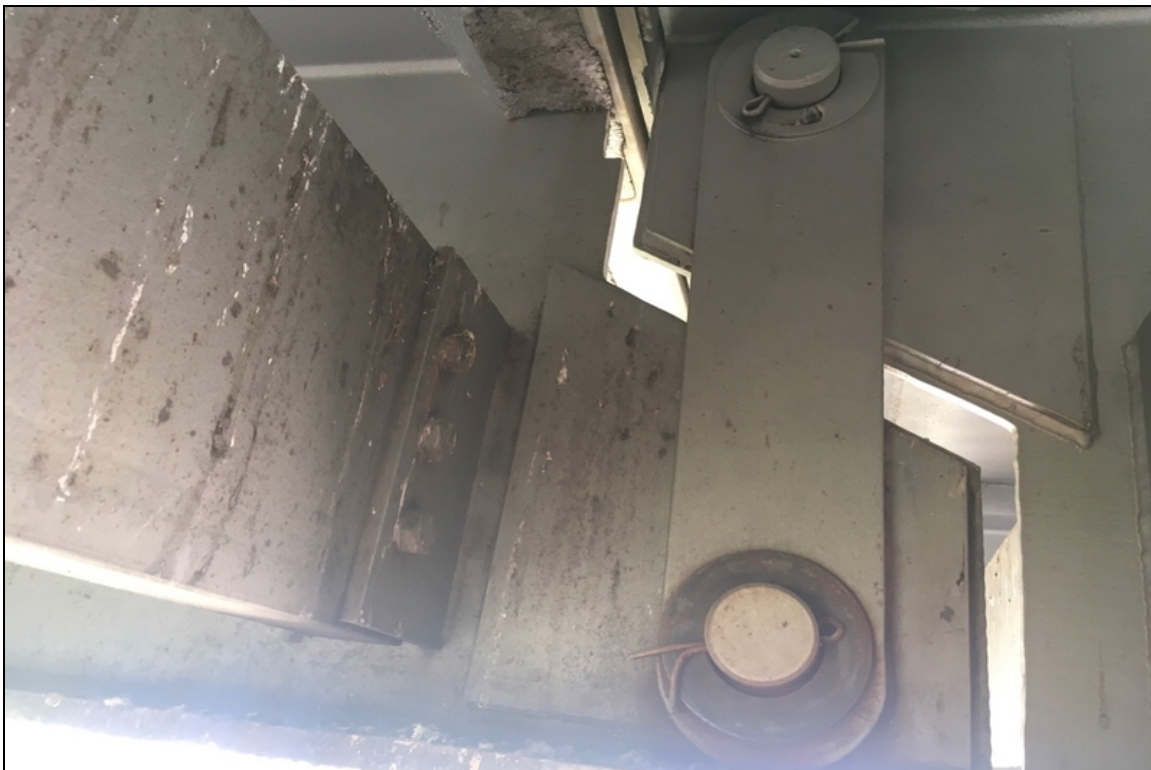
Span 20, Girder 4, Pin & Hanger: Floating.

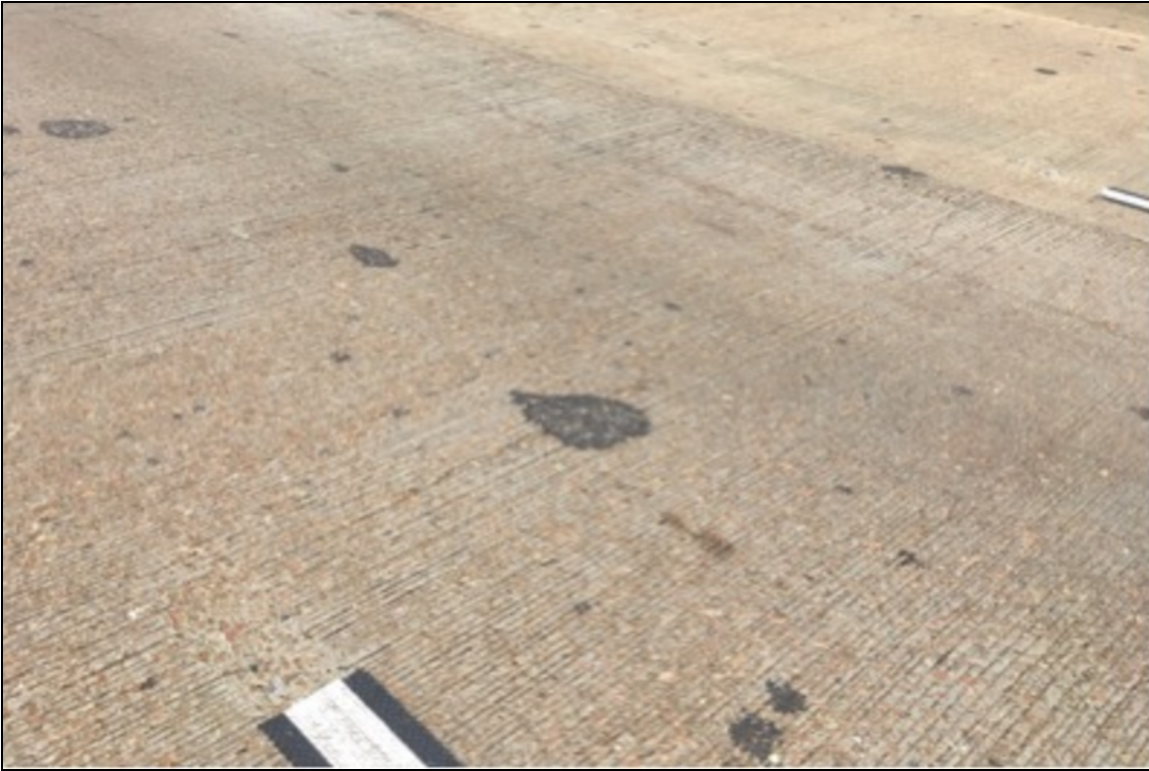
Span 8: Sealable deck cracking.

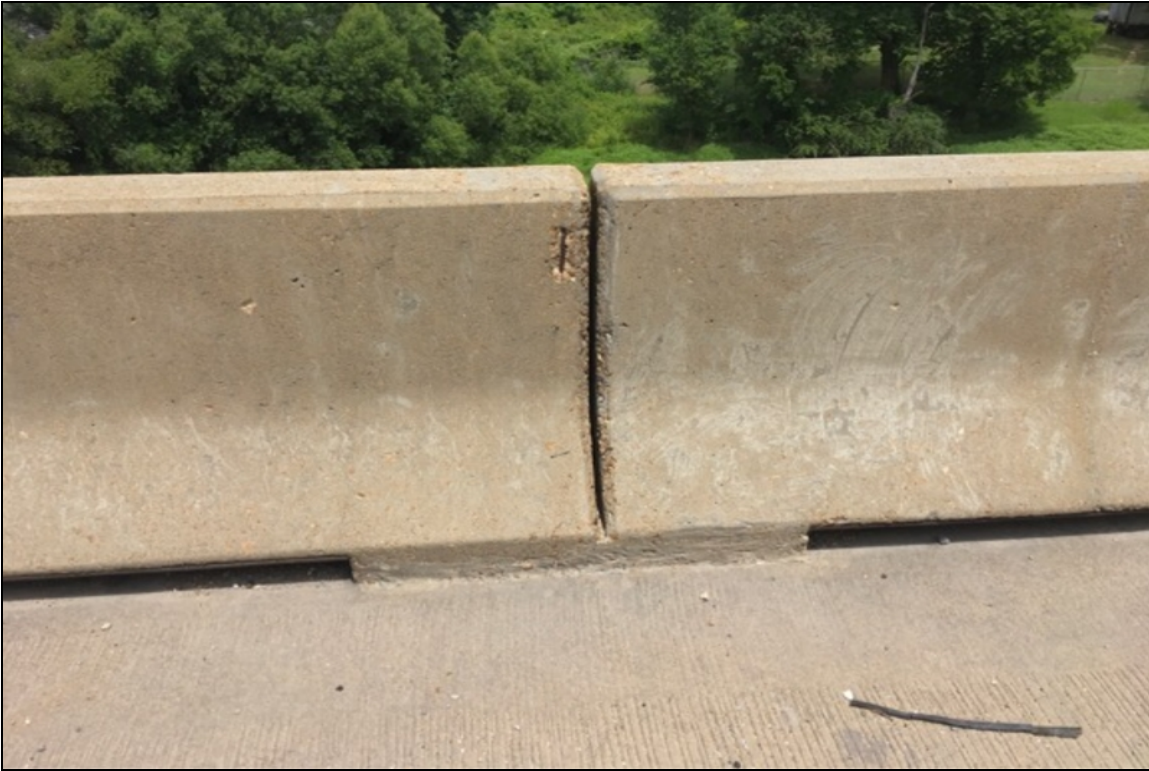
Bridge Rail: Typical exposed reinforcing steel.

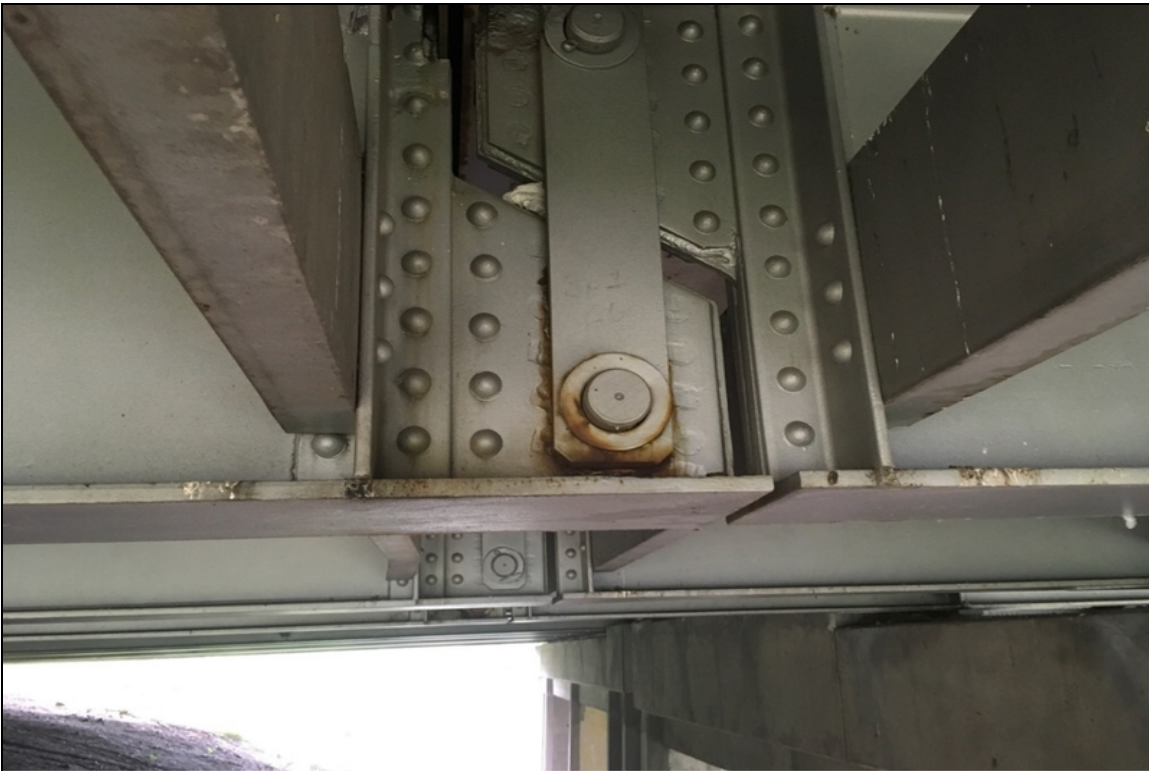
Span 1, Girder 6, Bottom Pin: Keeper missing washer is loose.

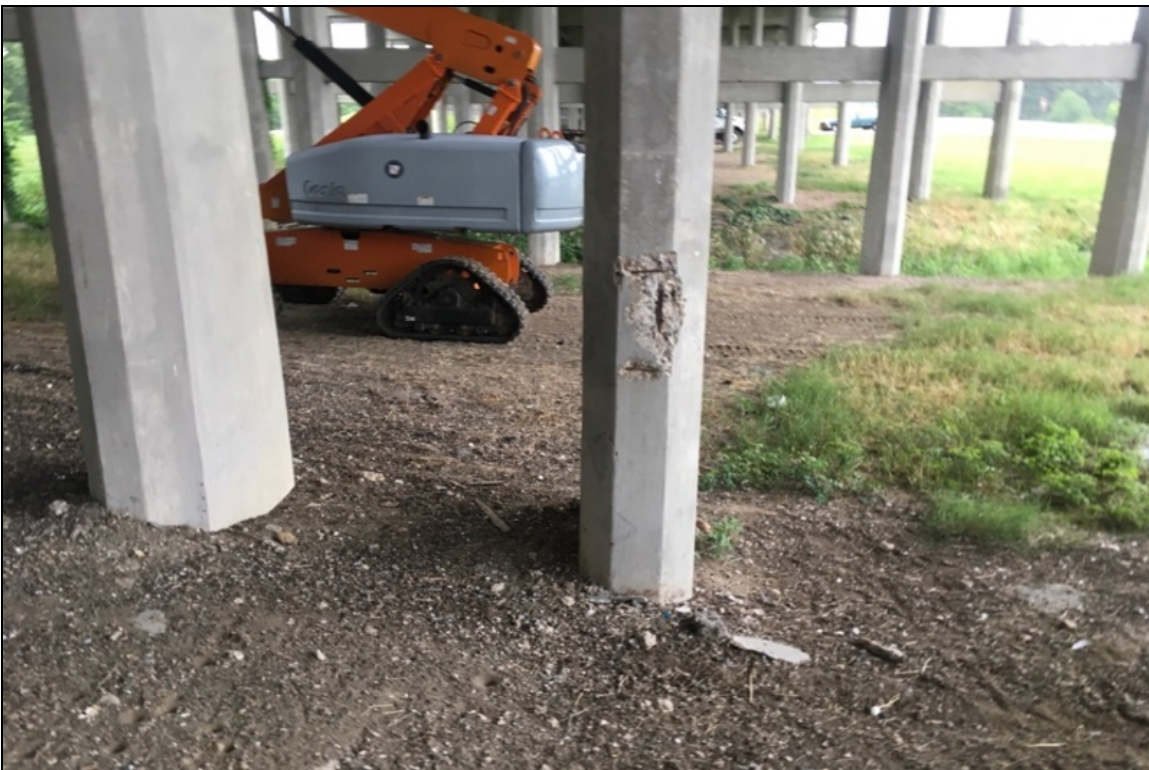
Bent 13, Column 3: Spalling with exposed reinforcing steel.

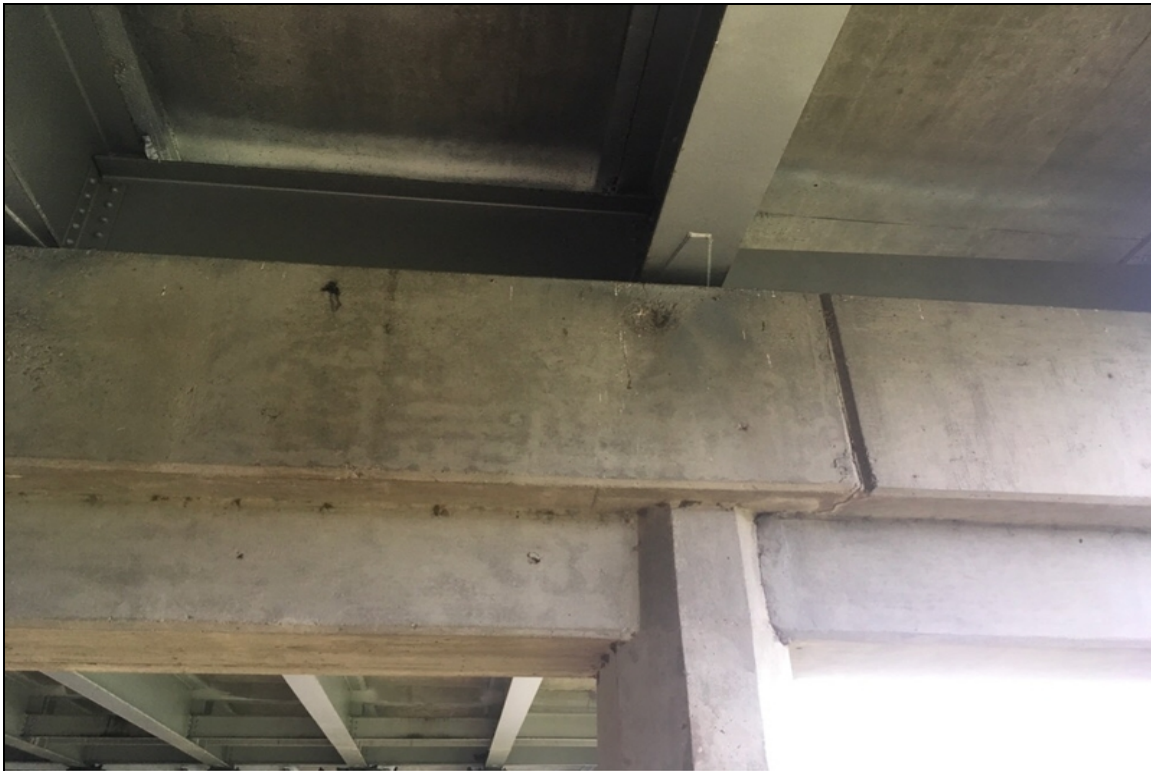
Bent 2, Girder 7, Cap: Minor spalling with exposed reinforcing steel.

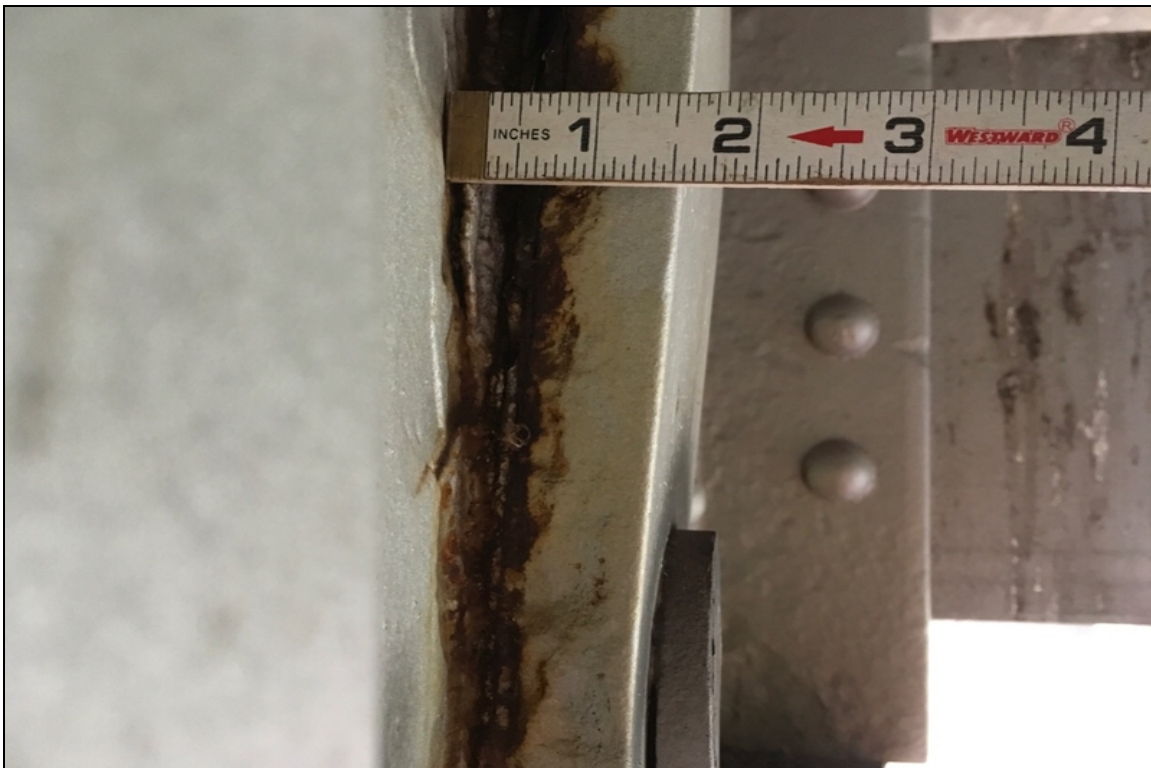
Span 3, Girder 6, Left, Hanger Bar: Out of plane bending.

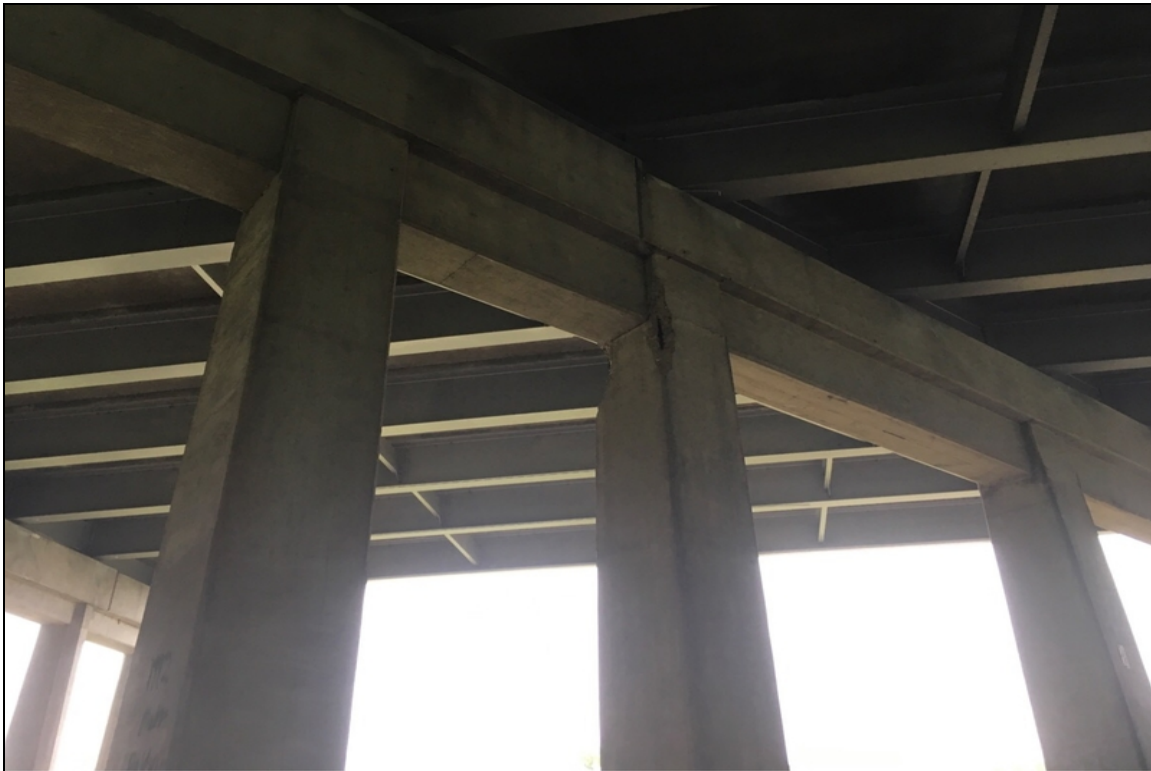
Bent 12, Column 3: Spalling with exposed reinforcing steel.

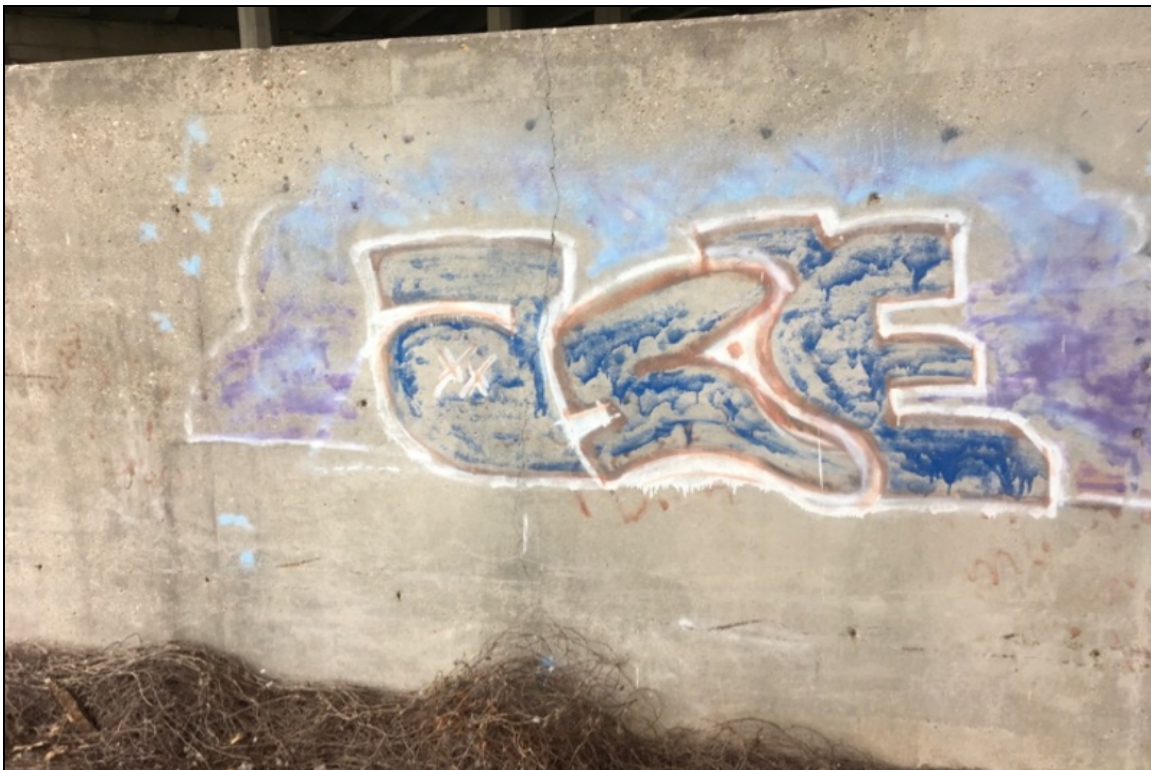
Bent 11, Pier Wall: Vertical cracking.

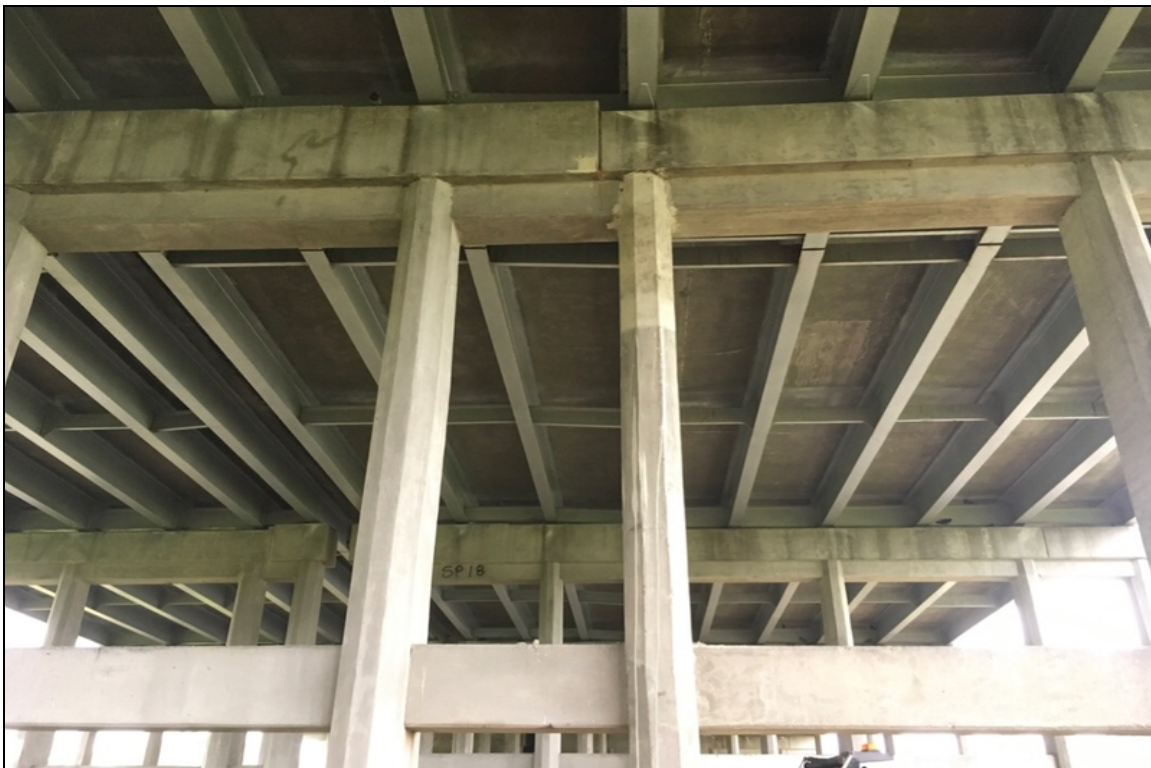
Bent 17, Column 3: Repaired.

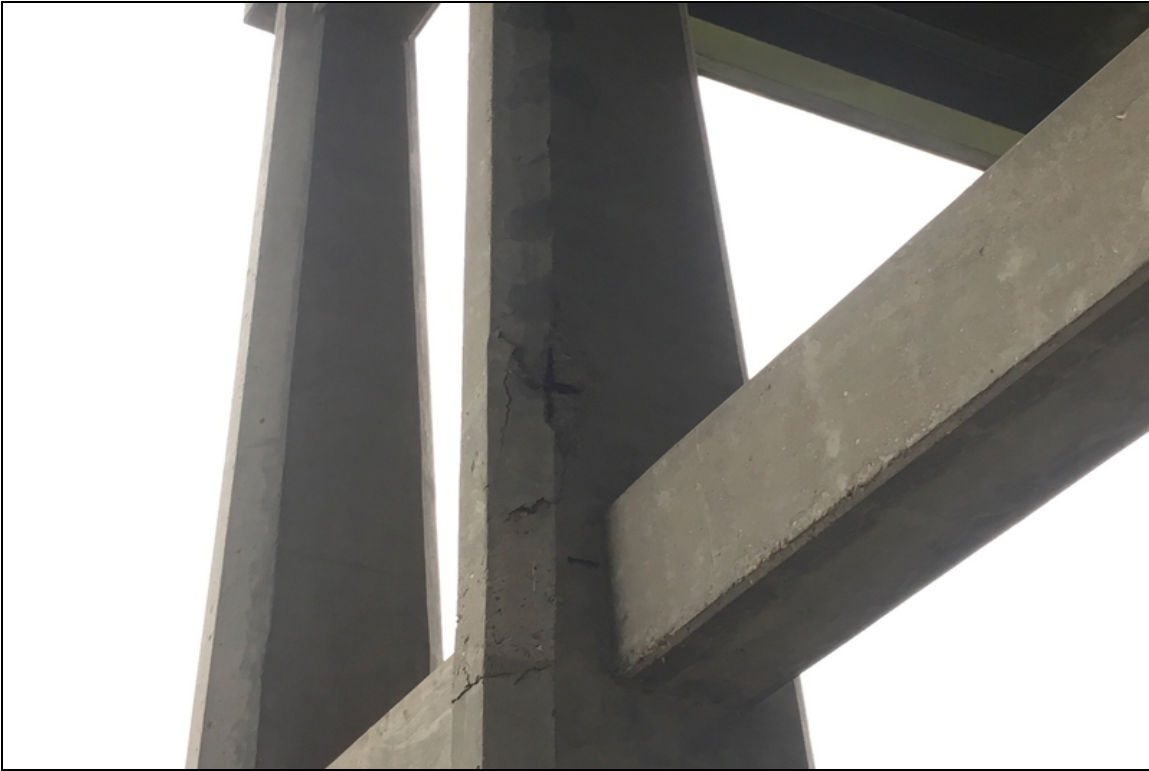
Bent 14, Column 5: Spalling with exposed reinforcing steel.

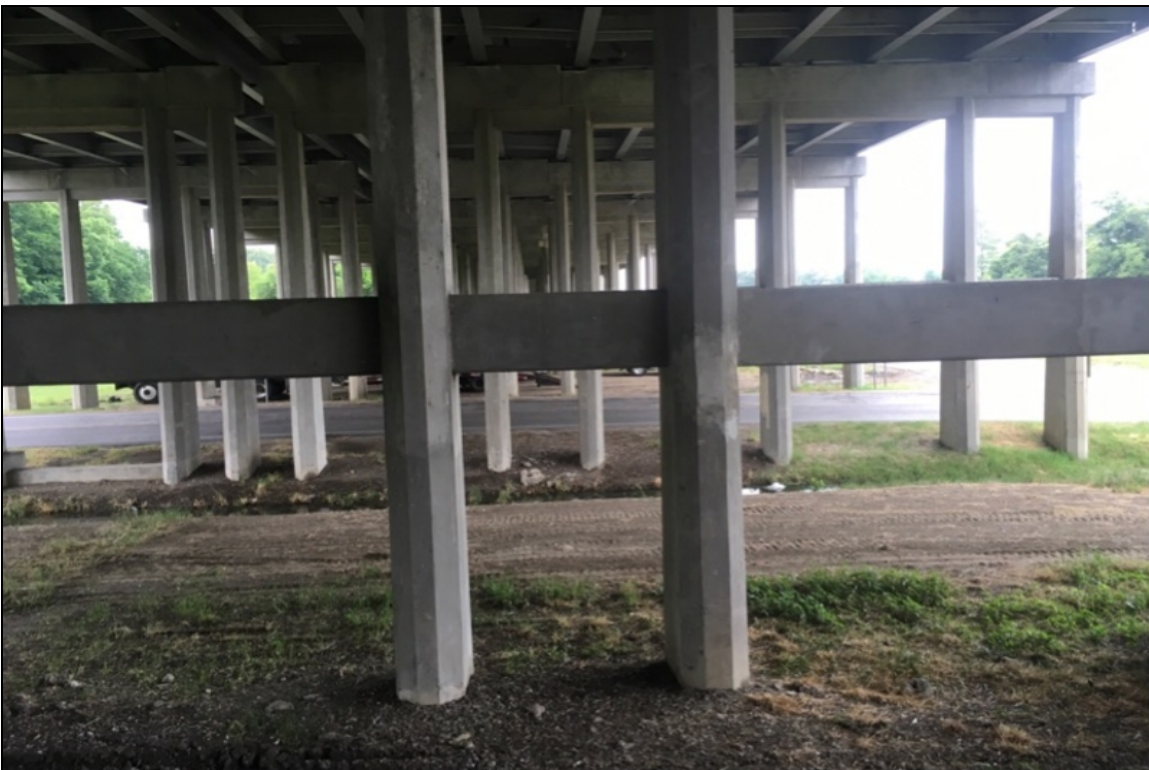
Bent 3, Column 3: Repaired.

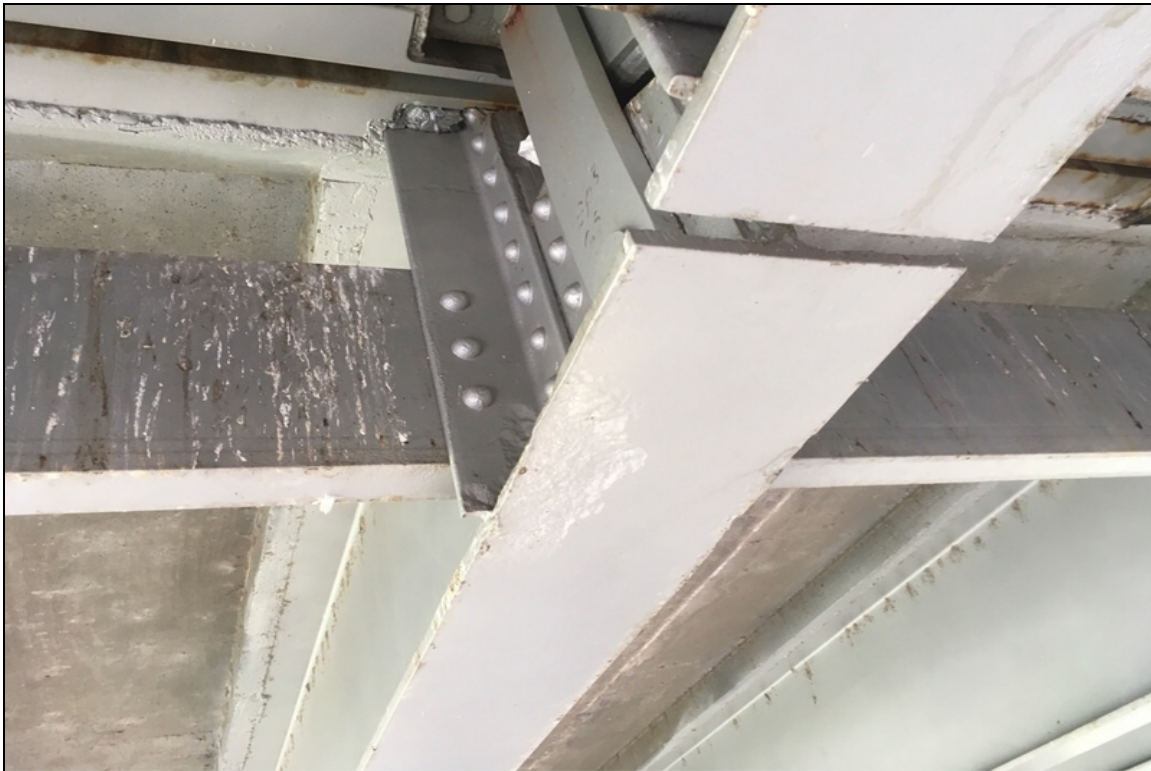
Span 3, Girder 5, Bottom Flange: Section loss.

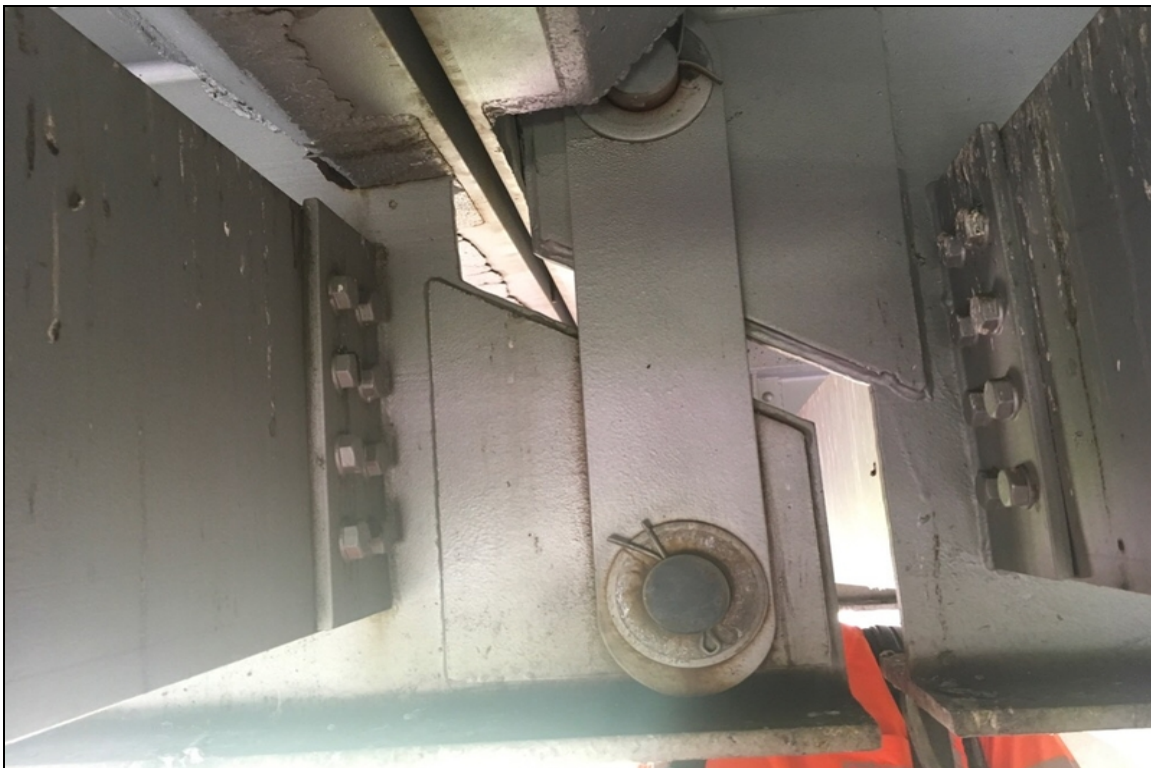
Span 21, Girder 4, Pin & Hanger: Floating.

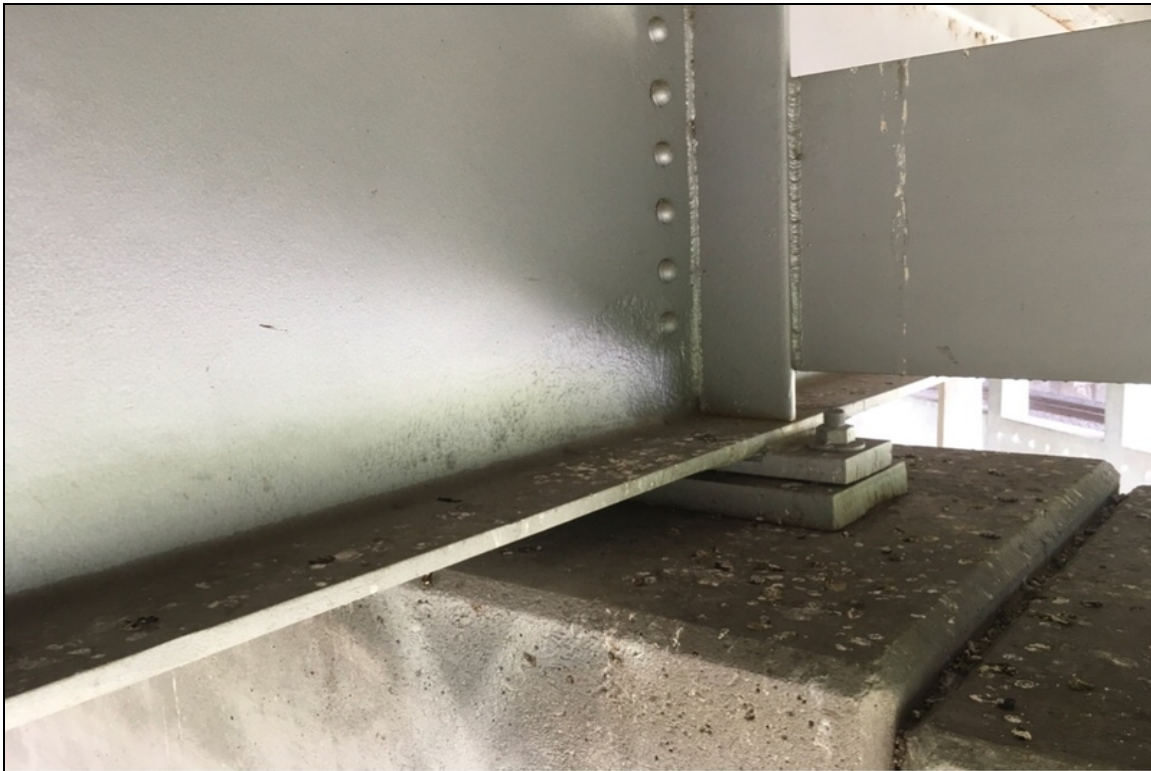
Bent 9, Girder 8, Web: Section loss.

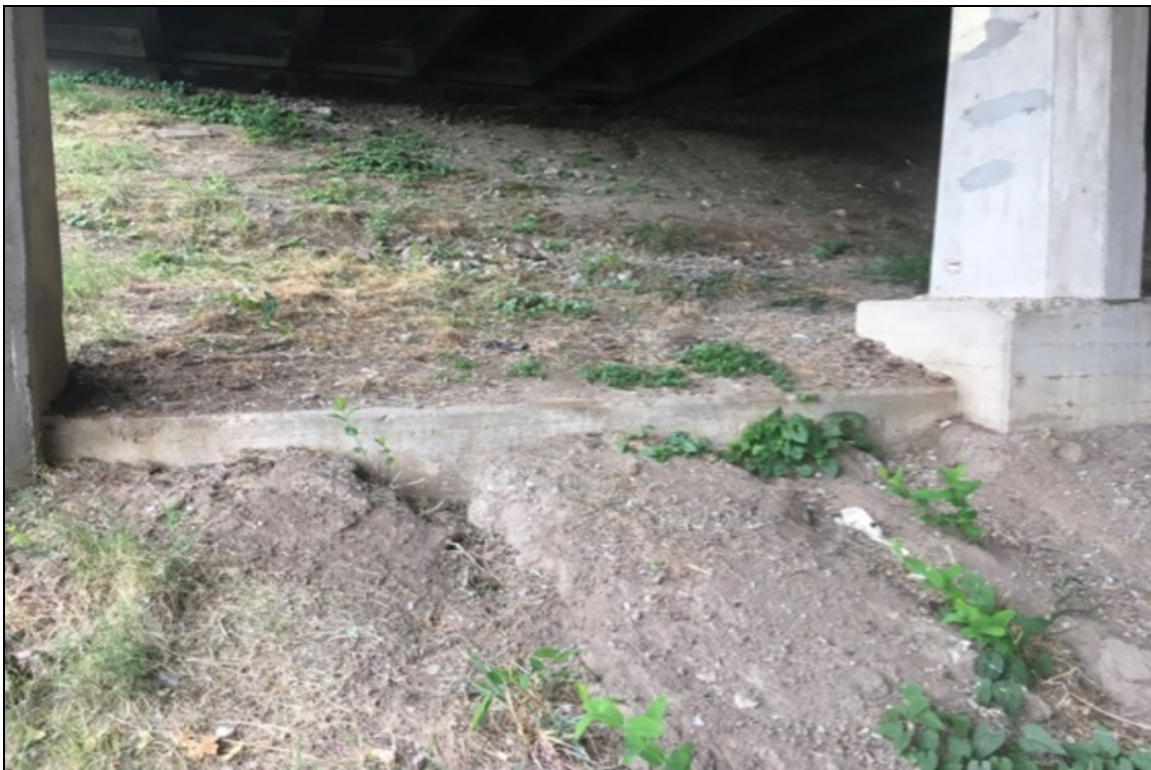
Bent 2, Footing: Spalling.

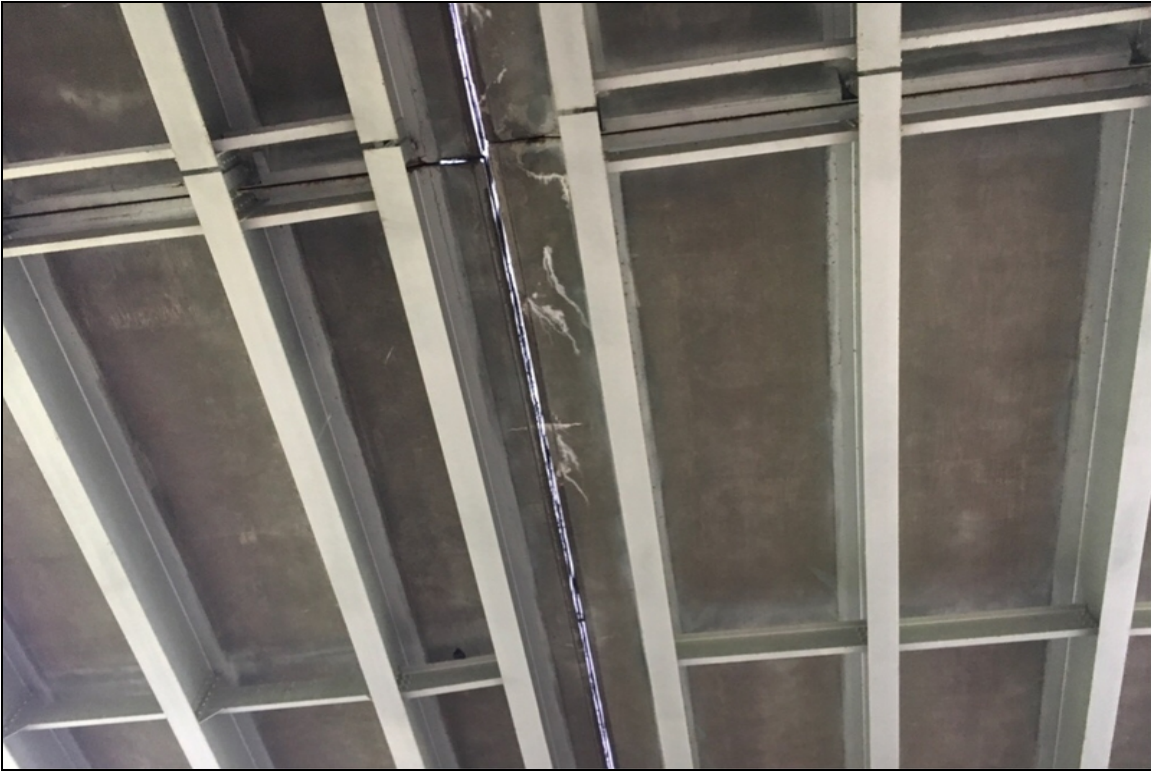
Span 17, Overhang, Left: Cracking with efflorescence.

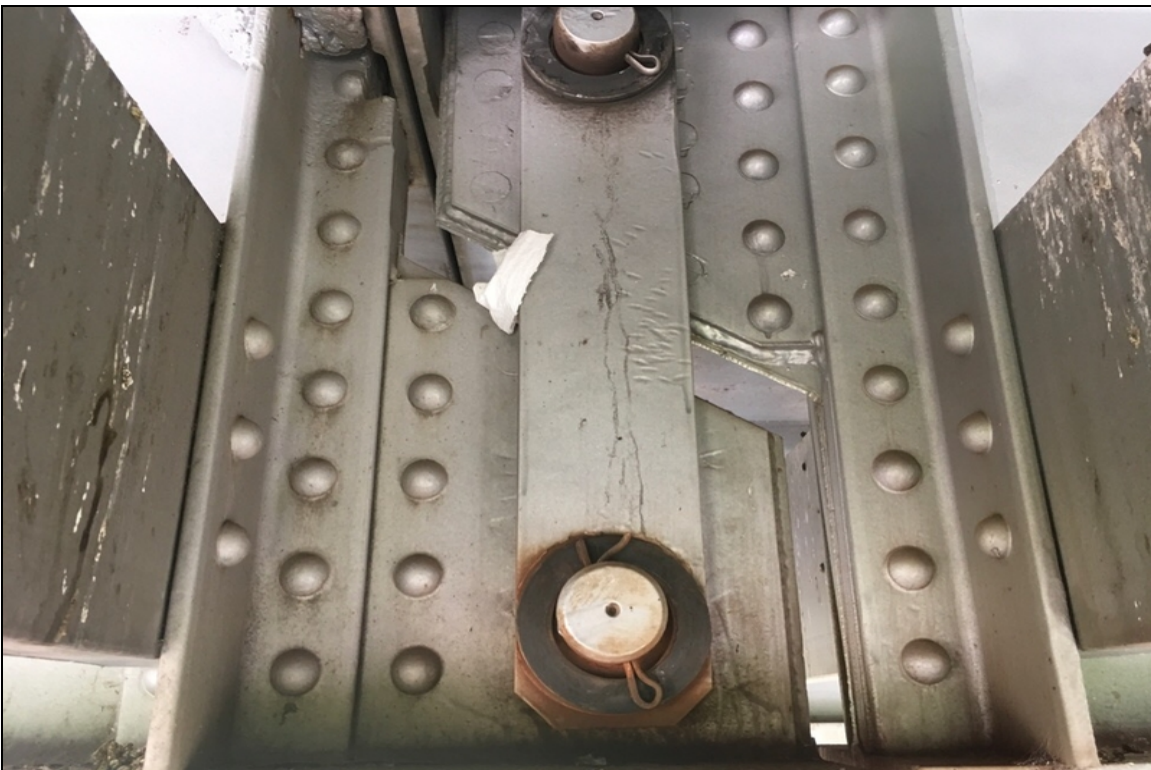
Span 5, Girder 6, Pin & Hanger: Floating.

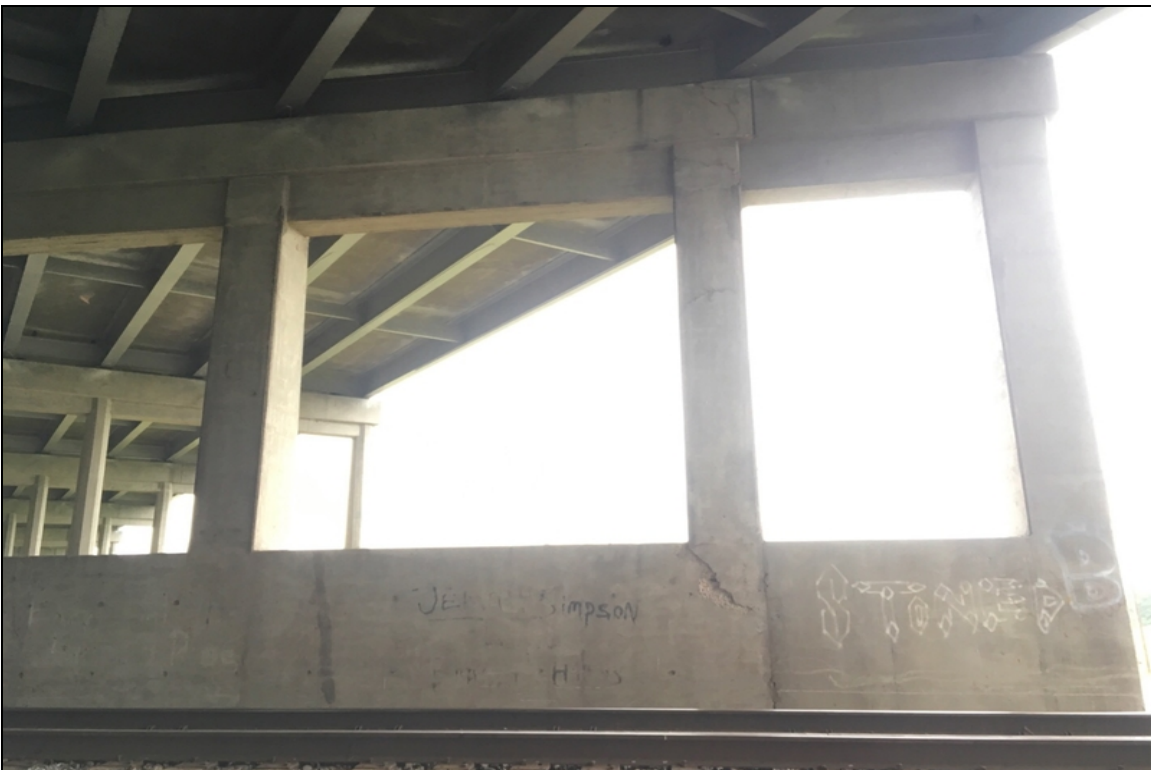
Bent 12, Column 5: Spalling.

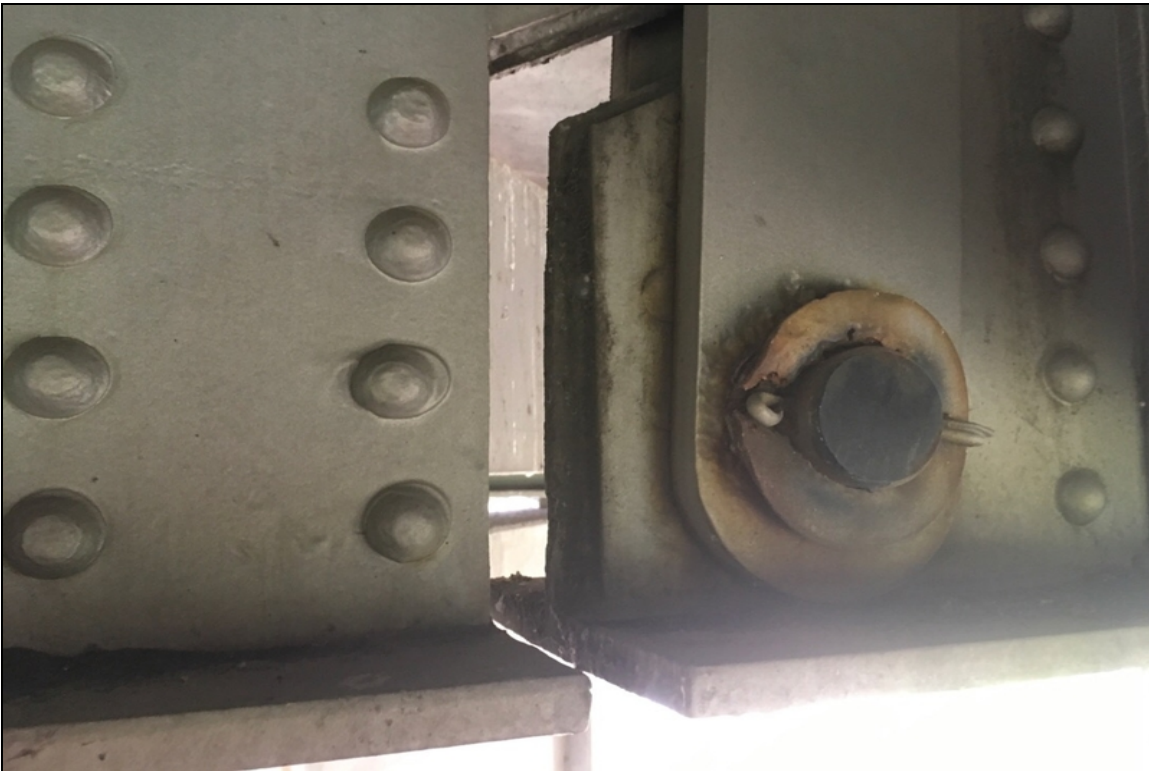
Span 10, Girder 6, Bottom Pin, Washer: Rusted through.

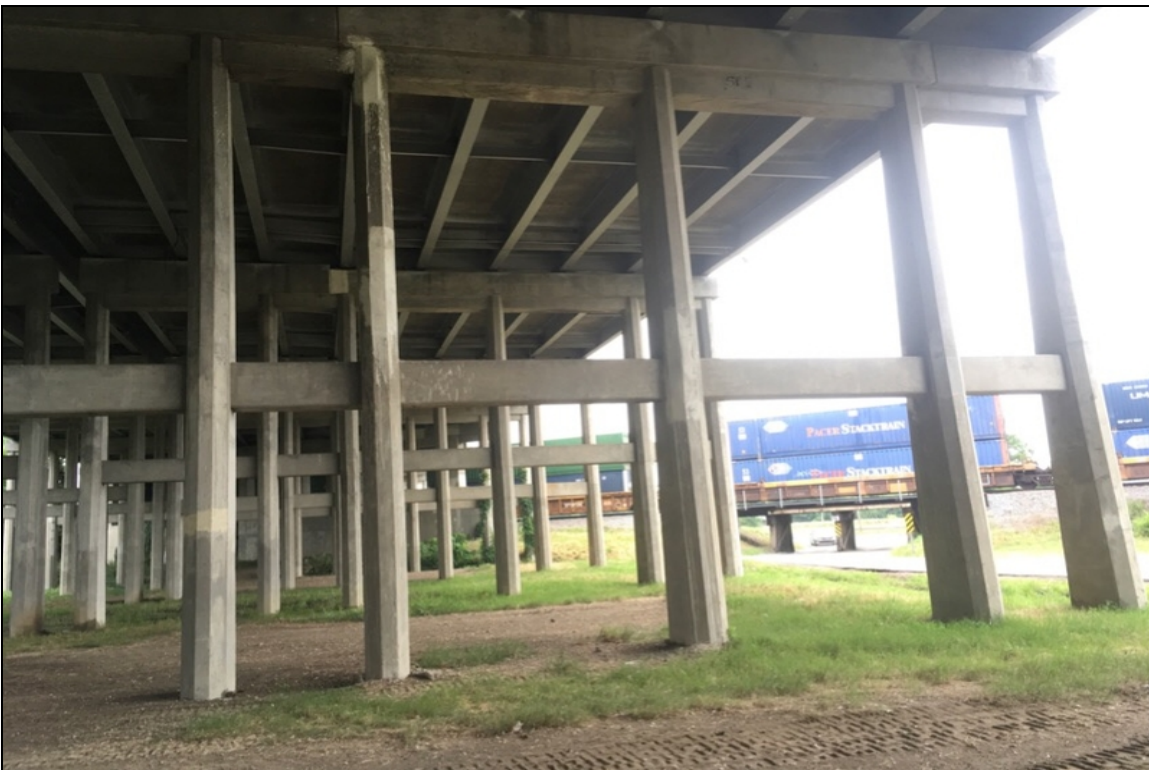
Bent 7, Column 3, 4 & 5: Repaired.

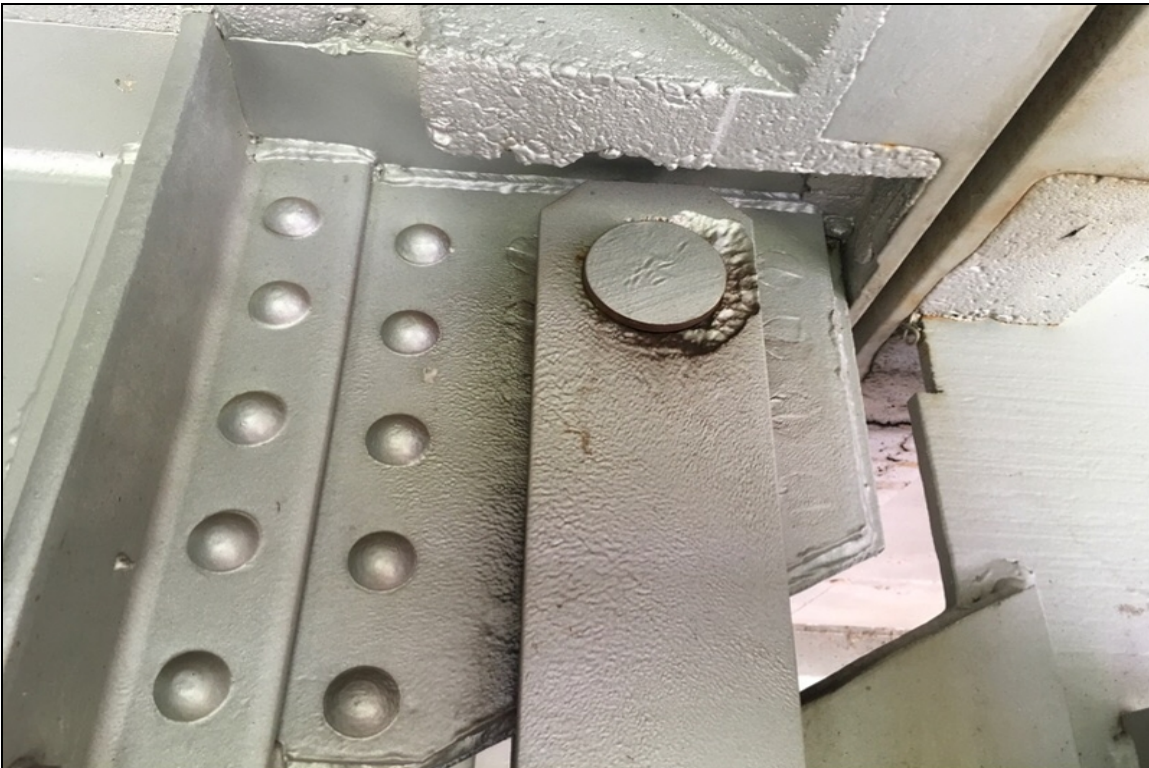
Span 18, Girder 9, Pin & Hanger: Floating.

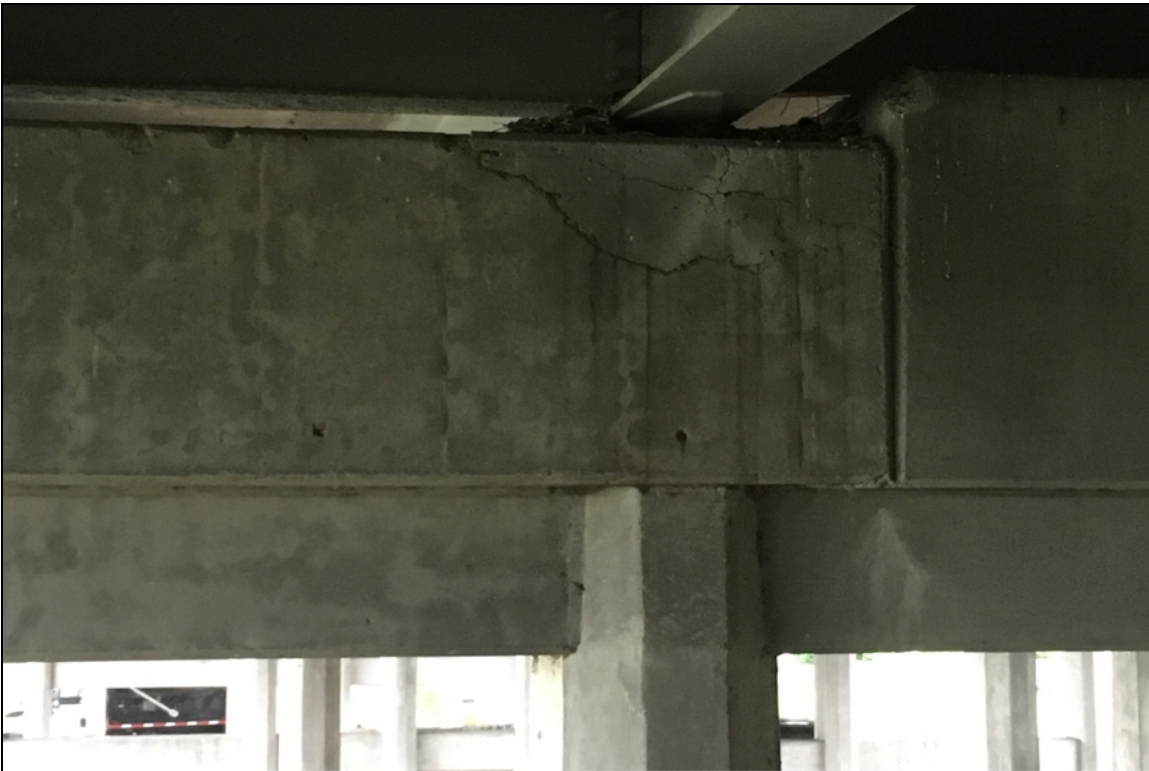
Bent 21, Girder 4: Delaminated repair.

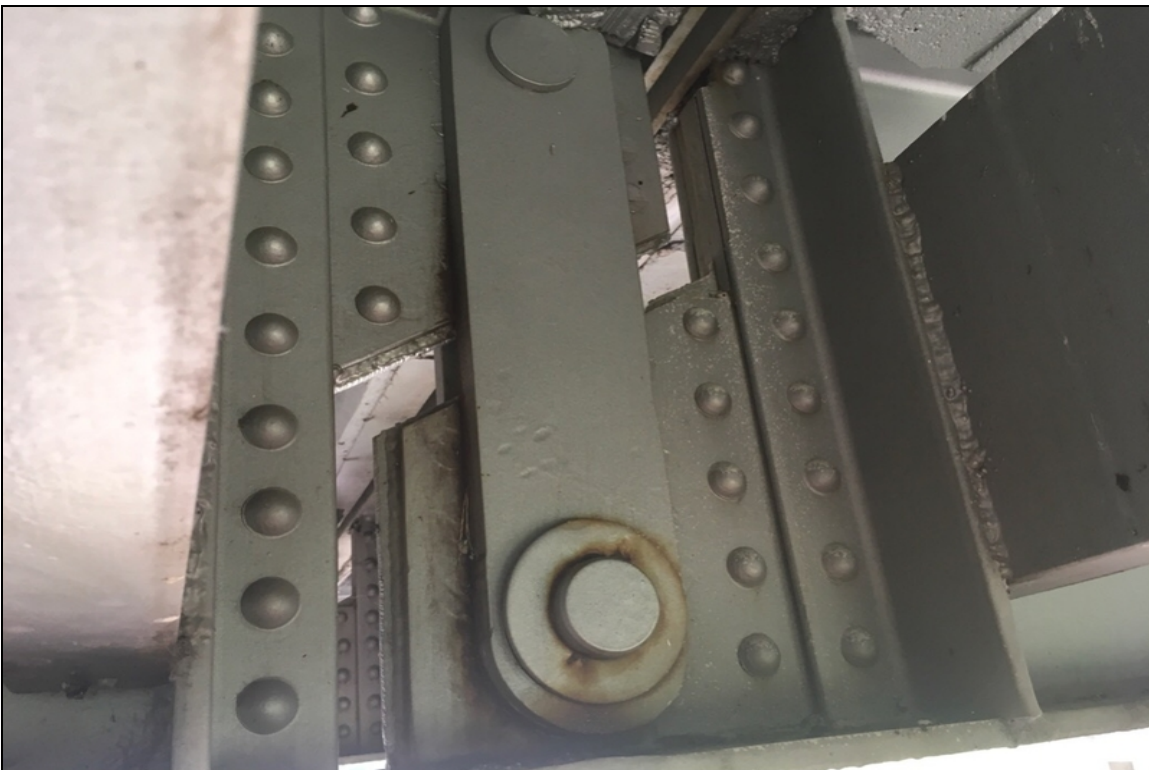
Span 9, Girder 4: Keeper missing washer is loose.

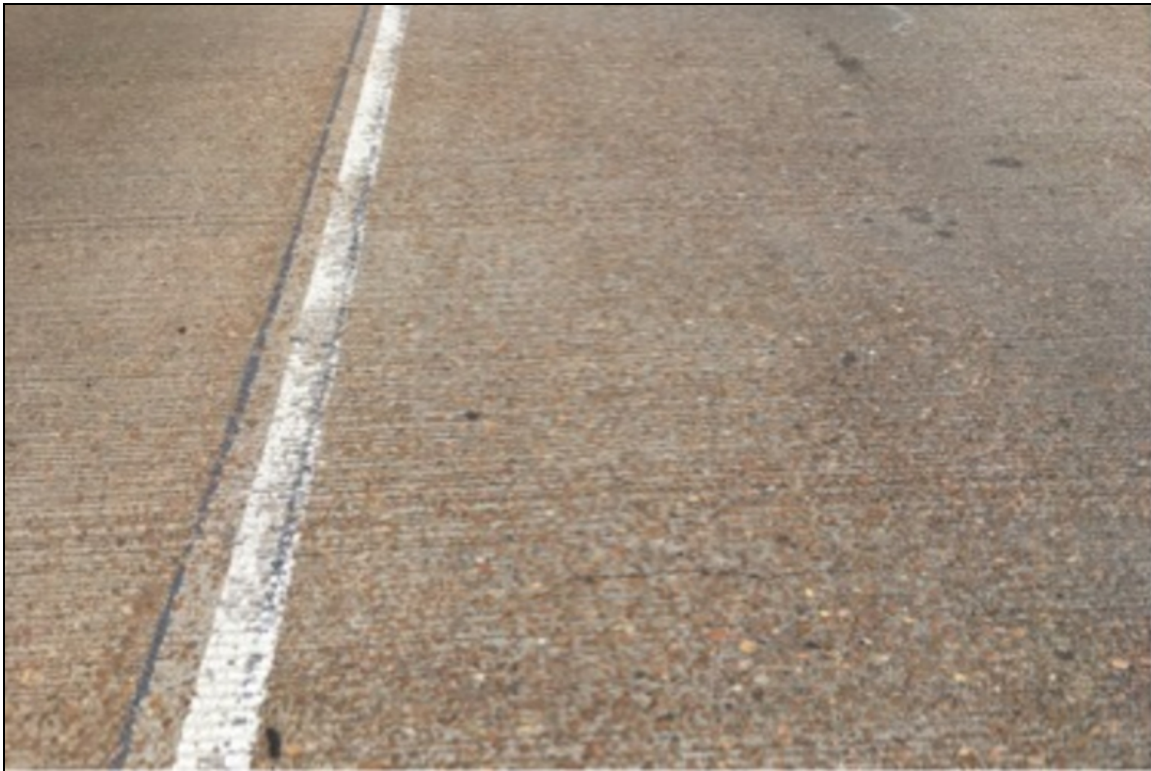
Typical map cracking.
