**Bridge #02671 (Routine)**  
**I 55 NO BND LNS over FLETCHER RD/I55 FR/BN RR**  
**Location: .30 MI N JCT OF I-40**  
**Team Lead: Rhett Franks Inspection Date: June 17, 2019**

IDENTIFICATION	
(1) State Names	Arkansas
(8) Structure Number	02671
(5) Inventory Route	55
(2) Highway Agency District	01
(3) County Code	35-Crittenden County, Arkansas

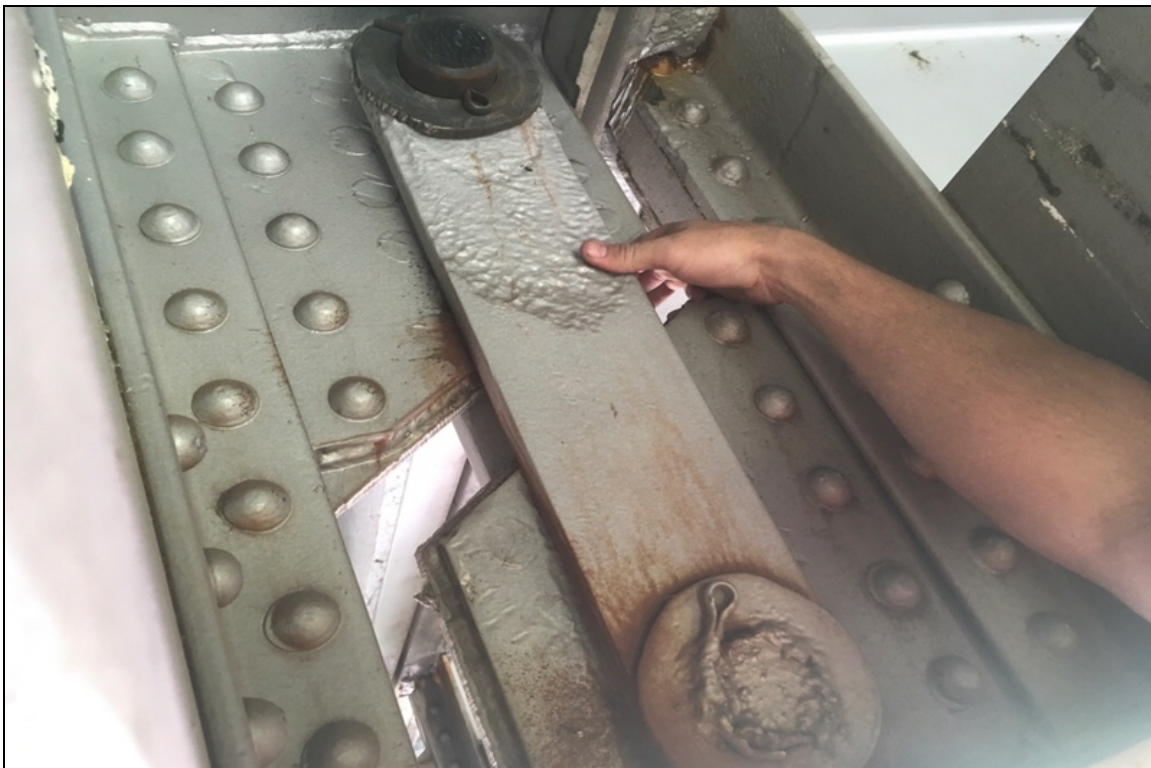
Span 9, Girder 6, Pin & Hanger: Floating.

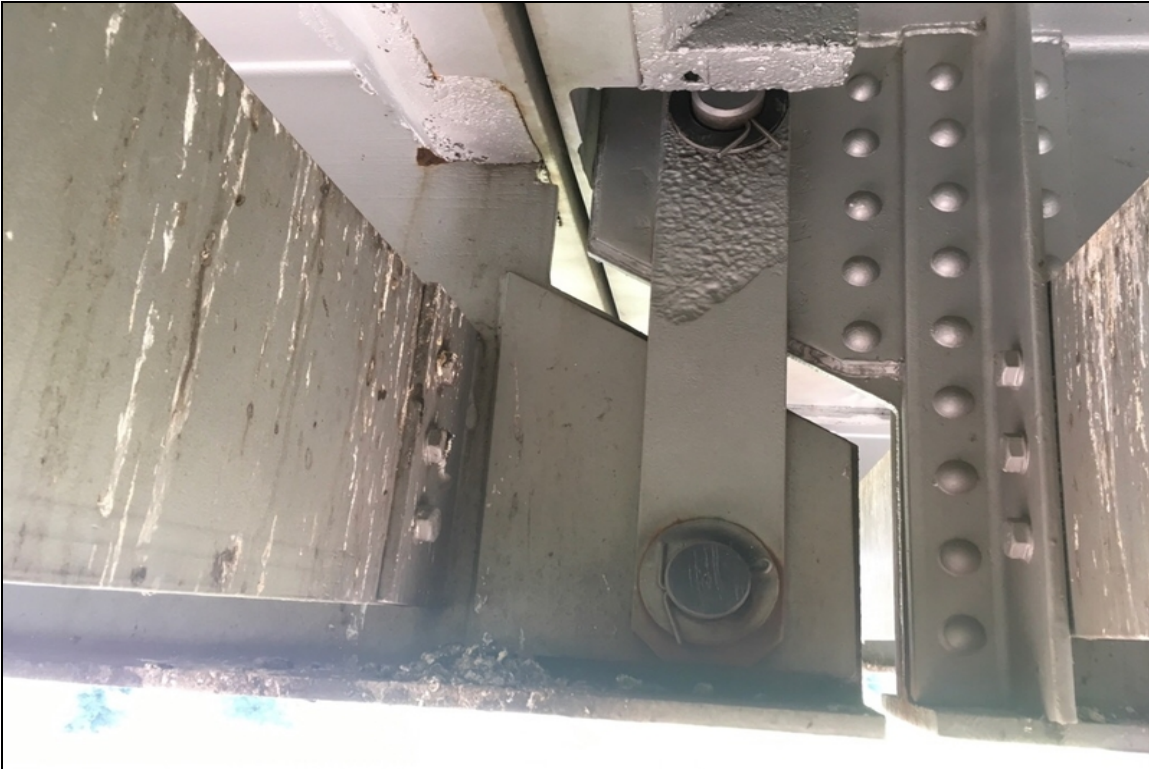
Span 18, Girder 7, Pin & Hanger: Floating.

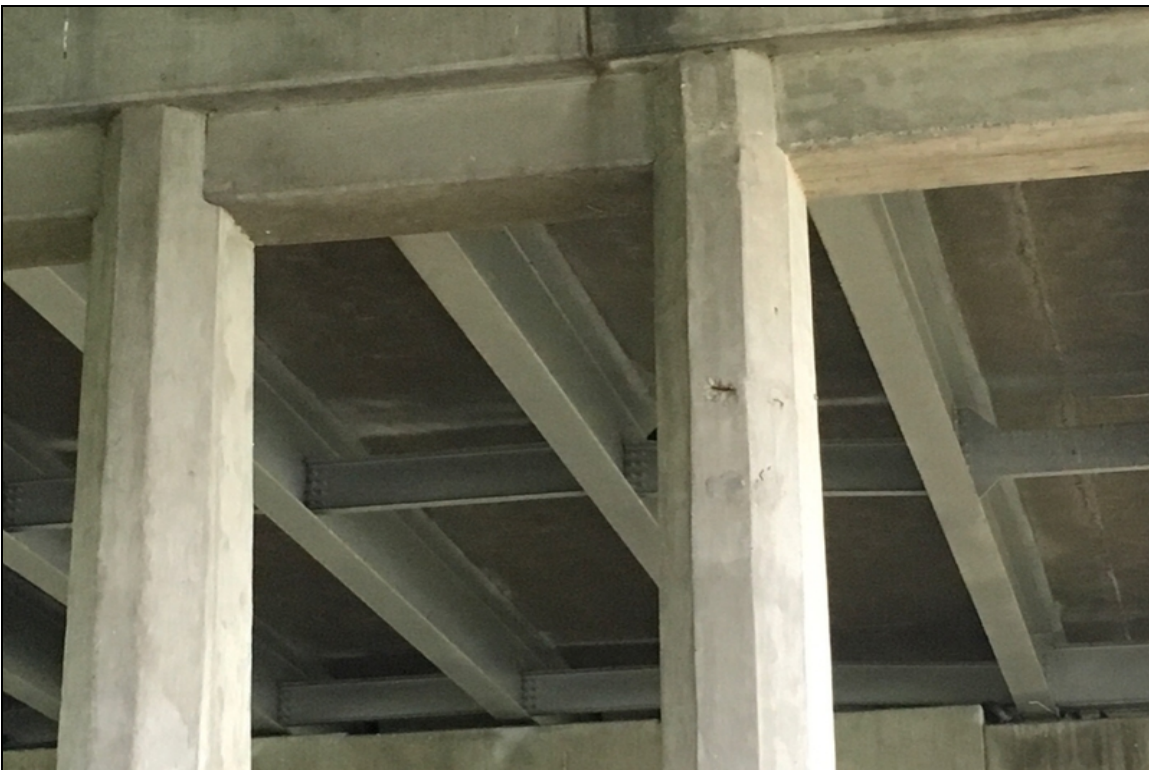
Bent 19, Column 3: Spalling with exposed reinforcing steel.

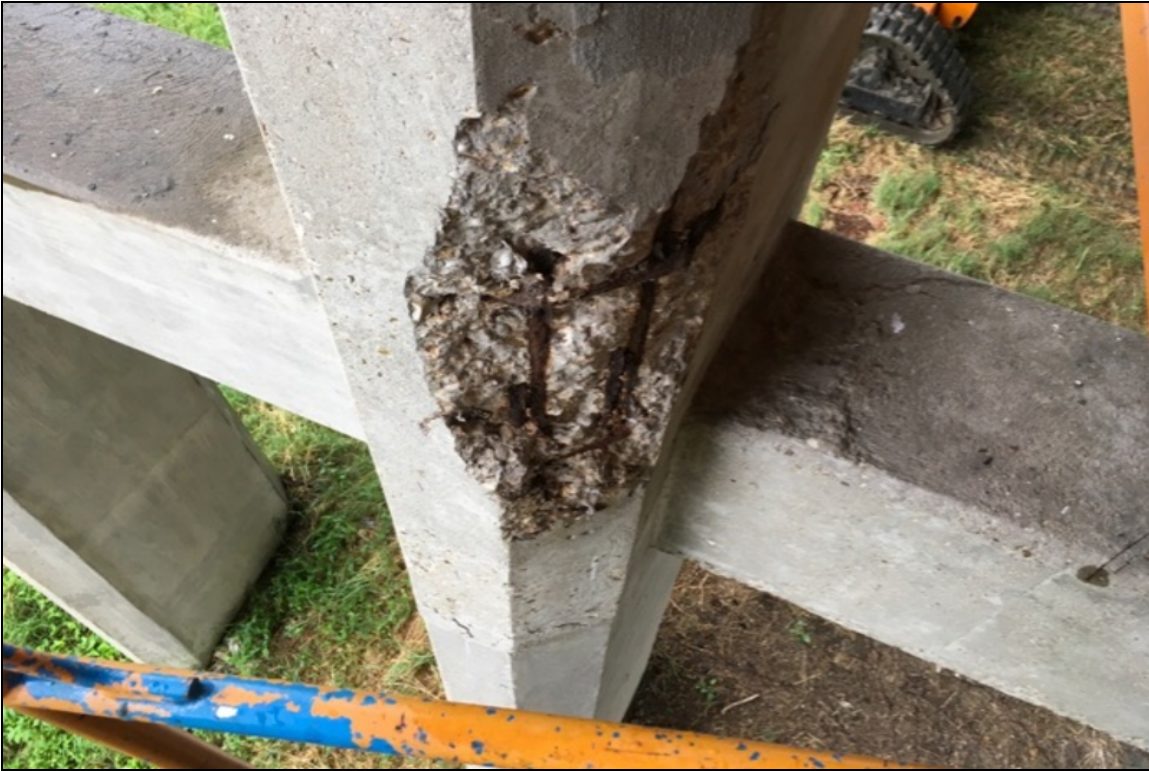
Bent 14, Column 5: Spalling with exposed reinforcing steel with section loss.

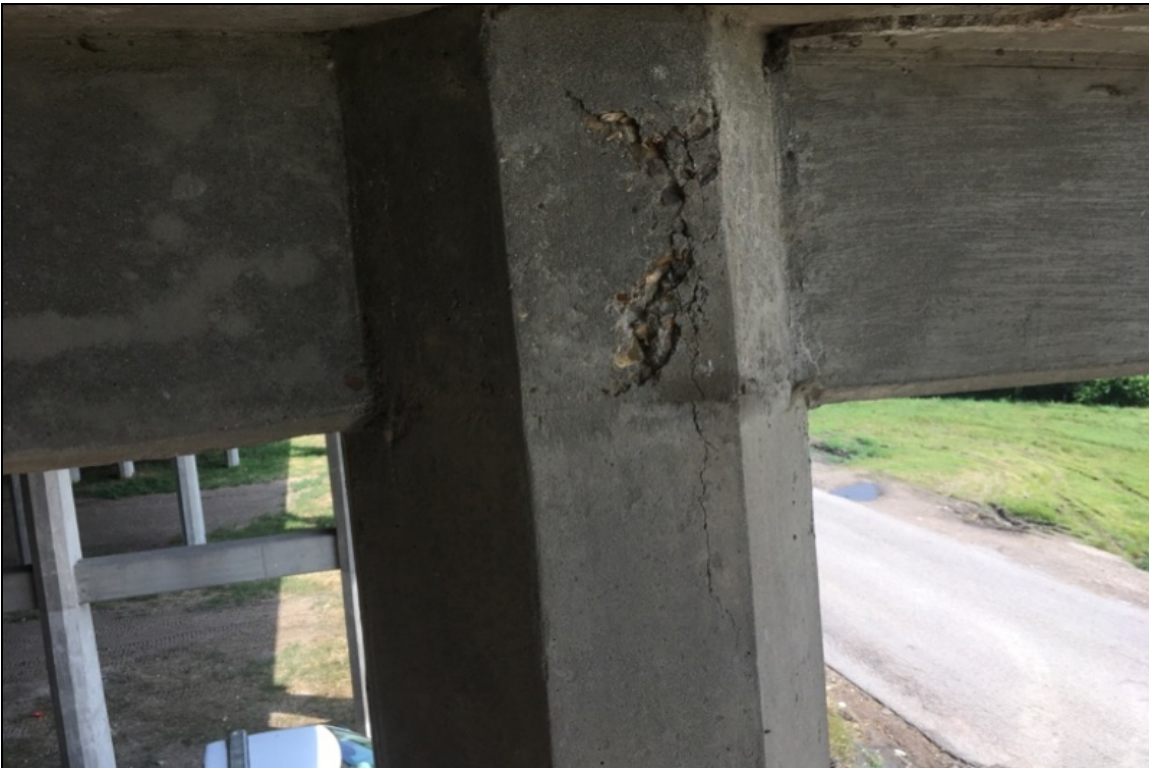
Bent 5, Column 5: Minor spalling.

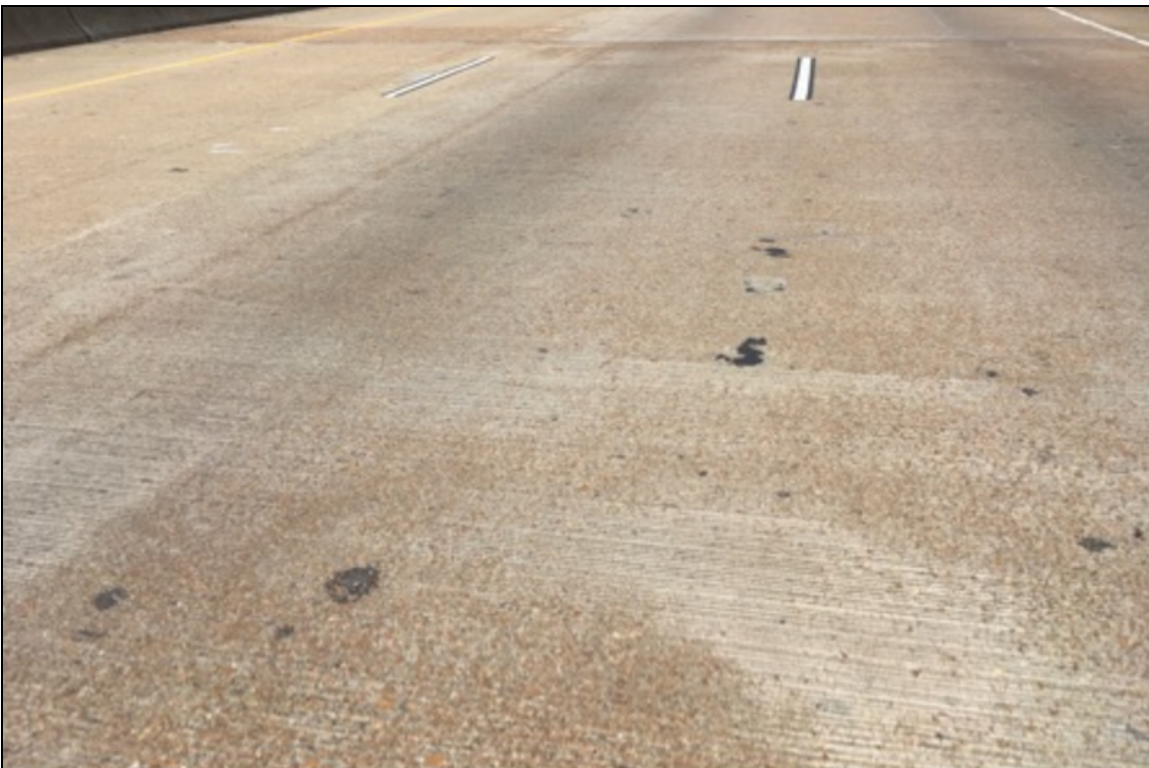
Span 17: Sealable transverse cracks.

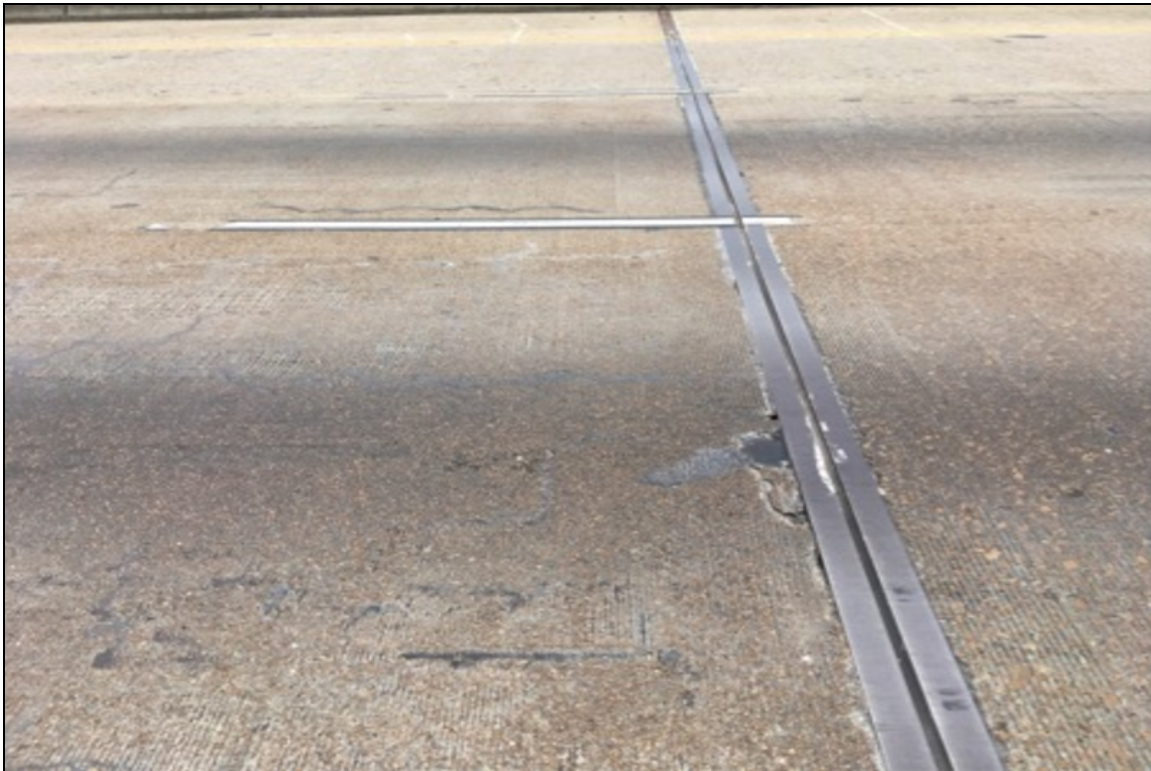
Span 1: Failing repairs.

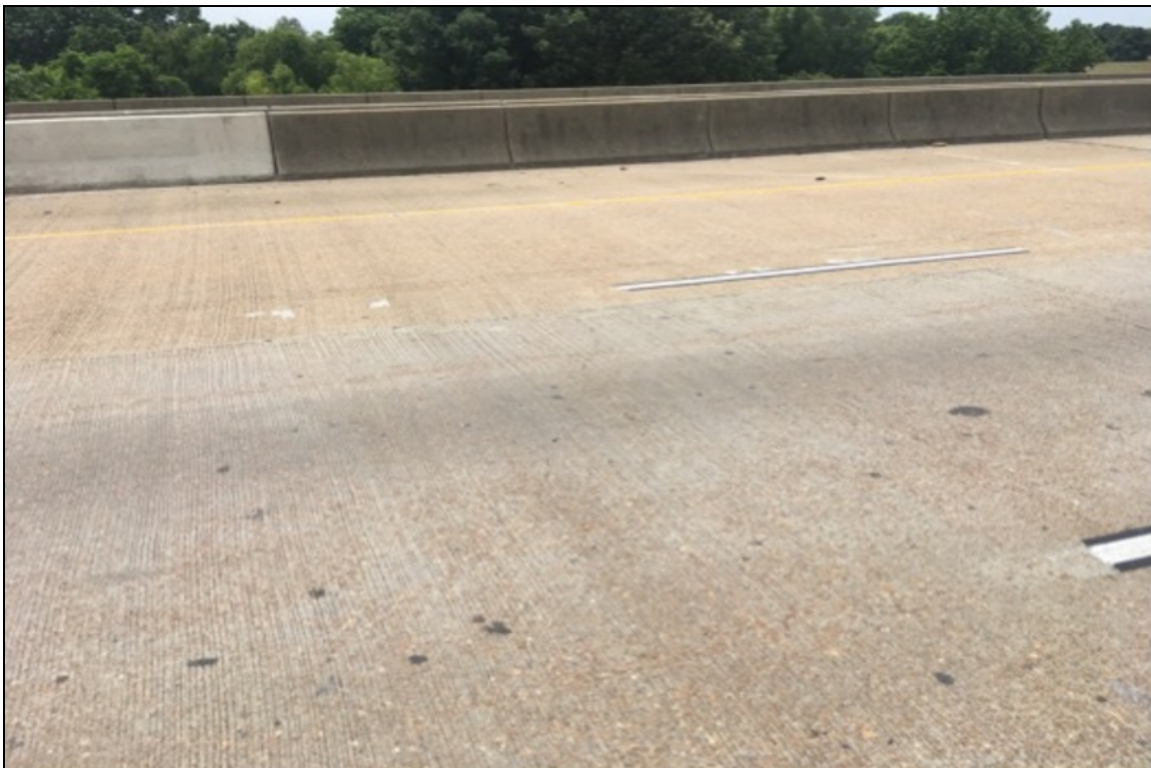
Span 21: Diagonal cracking.

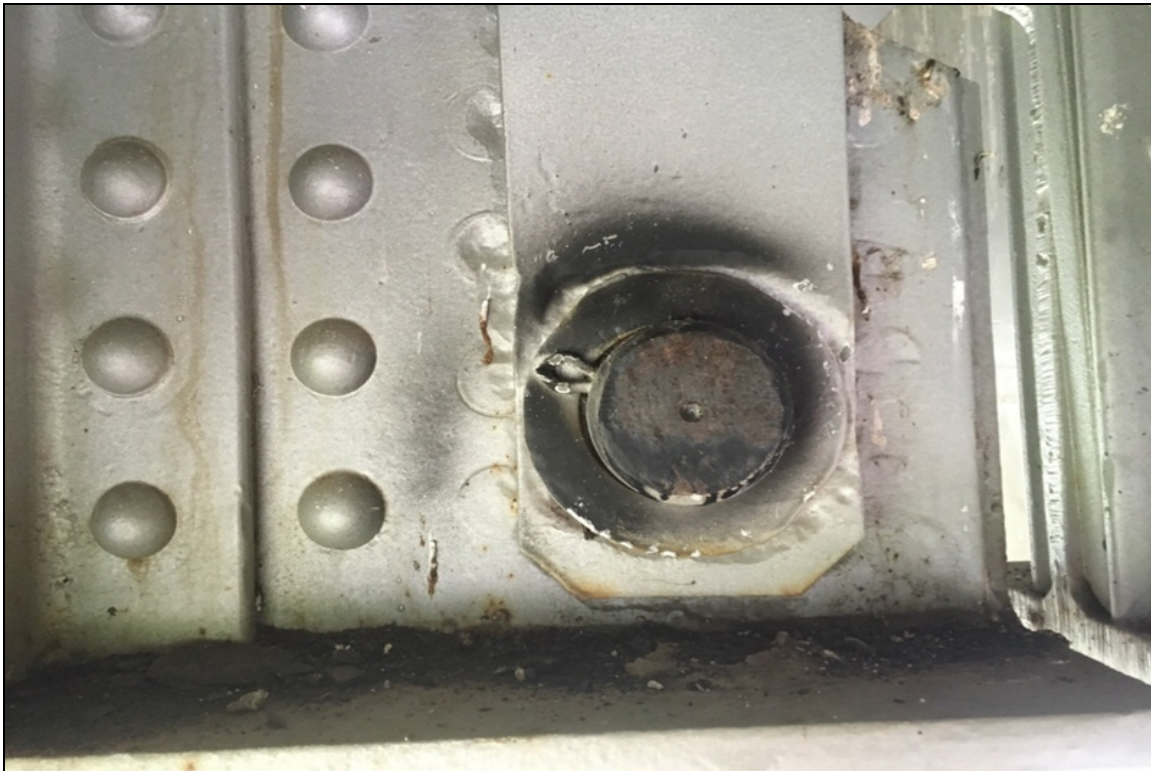
Span 3, Girder 4, Keeper: Sheared.

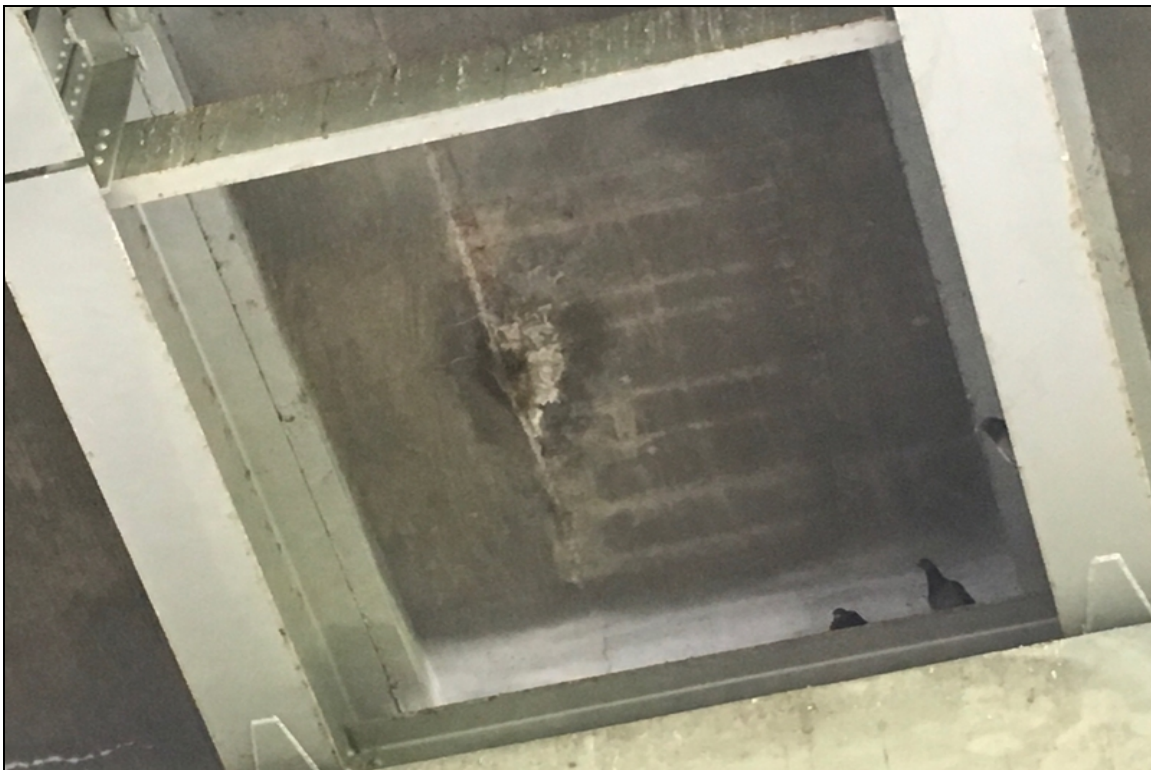
Span 3, Bay 4: Spalling.

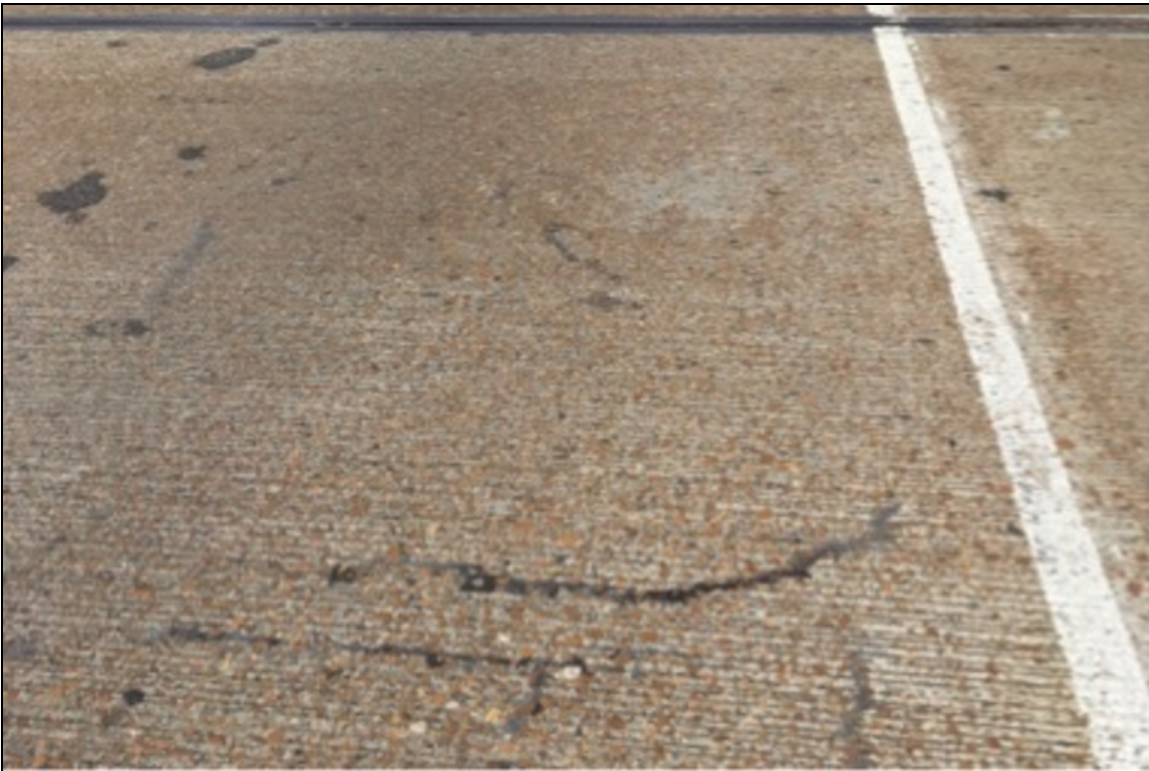
Span 6: Sealable deck cracking.

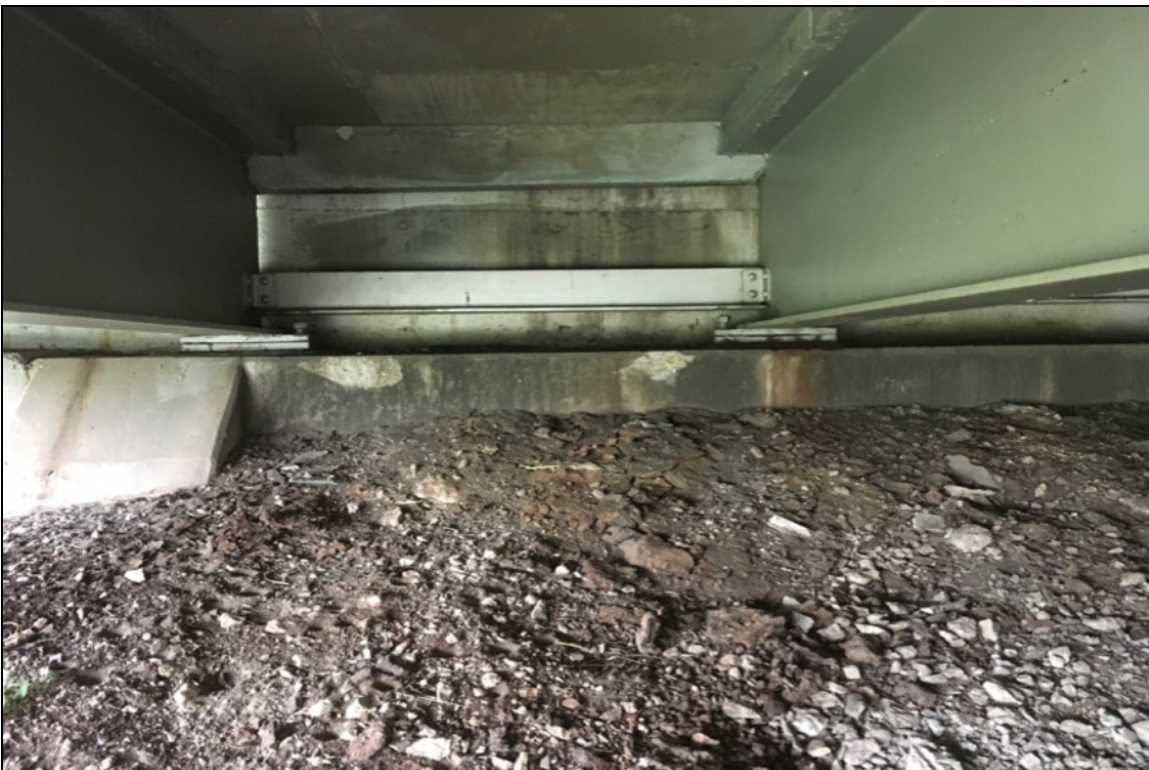
Bent 1: Spalling.

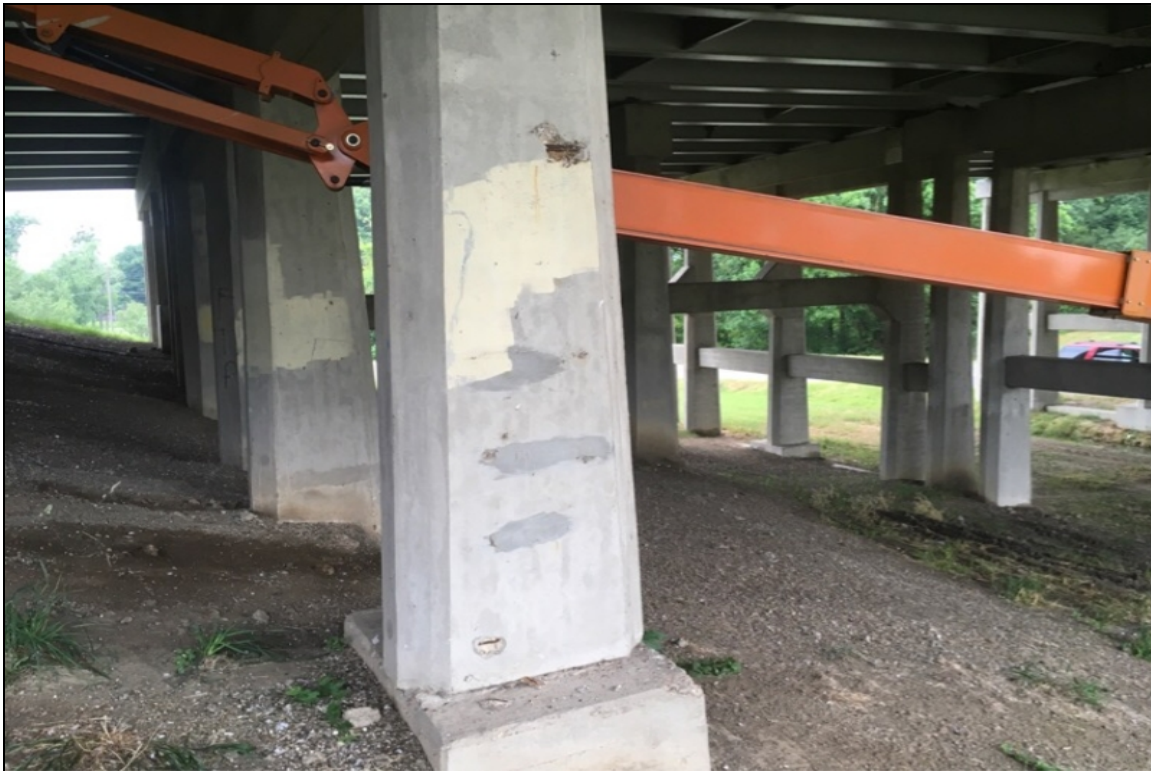
Bent 2, Column 4: Spalling with exposed reinforcing steel.

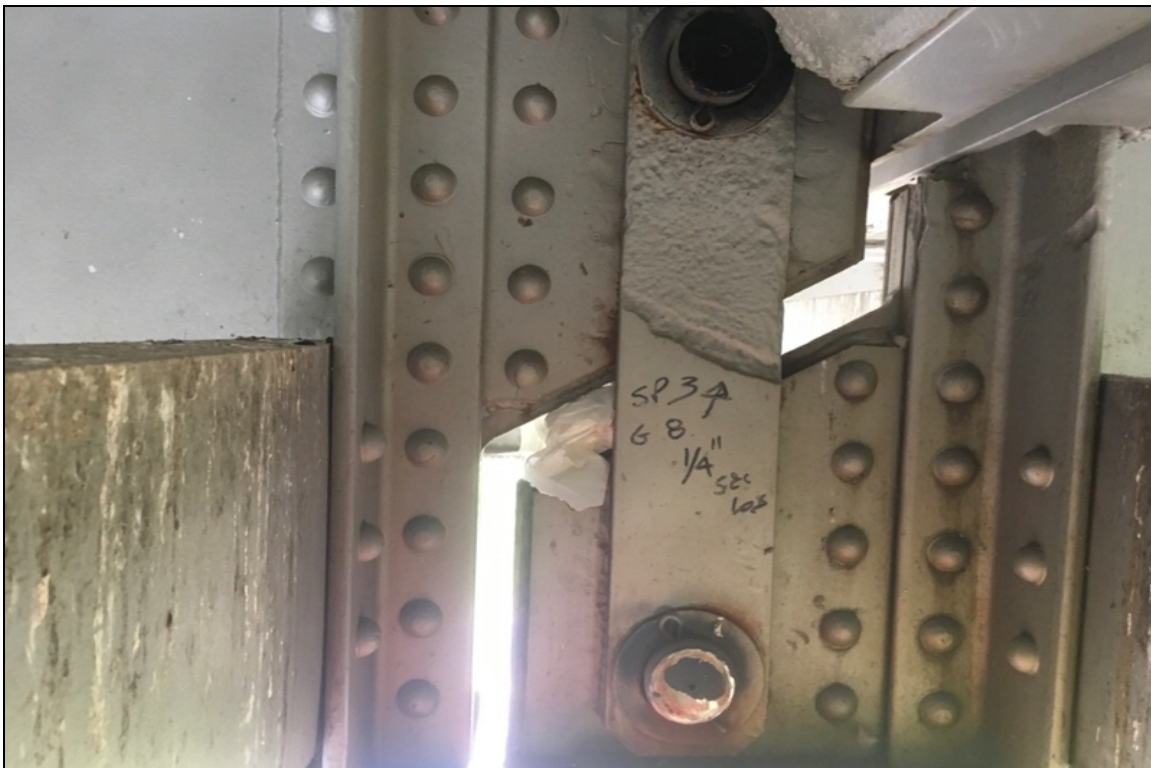
Span 3, Girder 8: Old section loss up to 1/4".

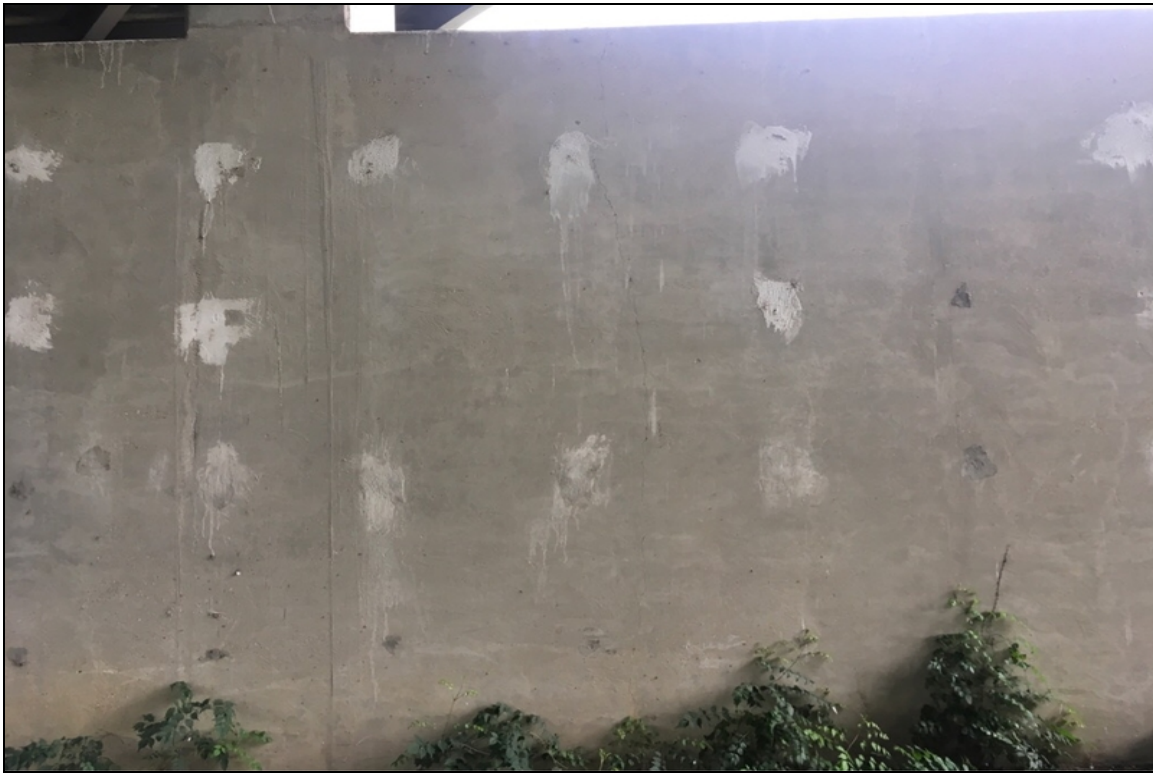
Pier Walls: Typical cracking.

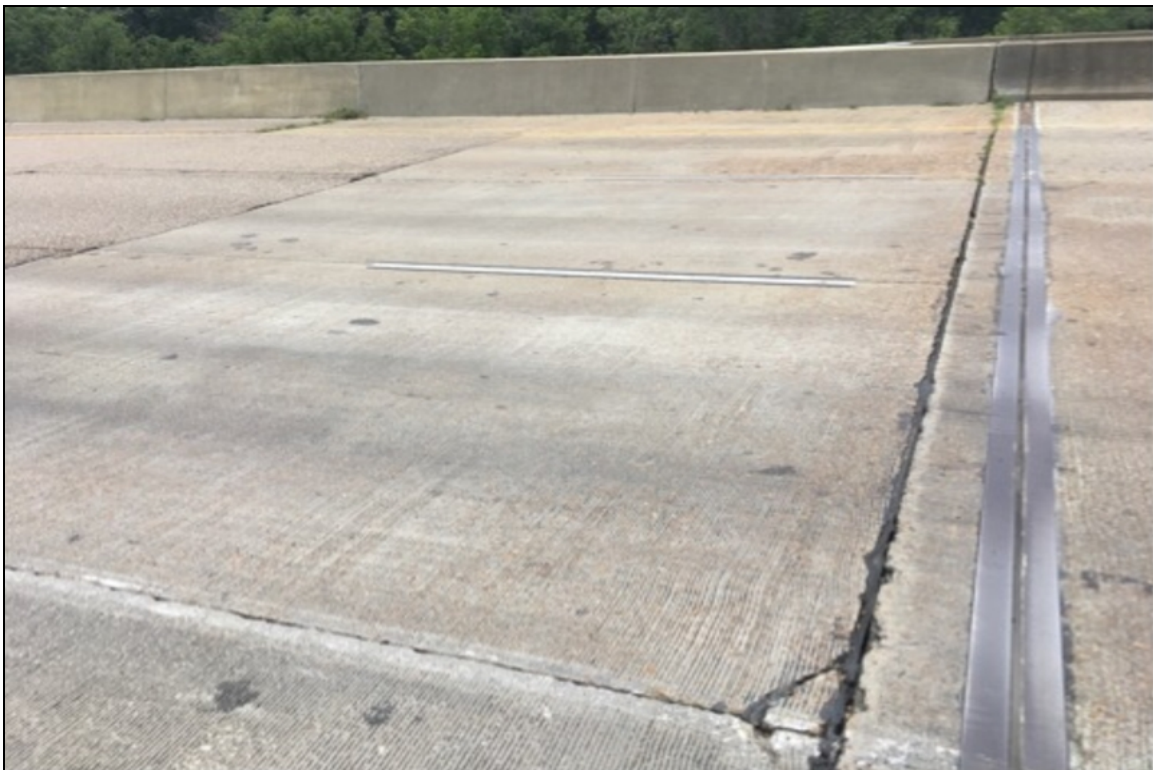
Approach 1: Spalling.

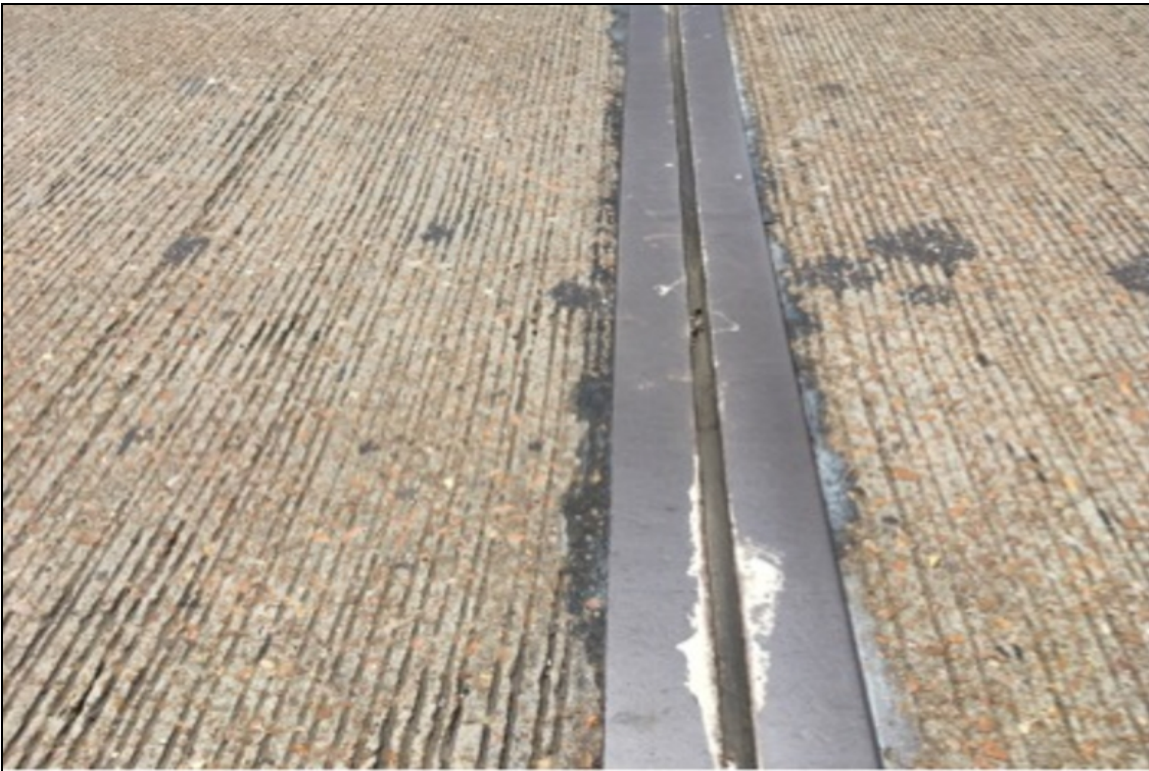
Span 4, Joint: 2' leakage.

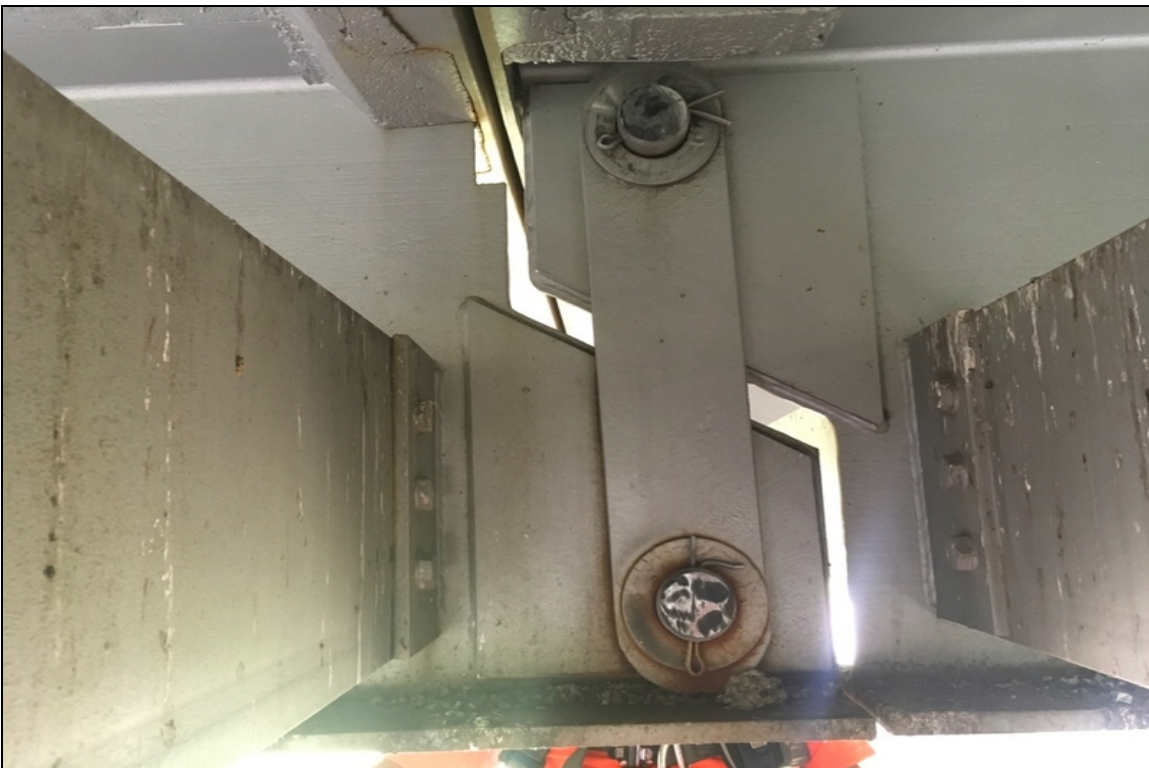
Span 21, Girder 6, Pin & Hanger: Floating.

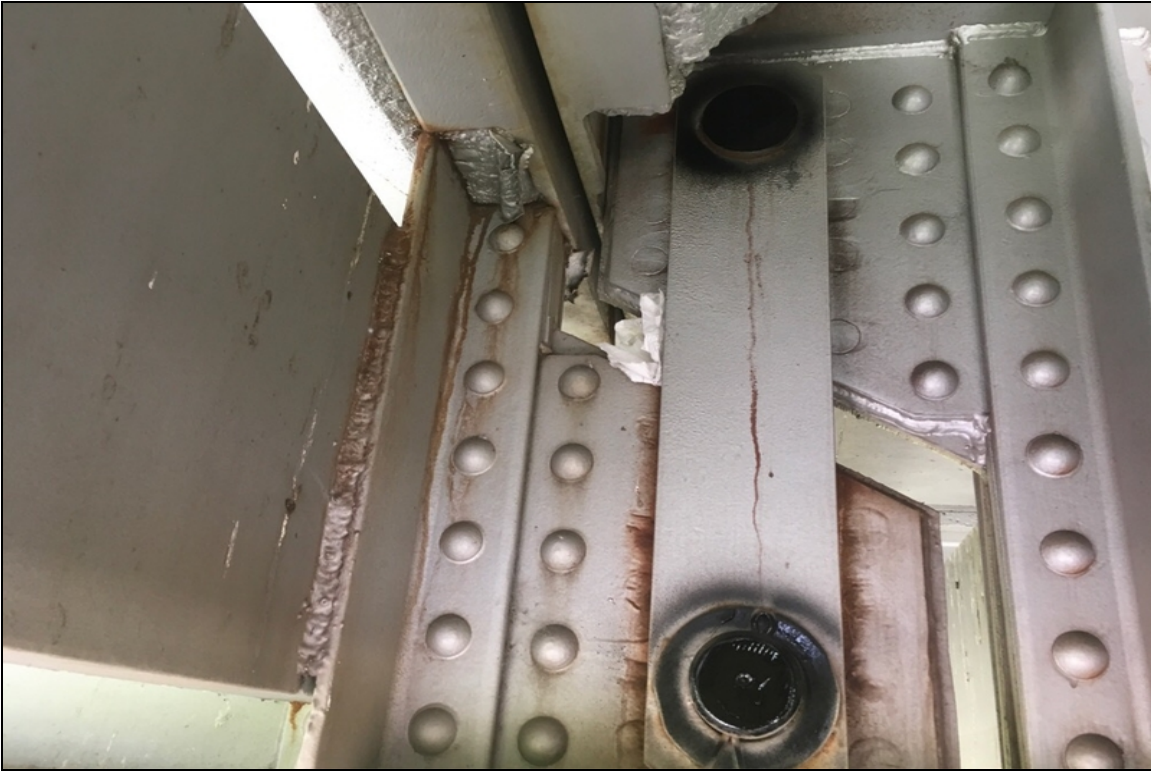
Span 8, Girder 8, Pin & Hanger: Floating.

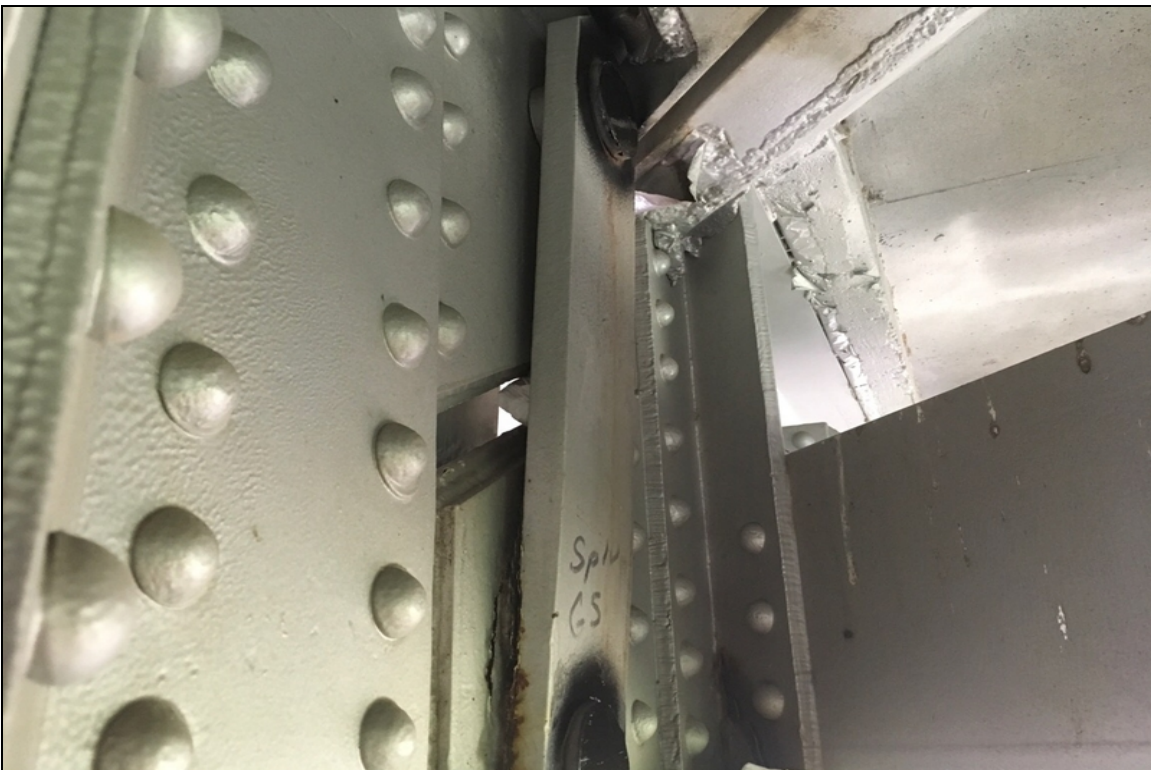
Span 10, Girder 5, Hanger Bar: Bulging.

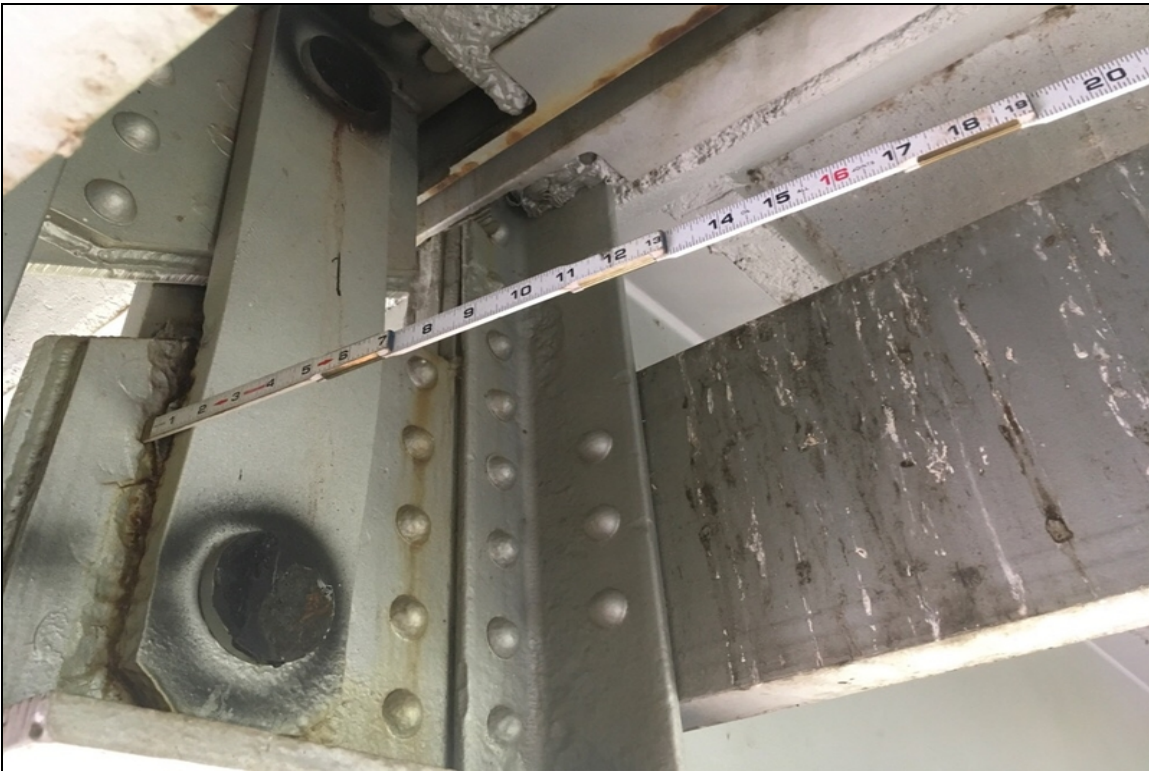
Span 3, Girder 6, Left, Hanger Bar: Out of plane bending.

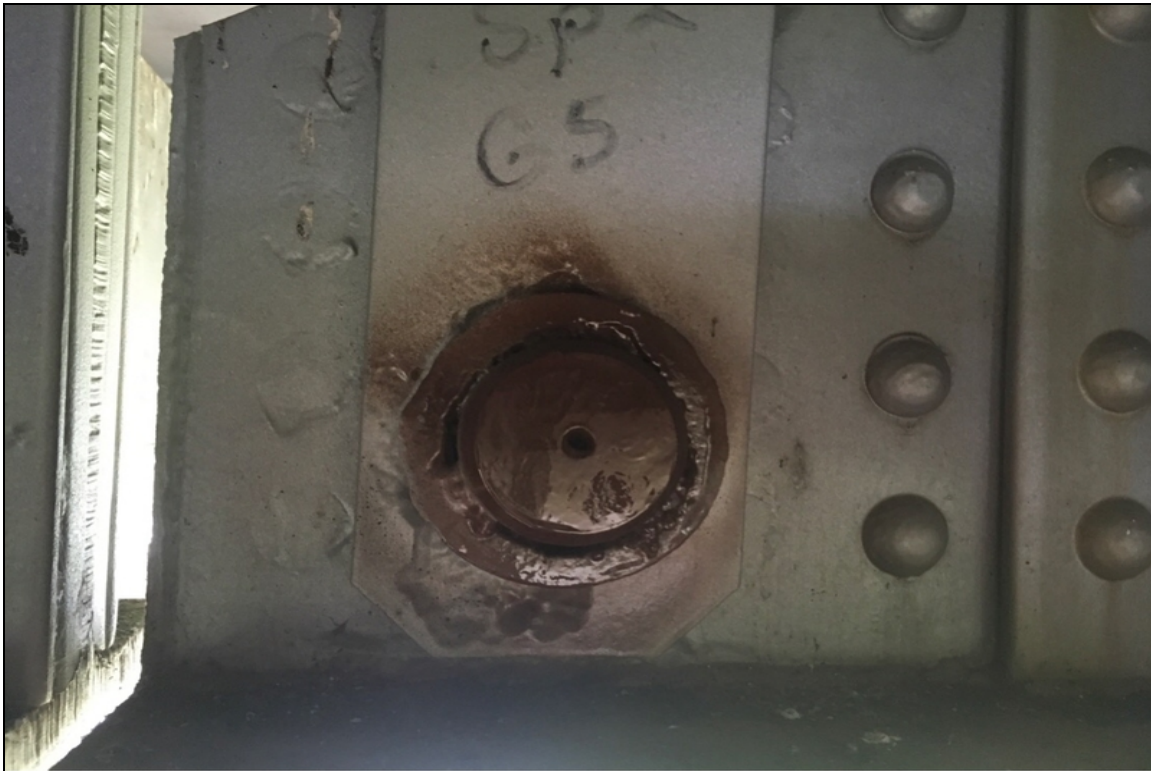
Span 2, Girder 5, Bottom Pin: Keeper missing washer is welded.
