Bridge #A2671 (Routine)
I - 55 SO BND LNS over FLETCHER RD/I55 FR/UP RR
Location: .30 MI N JCT I-40
Team Lead: Rhett Franks Inspection Date: June 03, 2019

IDENTIFICATION	
(1) State Names	Arkansas
(8) Structure Number	A2671
(5) Inventory Route	55
(2) Highway Agency District	01
(3) County Code	35-Crittenden County, Arkansas

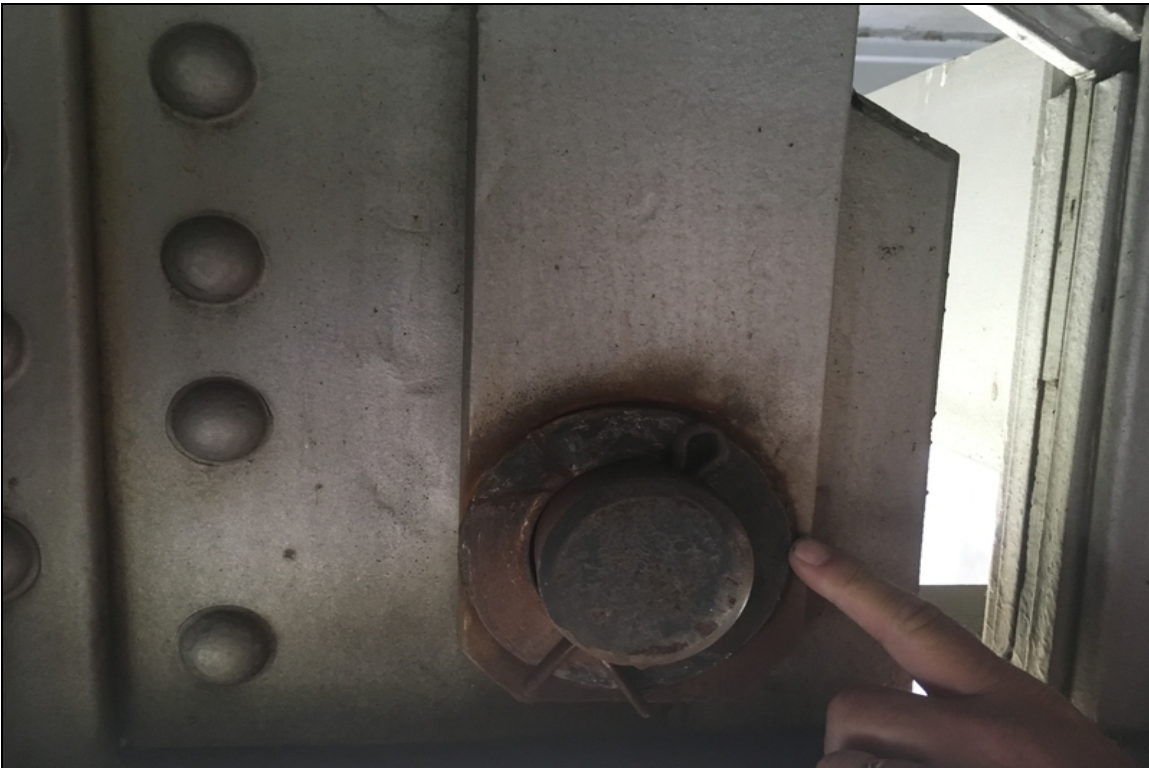
Span 9, Girder 3, Pin & Hanger: Floating.

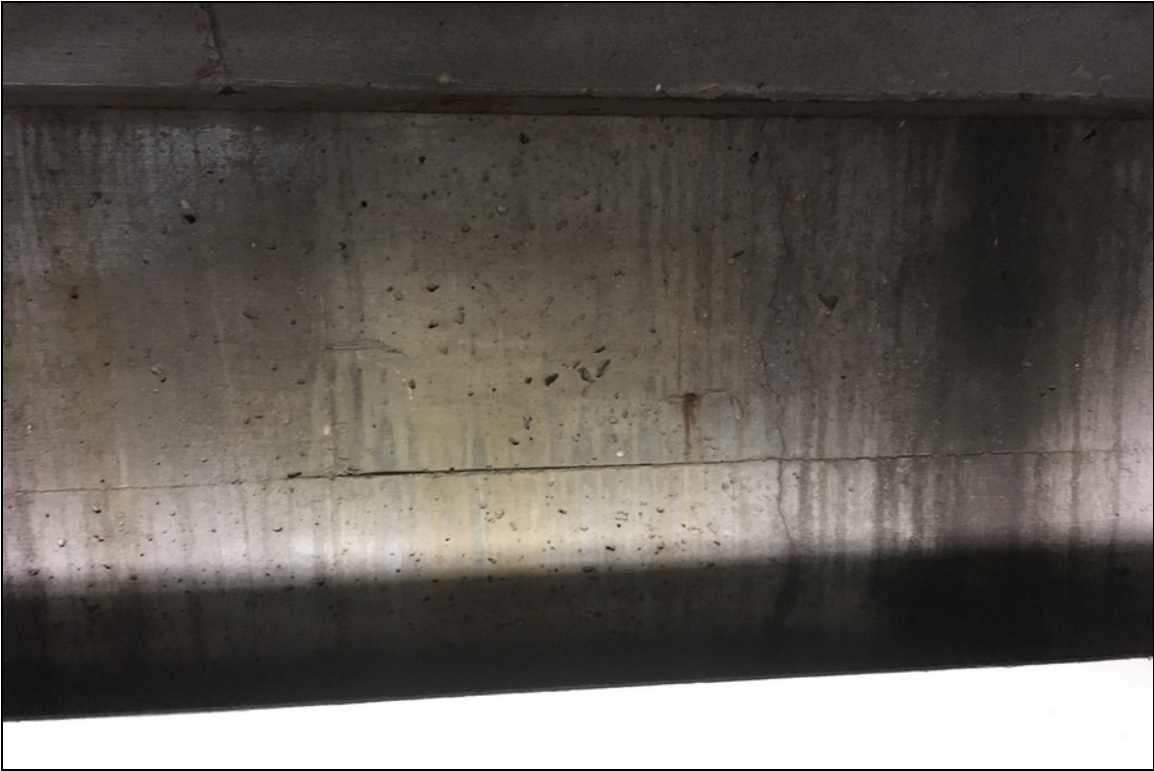
Bent 1, Back Wall: Typical cracking.

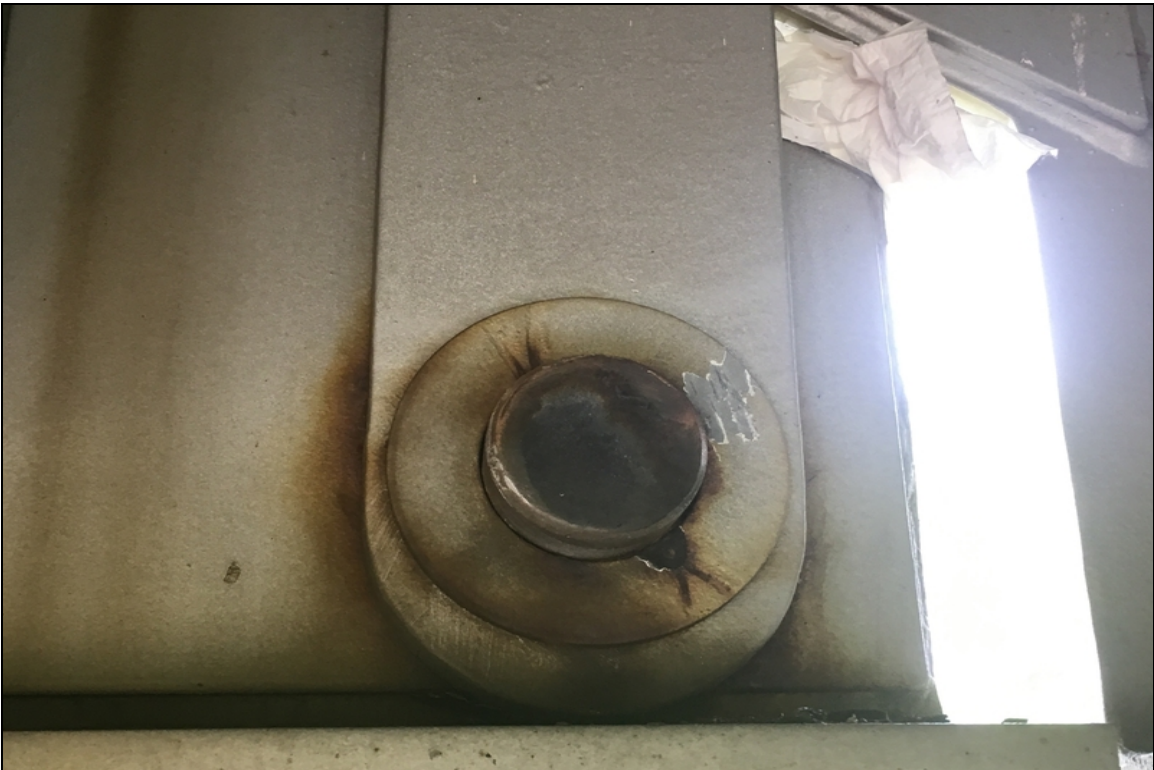
Span 6, Girder 1, Bottom Pin: Keeper missing.

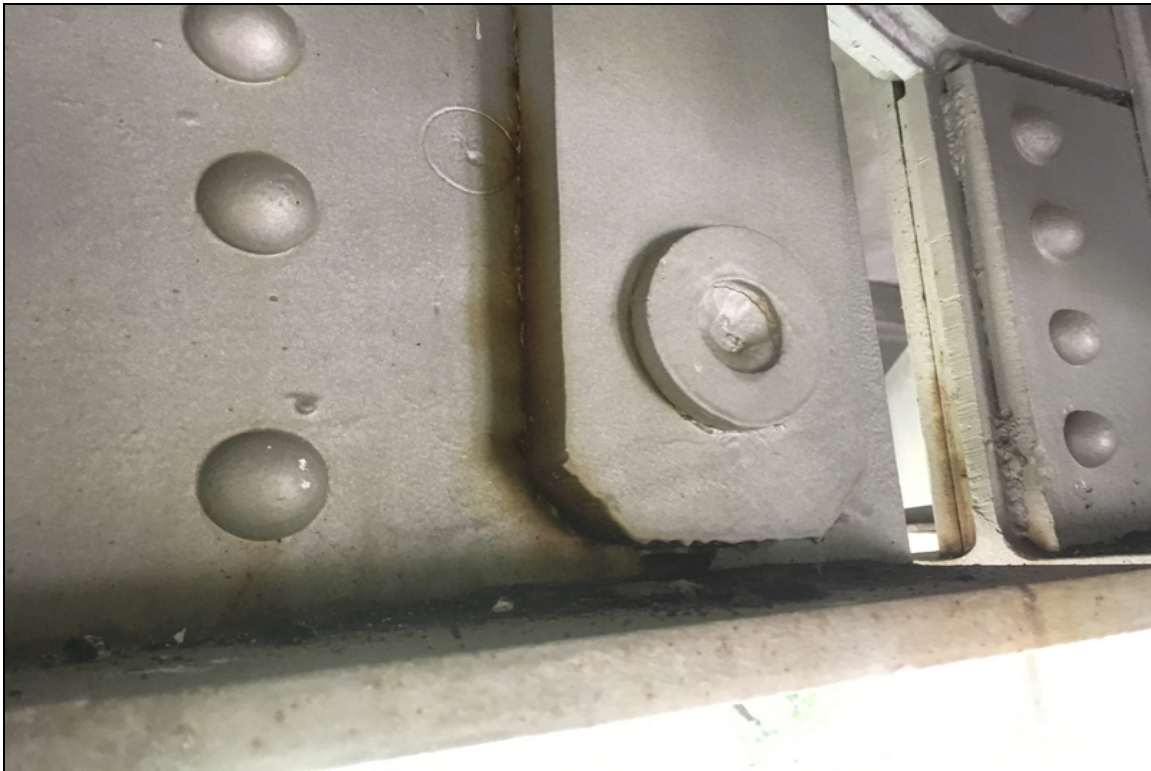
Span 12, Girder 6, Bottom Pin: Retaining washer weld fractured.

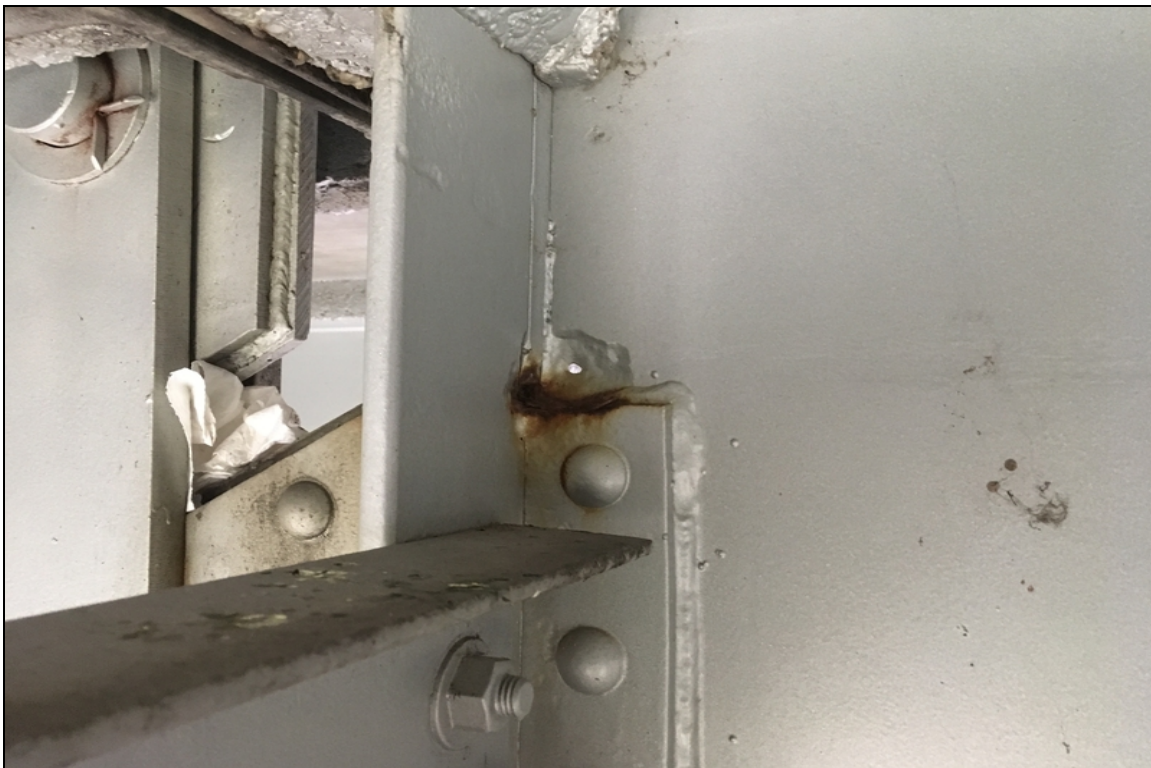
Span 9, Girder 4: Hole through web.

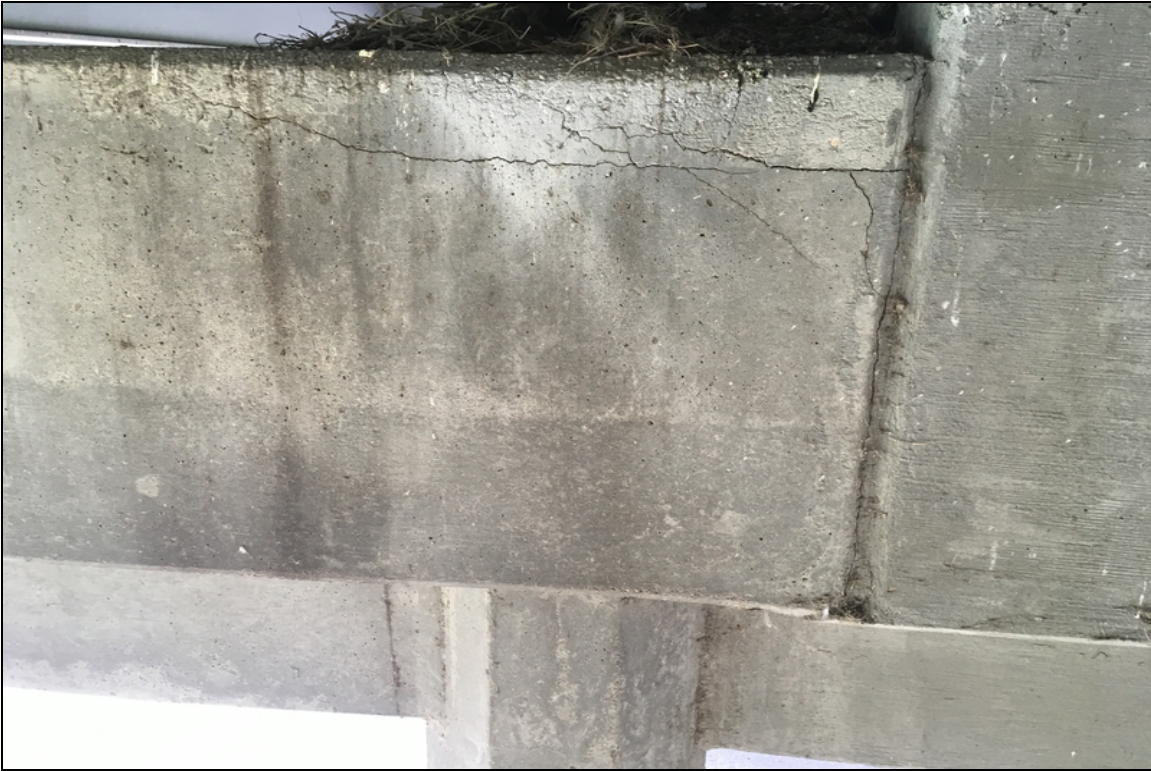
Bent 5, Column 4, Cap: Cracking.

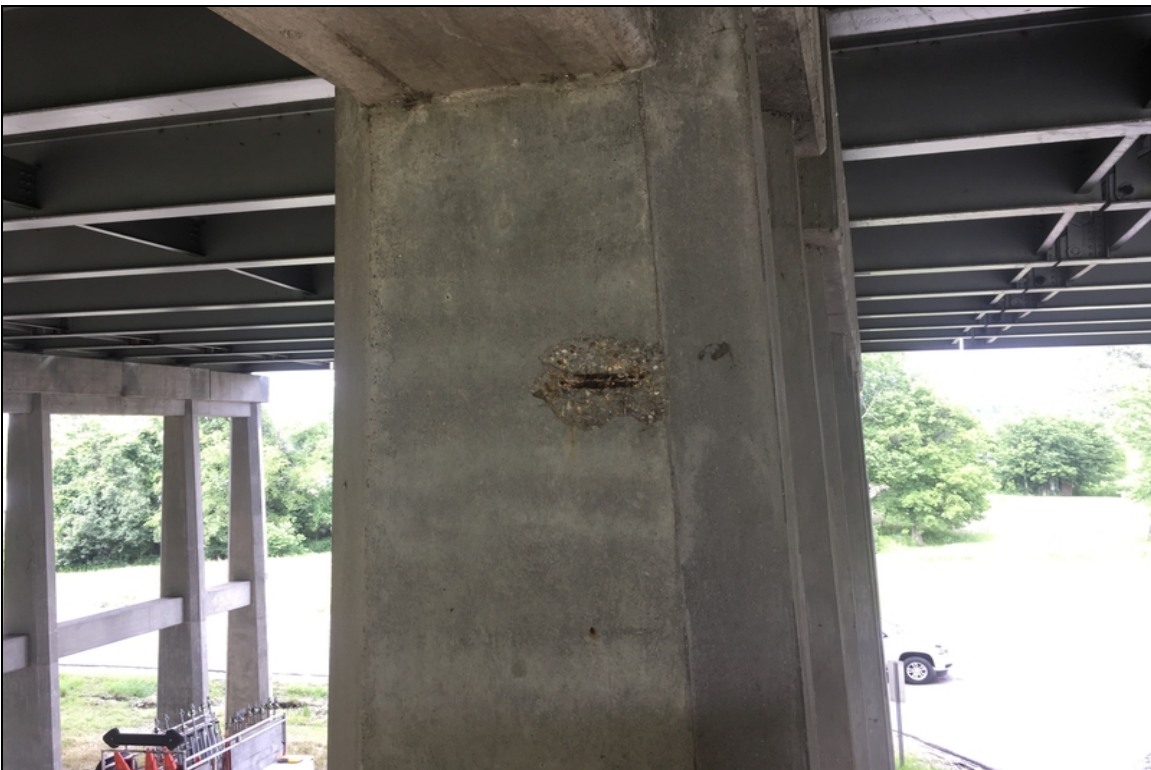
Bent 5, Column 4: Spalling with exposed reinforcing steel.

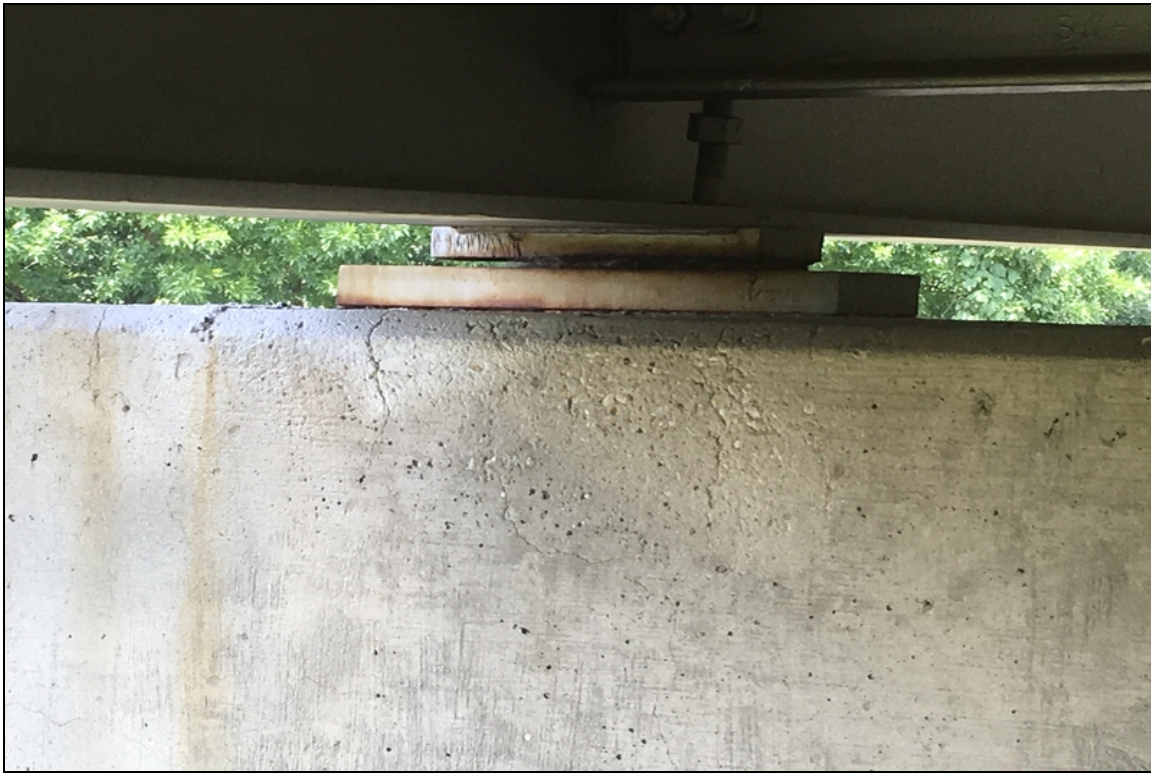
Bent 2, Girder 1, Bearing: Active corrosion and floating

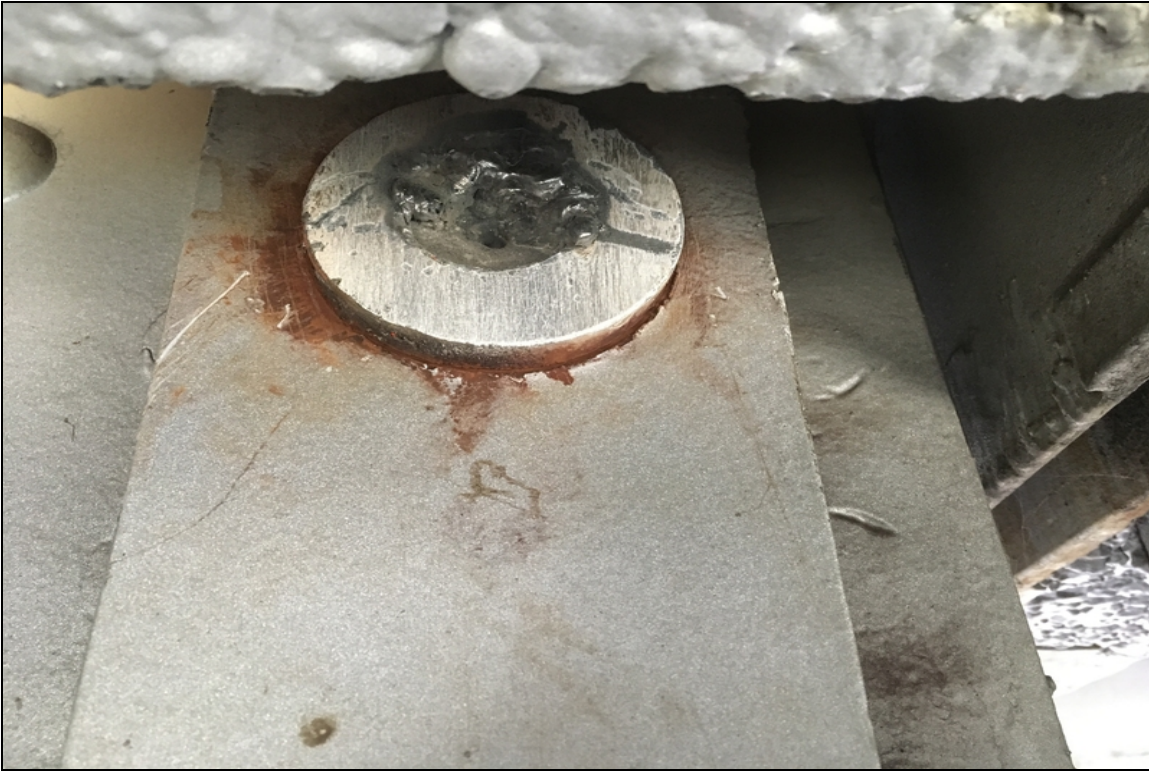
Span 8, Girder 3, Top Pin: Repaired.

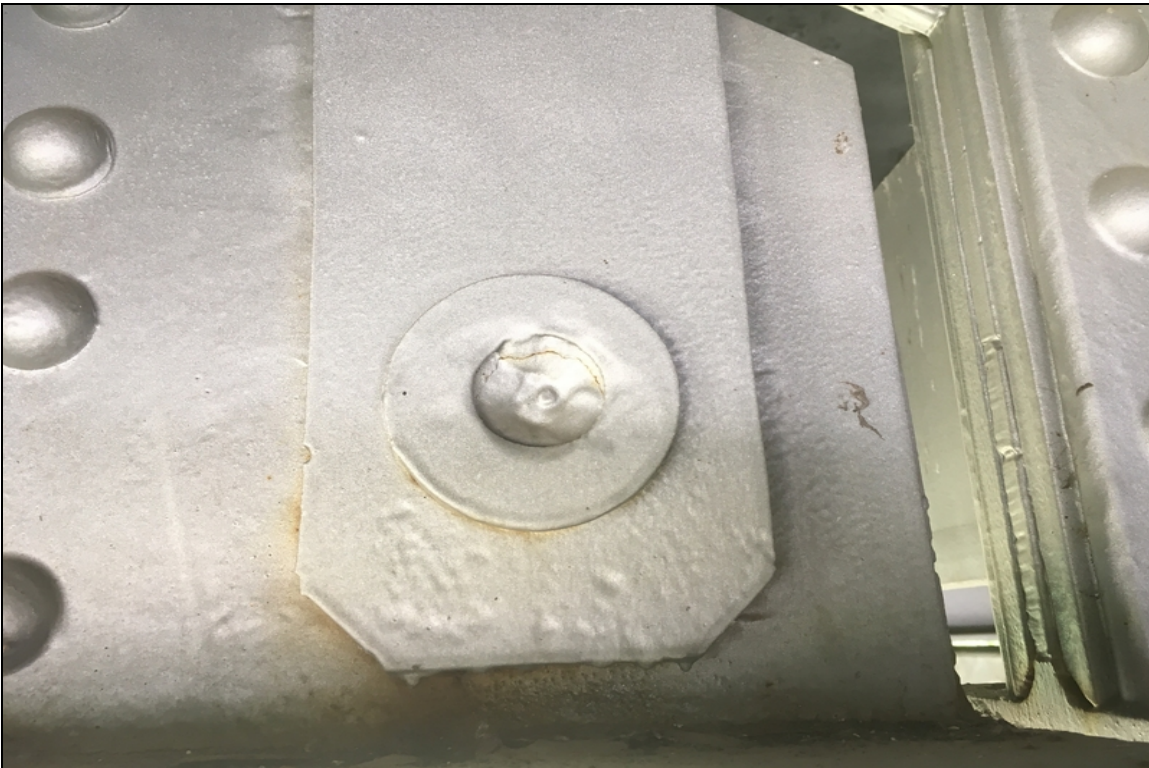
Span 11, Girder 6, Bottom Pin: Retaining washer weld fractured.

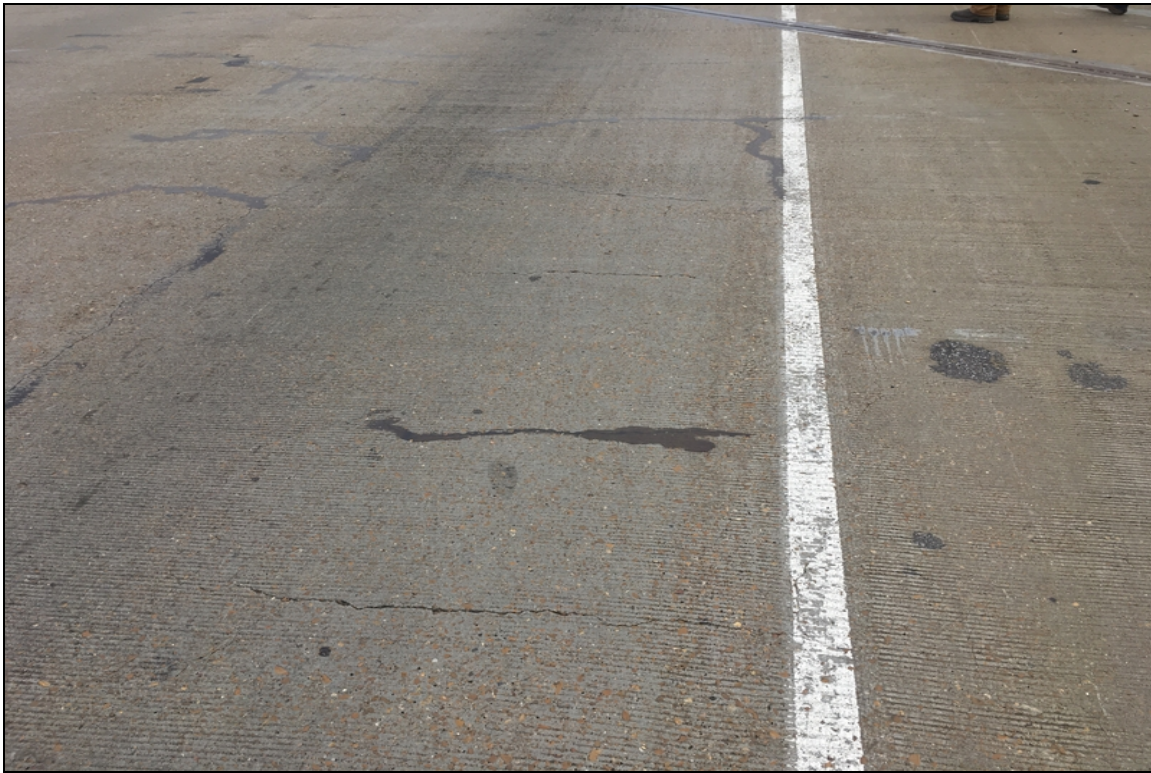
Sealable deck cracking.

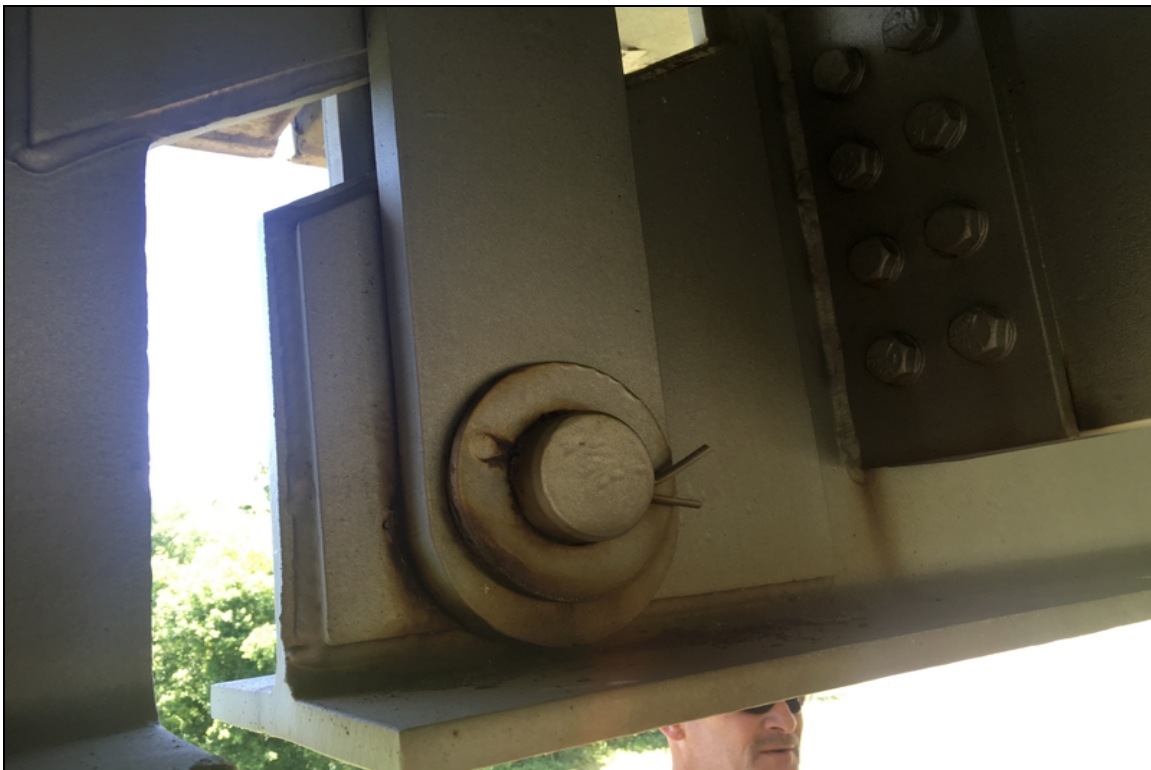
Span 18, Girder 1: Fractured cotter key.

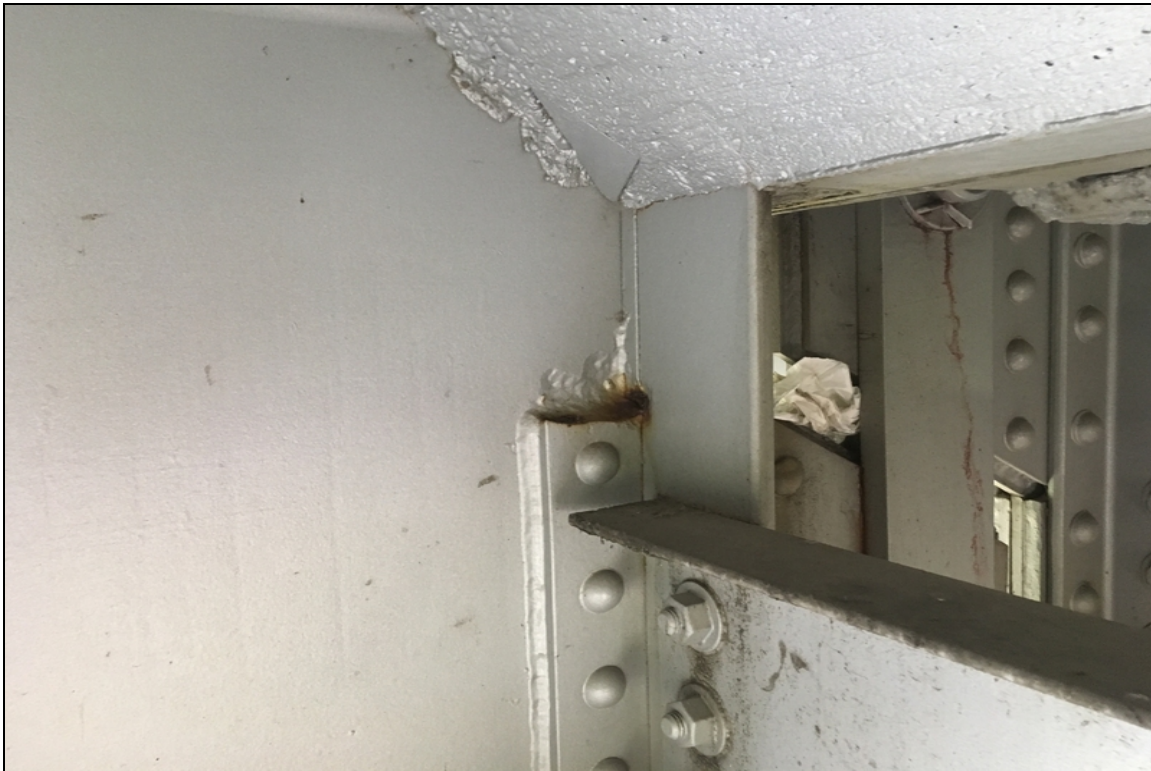
Typical section loss to the diaphragm connections.

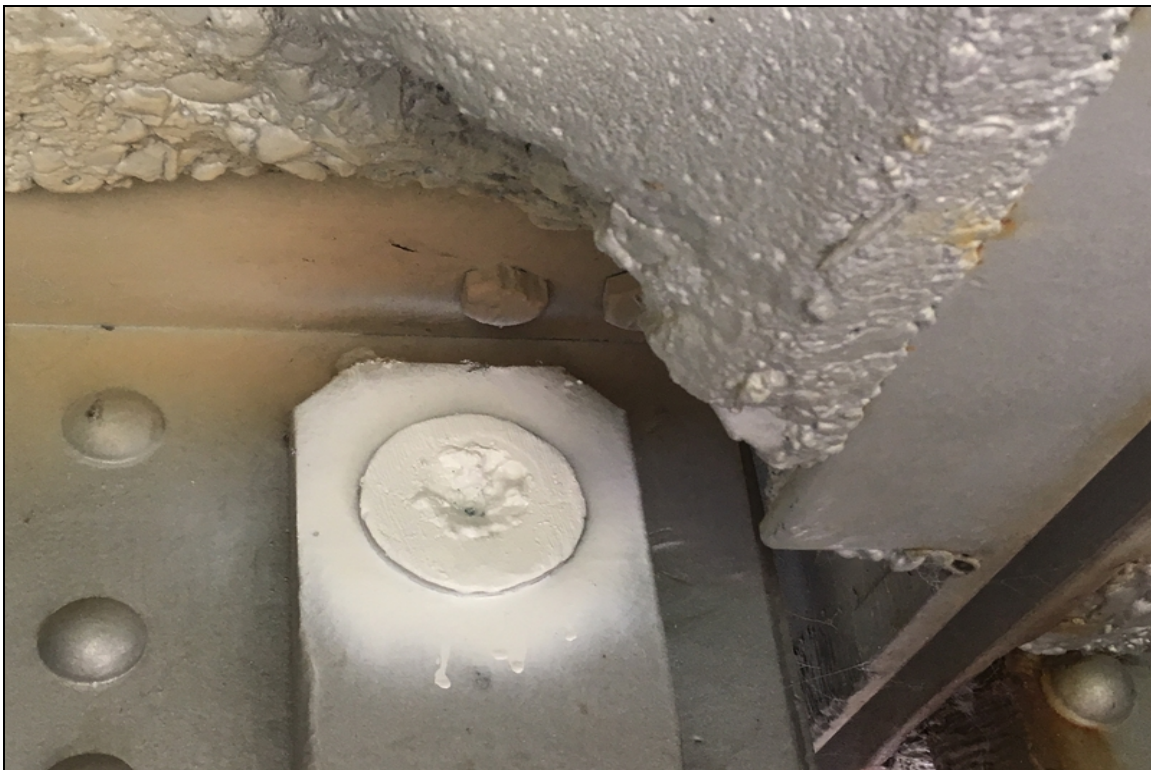
Span 6, Girder 2, Top Pin: Repaired.

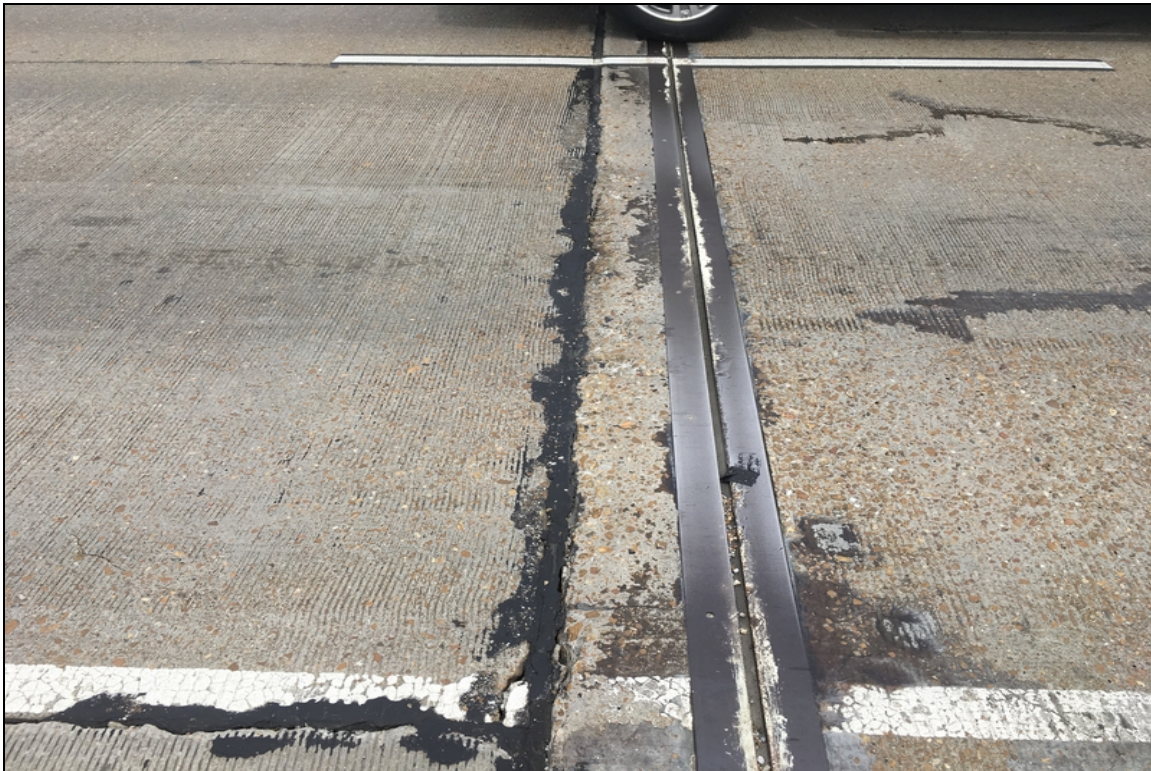
Bent 22, Back Wall: Spalling.

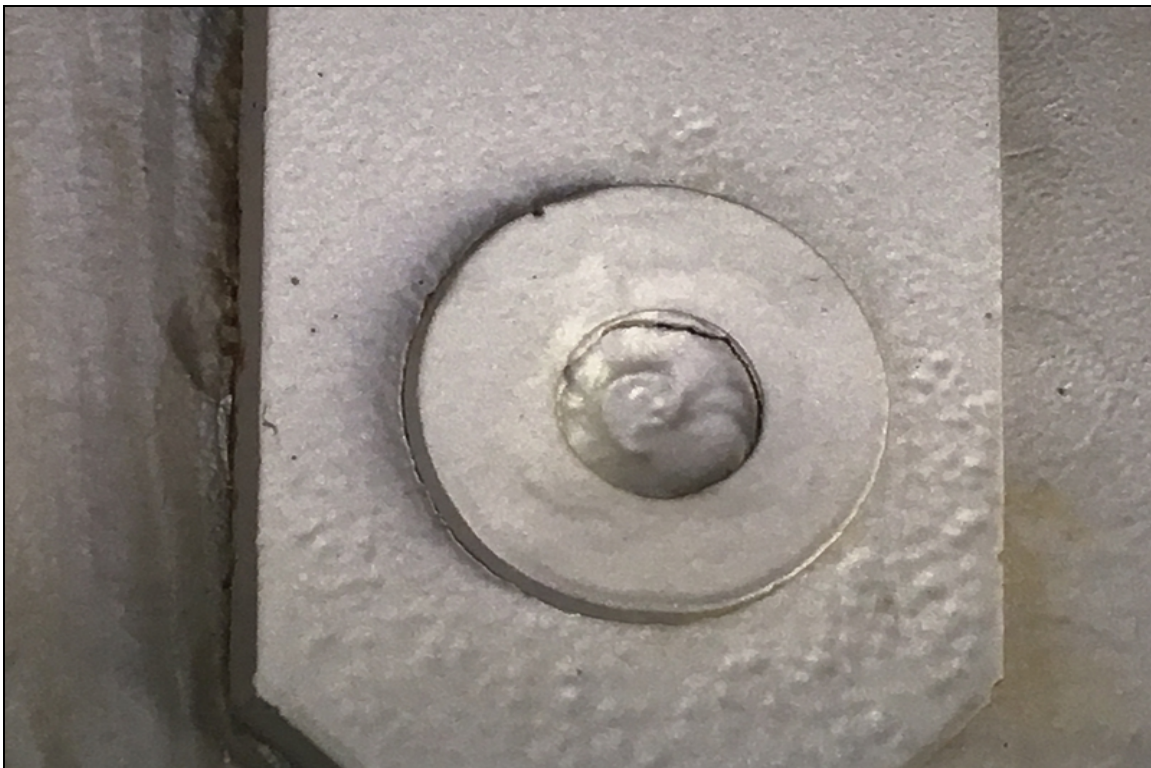
Span 4, Girder 2, Bottom Pin: Retaining washer weld fractured.

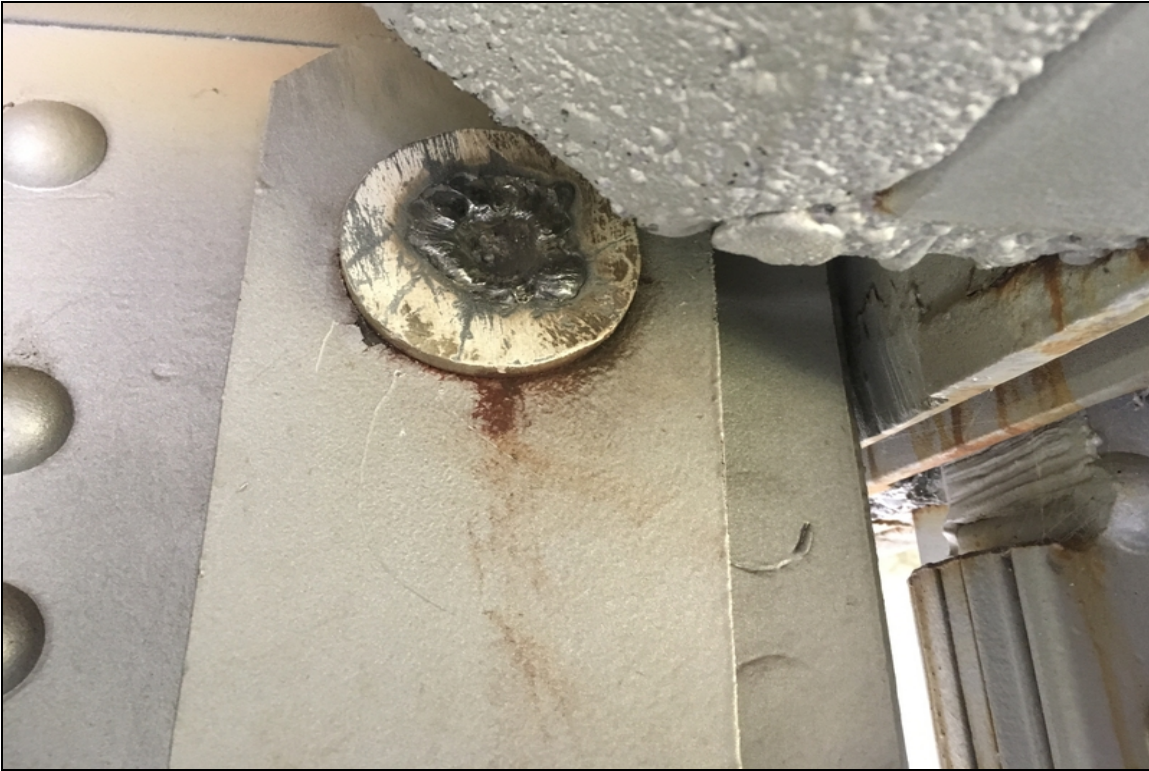
Span 4, Girder 3, Top Pin: Repaired.

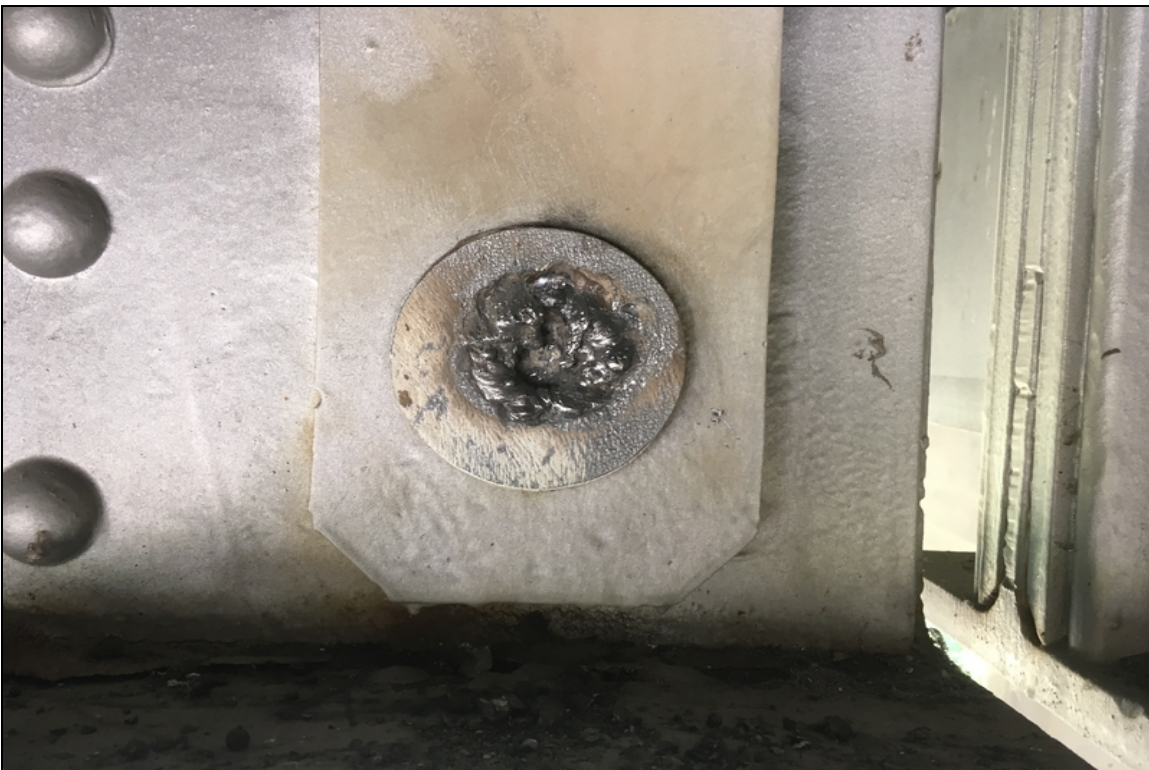
Span 11, Girder 6, Bottom Pin: Repaired.

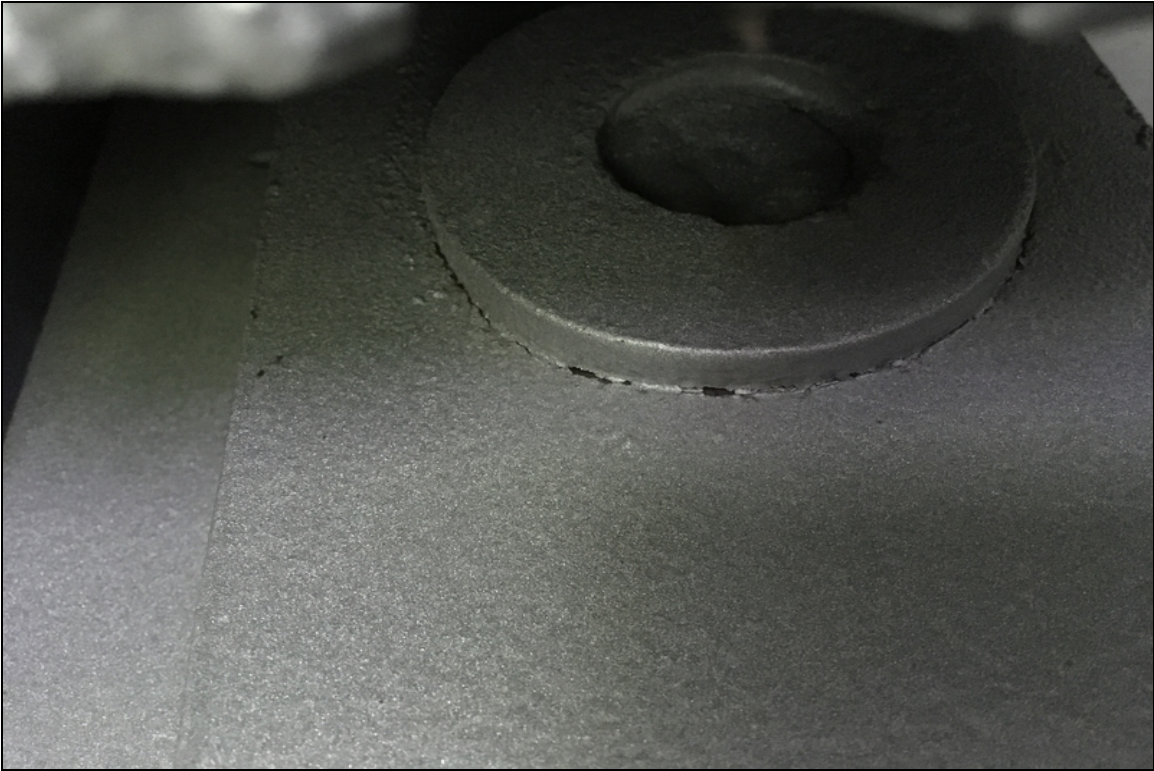
Span 14, Girder 2, Top Pin: Retaining washer weld fractured.

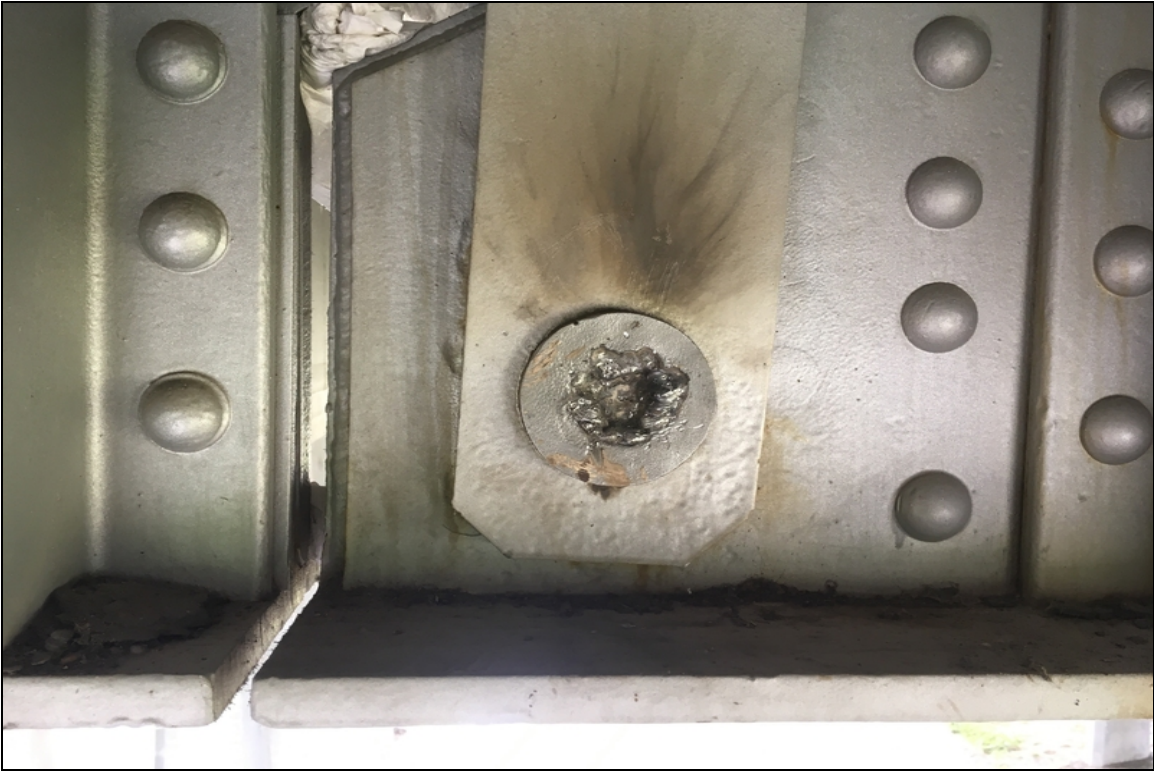
Span 4, Girder 2, Bottom Pin: Repaired.

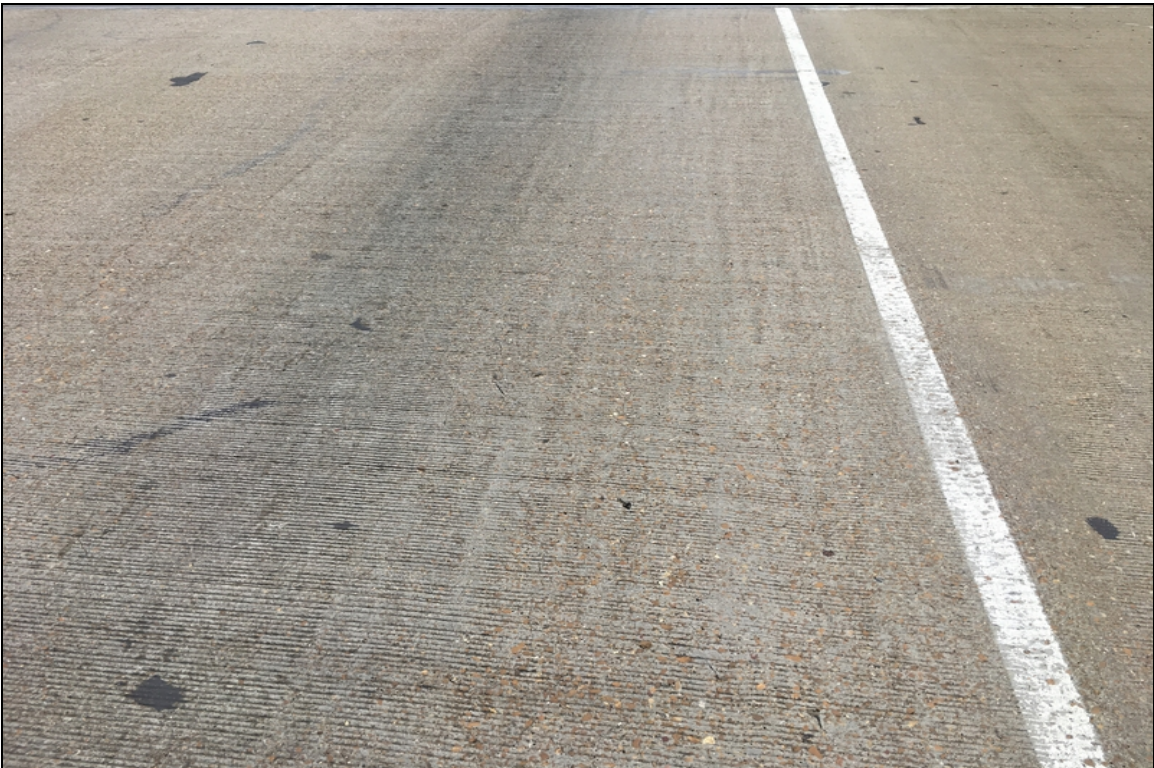
Sealable deck cracking.

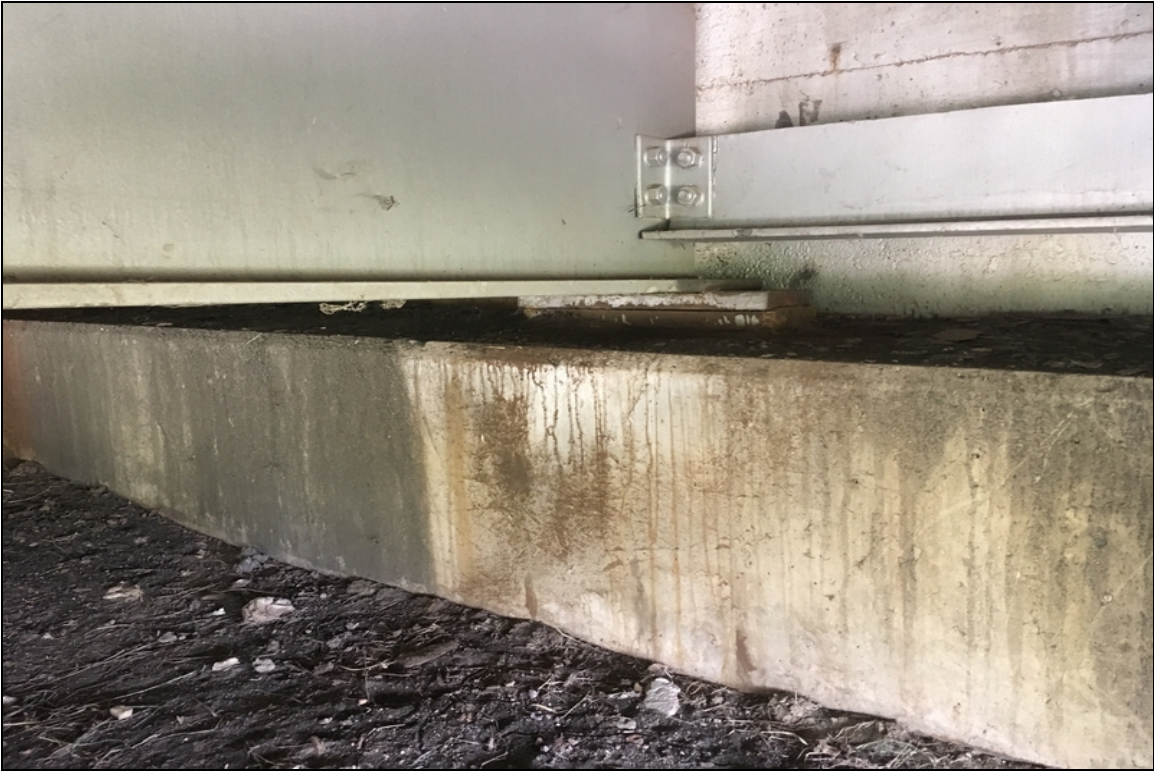
Bent 1, Girder 3 & 4, Bearings: Floating

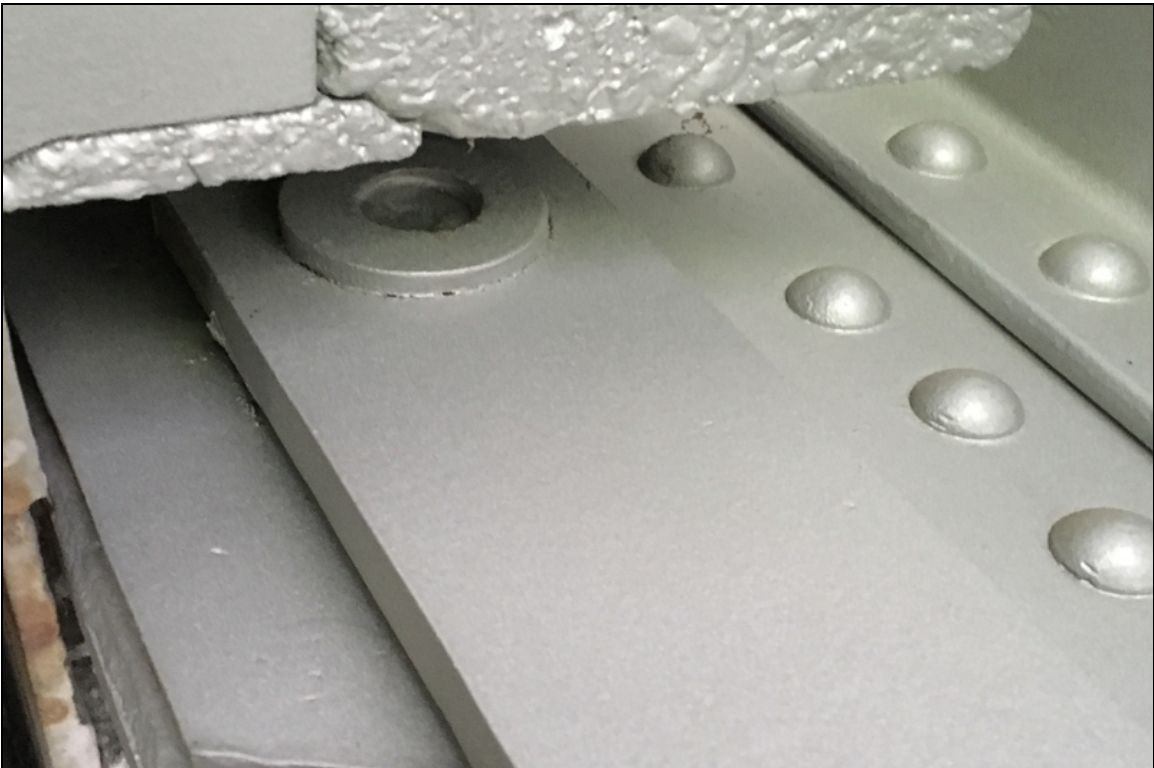
Span 14, Girder 2, Top Pin: Retaining washer weld fractured.

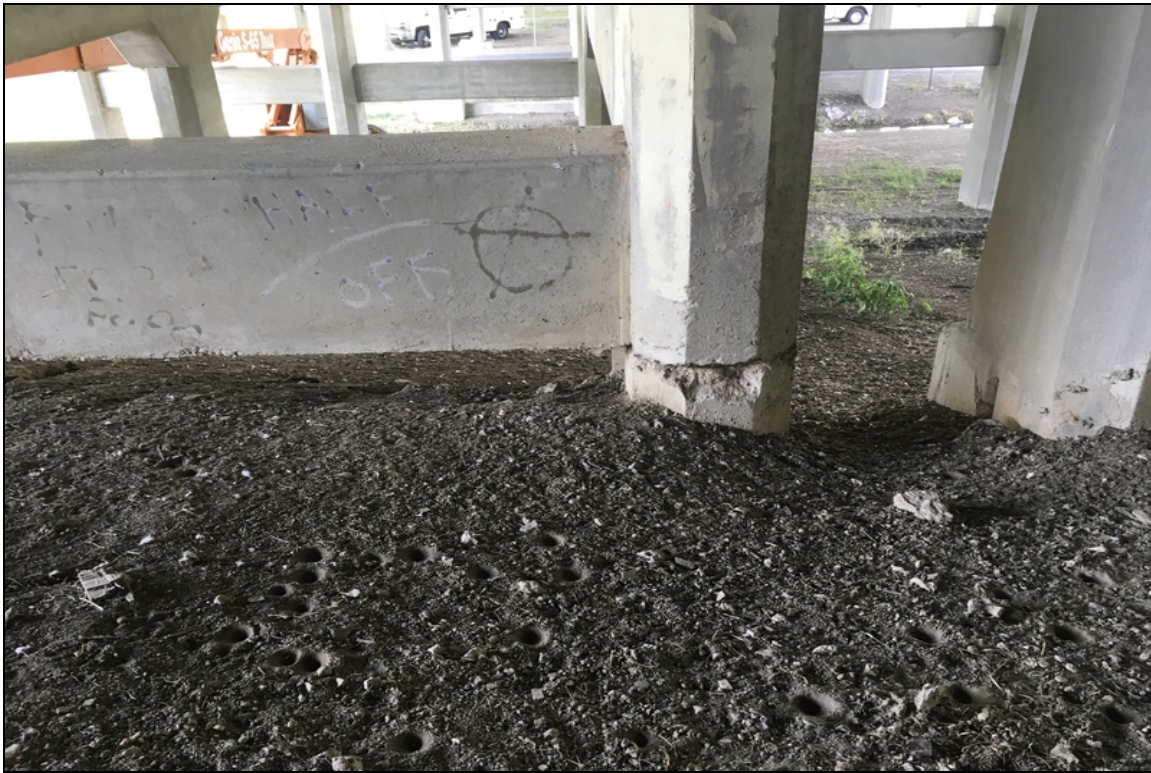
Bent 2, Column 4: Spalling with exposed reinforcing steel.

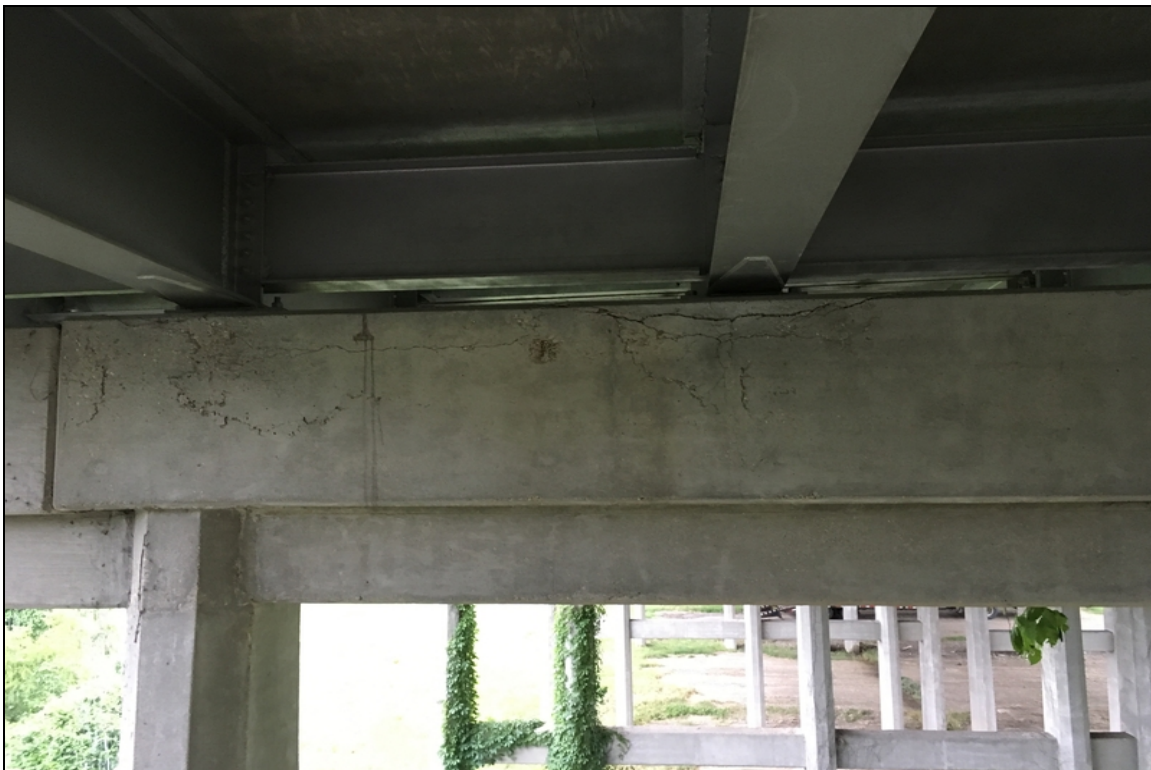
Bent 15, Girder 3, Cap: Cracking.
