Bridge #A2671 (Routine)
I - 55 SO BND LNS over FLETCHER RD/I55 FR/UP RR
Location: .30 MI N JCT I-40
Team Lead: Rhett Franks Inspection Date: June 03, 2019

IDENTIFICATION	
(1) State Names	Arkansas
(8) Structure Number	A2671
(5) Inventory Route	55
(2) Highway Agency District	01
(3) County Code	35-Crittenden County, Arkansas

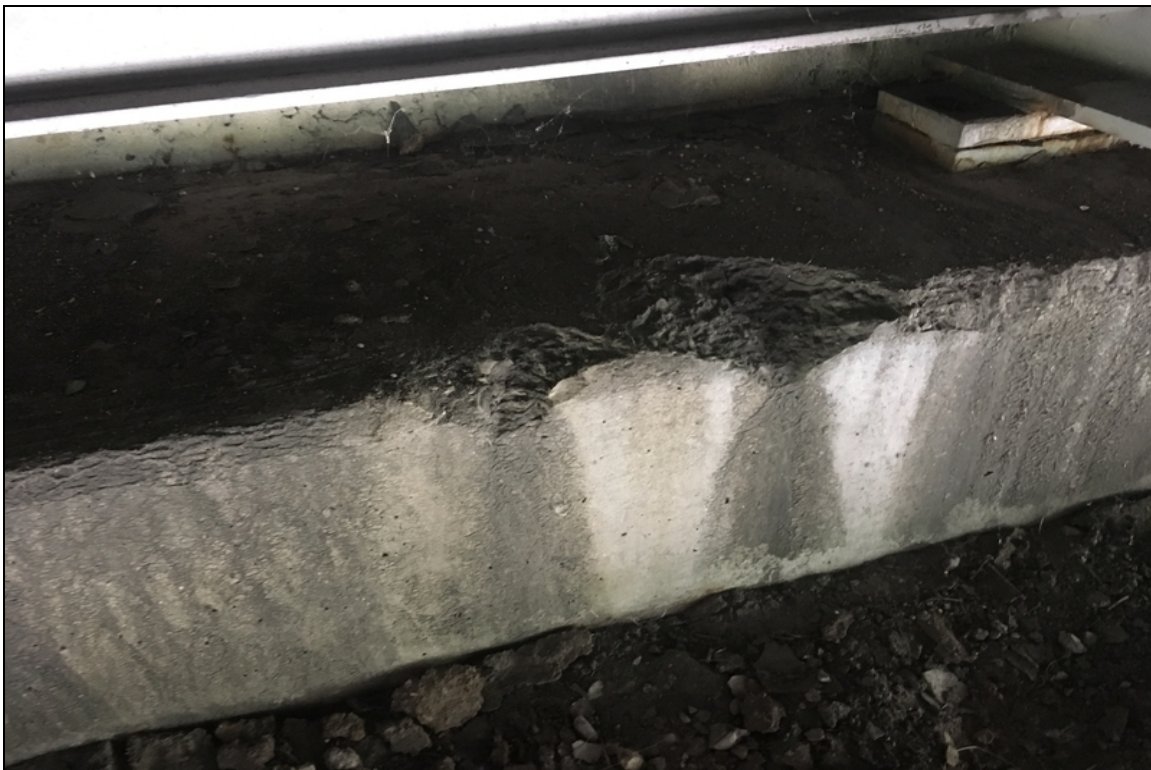
Bent 1: Spalling.

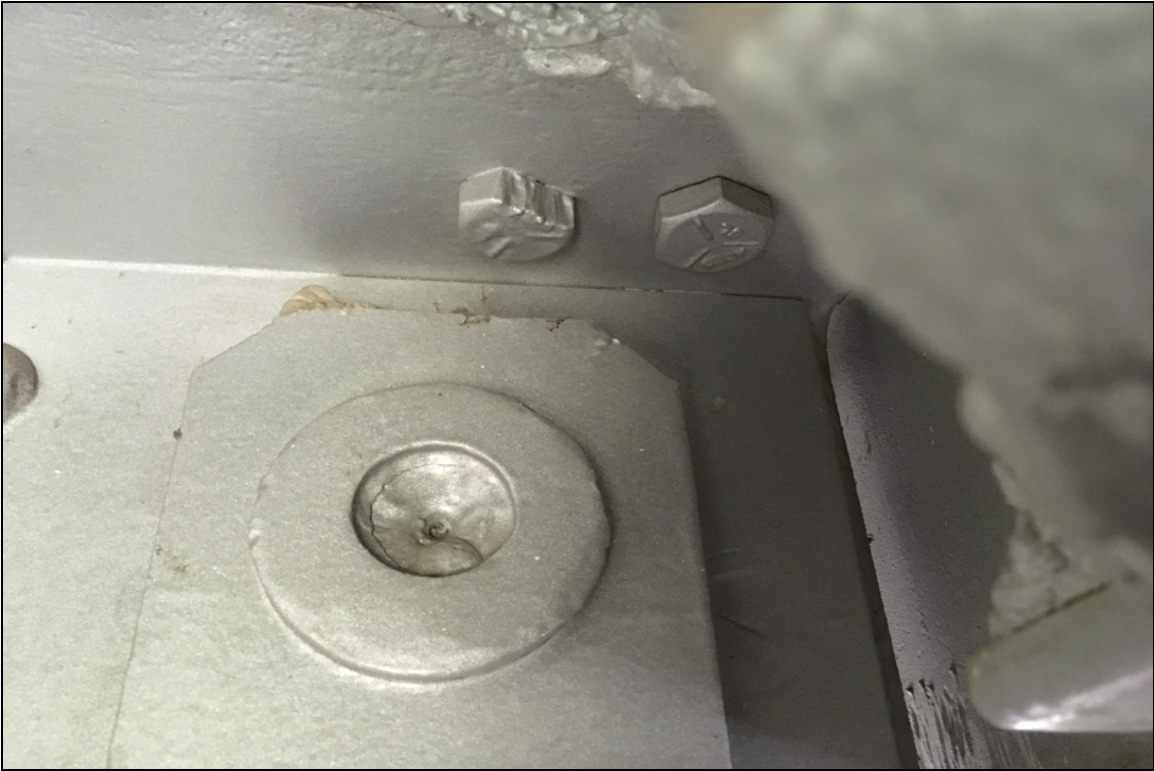
Span 6, Girder 2, Top Pin: Retaining washer weld fractured.

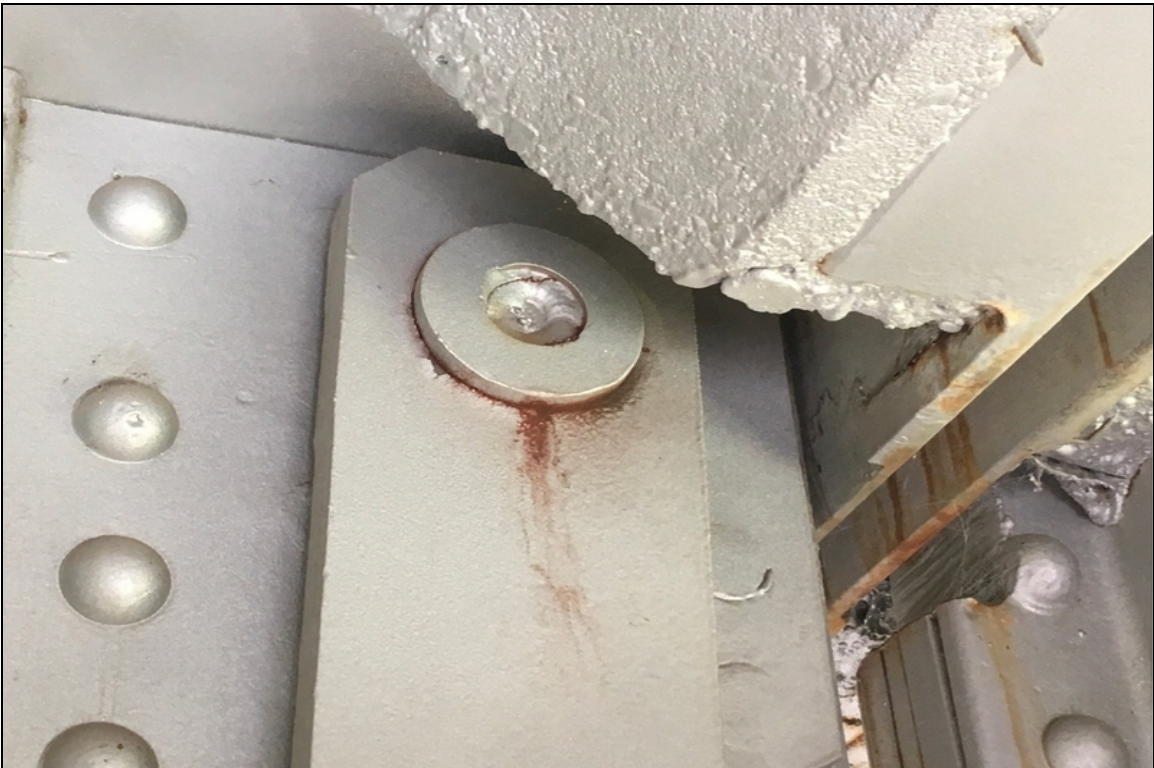
Span 4, Girder 3, Top Pin: Retaining washer weld fractured.

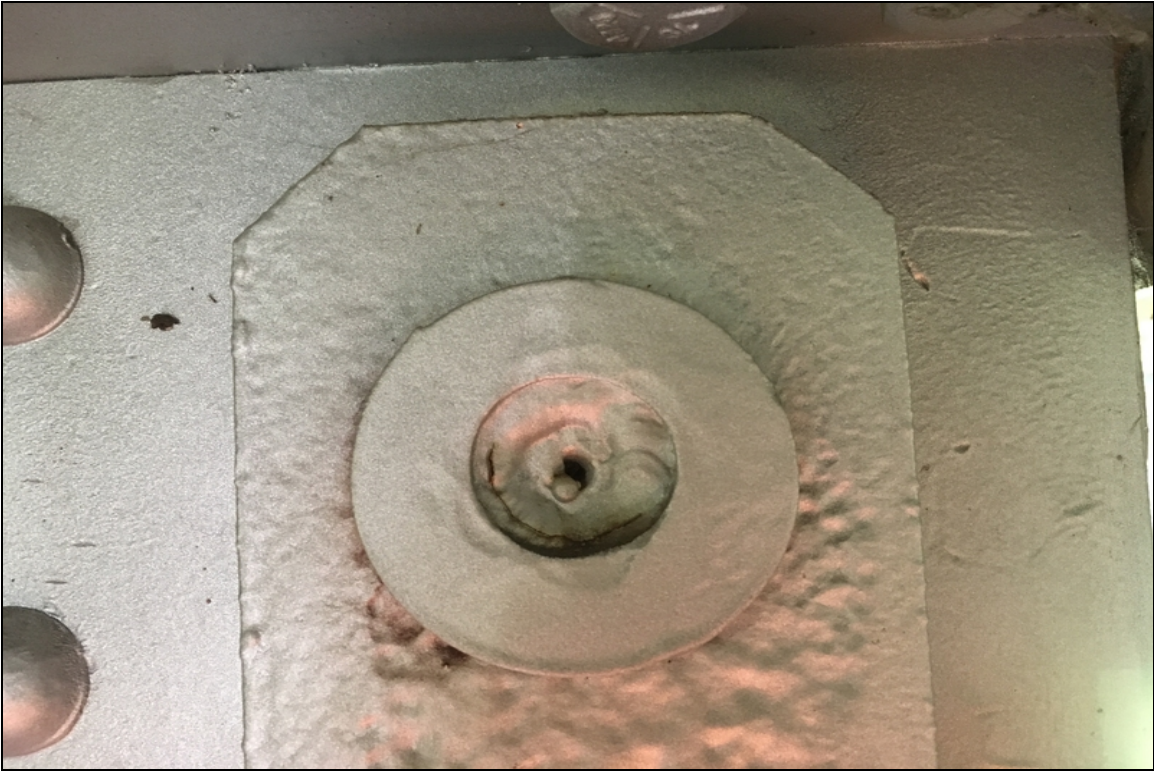
Span 20, Girder 6, Top Pin: Retaining washer weld fractured.

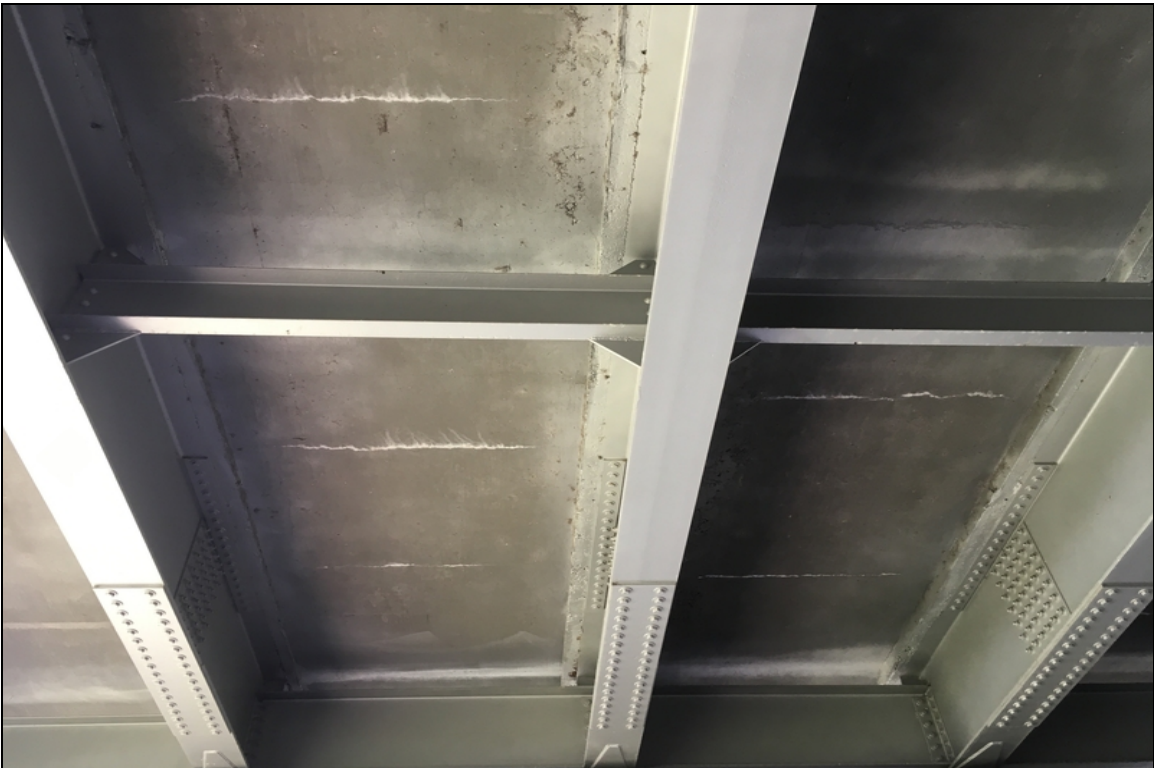
Typical efflorescence in the undersurface.

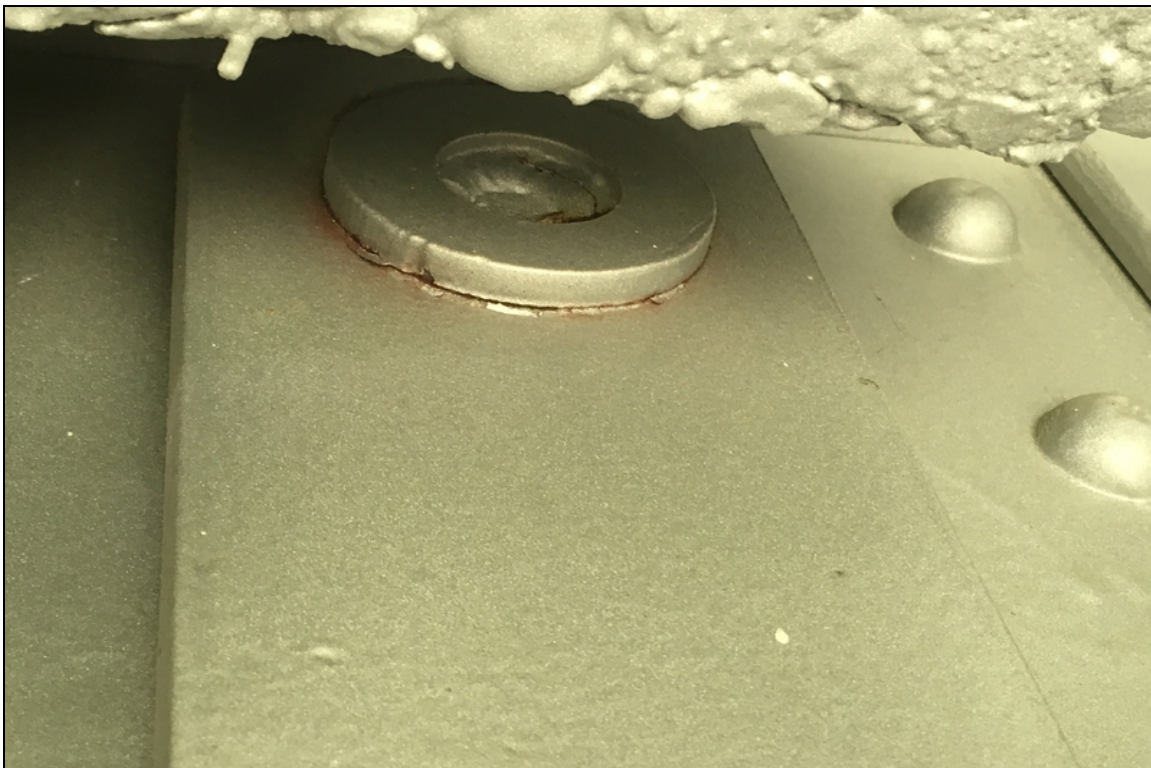
Span 17, Girder 2, Top Pin: Retaining washer weld fractured.

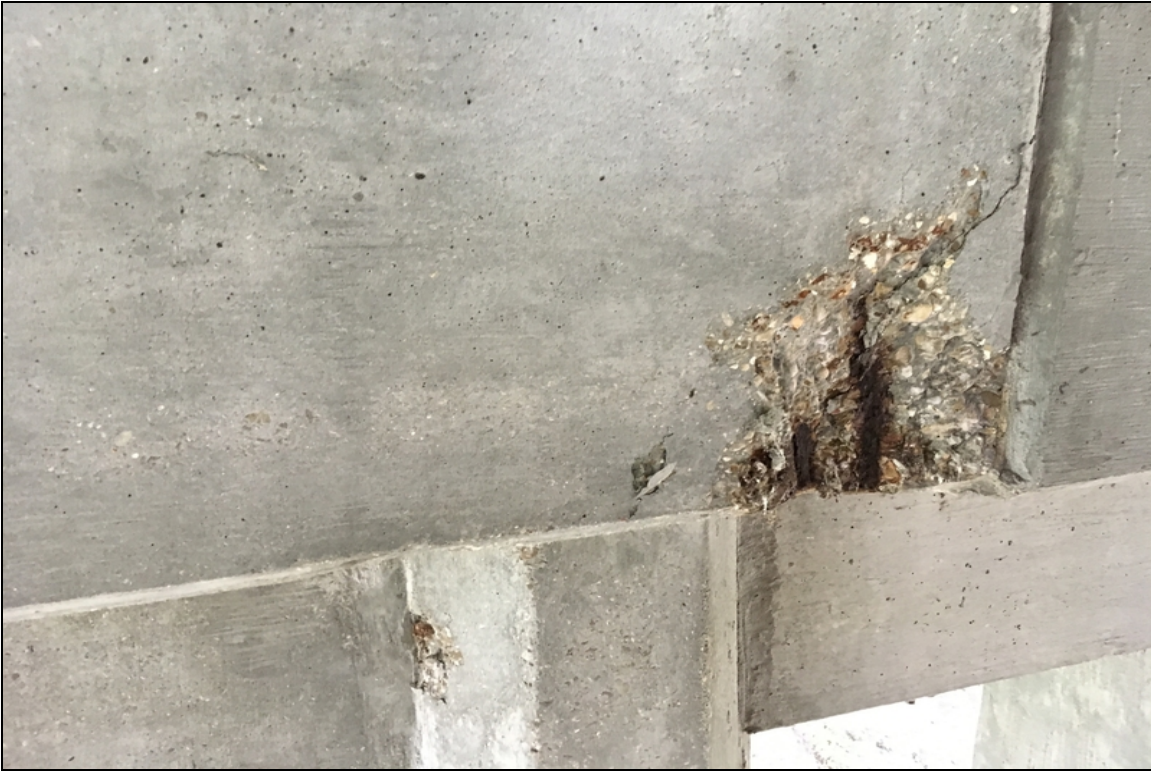
Bent 15, Girder 6, Cap: Spalling.

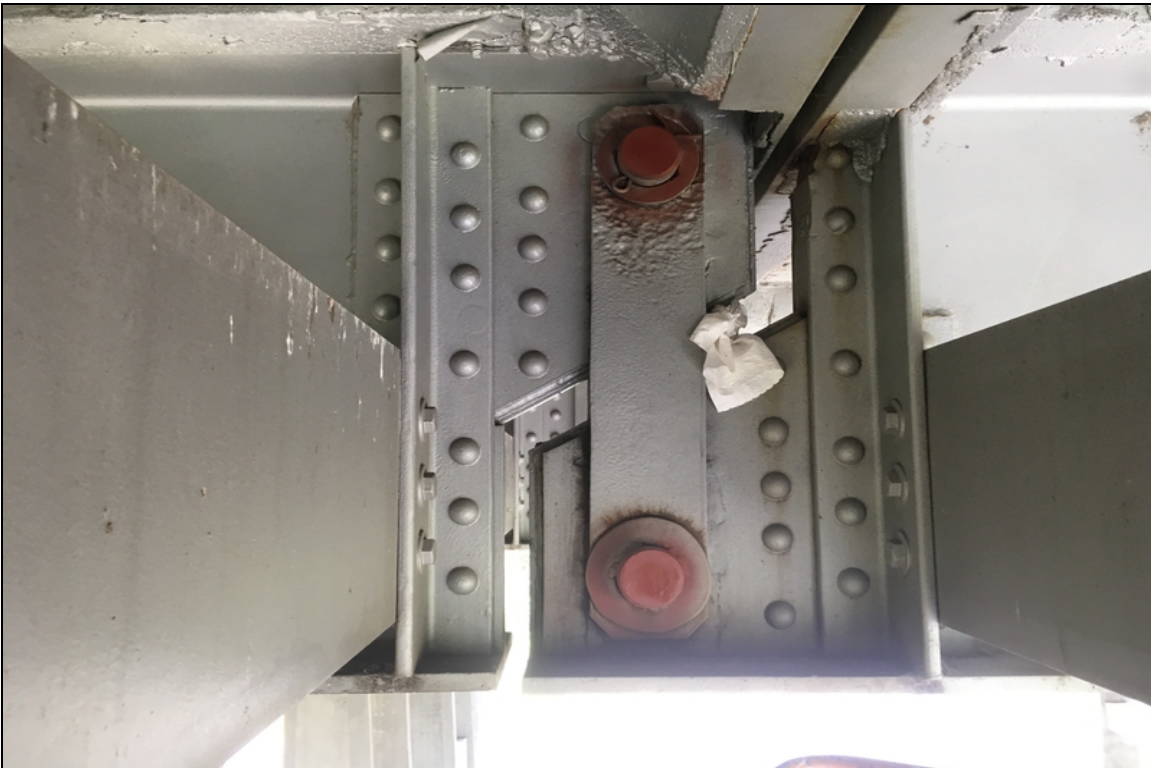
Span 5, Girder 5, Pin & Hanger: Floating.

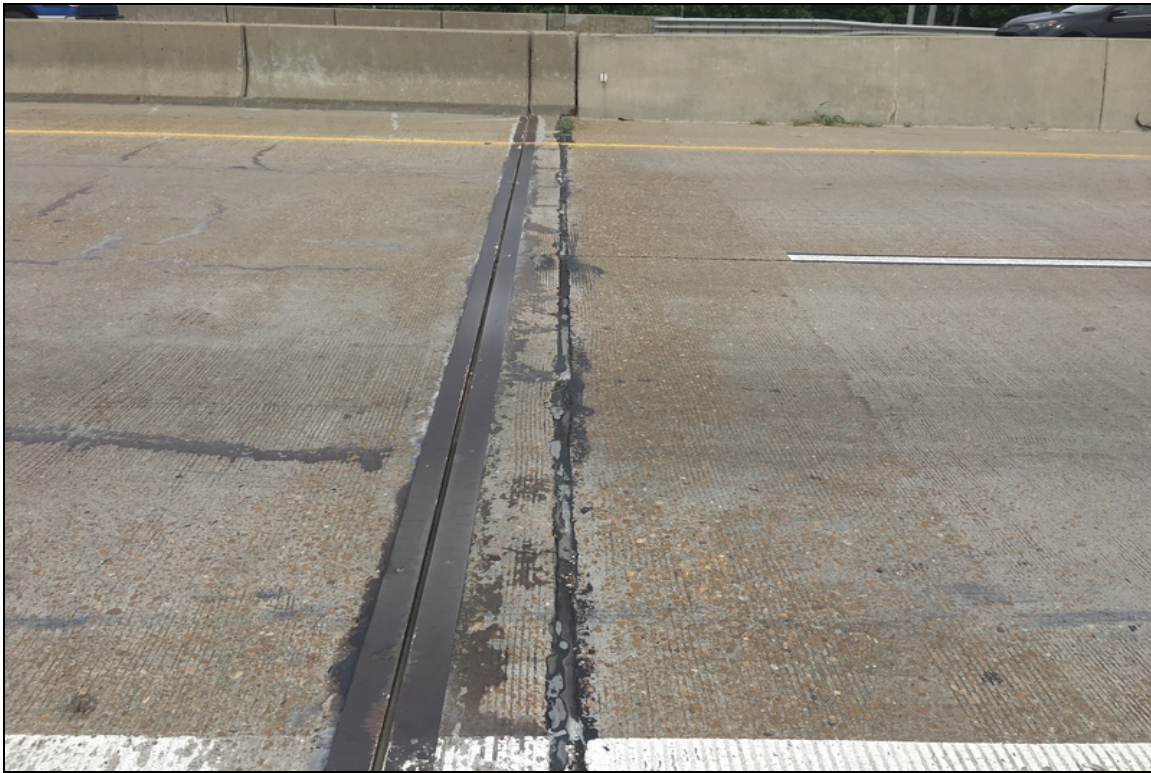
Bent 1, Back Wall: Minor spalling.

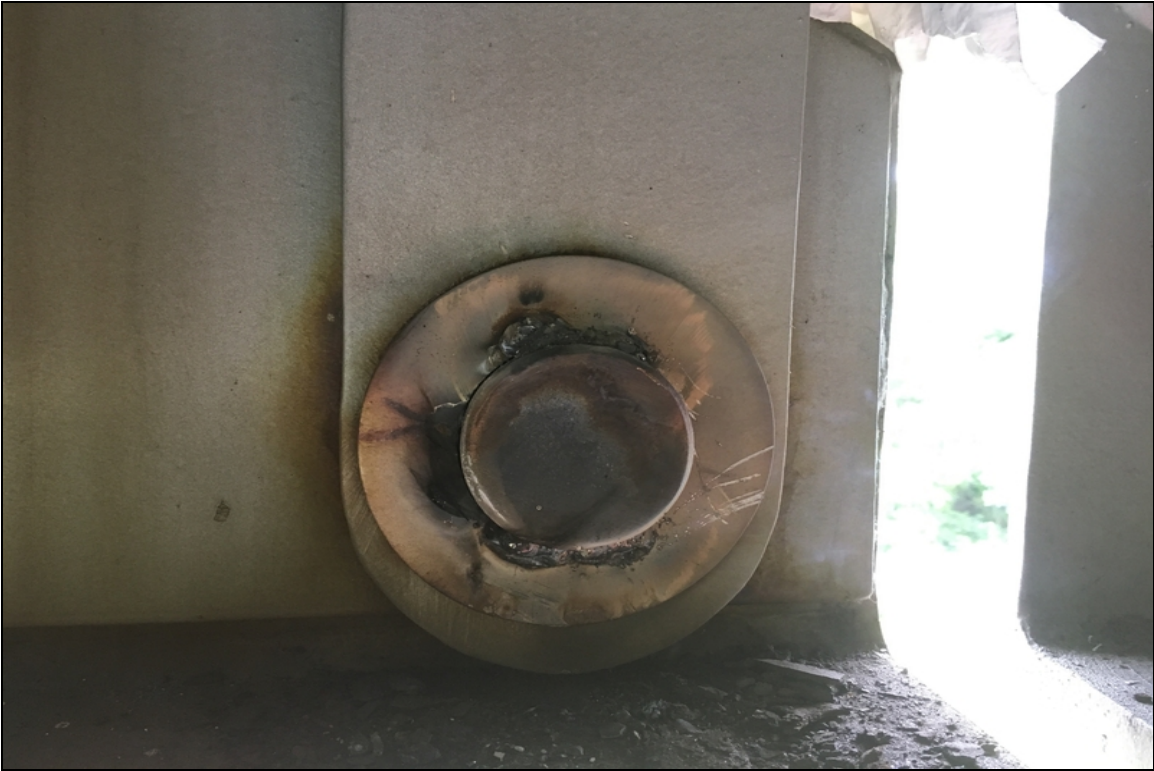
Span 6, Girder 1, Bottom Pin: Repaired.

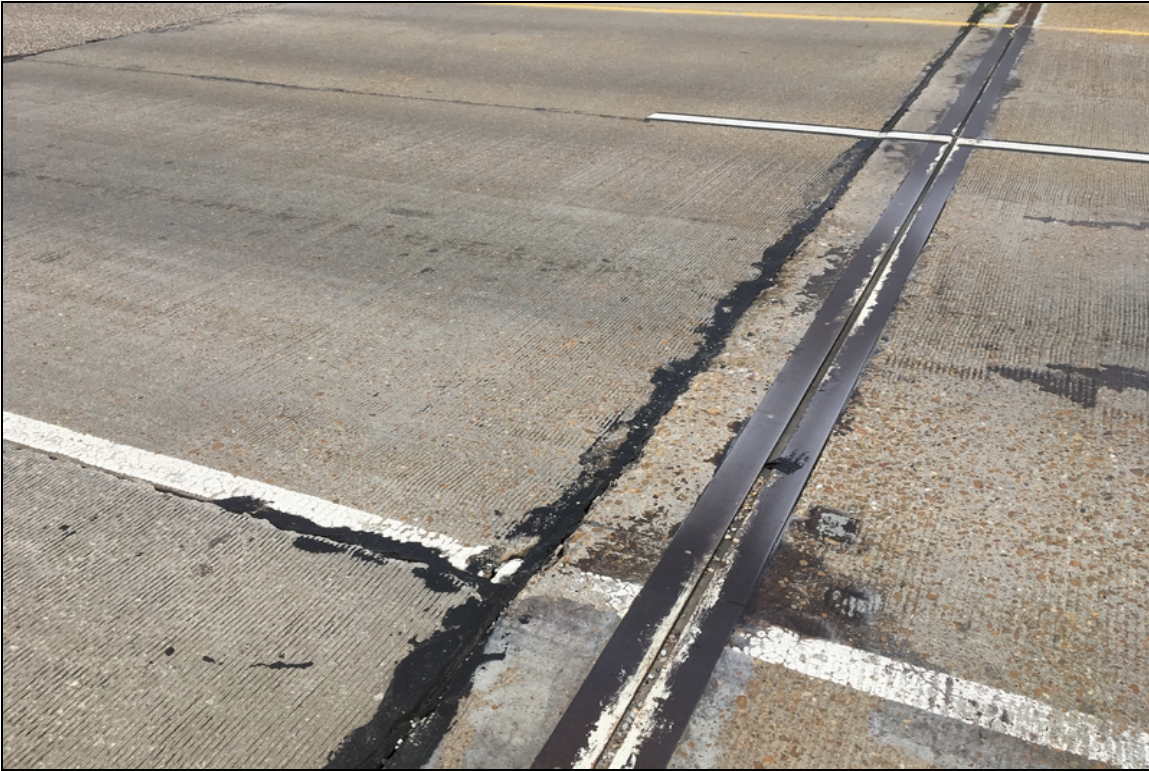
Approach 2: Settlement.

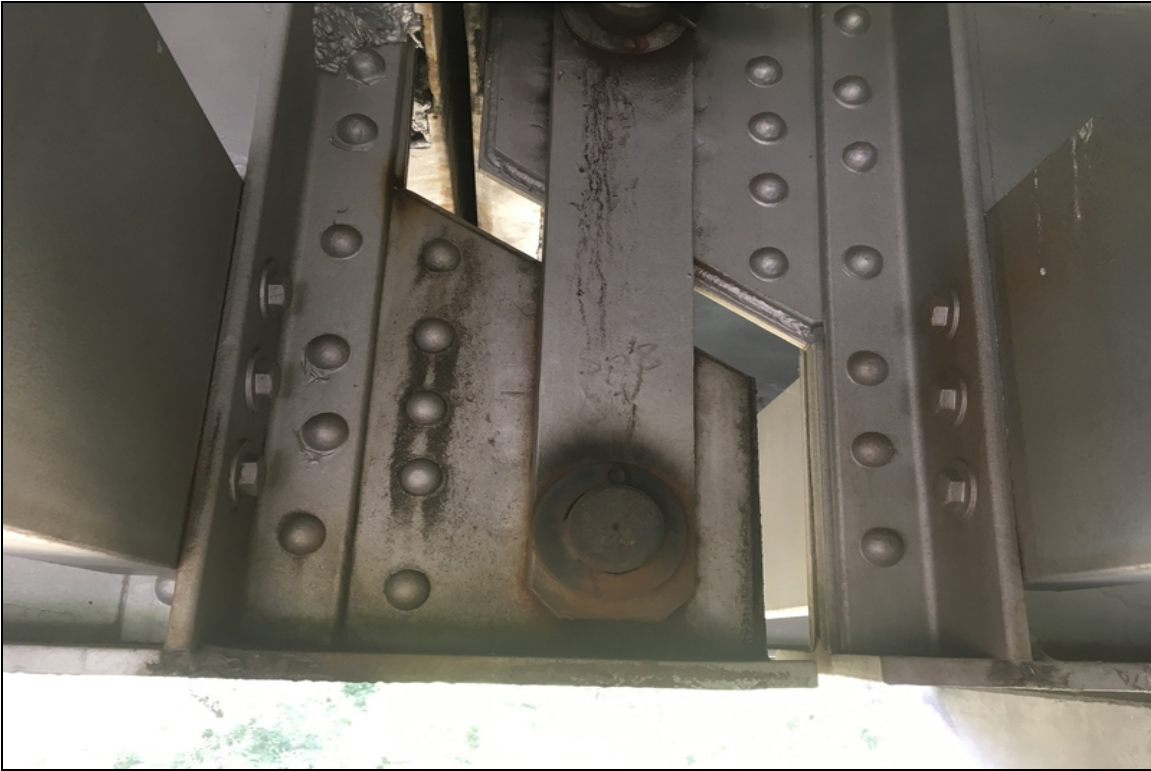
Span 8, Girder 3, Pin & Hanger: Floating.

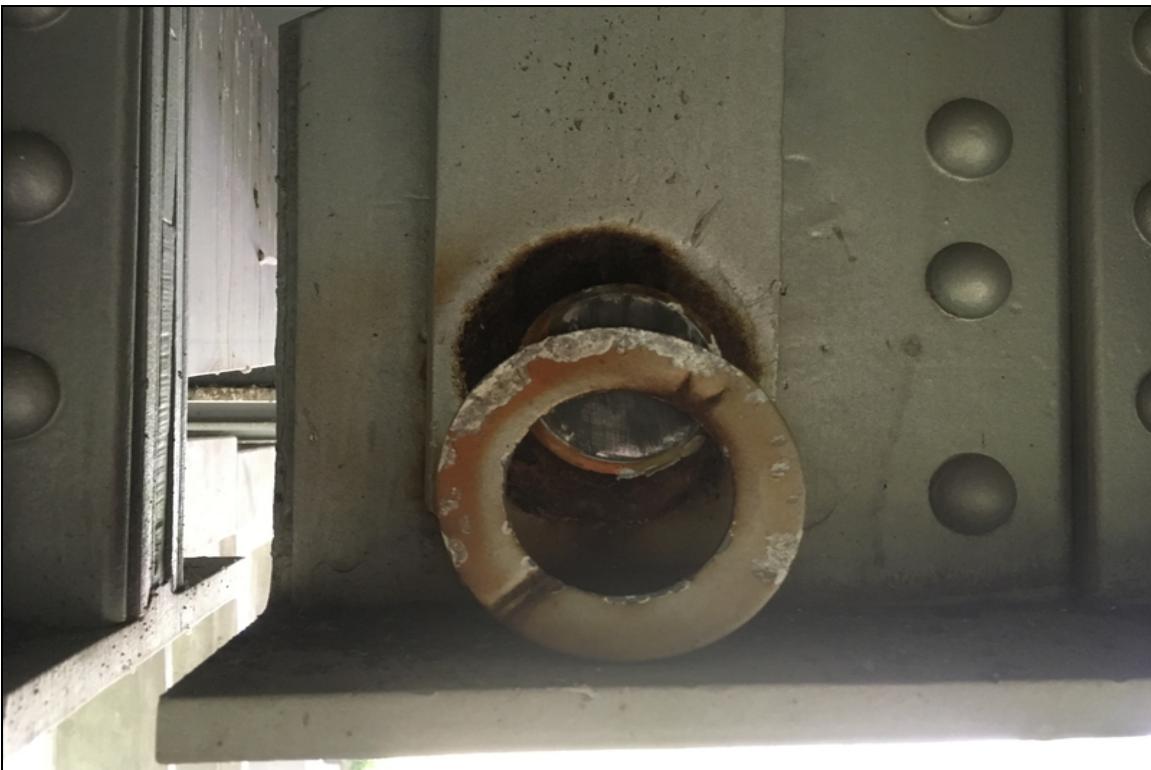
Span 10, Girder 6, Bottom Pin: Keeper missing. Washer loose.

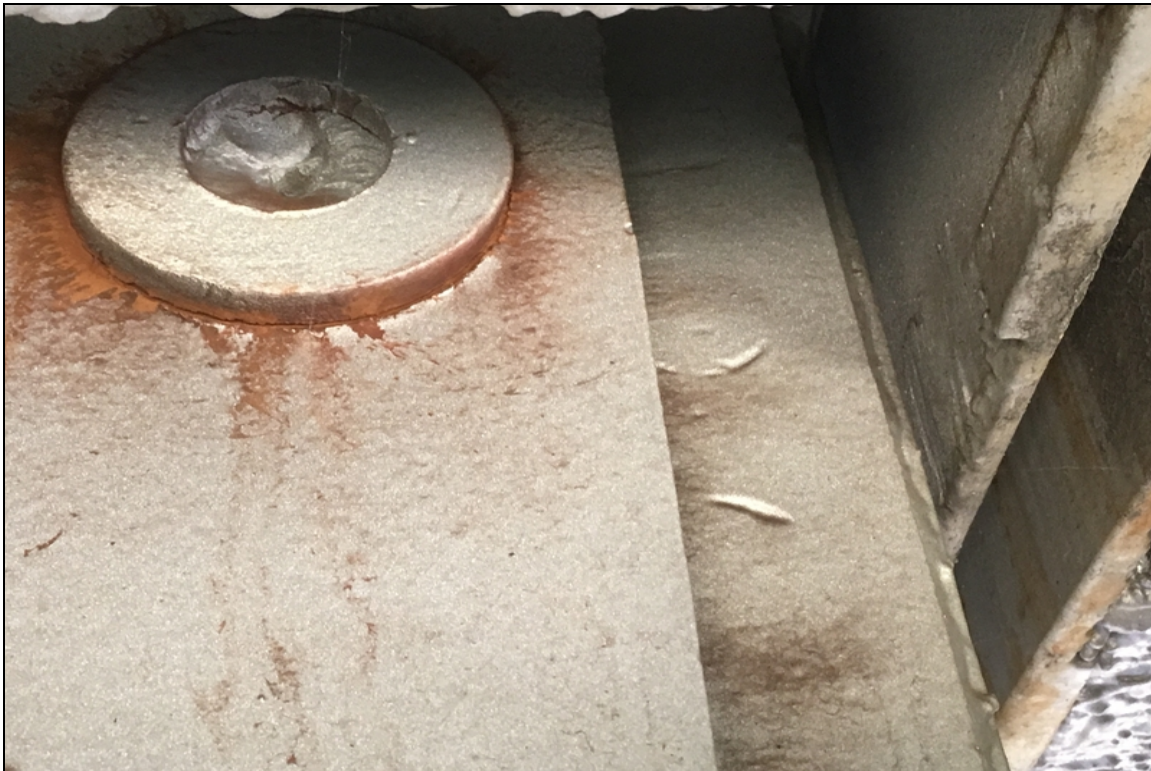
Span 8, Girder 3, Top Pin: Retaining washer weld fractured.

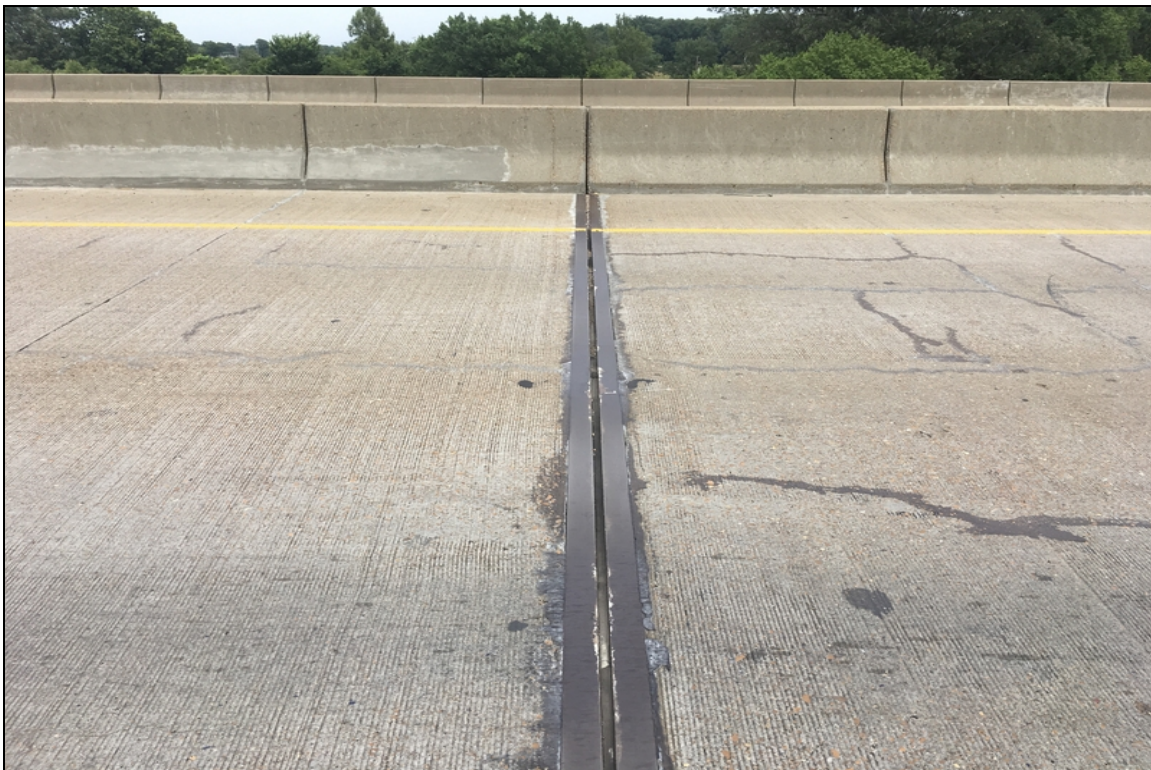
Span 4, Pourable Joint: Sag with minor leakage

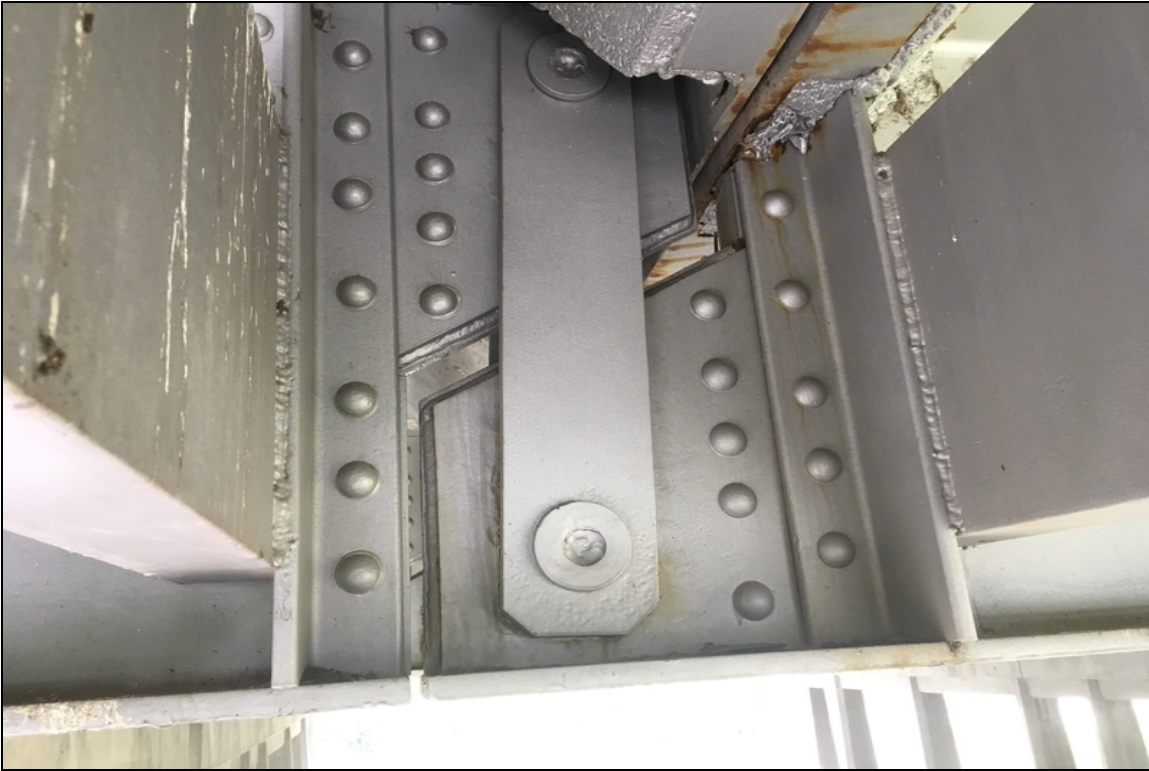
Span 4, Girder 2, Pin: Retaining washer weld fractured.

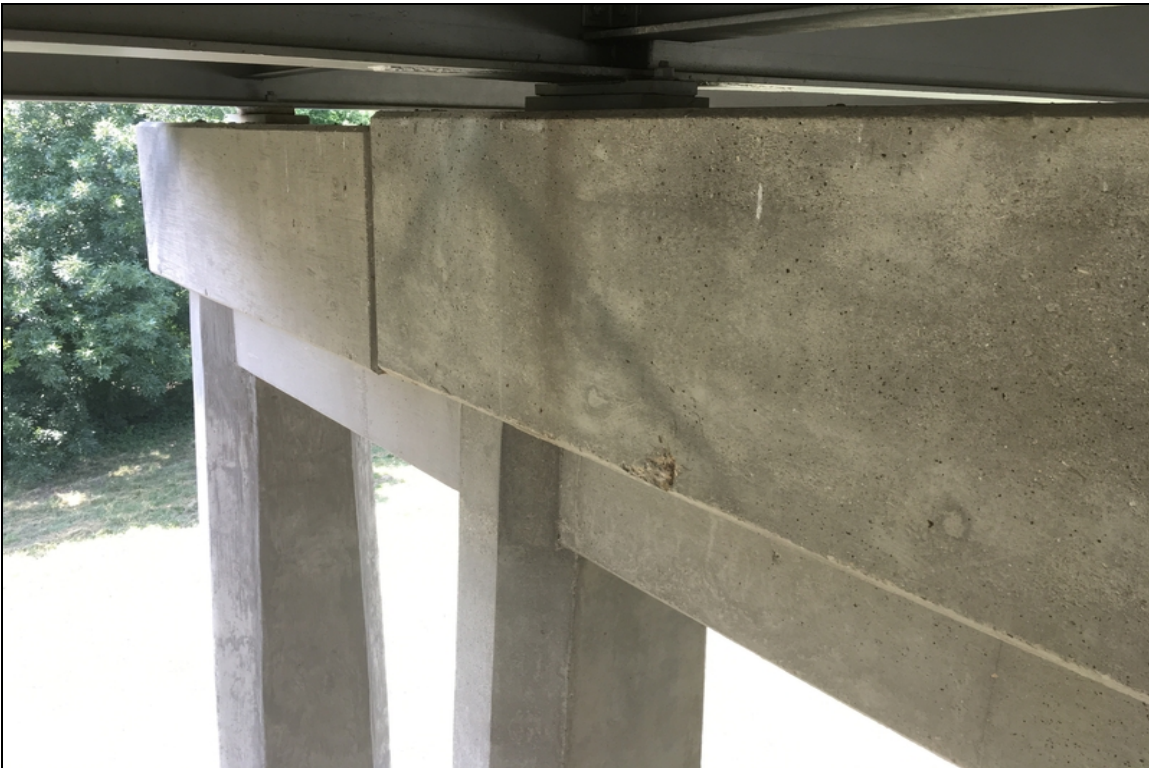
Bent 8, Cap: Minor spalling with exposed reinforcing steel.
