Bridge #A2808(Routine)

I-55SO/Sec11/12.68 over 15 Mile Bayou

Location: 2.5 Mi N Of Marion, Ark

Team Lead: Drew Melton Inspection Date: April 13, 2020

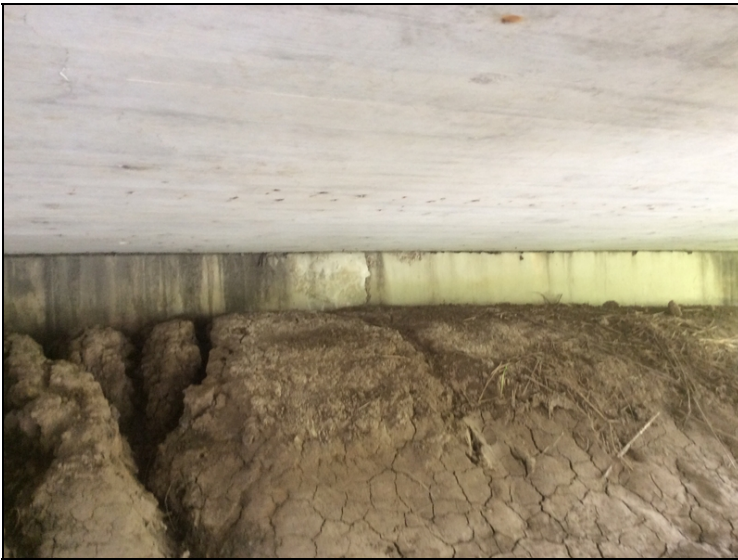
Date Reported: 04/18/2012
Priority: D- Routine
Type of Work: Repair
Status: Monitor
Component: 215 - Reinforced Concrete Abutment

Abutment #2 has open vertical crack 1" wide x 9" deep for full height & 1' spall on right side of crack.

Abutment 2 cap

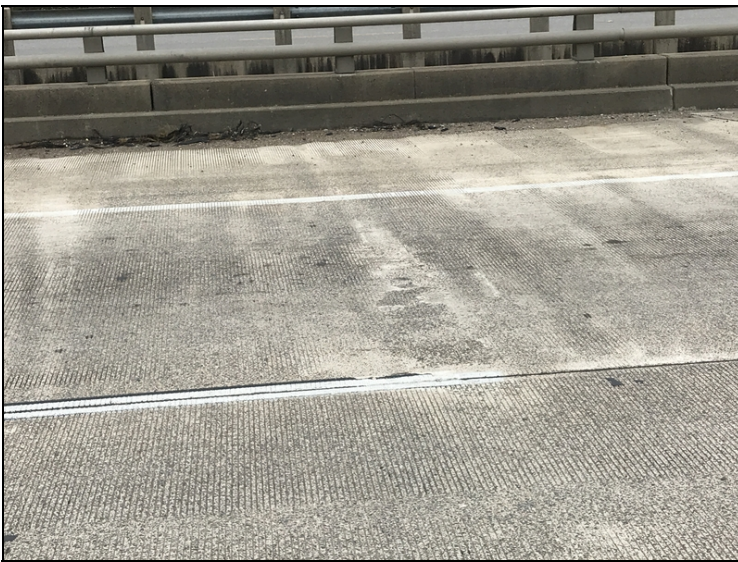
Type of Work: Clean

Gutters are full of dirt and debris.

Typical debris in gutter.
