Bridge #A2809 (Routine)

I-55SO/Sec11/20.55 over Big Creek

Location: 1.0 Mile South Of Sh 42

Team Lead: Drew Melton Inspection Date: April 13, 2020

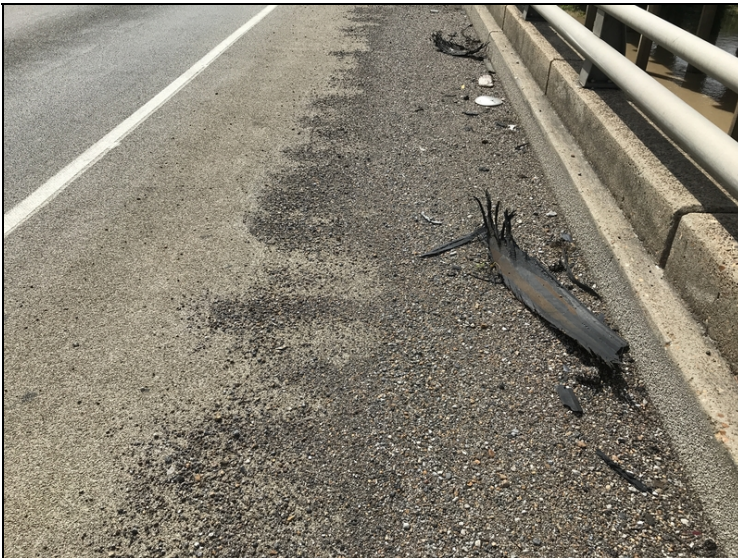
Gutters have dirt, debris.

Typical deck debris in gutters

Date Reported: 04/21/2014
Priority: C - Important
Type of Work: Clean
Status: Monitor
Component: Deck

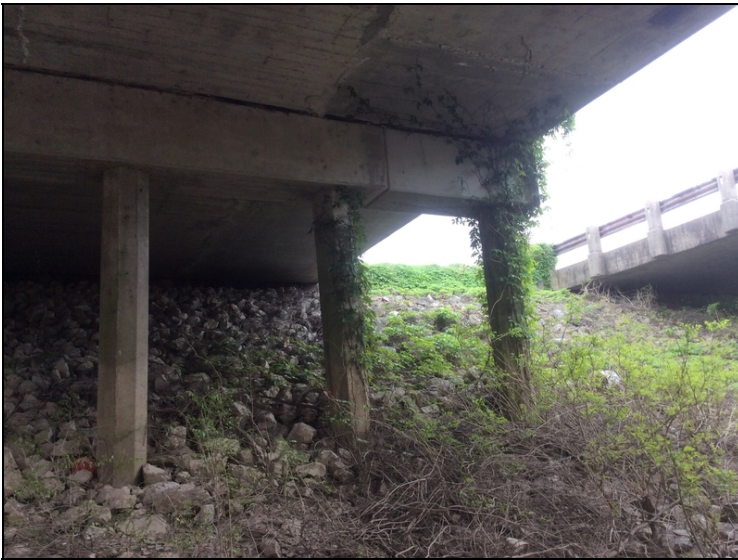
Vegetation is growing under and beside bridge and onto bridge.

Bent 2 pile 1,2 has vines growing on them onto the soffit.

Date Reported: 04/19/2016
Priority: C - Important
Type of Work: Clean
Status: Monitor
Component: Channel

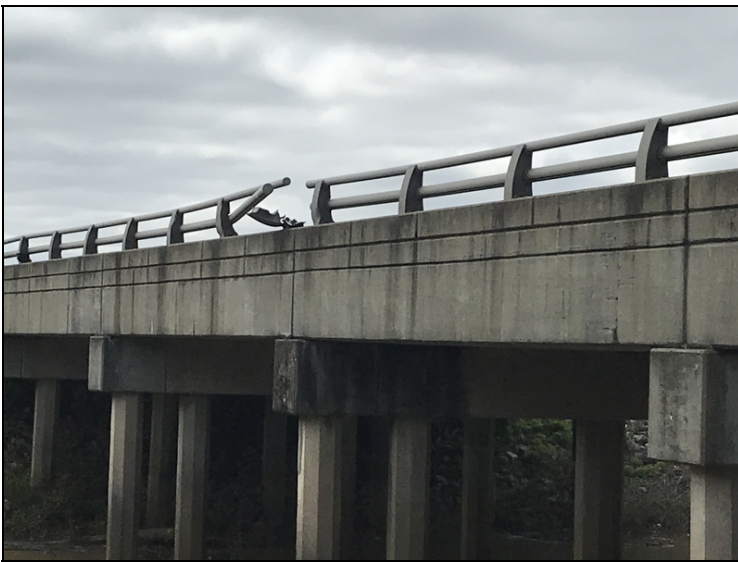
(301)							
Joints are covered with epoxy overlay.							
330	Metal Bridge Railing	LF	324	308	6	0	10
1900	Distortion	LF	16	0	6	0	10
(330)							
Span #2 right side top of rail has minor collision damage. Span #3 right rail has collision damage destroying our post and bending rail.							
331	Reinforced Concrete Bridge Railing	LF	324	162	162	0	0
1120	Efflorescence/Rust Staining	LF	162	0	162	0	0

Span #3 right rail has collision damage destroying our post and bending rail.

Date Reported: 04/13/2020
Priority: C - Important
Type of Work: Replace
Status: Open
Component: 330 - Metal Bridge Railing

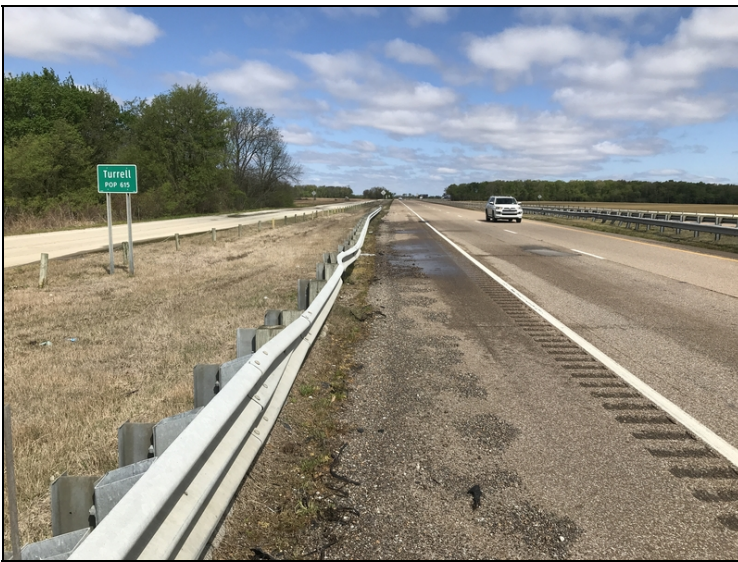
Abutment #2 both approach rails have moderate collision damage.

Abutment #2 left approach rail

Date Reported: 04/14/2020
Priority: C - Important
Type of Work: Repair
Status: Open
Component: Approach

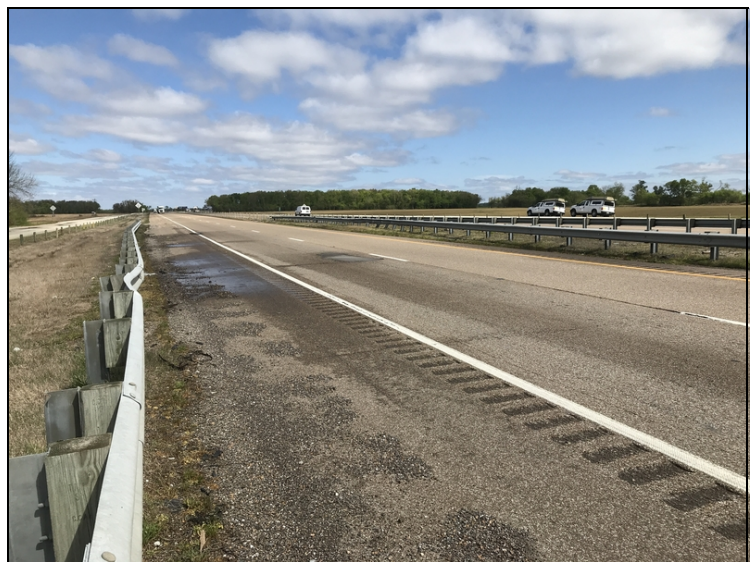
Abutment #2 right approach rail
