**Bridge #A2810(Routine, Underwater type 2)**

**I-55SO/Sec11/22.26 over Dry Bayou**

**Location: .70 Mi No Jct Sh 42 & 55**

**Team Lead: Drew Melton Inspection Date: April 08, 2020**

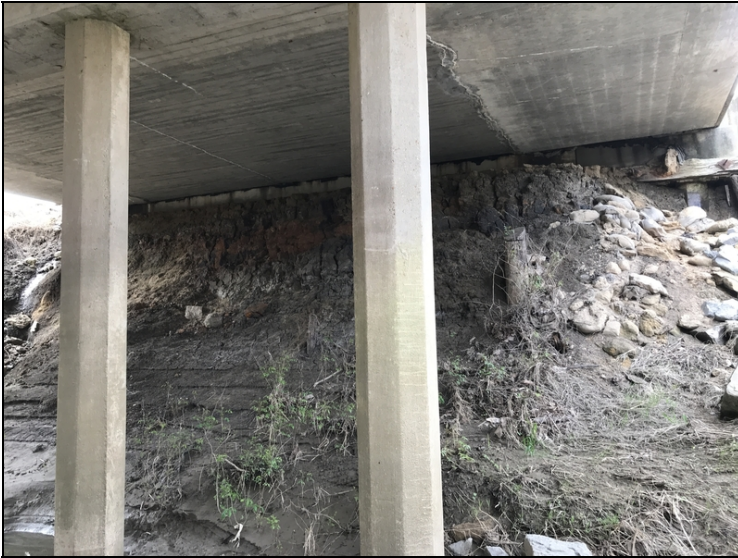
Abutment #1 slope is eroded to vertical face eight feet from cap in center and to cap on each side.

Abutment #1 slope

04-08-2020 lowered substructure rom 7 to 6 due to erosion.

**Date Reported:** 04/10/2012  
**Priority:** B - Pressing; 6 month completion goal  
**Type of Work:** Repair  
**Status:** Open  
**Component:** Channel

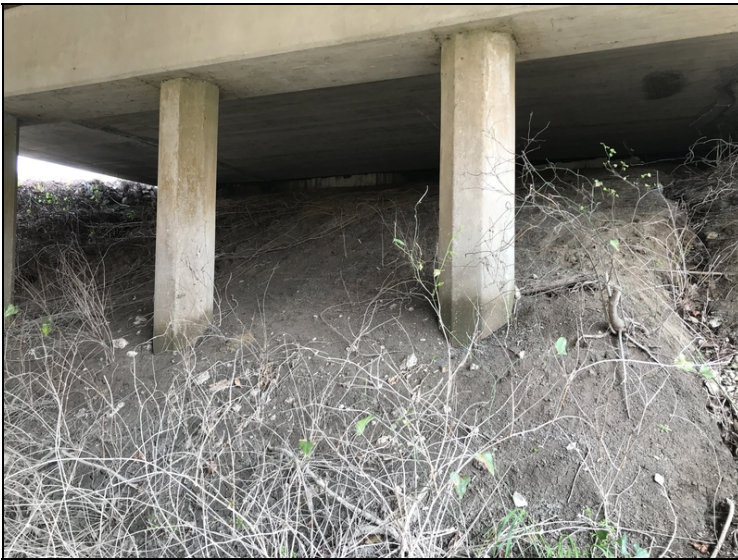
Abutment #2 slope is eroded between pile #2,3 and pile #5,6 with depths up to two feet extending down slope.

Abutment #2 slope erosion

**Date Reported:** 04/08/2020

**Priority:** D- Routine

**Type of Work:** Repair
