Bridge #A3131(Record Change)

I-55SO/Sec11/10.16 over Us-64/Sec-17/L-19.12

Location: Jct Us 64 & I-55

Team Lead: Drew Melton Inspection Date: September 14, 2020

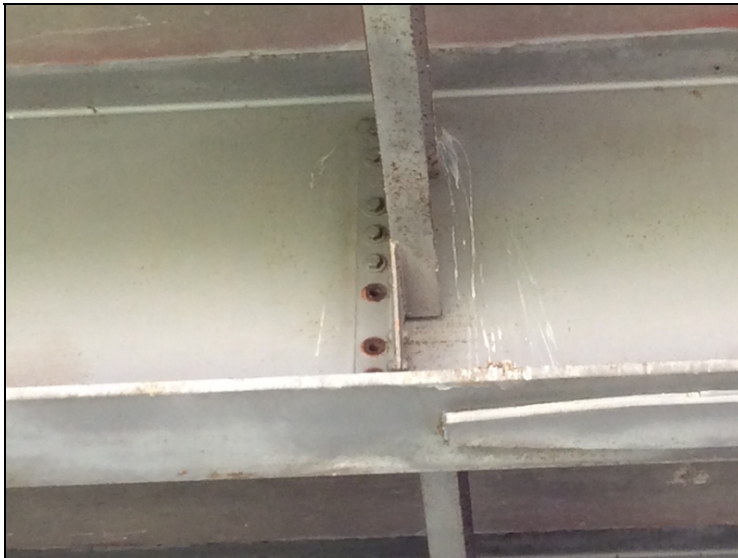
(107)							
Girders have areas of surface rust on web and bottom chord for full length rest of paint has limited effectiveness. Span #1 girder #4 first diaphragm connection has lower 2 bolts missing. Span #3 girder #5 last diaphragm connection has lower bolt missing. Span #4 girder #1 has collision damage from traffic. Span #6 between girder #2 & 3 top bolt is broken in next to last diaphragm. Span #7 between girder #1 & 2 middle diaphragm connection top bolt broken & second bolt missing. All girders have been scraped over roadway with minor damage.							
205	Reinforced Concrete Column	EA	24	21	3	0	0
1090	Exposed Rebar	EA	3	0	3	0	0

Span #1 girder #4 first diaphragm connection has lower 2 bolts missing.
Span #3 girder #5 last diaphragm connection has lower bolt missing.
Span #4 girder #1 has collision damage from traffic.
Span #6 between girder #2 & 3 top bolt is broken in next to last diaphragm.
Span #7 between girder #1 & 2 middle diaphragm connection top bolt broken & second bolt missing.

Typical diaphragm bolts missing.

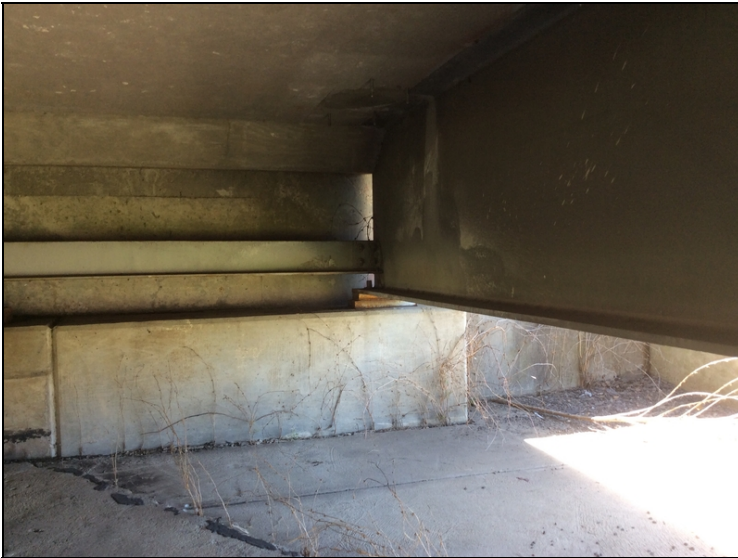
(313)	Bearings have surface rust with little to no section loss Bent #1 girder #1, 2 & 6 have nuts missing from anchor bolts. Bent #8 girder #2, 3, 4, 5 & 6 have nuts missing from anchor bolts.						
321	Reinforced Concrete Approach Slab	SF	960	599	310	51	0
1080	Delamination/Spall/Patched Area	SF	1	0	0	1	0
1130	Cracking (RC and Other)	SF	110	0	60	50	0
1190	Abrasion/Wear (PSC/RC)	SF	250	0	250	0	0

BENT #1 GRD #1, 2 & 6

BENT #8 GRD #2, 3, 4, 5 & 6

GIRDERS HAVE NUTS MISSING FROM ANCHOR BOLTS AT BENT #1 & 8.

Typical bearing nut missing.

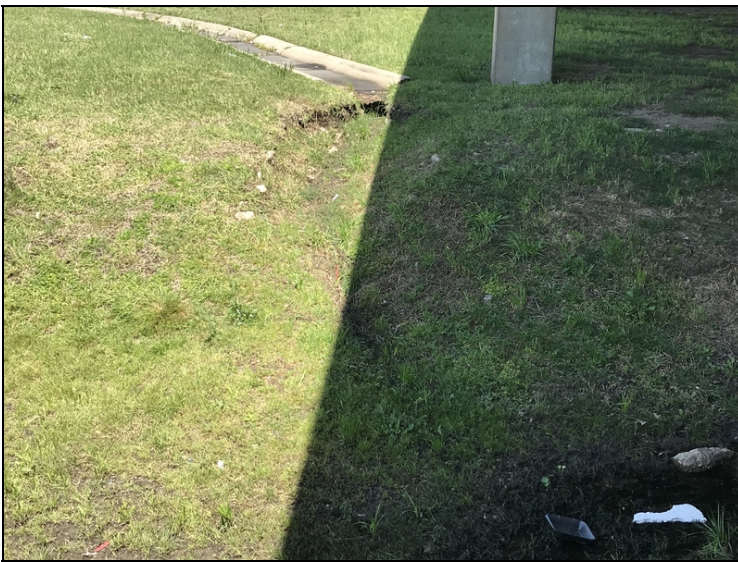
Span #2 left side slope is eroded 1' deep extending down slope.

Span #2 left side slope erosion.

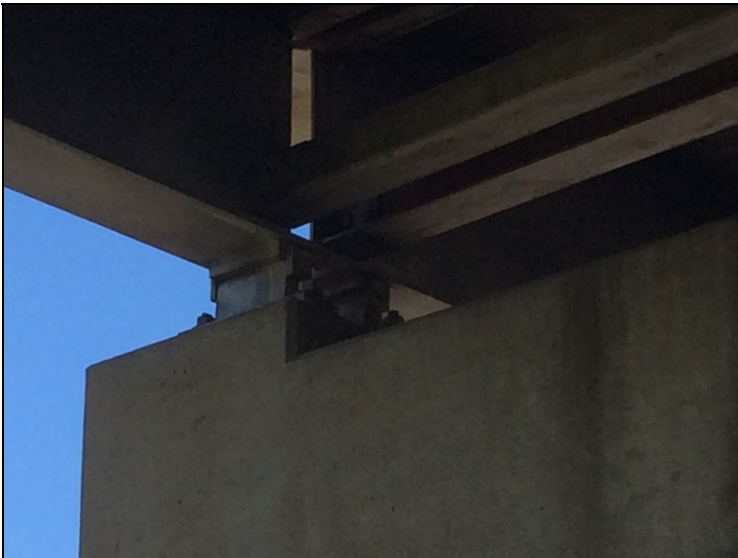
(311)	Span #4 girder #1 at bent #4 girder to bearing bolt is missing on right side Span #7 girder #7 at bent #6 girder to bearing bolt is broken on right side Span #7 girder #1 at bent #6 girder to bearing bolt is backed out on right side. Bearings have surface rust with little to no section loss.						
313	Fixed Bearing	EA	49	0	41	8	0
1000	Corrosion	EA	41	0	41	0	0
1020	Connection	EA	8	0	0	8	0
515	Steel Protective Coating	SF	98	0	0	49	49
3440	Effectiveness (Steel Protective Coatings)	SF	98	0	0	49	49

Bent #1 girder #1, 2 & 6 have nuts missing from anchor bolts.
Span #4 girder #1 at bent #4 girder to bearing bolt is missing on right side
Span #7 girder #7 at bent #6 girder to bearing bolt is broken on right side
Span #7 girder #1 at bent #6 girder to bearing bolt is backed out on right side.
Bent #8 girder #2, 3, 4, 5 & 6 have nuts missing from anchor bolts.

Typical girder to bearing bolt missing.

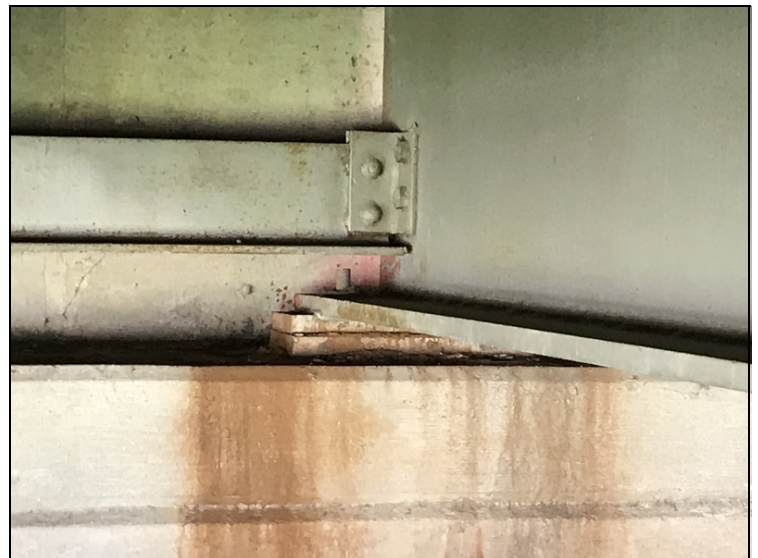
Typical abutment bearing nut missing.

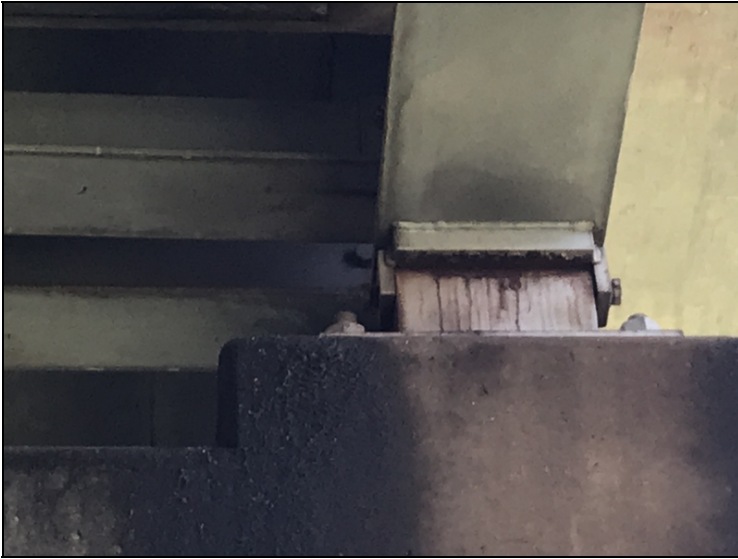
Typical backed out girder to bearing bolt.

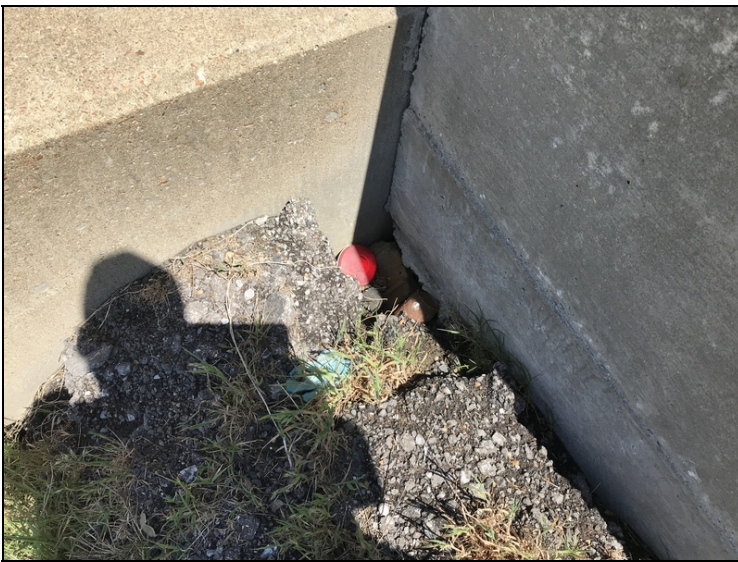
Abutment #1 left approach at bridge end has erosion with small void under approach slab.

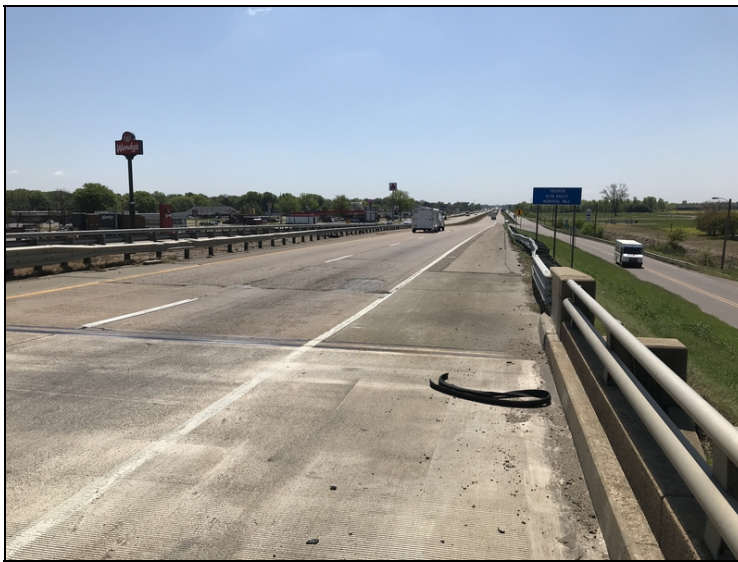
Abutment #1 both approach rails have collision damage.
Abutment #2 right approach rail has collision damage.

Abutment #1 both approach rails have collision damage.

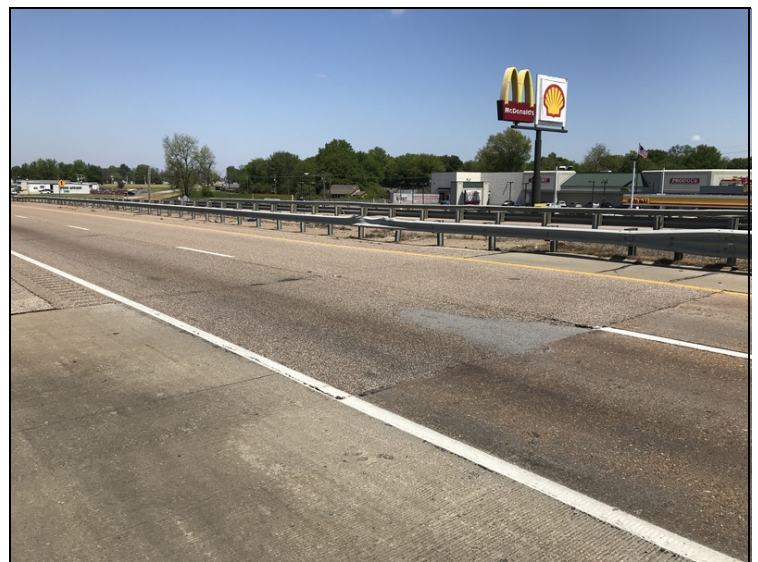
Abutment #2 right approach rail has collision damage.

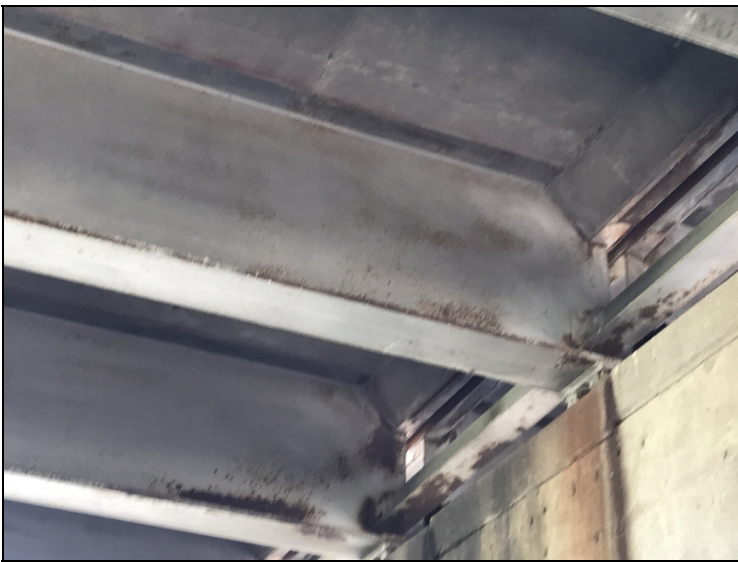
Girders have areas of surface rust on web and bottom chord for full length. The rest of paint has limited effectiveness.

Typical girder ends.

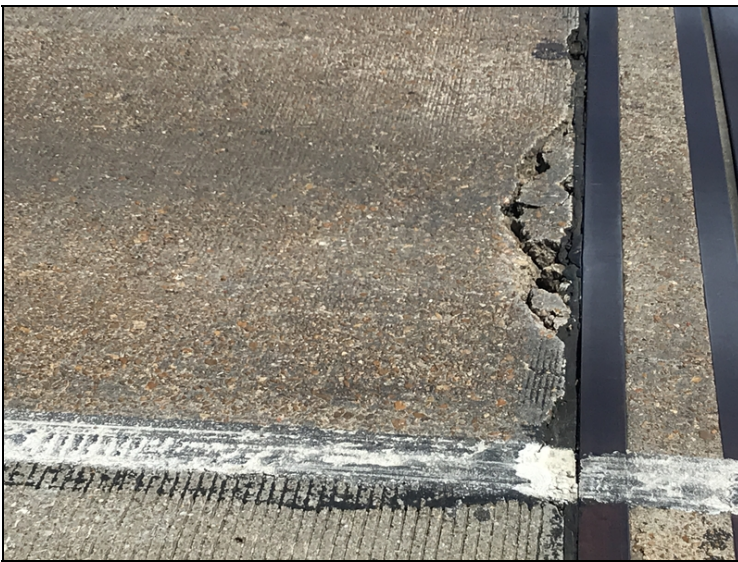
(321)	Approach slabs have cs2 and cs3 longitudinal and transverse cracks. Abutment #2 left lane approach slab has one foot spall at bridge end. Wheel paths have moderate abrasion.						
330	Metal Bridge Railing	LF	980	980	0	0	0
515	Steel Protective Coating	SF	3938	3938	0	0	0
331	Reinforced Concrete Bridge Railing	LF	980	980	0	0	0

Abutment #2 left lane approach slab has one-foot spall at bridge end.

Abutment 2 left lane has 1' spall at bridge end.
