Bridge #B3131 (Record Change)

I-55NB/Se11/L10.15 over Us-64/Sec-17/L-19.11

Location: Jct Us 64 & I-55 @ Marion

Team Lead: Drew Melton Inspection Date: September 14, 2020

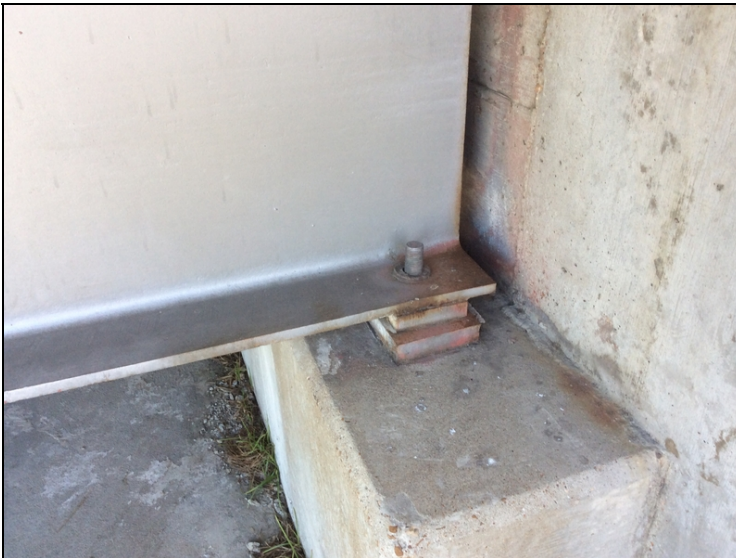
(313)							
Abutment #1 girders #2&7 have anchor nuts missing. Paint has surface rust.							
321	Reinforced Concrete Approach Slab	SF	960	0	920	40	0
1080	Delamination/Spall/Patched Area	SF	30	0	30	0	0
1190	Abrasion/Wear (PSC/RC)	SF	930	0	890	40	0

BENT #8 GRD #2 & 7
GIRDERS HAVE NUTS MISSING FROM ANCHOR BOLTS.

Typical bearing nut missing.

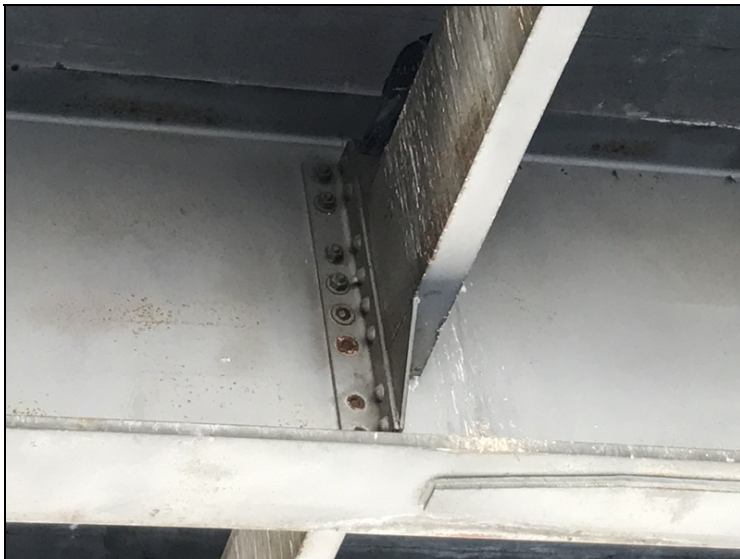
Span #1 girder #3 4th diaphragm connection bottom 2 bolts are broken.
Span #2 girder #6 diaphragm connection #2 & 3 top bolt is broken & 2nd bolt is missing.
Span #5 girder #3 diaphragm connection has 2 lower bolts missing from 2nd & 3rd diaphragm.
Span #6 diaphragm connection between girder #2 & 3 right side has 2 lower bolts missing.

Typical diaphragm nuts missing

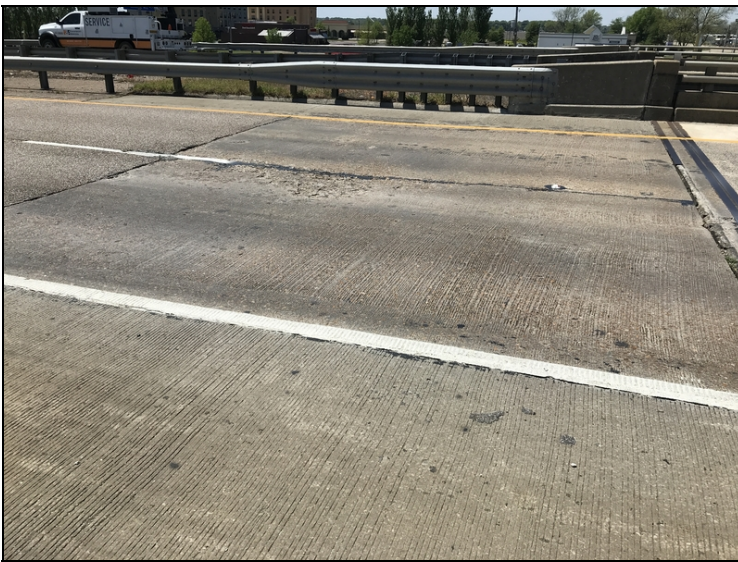
Abutment #1 approach slab

(321)							
Abutment #1 left & right approach slabs have heavy scaling. Abutment #2 approach slab has thirty square feet of sound patches.							
330	Metal Bridge Railing	LF	980	900	80	0	0
7000	Damage	LF	80	0	80	0	0
515	Steel Protective Coating	SF	3938	3938	0	0	0

Abutment #1 left & right approach slabs have heavy scaling.

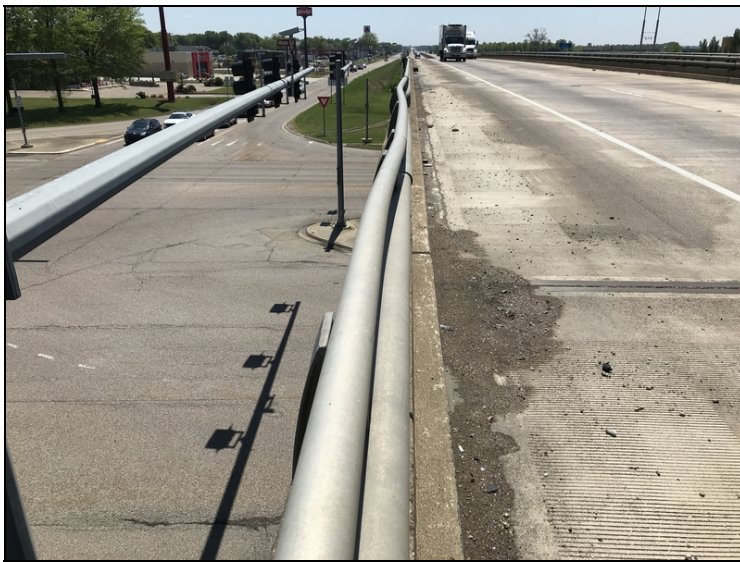
(330)							
Right aluminum bridge rail has collision damage in spans #4,5,6.							
331	Reinforced Concrete Bridge Railing	LF	980	978	2	0	0
1090	Exposed Rebar	LF	2	0	2	0	0

Right aluminum bridge rail has collision damage in spans #4,5,6.

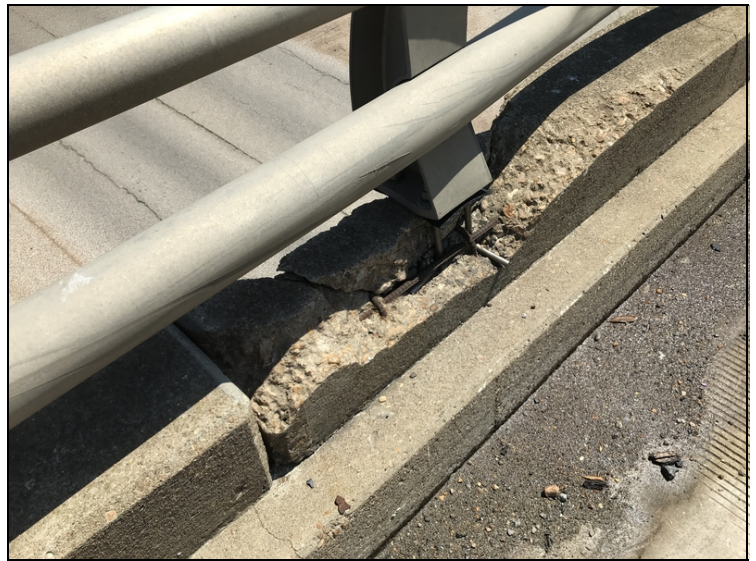
(331)							
Span 4 right side has 2' spall exposed rebar due to collision damage.

Span #4 right side concrete bridge rail has 2' spall exposed rebar due to collision damage.

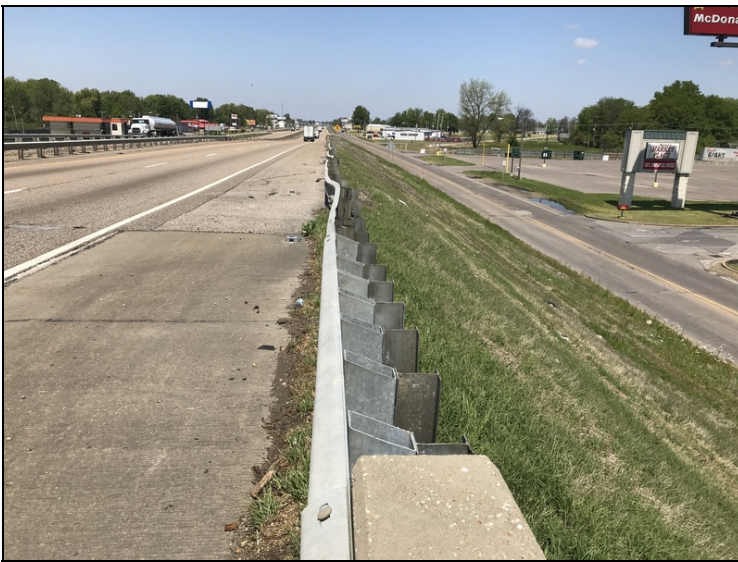
Abutment #2 right approach rail has collision damage.

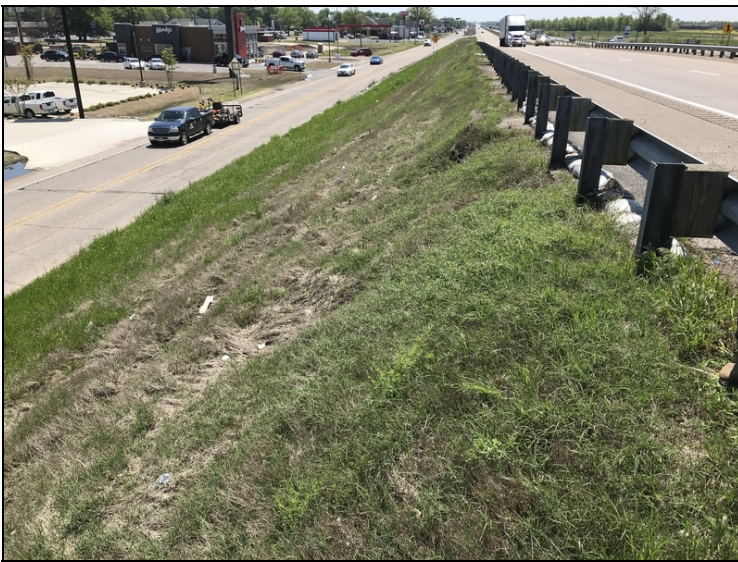
Abutment #1 right side slope is sliding 50' back from abutment.

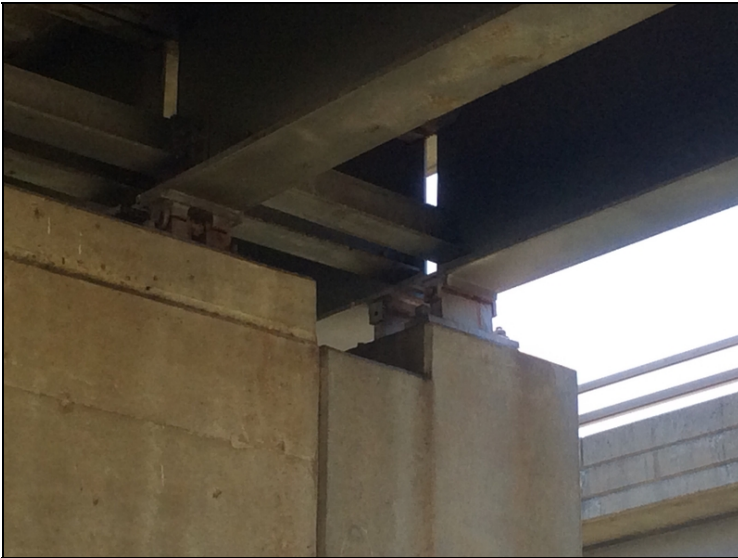
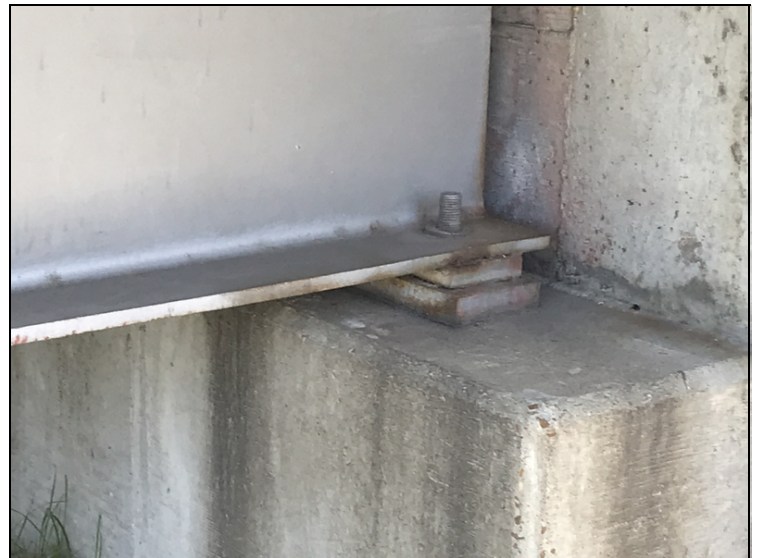
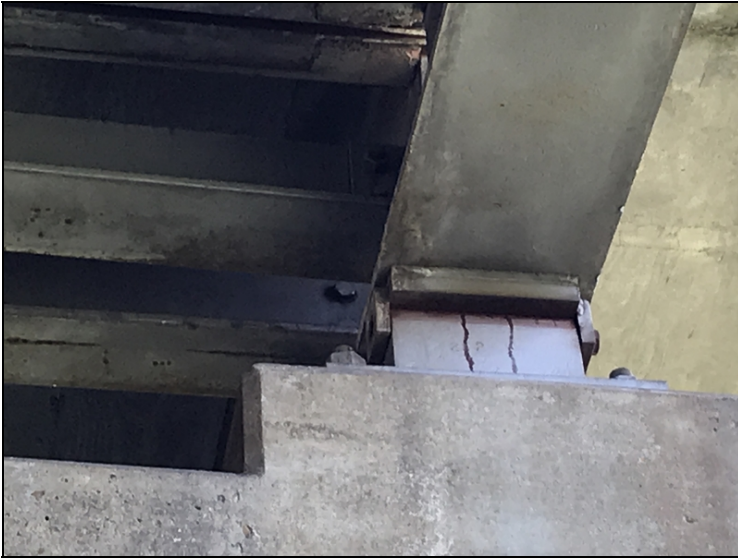
(311)							
Span #1 girder #7 left side bolt from bearing to girder is broken. Span #6 girder #1 right side bolt from bearing to girder is broken. paint has surface rust.							
313	Fixed Bearing	EA	49	47	0	2	0
1020	Connection	EA	2	0	0	2	0
515	Steel Protective Coating	SF	98	8	0	45	45
3440	Effectiveness (Steel Protective Coatings)	SF	90	0	0	45	45

Abutment #1 girders #2&7 have anchor nuts missing.
Span #1 girder #7 left side bolt from bearing to girder is broken.
Span #6 girder #1 right side bolt from bearing to girder is broken.

Typical bearing to girder bolt missing.

Typical abutment bearing nut missing.

Typical missing girder to bearing bolt.

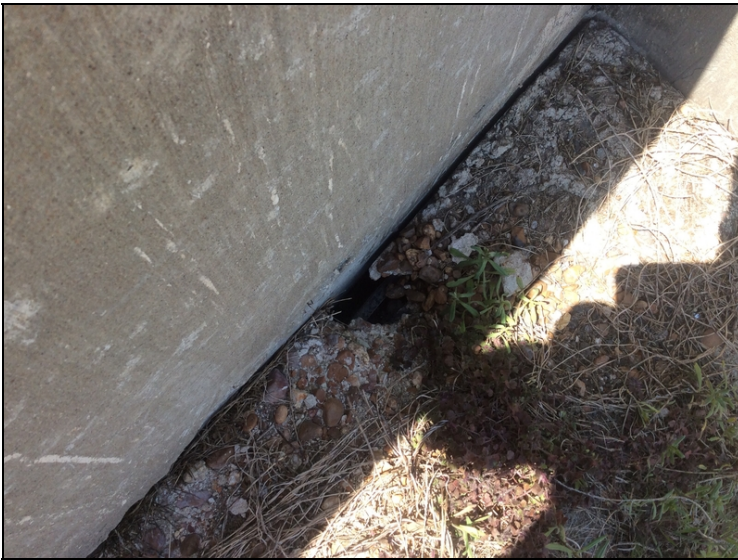
Abutment #1 right transition wall is starting to undermine

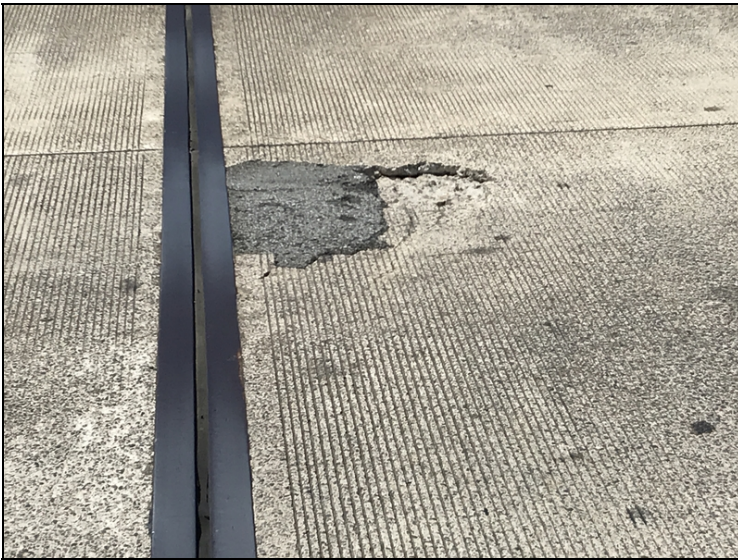
Spans #5 at bent #5 right lane has a two-foot spall with half patched with asphalt.

Spans #5 at bent #5 right lane has a two foot spall
with half poached with asphalt.

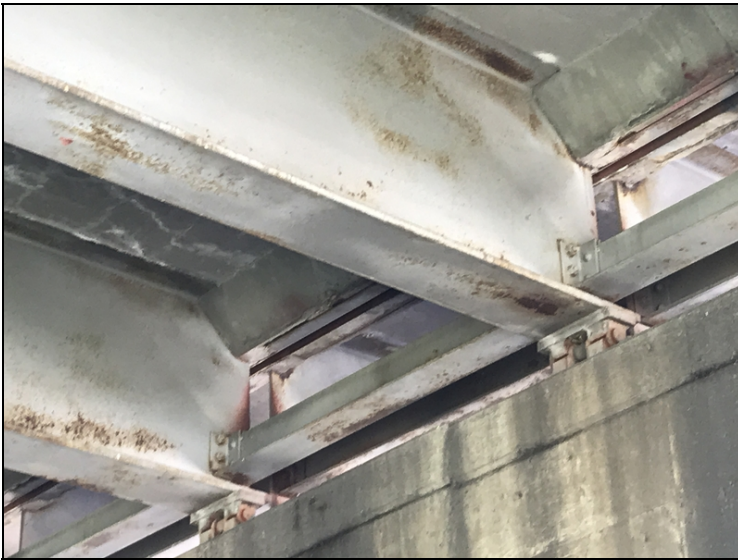
Typical girder ends

(107)	Girders have areas of surface rust on webs and lower flanges for full length rest of paint has limited effectiveness. Span #1 girder #3 4th diaphragm connection bottom 2 bolts are broken. Span #2 girder #6 diaphragm connection #2 & 3 top bolt is broken & 2nd bolt is missing. Span # 4 girder # 7 has moderate traffic damage. Span #5 girder #3 diaphragm connection has 2 lower bolts missing from 2nd & 3rd diaphragm. Span #6 diaphragm connection between girder #2 & 3 right side has 2 lower bolts missing. All girders over travel lanes have minor scrapes & bends.						
205	Reinforced Concrete Column	EA	24	24	0	0	0
215	Reinforced Concrete Abutment	LF	98	88	10	0	0
1120	Efflorescence/Rust Staining	LF	10	0	10	0	0

Girders have areas of surface rust on webs and lower flanges for full length rest of paint has limited effectiveness.
