Bridge #03577 (Record Change)

Sh-1/Sec-14/L-1.0 over Drainage Ditch

Location: 1.0 Mi North Jct Of Us 64

Team Lead: Drew Melton **Inspection Date:** May 28, 2020

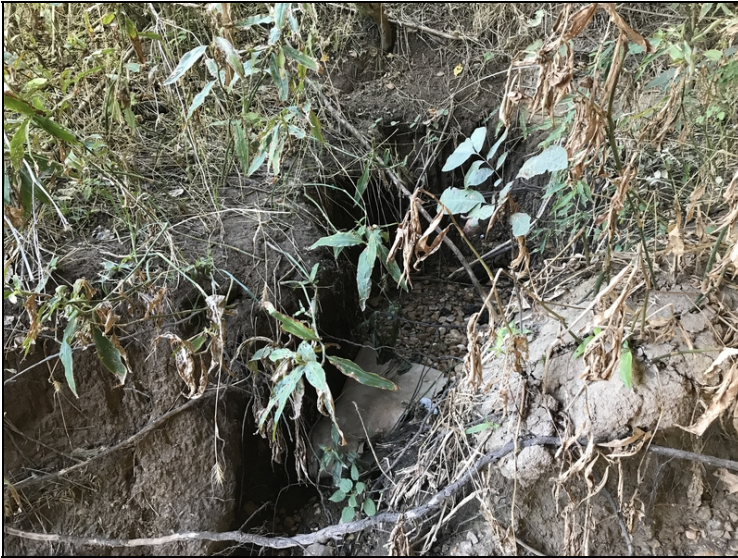
Abutment #2 left side under drain has eroded slope up to three feet down the slope.

Abutment #2 left side under drain has eroded slope
up to three feet down the slope.

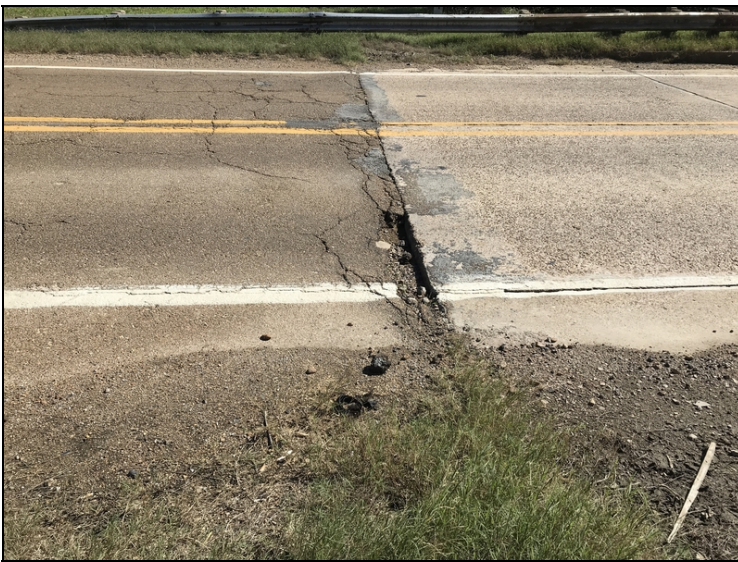
Abutment #2 left lane approach roadway has two foot spall in asphalt at concrete approach slab.

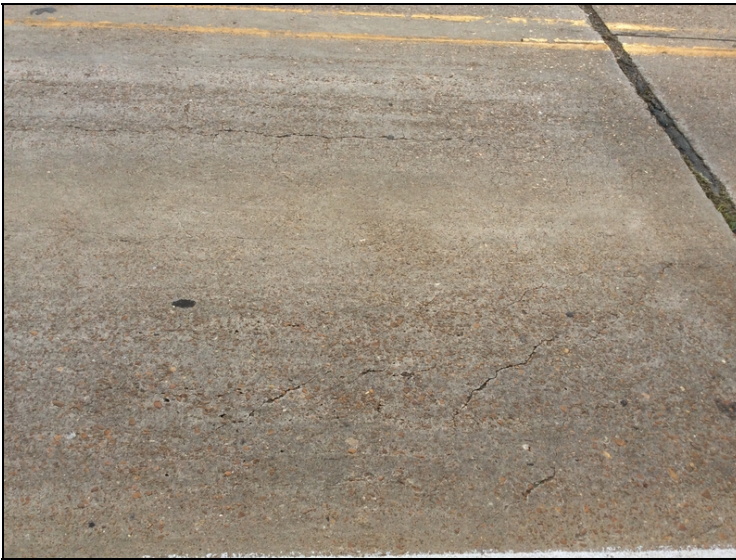
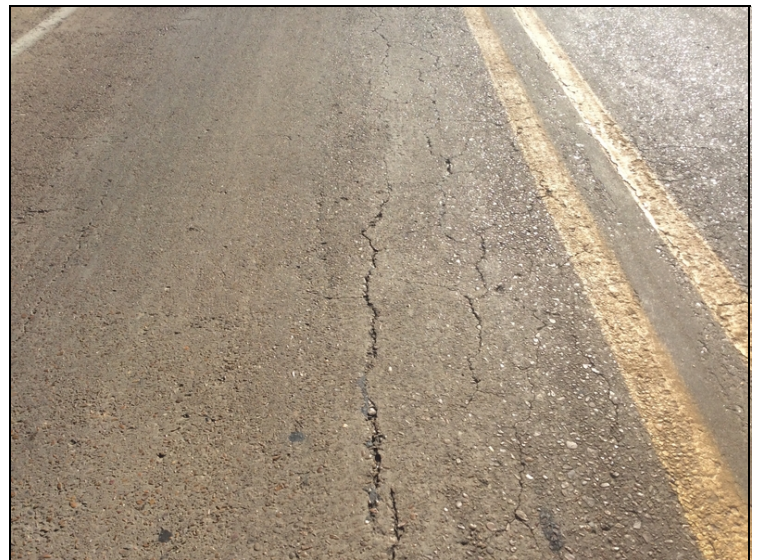
All spans have open longitudinal and transverse cracks spaced one to two feet apart up to eighth inch wide

Typical deck cracks.

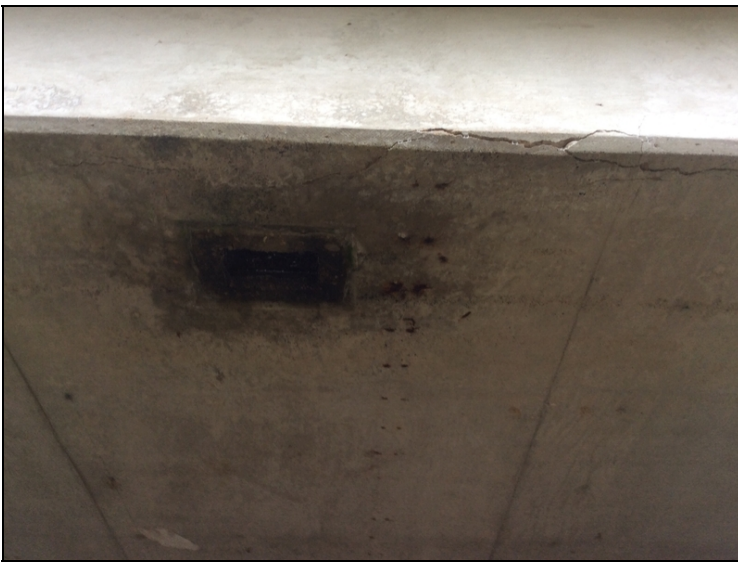
(38)	Span #1 soffit both sides at gutter drain is cracked and delaminated. Soffit has hairline cracks with span #2 having one foot long with rust stains in center at bent #2. Concrete slab is cracked,delaminated,and spalled at bent #2 right and left side at haunch. All spans have open longitudinal and transverse cracks spaced one to two feet apart up to eighth inch wide. Deck has small areas of scaling in gutters. Entire deck has light abrasion exposing coarse aggregate. Sides of slab have vertical hairline cracks spaced one foot apart.						
215	Reinforced Concrete Abutment	LF	75	74	1	0	0
1130	Cracking (RC and Other)	LF	1	0	1	0	0

Span #1 soffit both sides at gutter drain is cracked and delaminated.

Crack and delamination in span one left side drain.

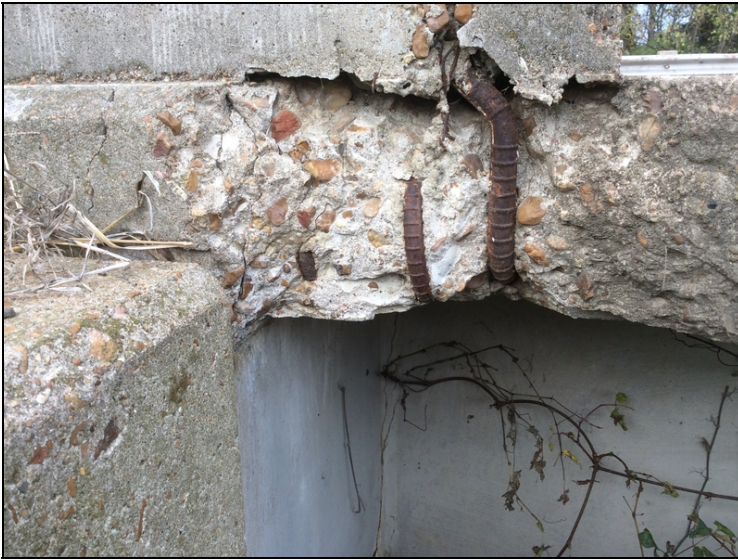
ELEM	DESCRIPTION	UNITS	TOTAL	CS1	CS2	CS3	CS4
1000	Corrosion	LF	88	0	88	0	0
7000	Damage	LF	2	0	0	2	0
515	Steel Protective Coating	SF	360	0	0	135	225
3440	Effectiveness (Steel Protective Coatings)	SF	360	0	0	135	225
(330)							
Span #1 right side first post and span #2 right side third post from abutment #2, posts are spalled on bottom with exposed rebar. Right side on back has no paint coverage front side has spotty rust. Left side on back half has no paint coverage front side half has spotty rust.

Span #1 right side first post and span #2 right side third post from abutment #2, posts are spalled on bottom with exposed rebar.

Right side rail post at abutment one.

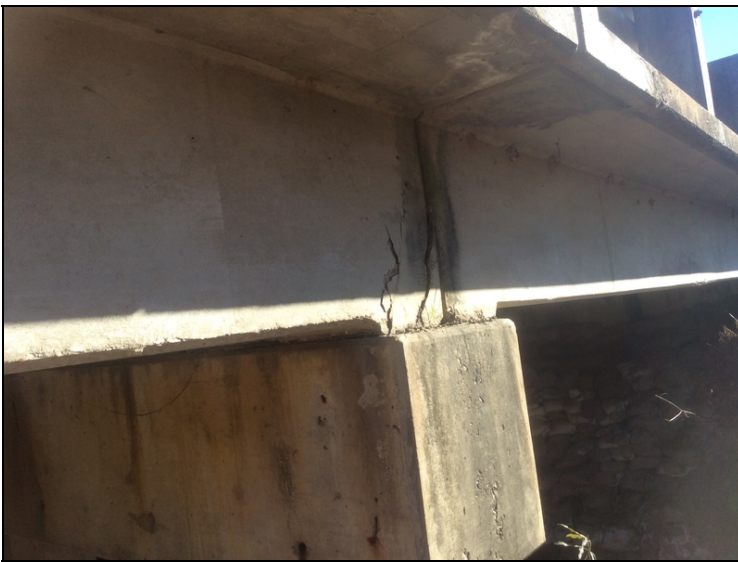
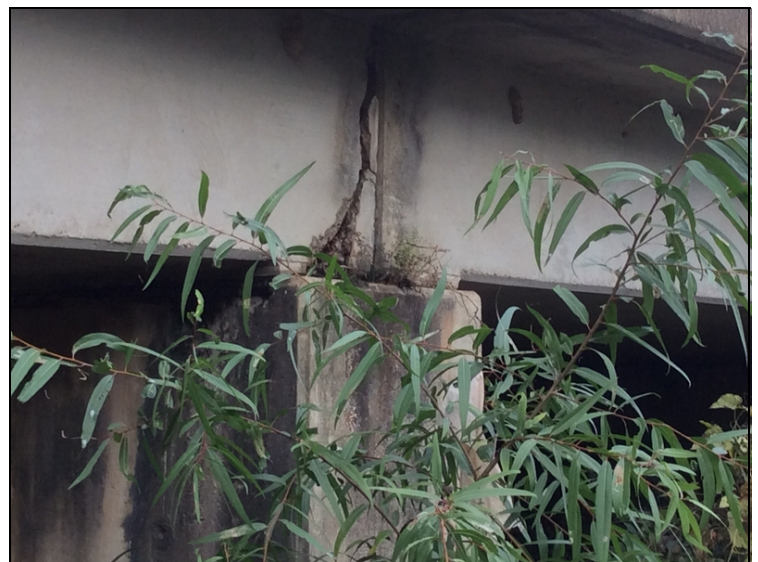
Concrete slab is cracked, delaminated, and spalled at bent #2 right and left side at haunch.

Side of slab at bent two, right side.

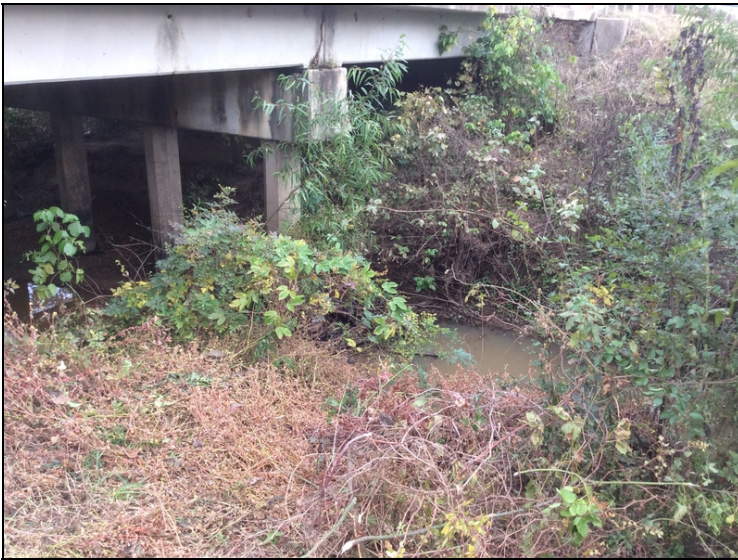
Vegetation growing under and beside bridge on both sides.

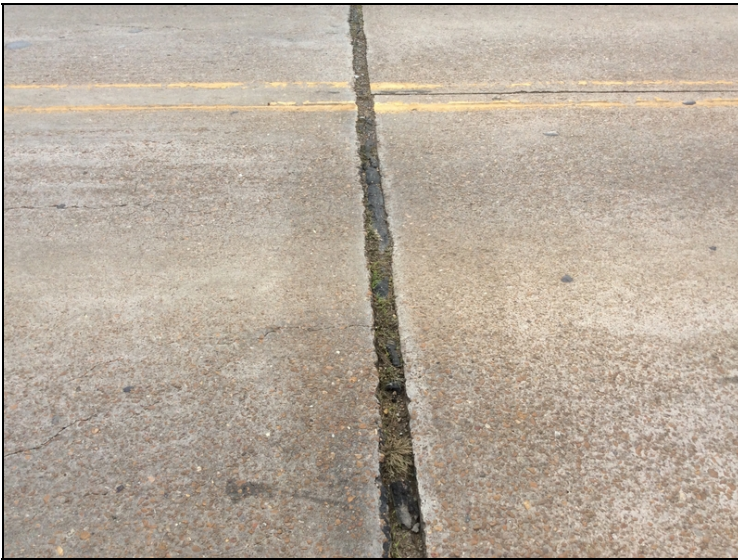
(301)	All deck joints, material is failing allowing non compressible material to enter and vegetation to grow.						
321	Reinforced Concrete Approach Slab	SF	1120	0	1120	0	0
1190	Abrasion/Wear (PSC/RC)	SF	1120	0	1120	0	0

All deck joints, material is failing allowing non compressible to enter and vegetation to grow.
