Bridge #02006(Routine)
US 49-02- LM 14.00 over JOHNSON CR
Location: 3.03 MI N JCT U S 412

Team Lead: Tim Myrick Inspection Date: March 29, 2021

IDENTIFICATION	
(1) State Names	Arkansas
(8) Structure Number	02006
(5) Inventory Route	49
(2) Highway Agency District	10
(3) County Code	55-Greene County, Arkansas

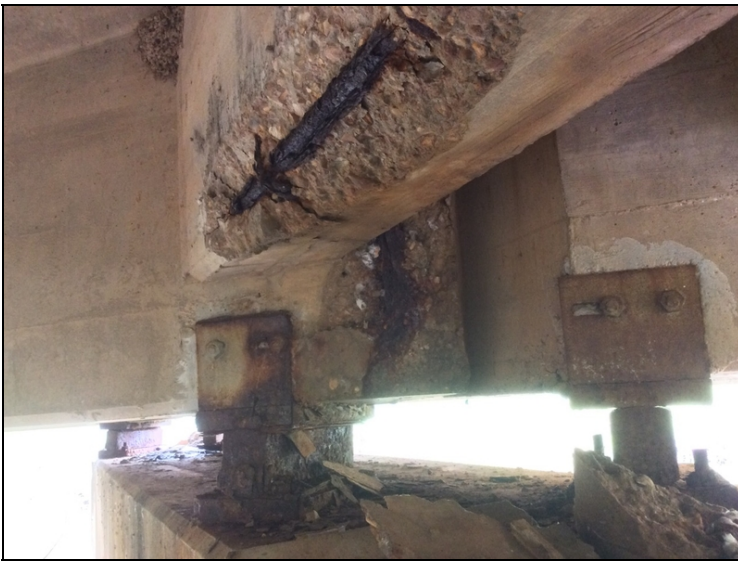
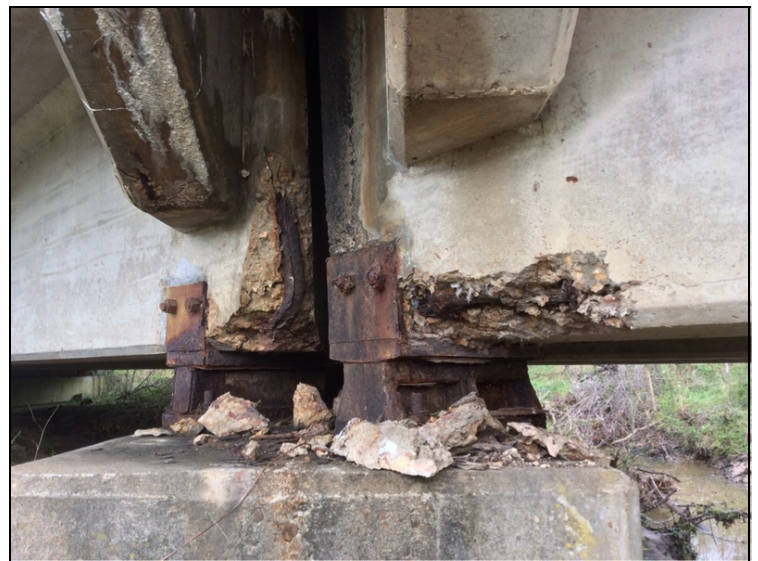
Ends of several Girders have shelled out areas with rebar exposed, 1ft. typical:

Span 1 Girder 2 Bent 2.

Span 2 Girder1&4 Bent 2

Span 2 Girders 1, 2,3 & 4 Bent 3

Span 3 Girders 1&3 Bent 3

Span 3 Girder 1 near Bent 4 has some rebar exposed due to lack of steel coverage.

Span 1 Bay 2 Diaphragm 3 and Span 2 Bay1 Diaphragm 1 have a shelled out area with rebar exposed.

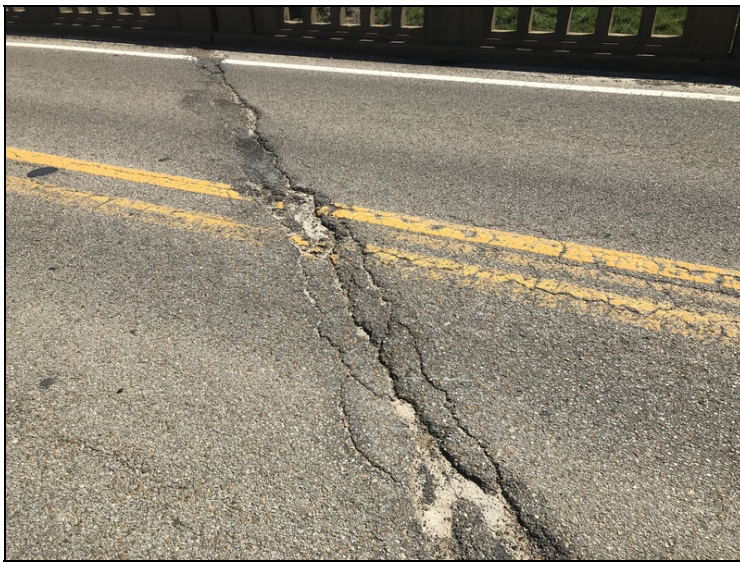
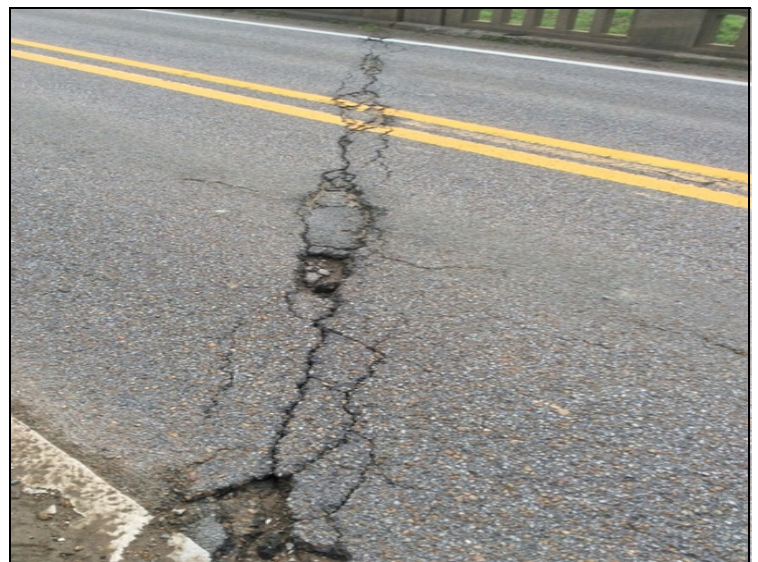
Bent 2

Concrete Deck with Asphalt Overlay, is cracked and spalled out with potholes especially over Bents 2&3 Joints, see 2019 photo.

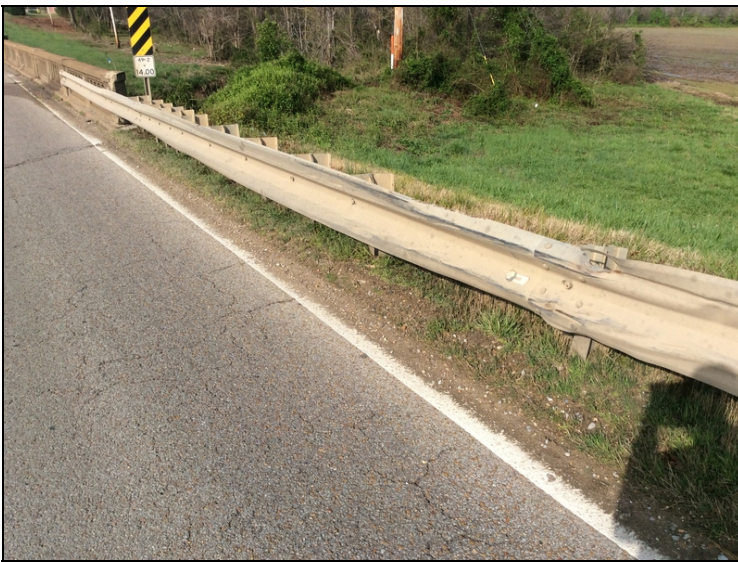
Beginning Bridge End right Approach Railing has 75ft. of rail damage.

minor damage and this area in STIP for reconstruction - KAW
