Bridge #05951 (Routine)
Us-79/Sec-16/L9.30 over Cow Bayou
Location: 9.0 Miles Ne Of Jct Sh 1

Team Lead: Drew Melton **Inspection Date:** August 24, 2020

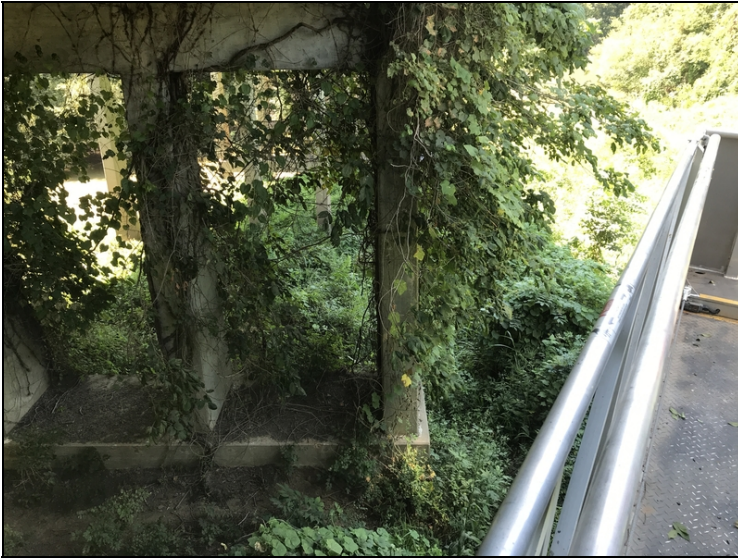
Vines and vegetation are growing under and beside bridge with vines growing up columns and onto caps.

Typical vegetation

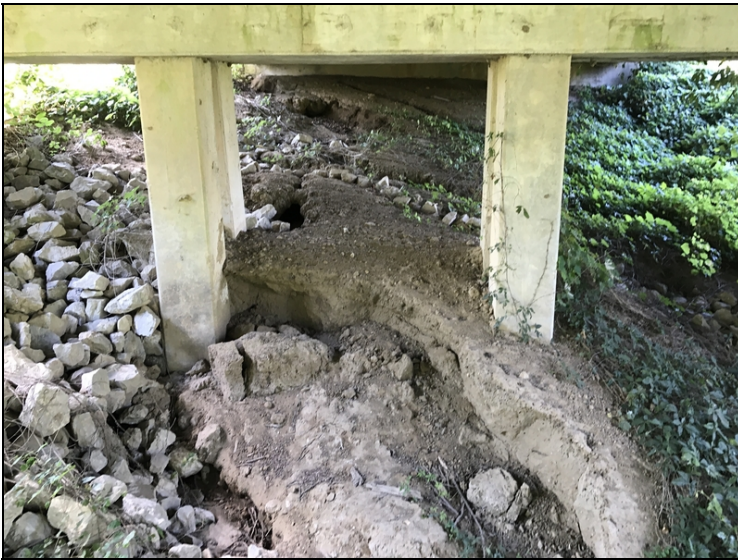
Span #1, 2,8 slopes are eroded with depths up to two feet extending down slopes.

Span #1 slope erosion

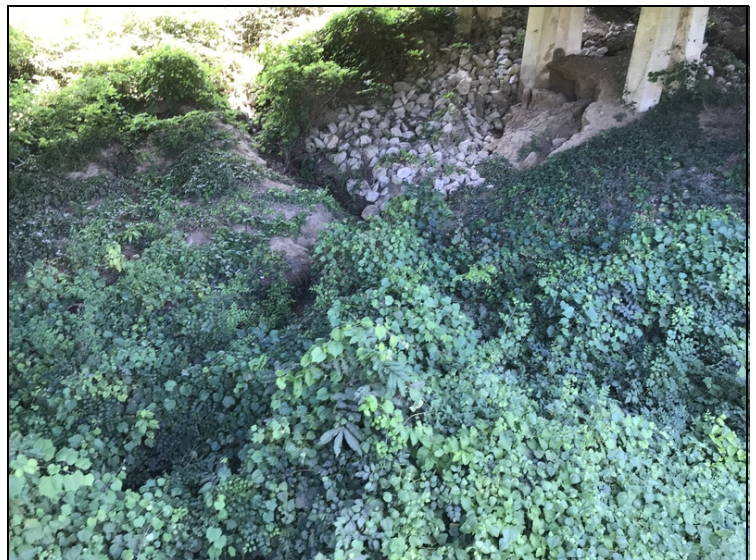
Slope #2 erosion

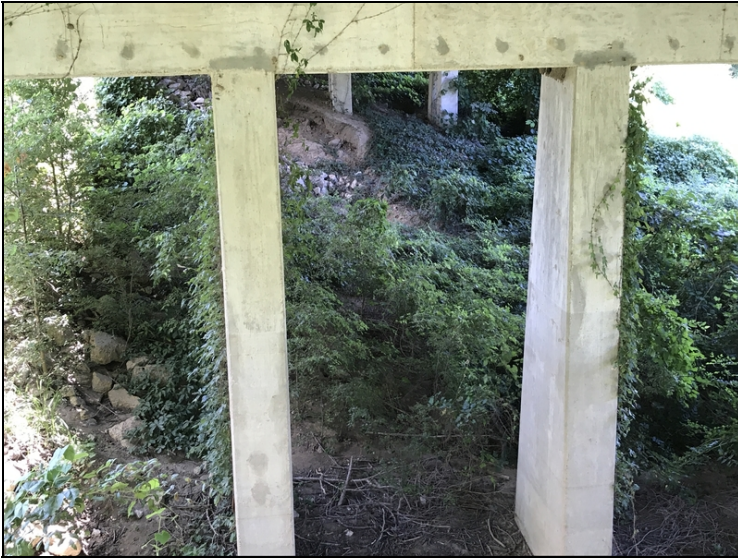
Span #2 erosion

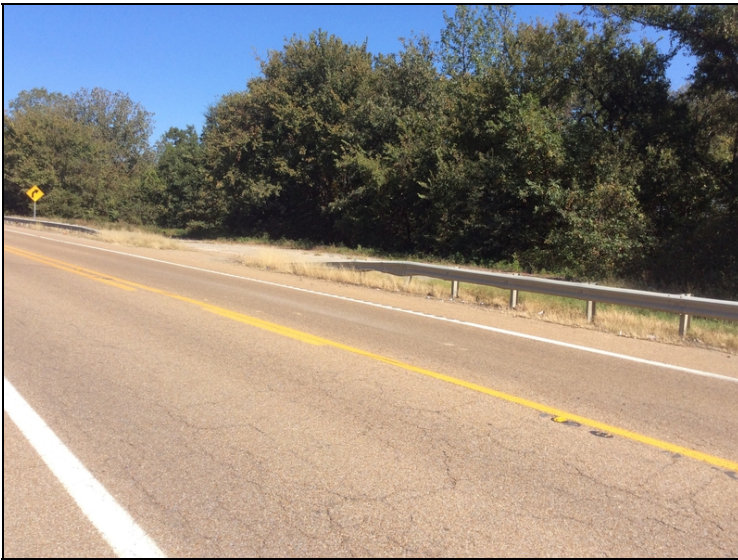
Abutment #2 right approach rail has collision damage.

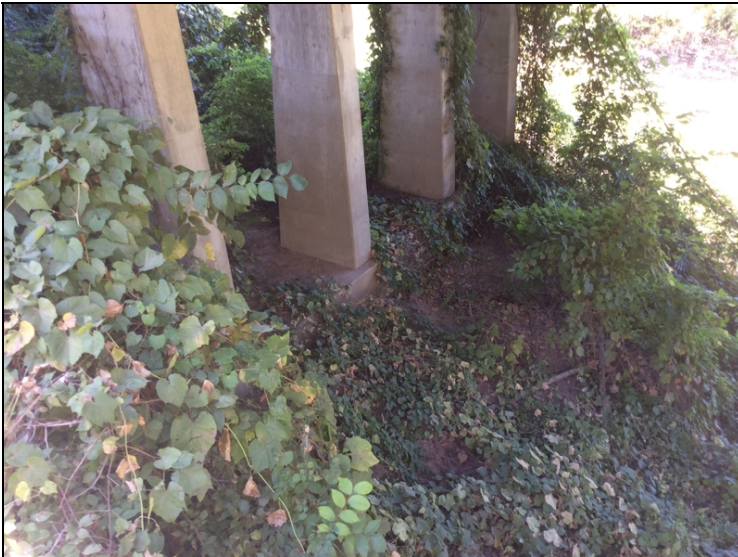
Bent #3 footing is exposed full length.
Bent #4 footing is exposed full length with undermining at left end up to two feet.
Bent #5 footing is exposed and undermined two feet on right end to four feet on left end.
Bent #6 footing is exposed and undermined three feet on left end to four feet on right end.
Bent #7 footing is exposed on right end.
Bent #8 footing is exposed full length.

Bent 2 footing

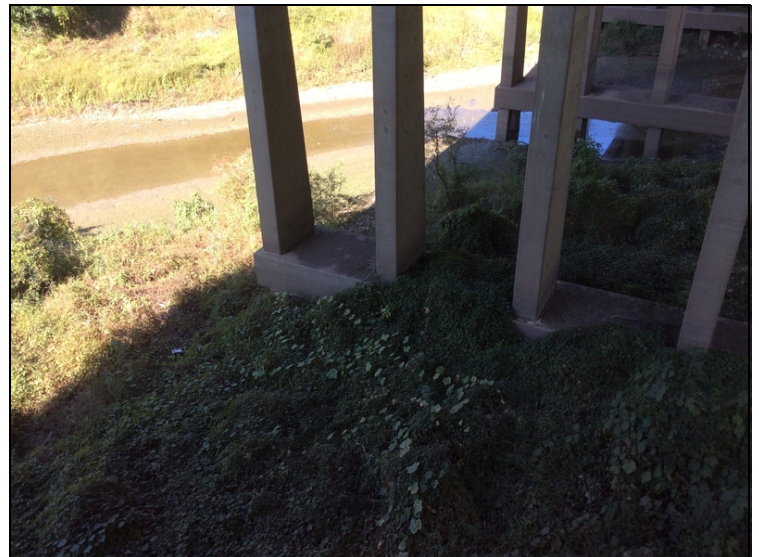
(220)	Bent #3 footing is exposed full length. Bent #4 footing is exposed full length with undermining at left end up to two feet. Bent #5 footing is exposed and undermined two feet on right end to four feet on left end. Bent #6 footing is exposed and undermined three feet on left end to four feet on right end. Bent #7 footing is exposed on right end. Bent #8 footing is exposed full length.						
227	Reinforced Concrete Pile	EA	15	15	0	0	0
234	Reinforced Concrete Pier Cap	LF	280	280	0	0	0
301	Pourable Joint Seal	LF	86	84	2	0	0

Bent 3,4 footing.

08/16/2018 lowered substructure from 7 to 6 due to shallow local scour.

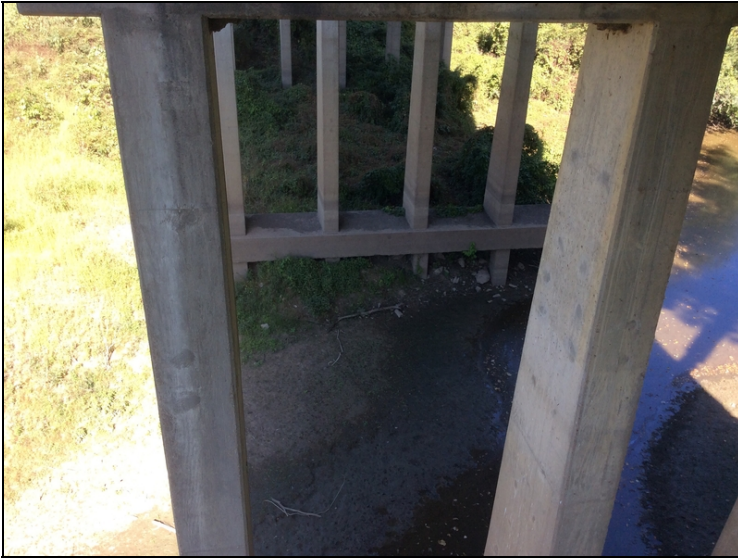
Bent 4 footing.

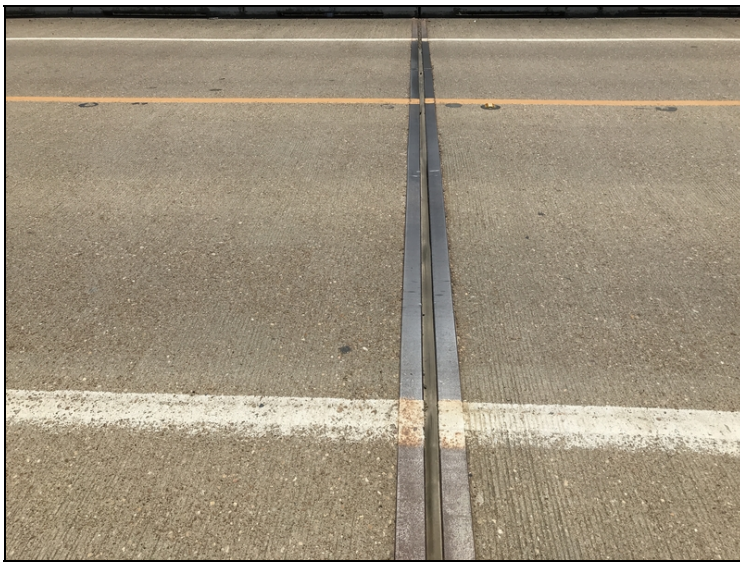
Bent #5 seal has lost adhesion for one foot in left lane.

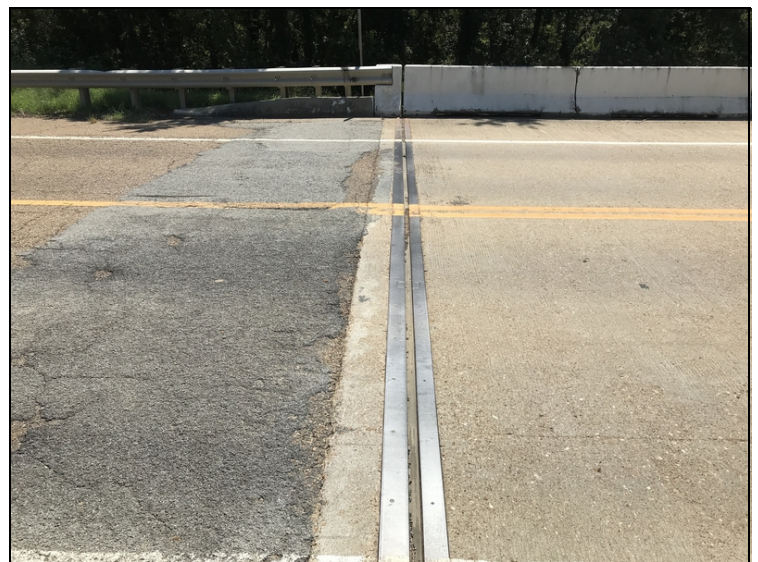
Abutment #2 seal has two one inch holes in the right lane and shoulder.

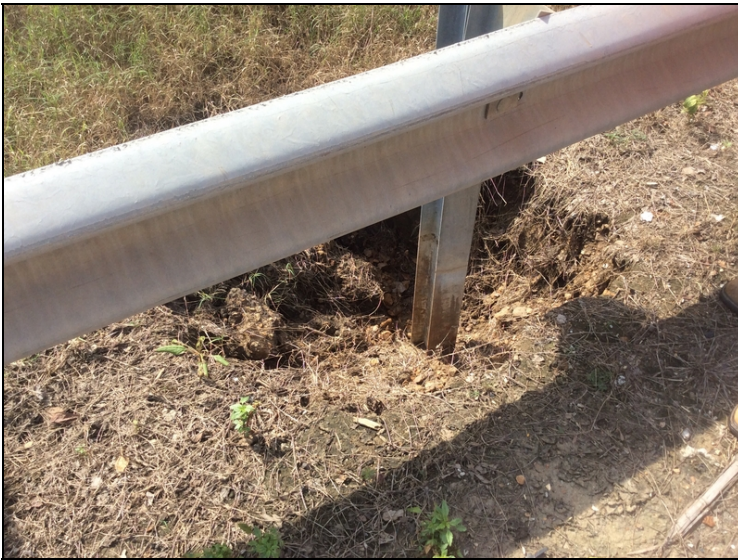
Abutment #2 approach rail right side four feet from bridge end has three foot deep hole around rail post.

Abutment #2 approach rail right side fourth feet from bridge end has three foot deep hole around rail post.

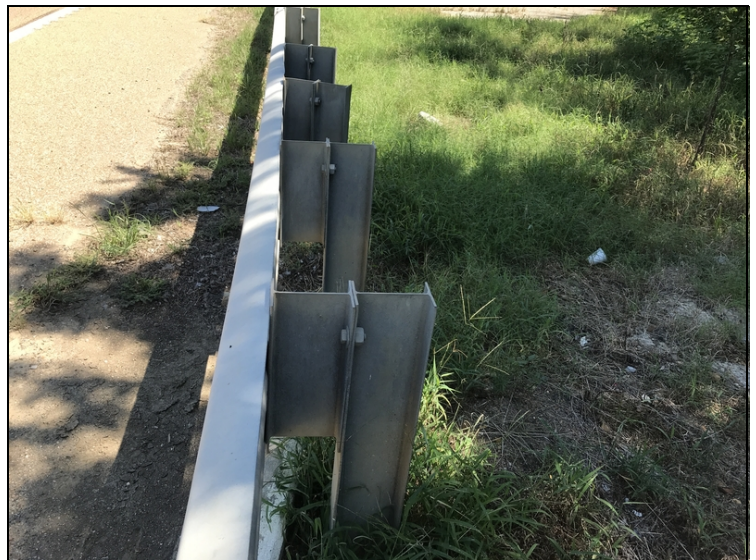
Abutment #2 right approach rail hole around post has been filled in since last inspection.

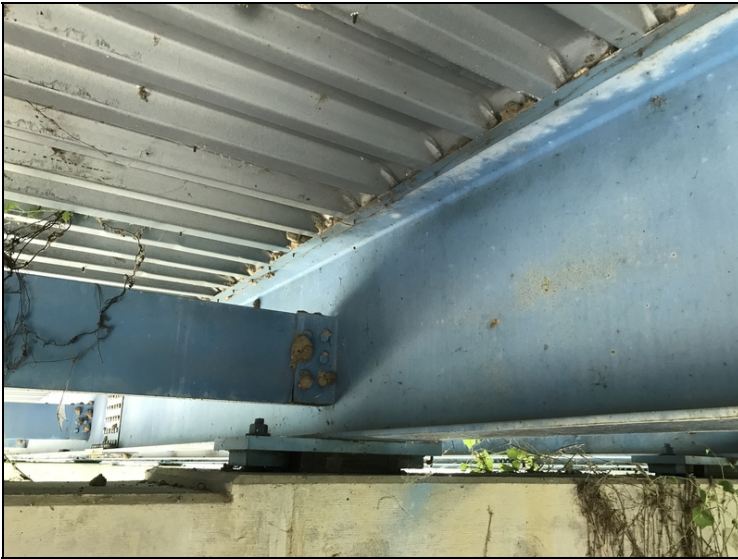
(107)	Girder paint is beginning to fail with surface rusting on all girders with 5% bare steel rest of paint is dull, chalky. and has lost its color pigment. Span #5 bent #5 girders #1,5,6 have corrosion on bottom flange at bearing connection with section loss up to 10%.						
205	Reinforced Concrete Column	EA	40	40	0	0	0
215	Reinforced Concrete Abutment	LF	122	116	6	0	0
1120	Efflorescence/Rust Staining	LF	6	0	6	0	0

Girder paint is beginning to fail with surface rusting on all girders with 5% bare steel rest of paint is dull, chalky. and has lost its color pigment.

Typical interior girder paint condition

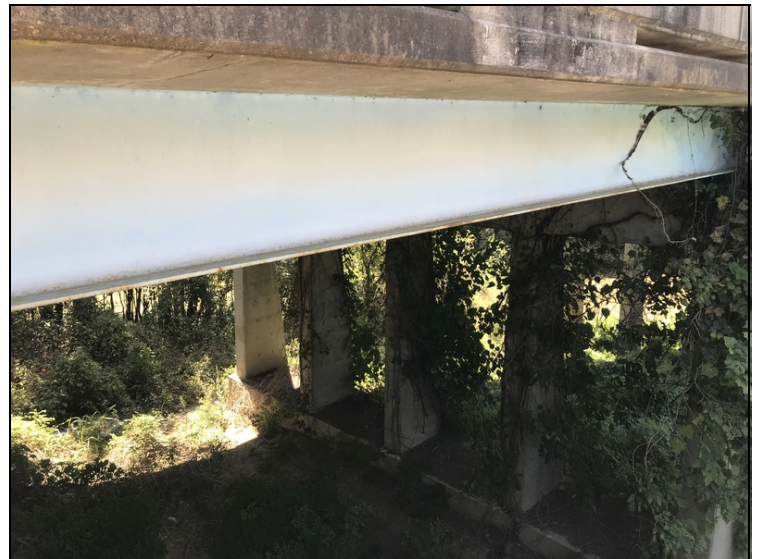
Typical paint outside girder

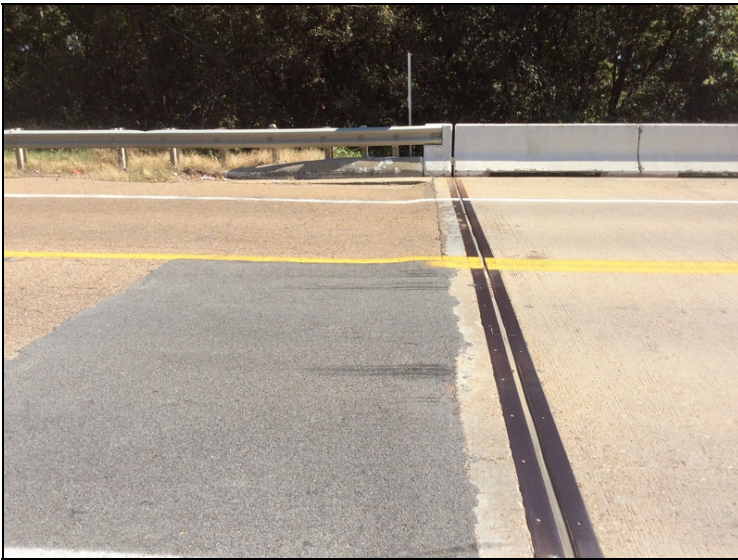
Abutment 2 approach roadway.

Abutment #2 approach roadway has settled one inch increasing impact loading on bridge.

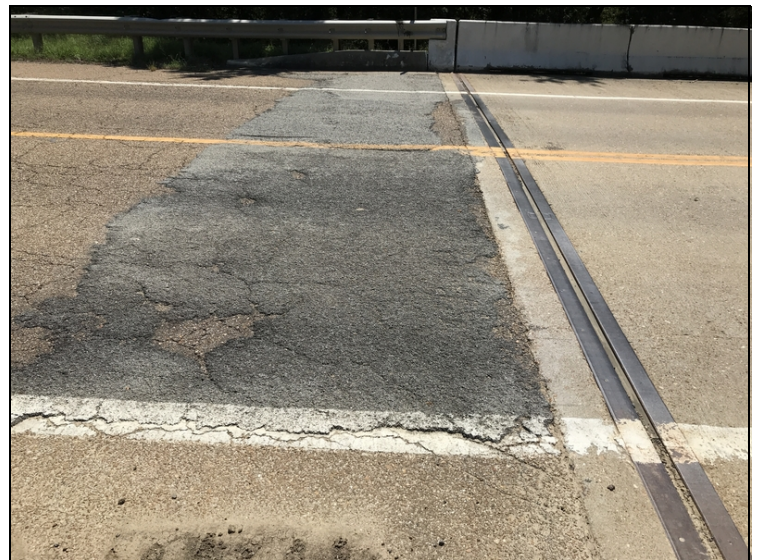
Abutment #2 approach roadway has been repaired since last inspection.

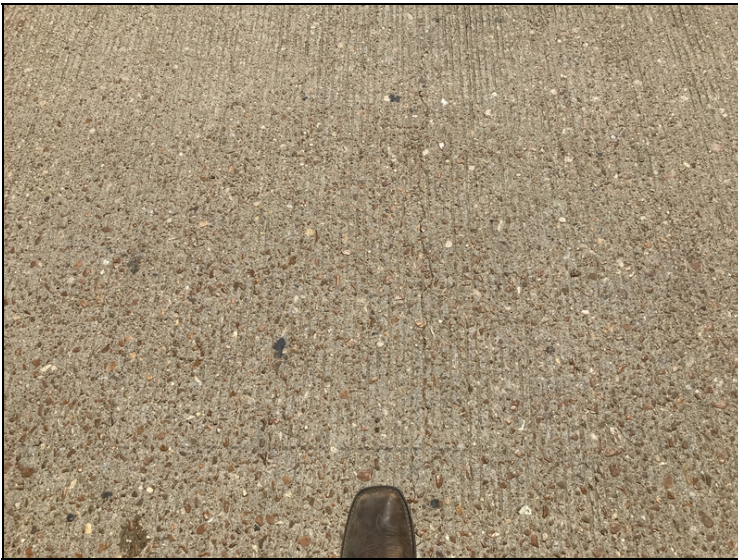
Deck has open transverse cracks spaced three feet apart.

Typical deck crack

08/16/2018 lowered deck from 8 to 7 due to deck cracks.

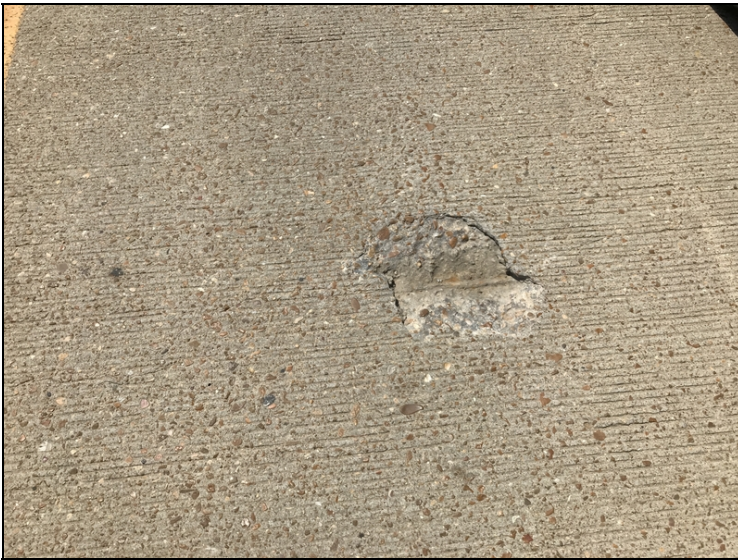
Span #1 left lane has a one foot spall with exposed rebar.
