**Bridge #02393**(Underwater type 2, Routine)

**Us-79/Sec-15/L1.86 over Big Piney Creek**

**Location: 1.86 Mi North Monroe Co**

**Team Lead:** Drew Melton **Inspection Date:** August 24, 2020

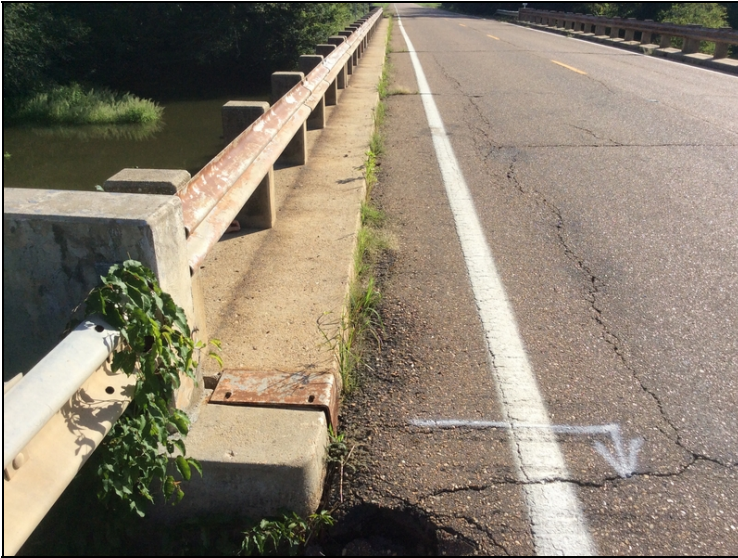
Dirt, debris, and vegetation growing in left and right gutters.

Typical gutters

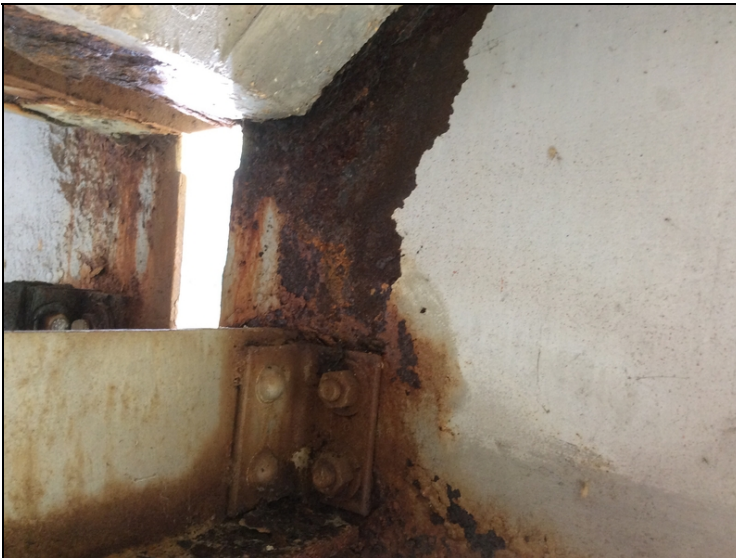
Outside girder ends have corrosion with laminations with section loss up to 50% at diaphragm and haunch's with Web bowing outward.

Typical outside girder.

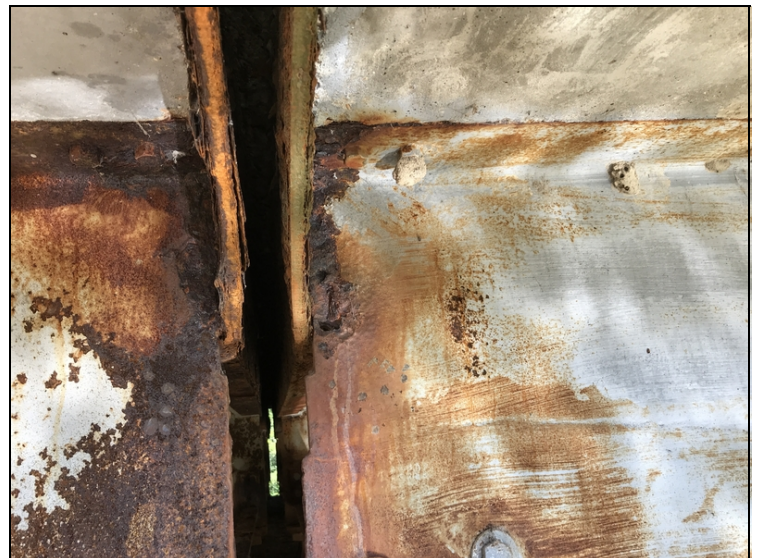
Span #4 bent #4 girder #4 has a one inch hole in web at haunch with rest of web at haunch with up to 75% section loss.

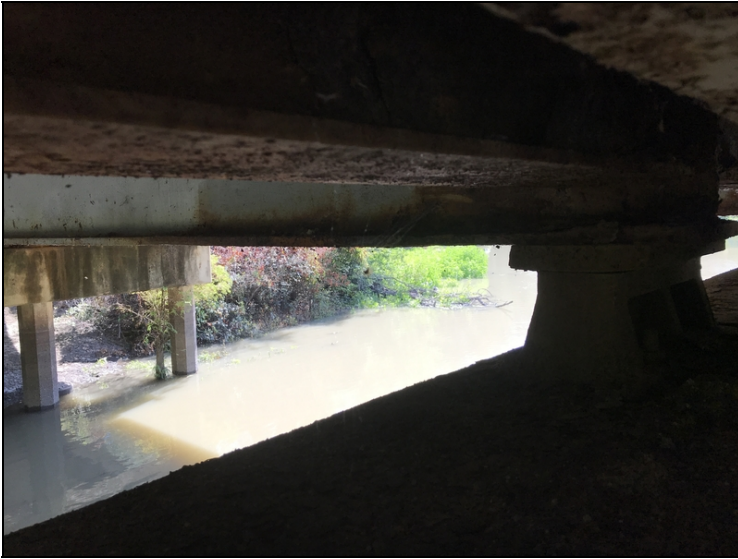
Span #4 bent #4 girder #2 first foot has lower flange with up to 50% section loss.

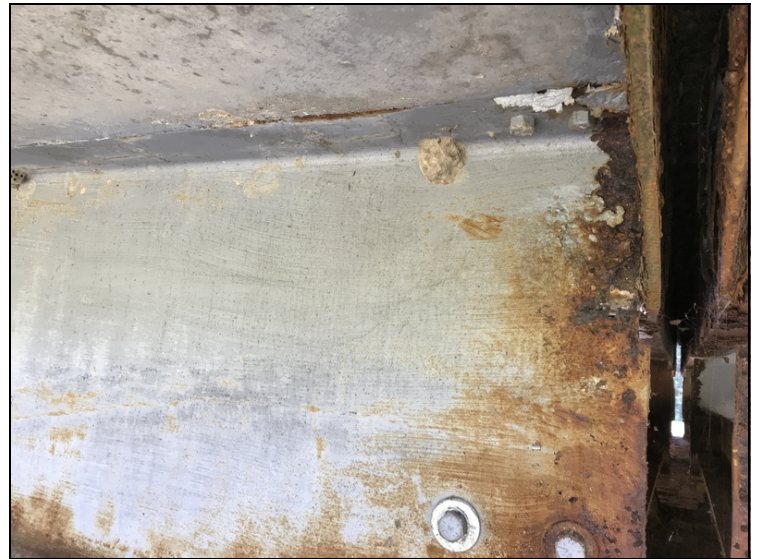
Span #4 bent #4 girder #1 has a one inch long hole in web at haunch rest of web around haunch has section loss up to 75%.

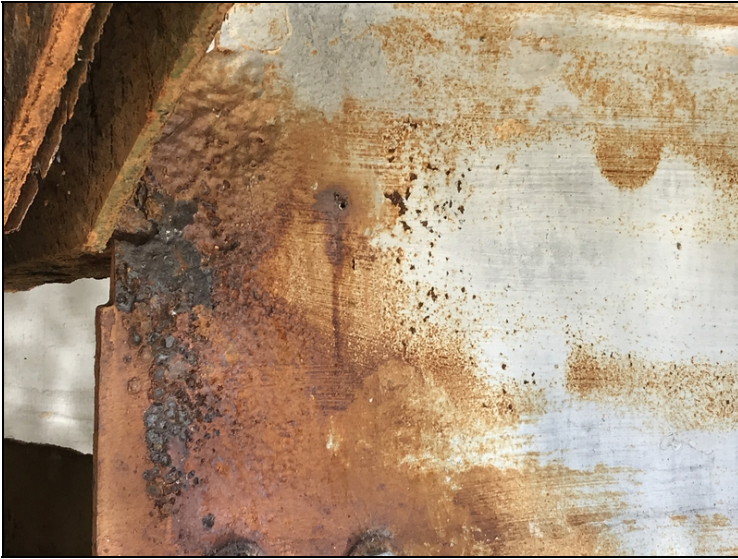
Span #3 bent #3 girder #4 has section loss with small pin hole and one inch hole at haunch.

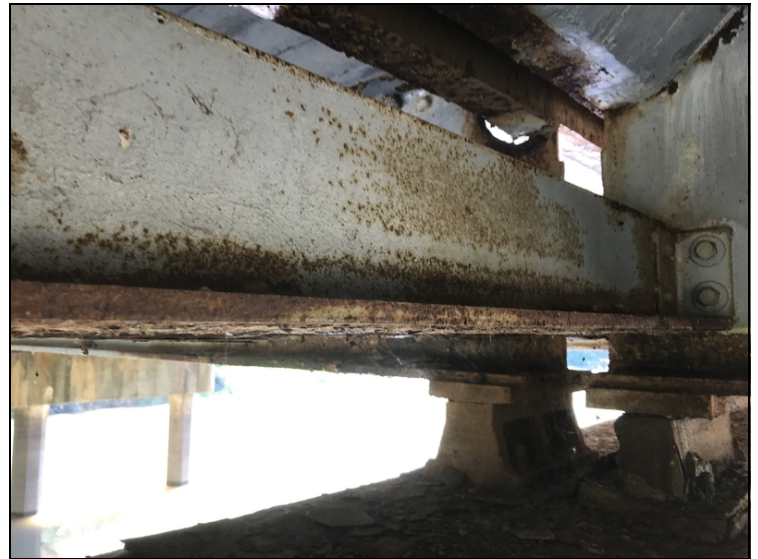
Span #3 bent #3 girder #2 has hole in web six inches long at haunch and up to 50% section loss in web around diaphragm.

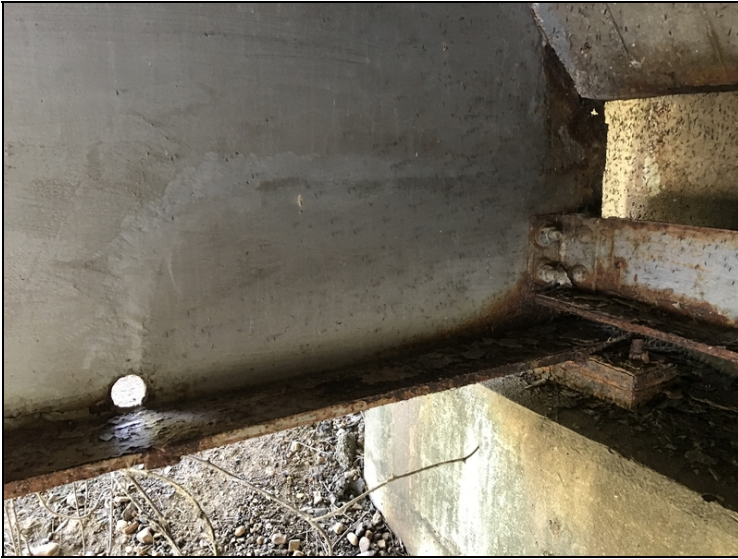
Span #5 abutment #2 girder #1 has a one inch hole in web at haunch with rest of web at haunch down to splice with section loss up to 50%.

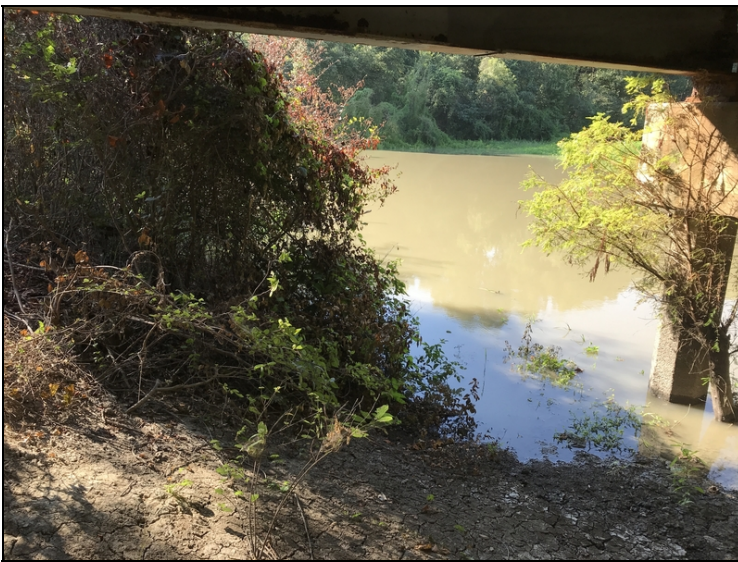
Vegetation is growing under and beside bridge on left and right side of abutment #1,2 and onto roadway.

Typical vegetation

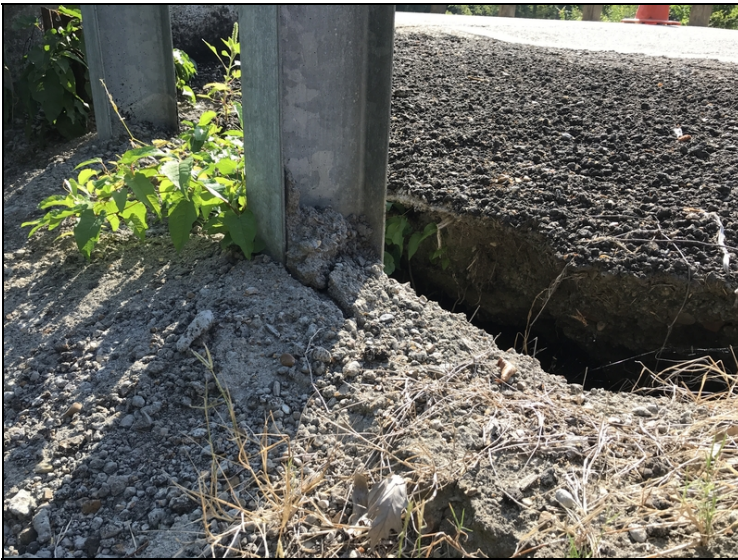
Approach #1 left side is eroded with void under approach shoulder.

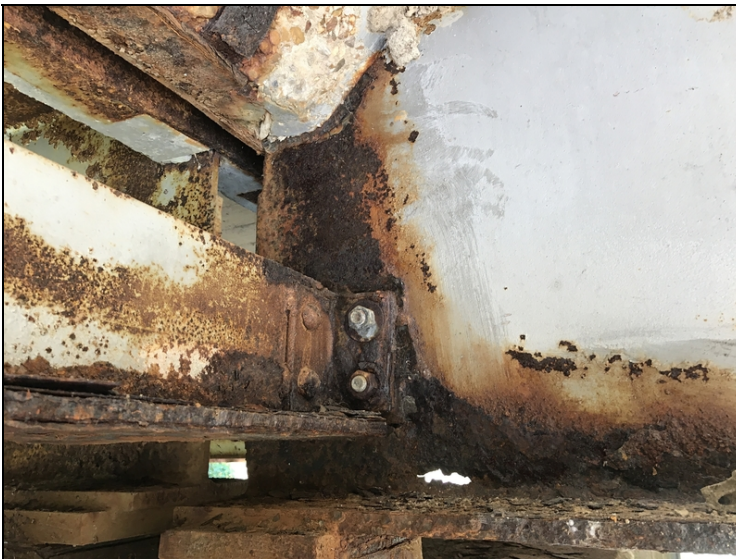
Span #2 girder #3 at bent #2 has three inch hole at haunch and two three inch holes in web one around diaphragm and another at lower flange. Lower web and lower flange has section loss for four feet.

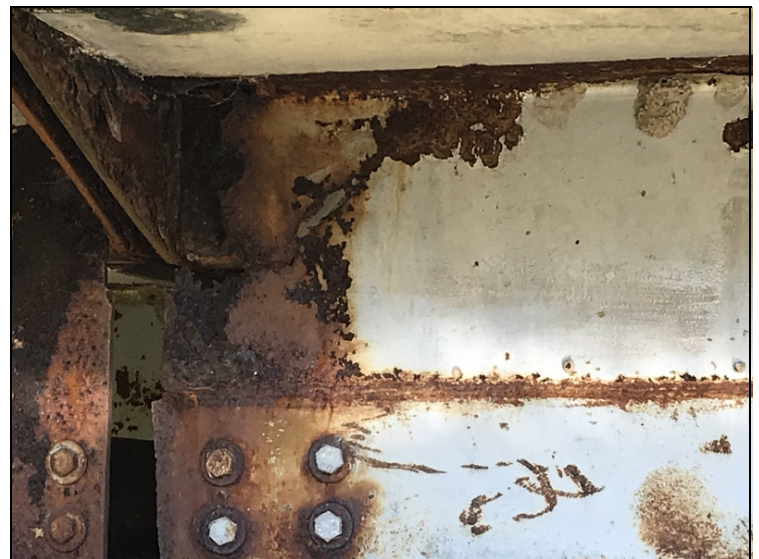
Span #2 girder #4 at bent #2 haunch has holes totaling one foot with section loss in web down to t-splice.

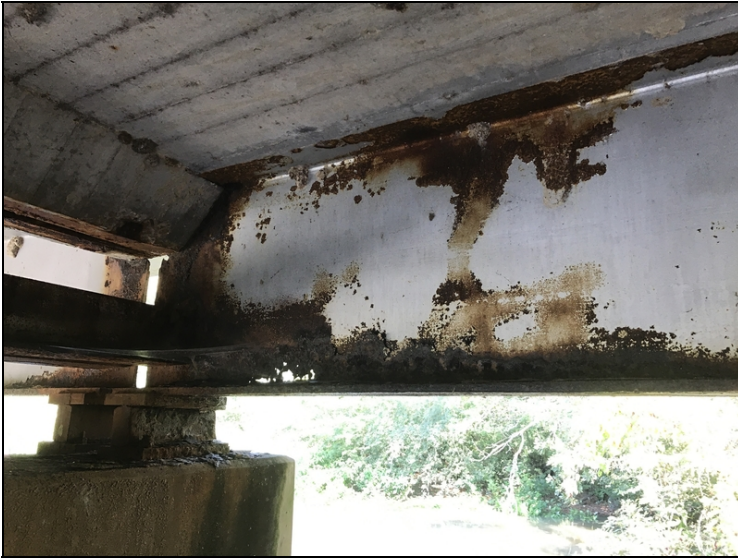
Span #5 bent #5 girder #1 has a hole in web at lower flange one foot long up to inch and a half tall approximately one and a half feet from end of girder. Lower flange for and lower web has section loss up to 60%. Haunch area on outside end of girder has 100% section loss.

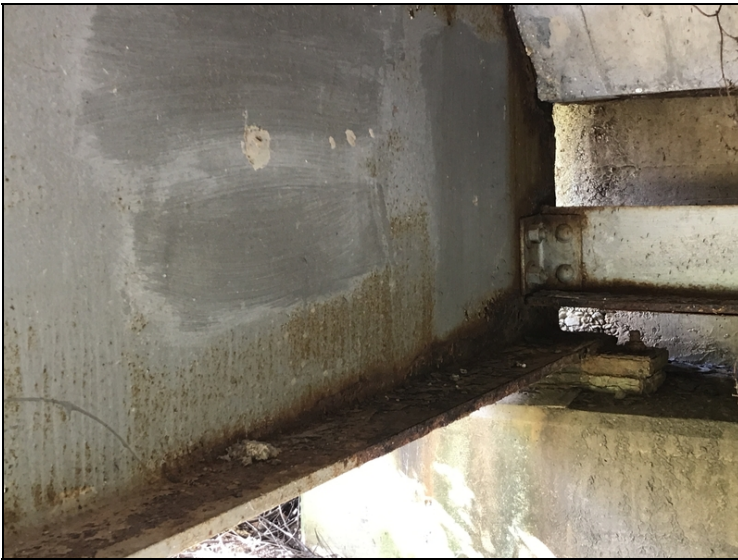
Girders have surface rust full length with 50% bare steel rest of paint is oxidized and peeling.

Typical outside girder condition.

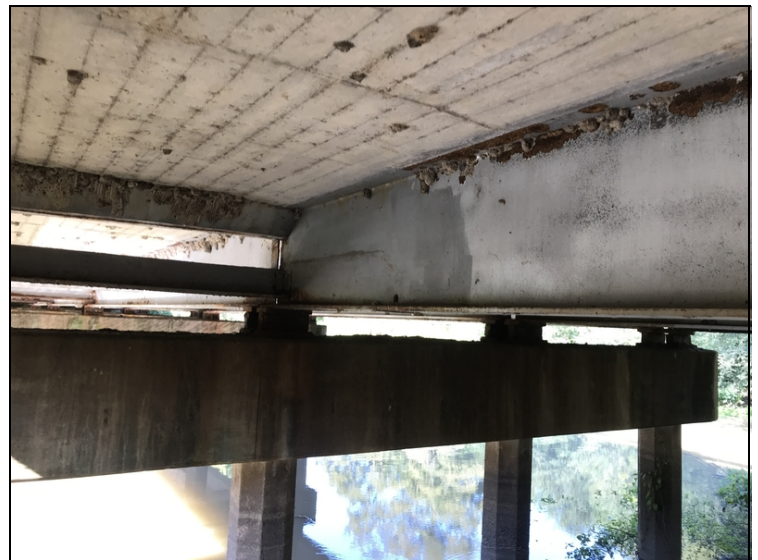
Typical paint condition inside girder.

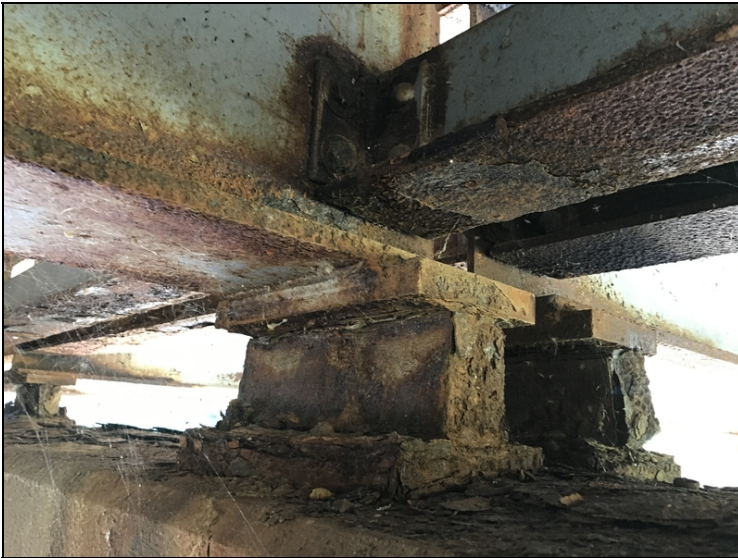
Movable bearings have corrosion and laminations with section loss up to 15%.  
There is little to no paint left on bearings.  
Span #4 bent #5 bearing #2 is rocked forward.

Typical movable bearing.

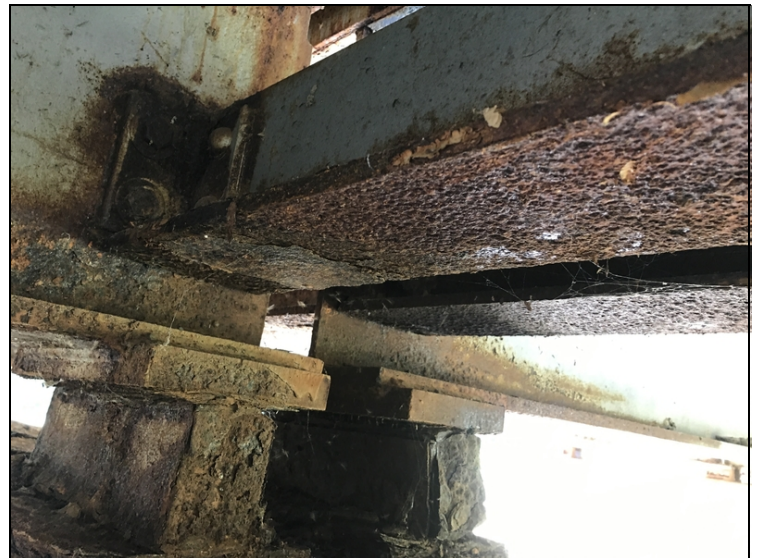
Span #4 bent #5 bearing #2 is rocked forward.

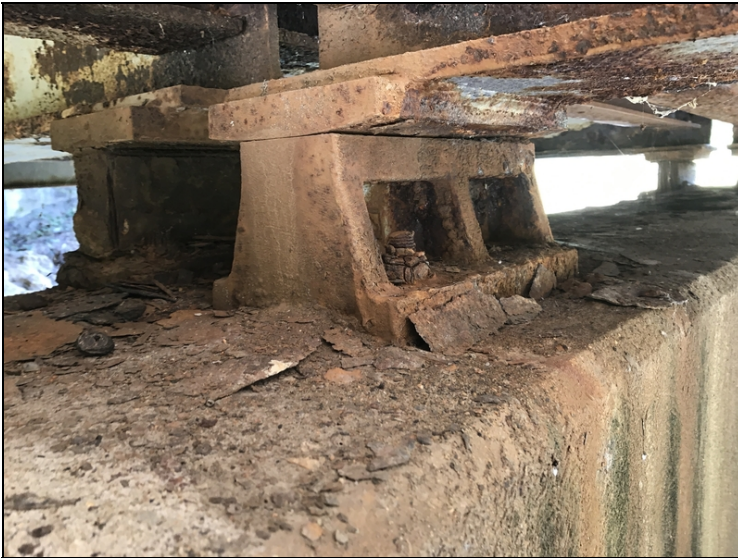
Fixed bearings have corrosion with laminations with up to 5% section loss.  
Abutment #1 girder #2 left anchor bolt broken / missing.  
There is little to no paint left on bearings.

Typical fixed bearing condition.

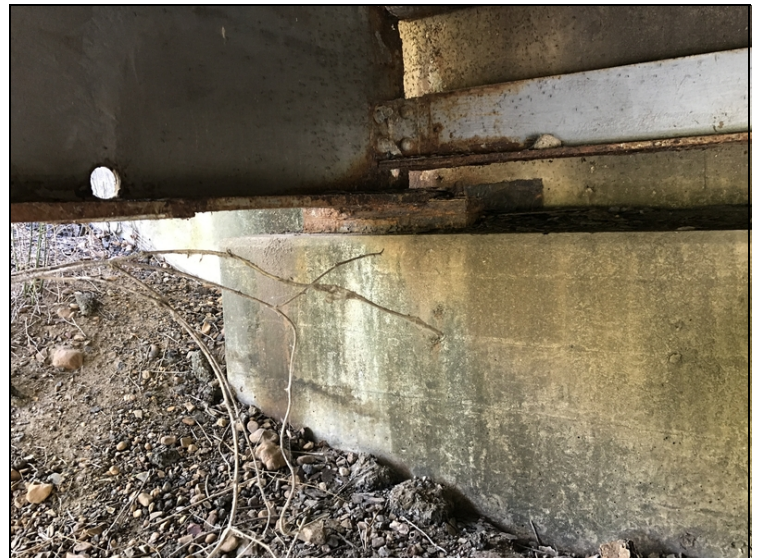
Typical abutment bearing
