District 01, Lee County

Bridge #02394(Routine)  
Us-79/Sec-15/L2.88 over Little Piney Creek  
Location: 4.8 Miles West Of Sh 258

Team Lead: Drew Melton Inspection Date: September 14, 2020

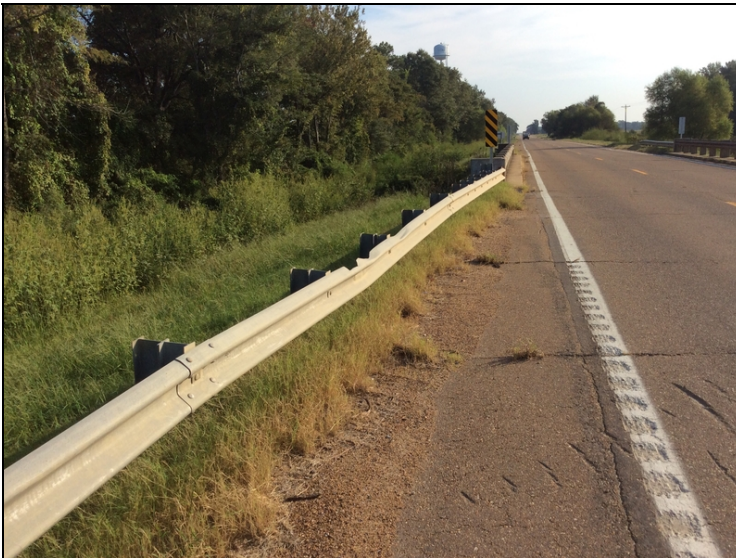
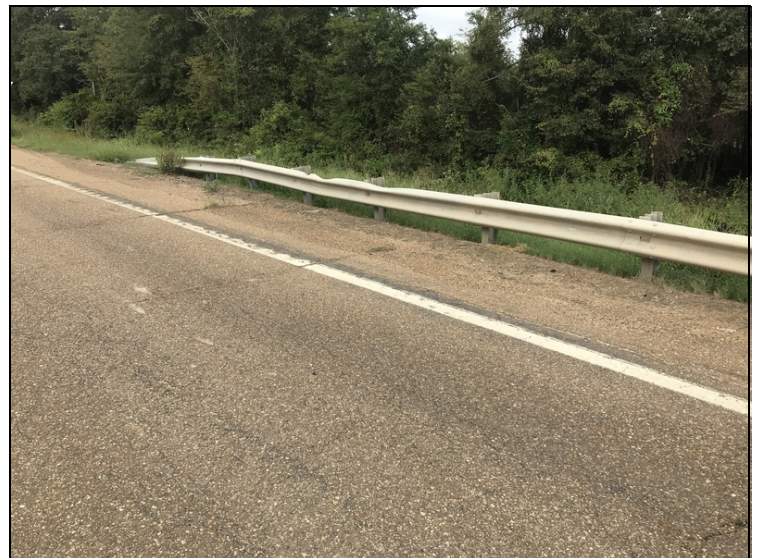
Abutment #1 left approach rail has minor collision damage.

Abutment 1 left approach rail.

Abutment one left approach rail.

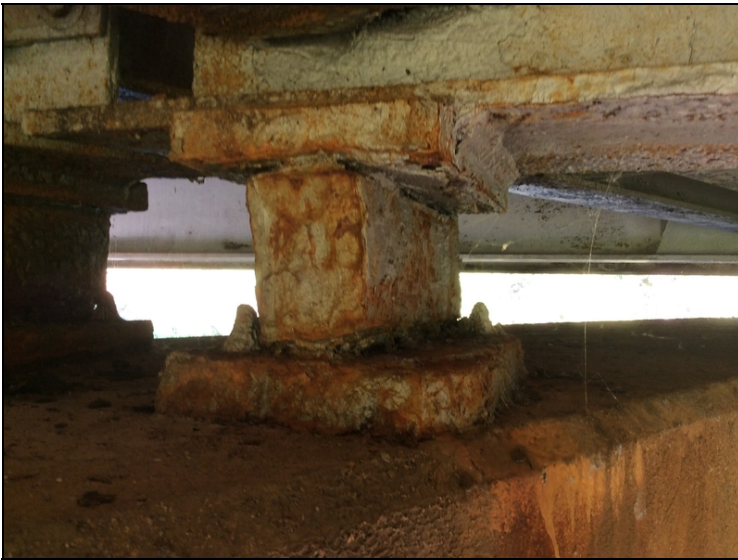
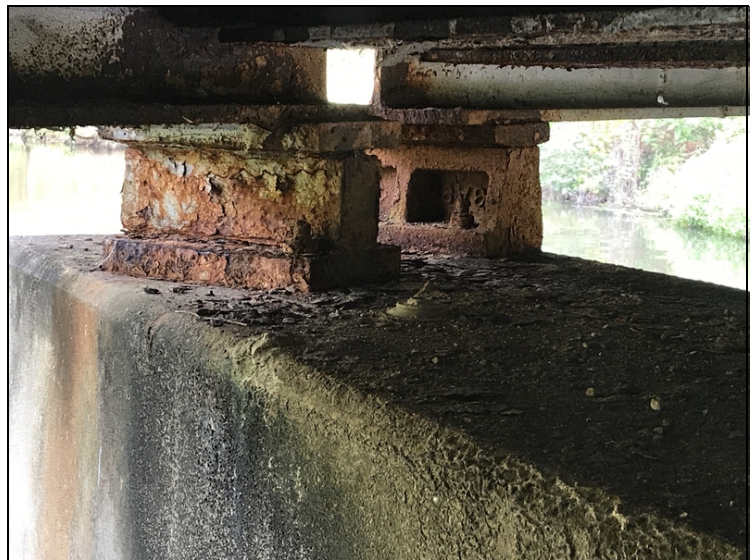
(311)							
No paint is left on bearings. All bearings are corroded with laminations with up to 50% section loss. Movable bearing are rocked forward approximately five degrees. Bent #3 girder #1 bearing retaining nut missing.							
313	Fixed Bearing	EA	12	0	1	11	0
1000	Corrosion	EA	11	0	0	11	0
1020	Connection	EA	1	0	1	0	0
515	Steel Protective Coating	SF	16	0	0	0	16
3440	Effectiveness (Steel Protective Coatings)	SF	16	0	0	0	16

All bearings are corroded with laminations and section loss up to 50%.

Typical movable bearing.

Typical bearing.

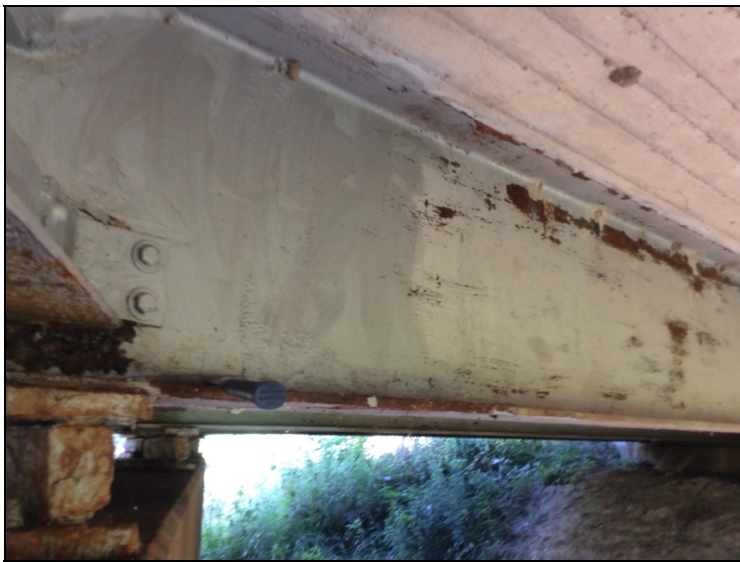
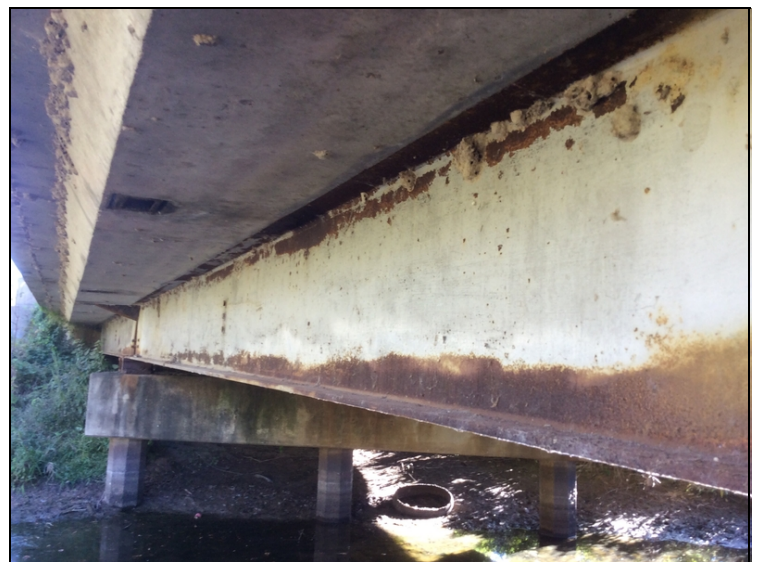
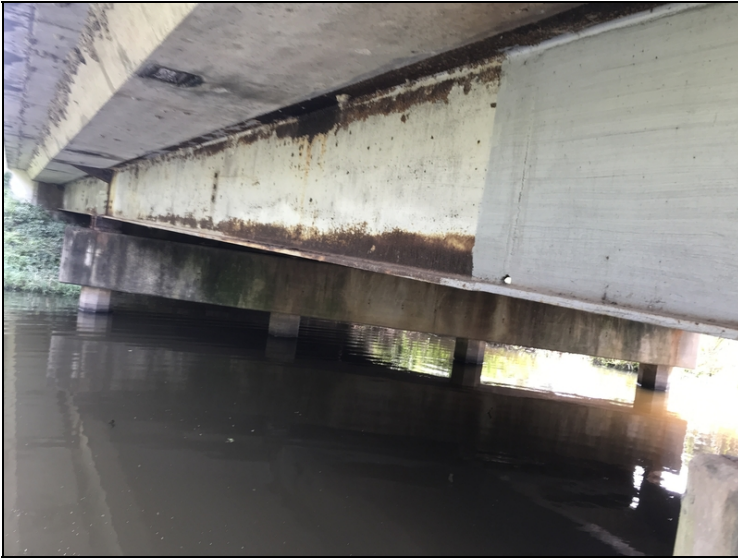
Paint has failed in many areas exposing bare metal allowing corrosion and section loss especially at girder ends and bearings.

9/15/16 crews have painted over girder ends not cleaning pact rust off first.

Typical paint on girder.

Typical paint

Typical girder.

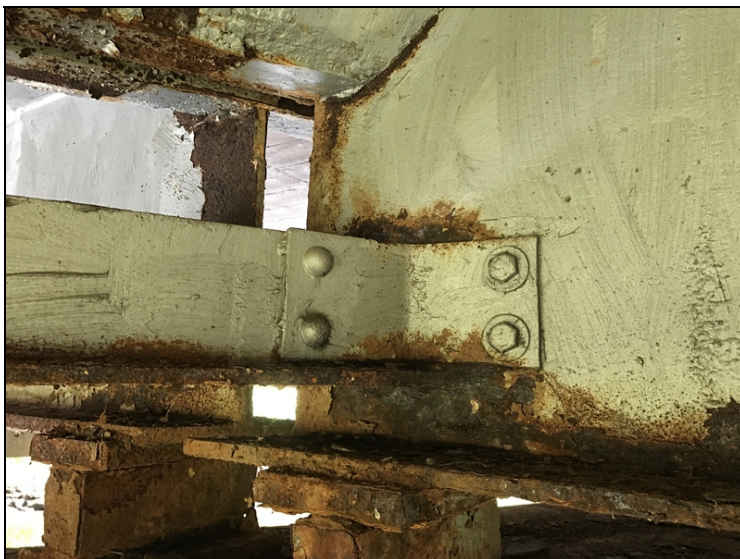
Bent #3 span #3 girder #3 corrosion at haunch and diaphragm connections with 70% sect. loss.

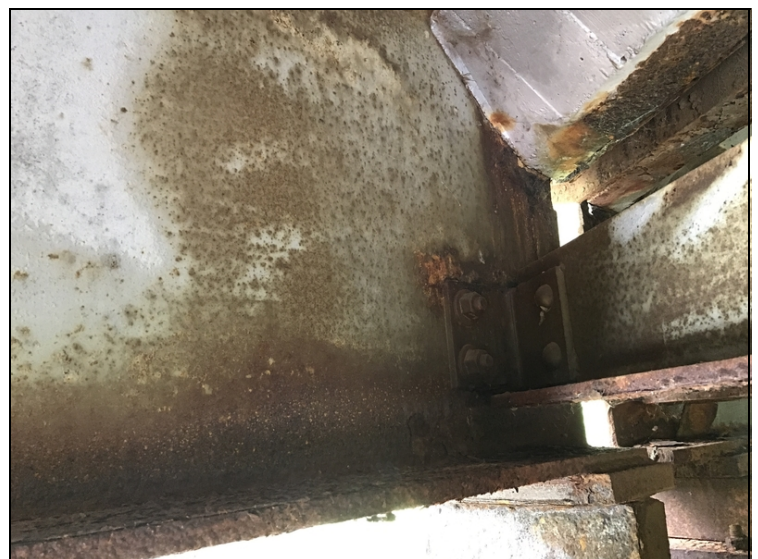
Bent #3 girder #1 span #2 corrosion at haunch and diaphragm connections with 60% sect. loss.

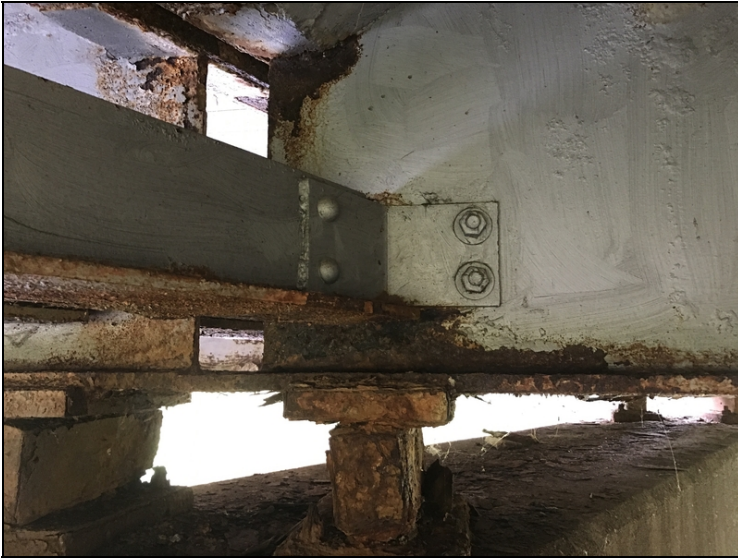
Bent #3 span #3 girder #2 corrosion at haunch and diaphragm connections with 70% sect. loss.

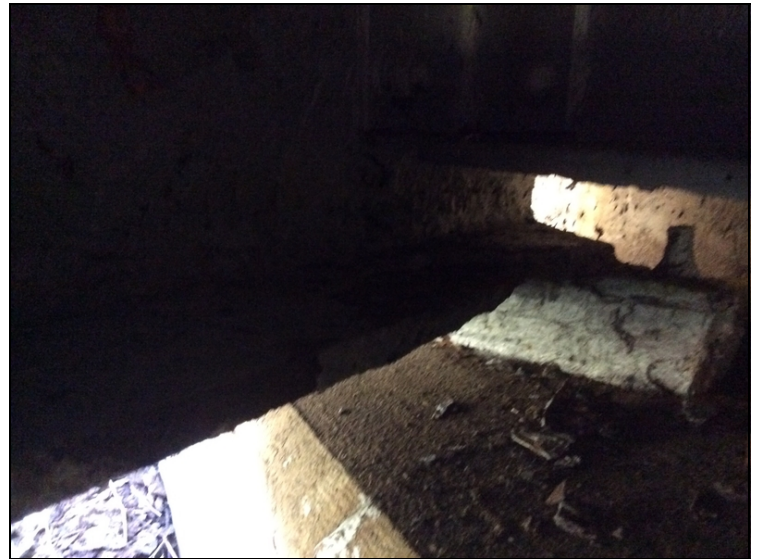
ABUTMENT # 2 GIRDER #1 LOWER FLANGE FOR FIRST 2' HAS SECTION LOSS UP TO 75% GROWING INTO WEB.

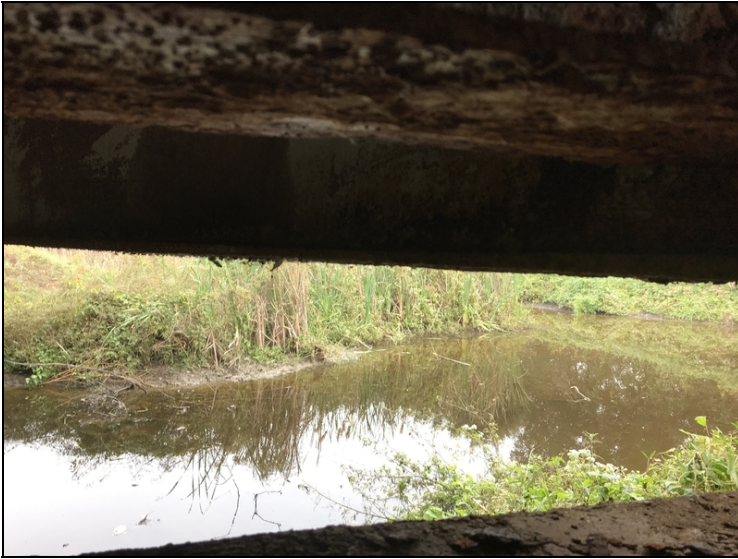
Bent #2 span #2 girder #4 has first 2' long area bottom flange inside with up to 50% section loss.

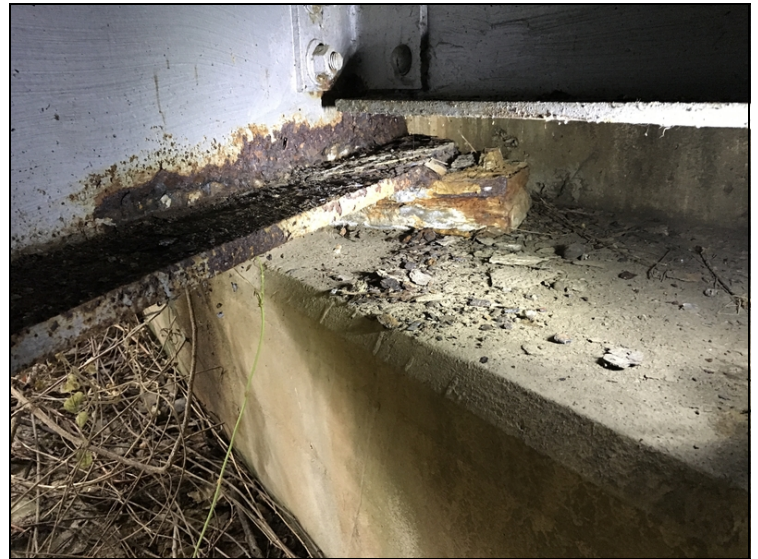
Abutment #1 girder #4 lower flange and lower web at lower flange has corrosion with laminations and section loss up to 25% for two feet.

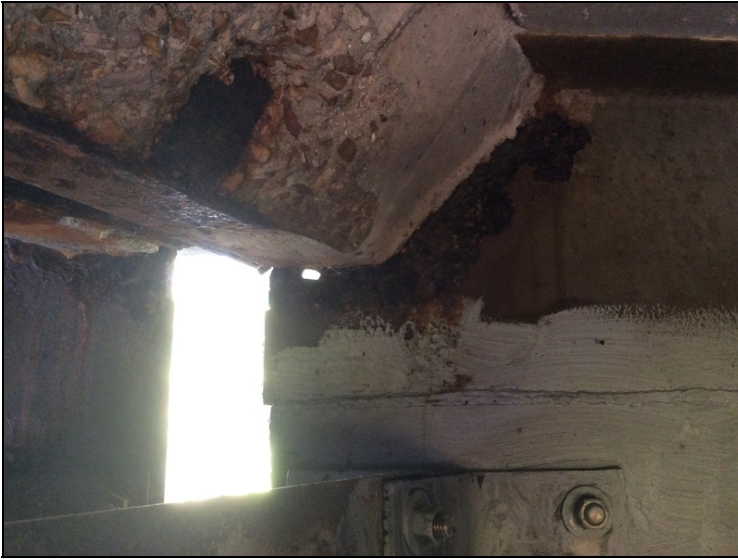
Bent 3 girder 1 span 3 has section loss up to 80% around haunch with small hole.

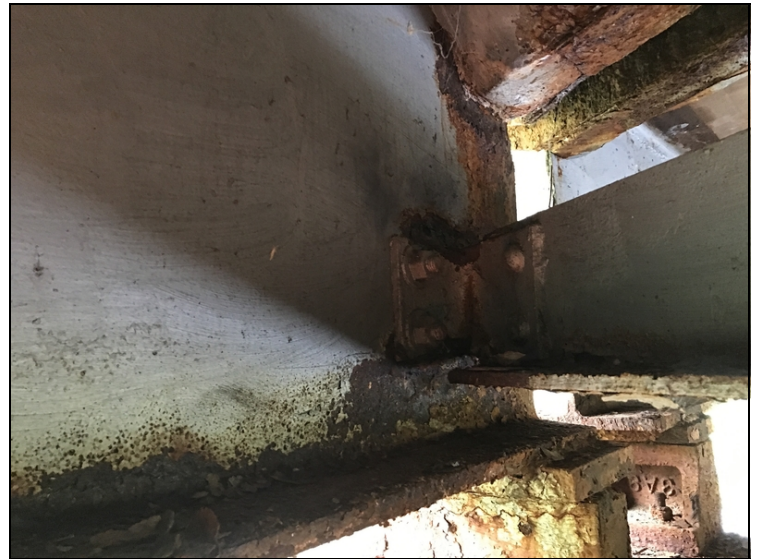
Bent #2 girder #1 span #1 corrosion at haunch and diaphragm connections with 70% sect. loss.

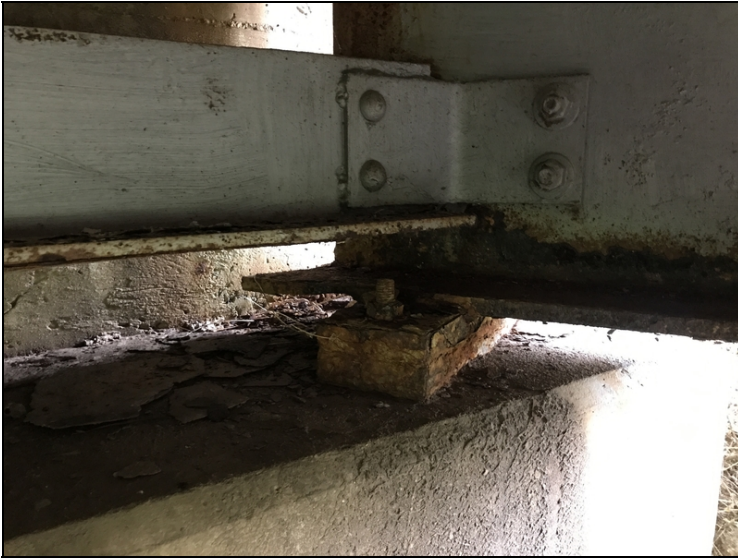
Abutment #2 girder #4 bottom flange has 25% section loss last one foot.

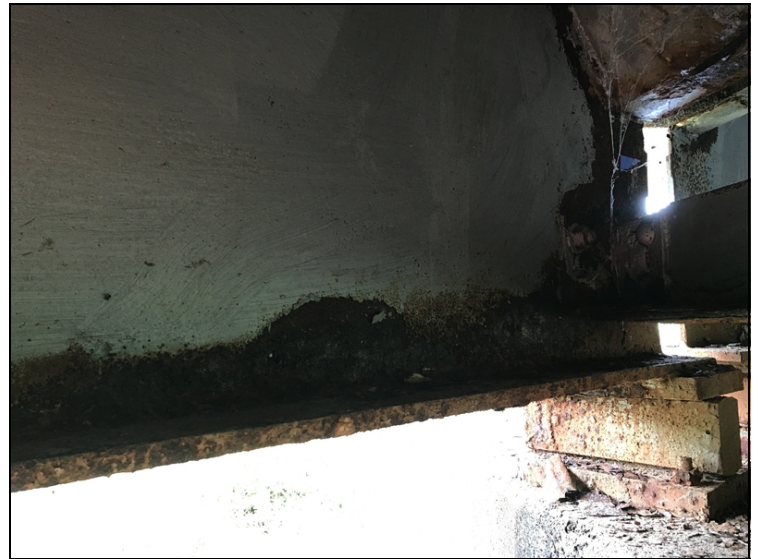
Bent #3 span #3 girder #4 corrosion at haunch and diaphragm connections with 70% sect. loss.

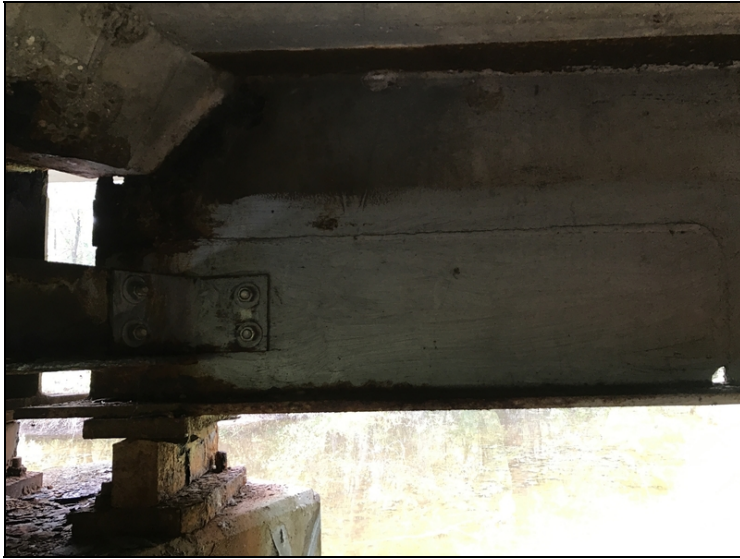
Bent #3 girder #1 span #3 has section loss up to 80% around haunch with small hole. Girder has been t-spliced for one foot tall three feet long.

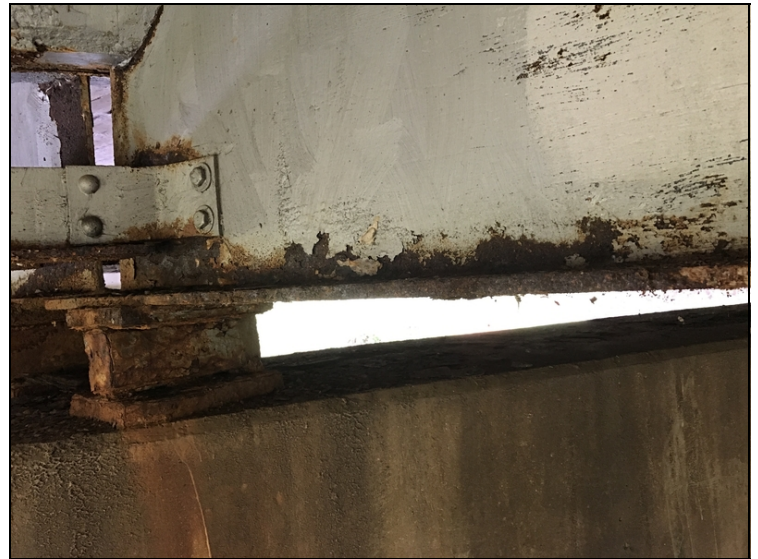
Bent #3 span #3 girder #3 lower flange first 2' corroded & laminated with section loss up to 20%.

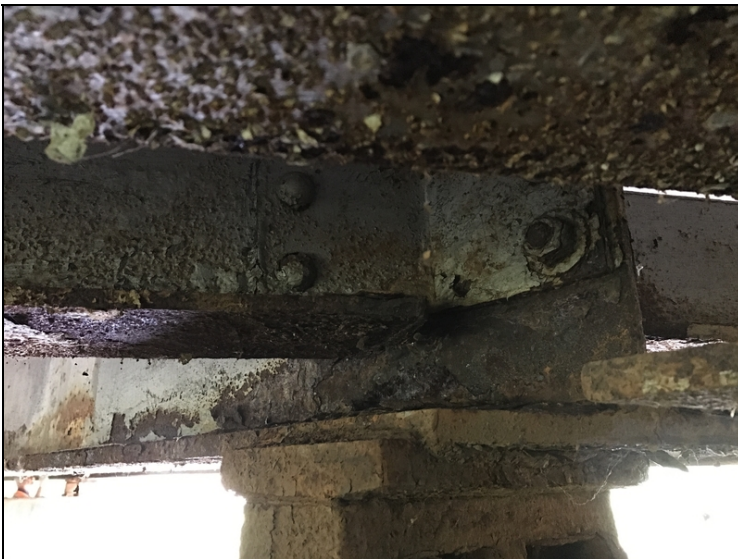
Bent #2 span #2 girder #3 corrosion at haunch and diaphragm connections with a small hole under diaphragm.

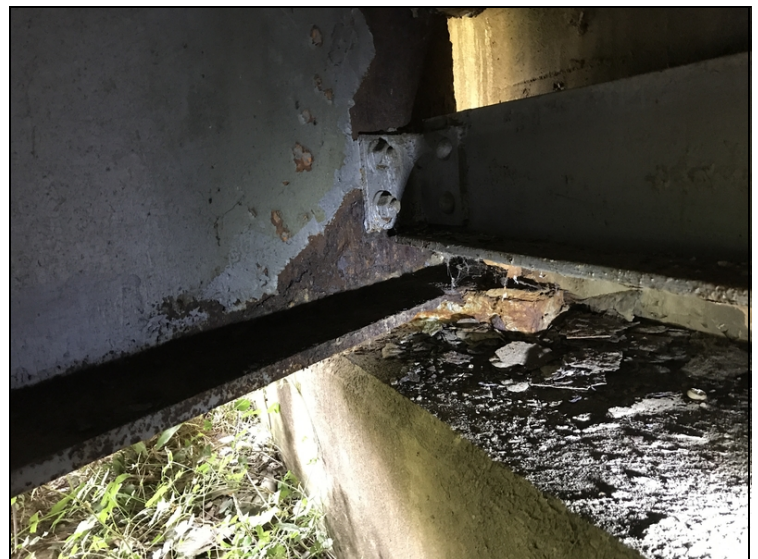
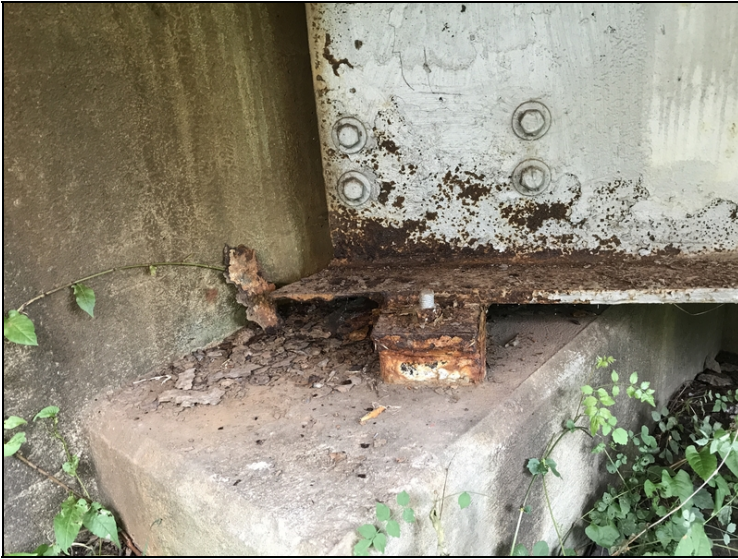
Abutment #2 girder #1 bottom flange into the lower web has up to 75% section loss for first foot of girder both sides.

Abutment #2 girder #1 bottom flange Into the lower web has up to 75% section loss for first foot of girder both sides.

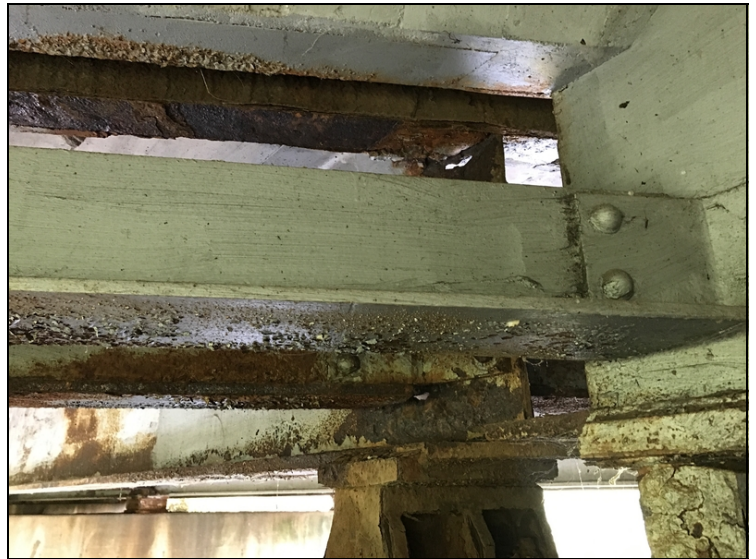
Bent #2 span #2 girder #2 corrosion at haunch and diaphragm connections with a two inch hole at diaphragm and a three inch hole at haunch.

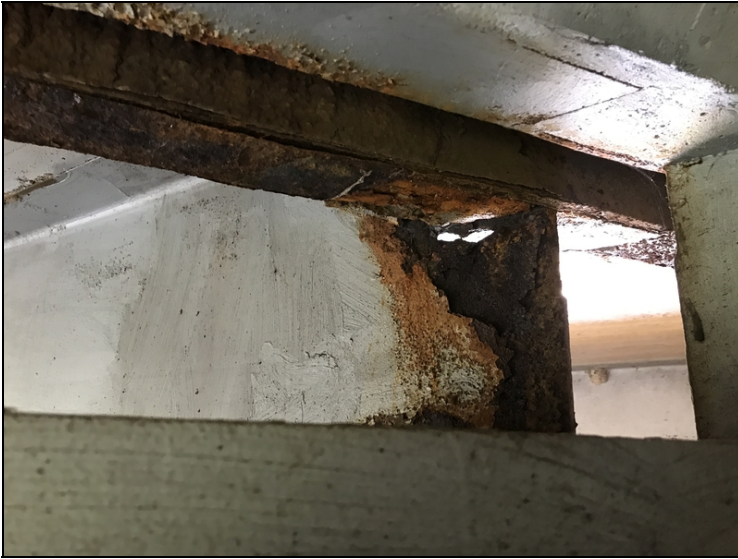
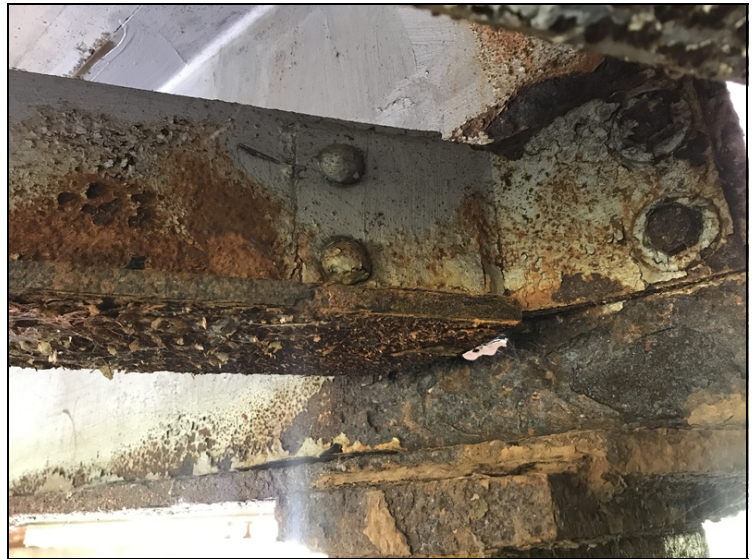
Span two bent two girder two.

Bent #2 span #2 girder #2 has corrosion at haunch and diaphragm connections with a two inch hole at diaphragm and a three inch hole at haunch.

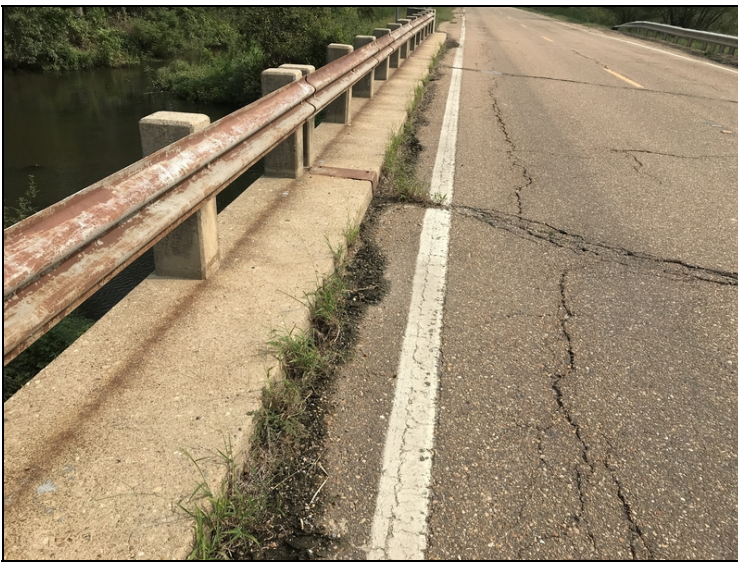
Vegetation is growing in gutters and beside bridge.

Vegetation is growing in gutters.

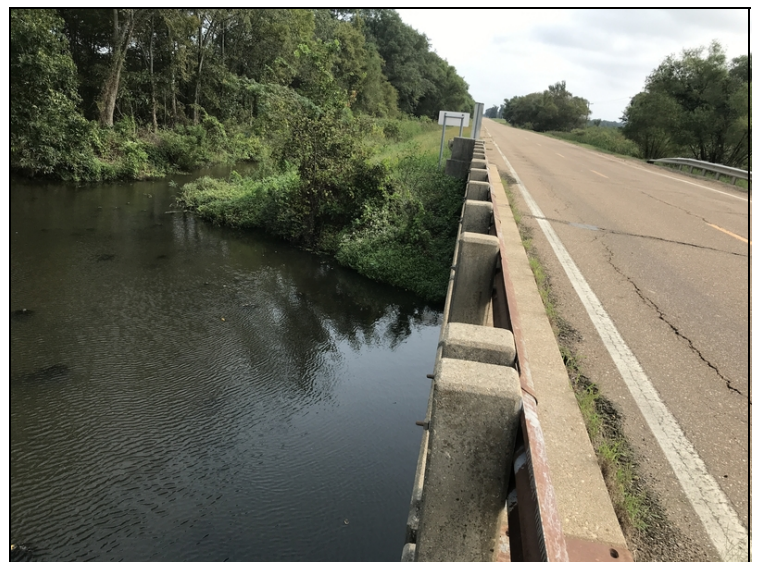
Vegetation growing beside the bridge.

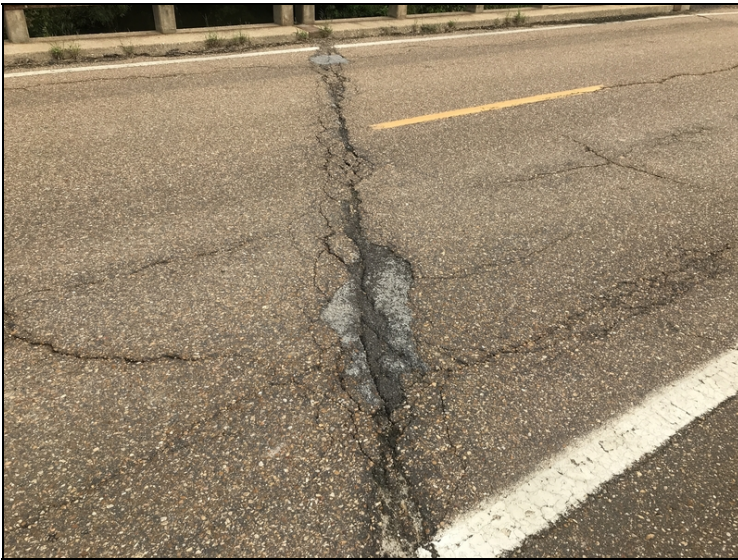
Joint at bent three.

Overlay at joints is cracked and beginning to spall.
