Bridge #06978(Routine, Underwater type 2)
Us-79/Sec-15/L4.29 over Walnut Lake / Big Creek

Location: 3.5 Miles West Of Sh 238

Team Lead: Myron Futrell **Inspection Date:** November 08, 2021

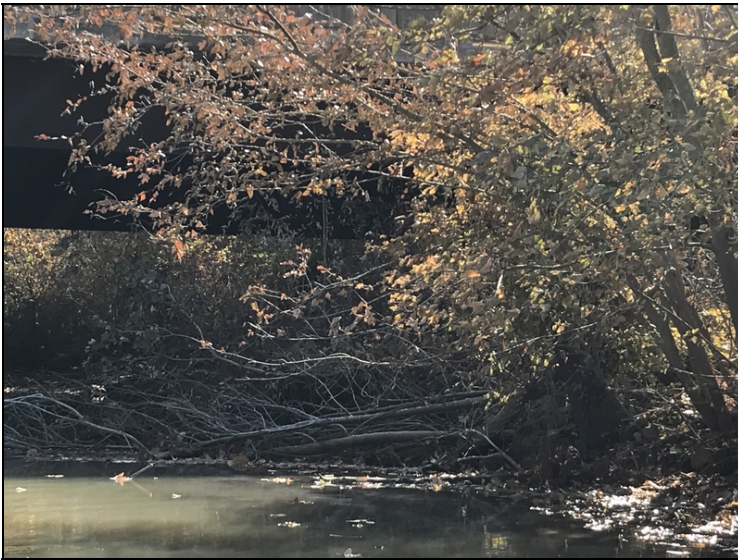
Vegetation is growing under and beside bridge.

Typical vegetation

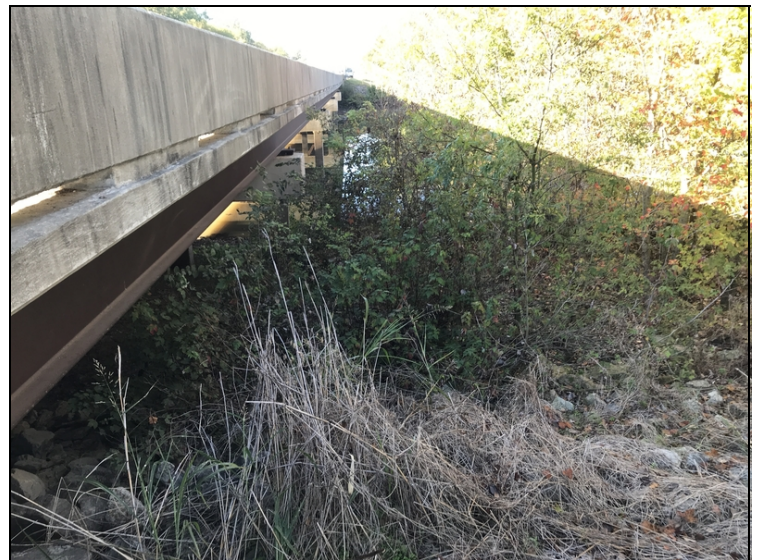
Trees and vegetation growing beside and under bridge

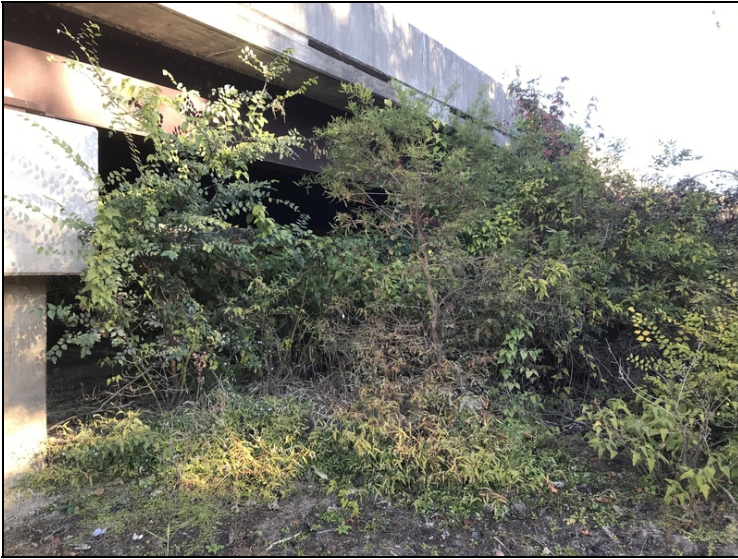
Vegetation growing beside and under bridge

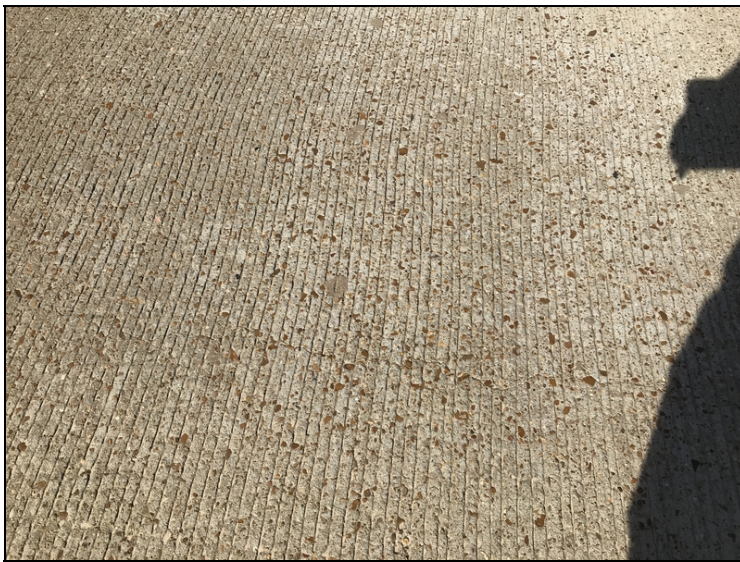
Deck has open transverse and longitudinal cracks spaced three to four feet apart.

Typical deck crack.

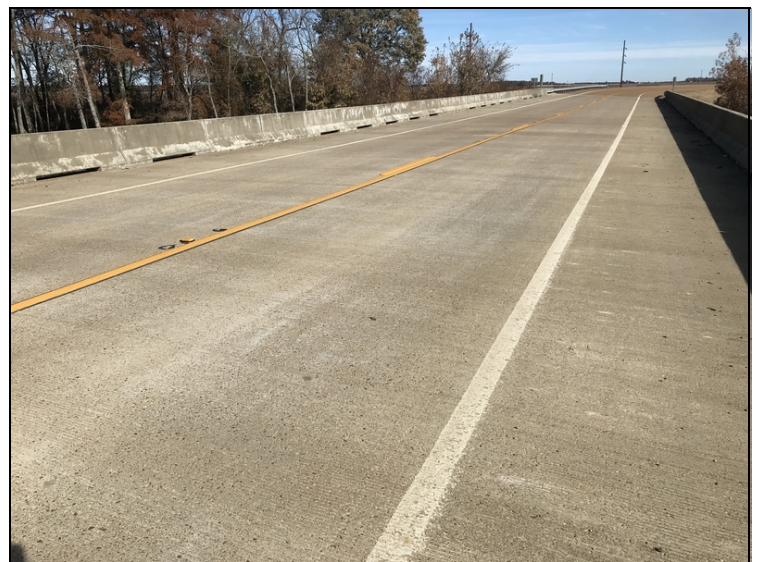
Typical deck

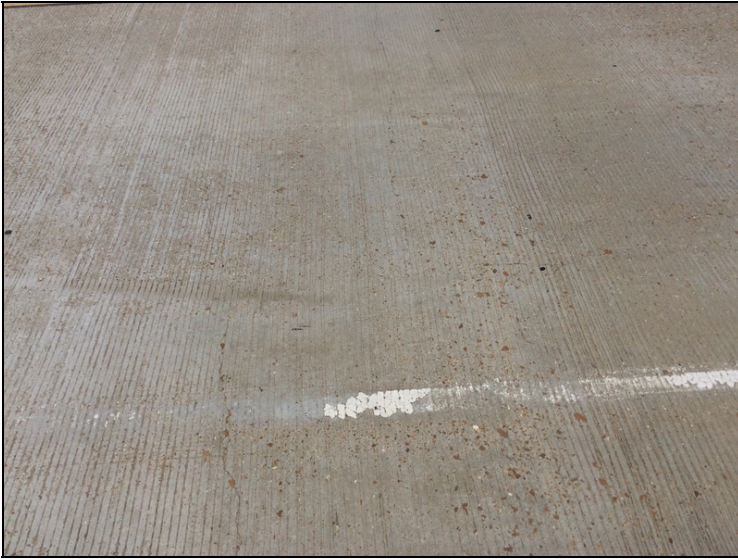
Typical deck cracks.

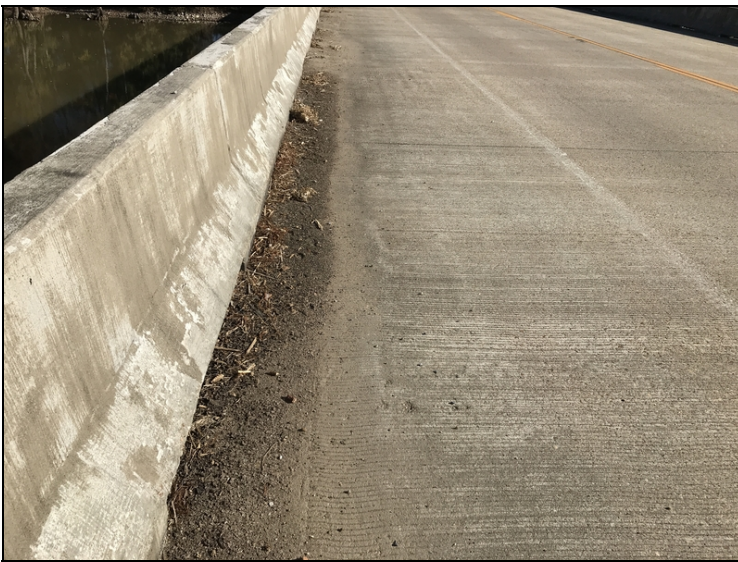
Gutters have dirt and debris.

Dirt and debris in gutters

Type of Work: Clean

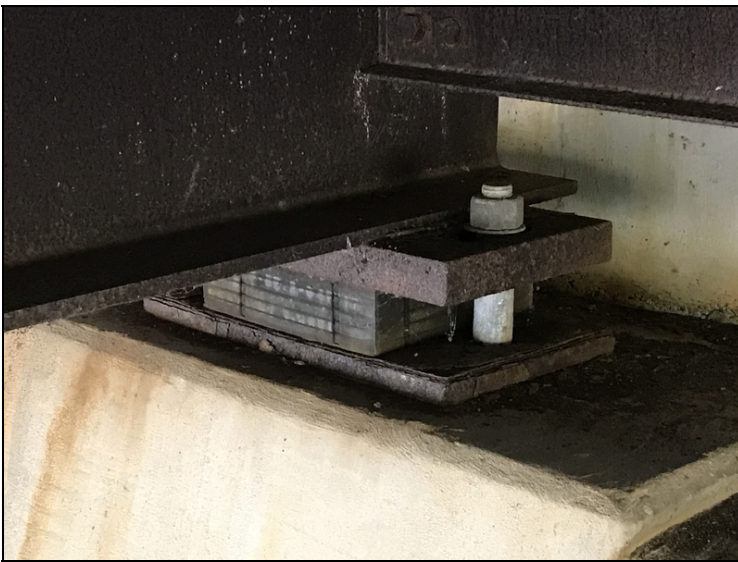
Abutment #1 bearings have corrosion with laminations on sole plates and masonry plates.
Abutment #2 girders #2,3,4,5 have corrosion on sole plates and masonry plates with laminations.

Typical corrosion with laminations on abutment #1 bearings

Date Reported: 11/16/2021
Priority: C - Important
Type of Work: Clean
Status: Open
Component: 310 - Elastomeric Bearing
