Bridge #05001(Routine)

Sh-20/Sec-1/L22.44 over Long Lake

Location: 0.3 MI S JCT 49 & 20

Team Lead: Drew Melton Inspection Date: May 05, 2021

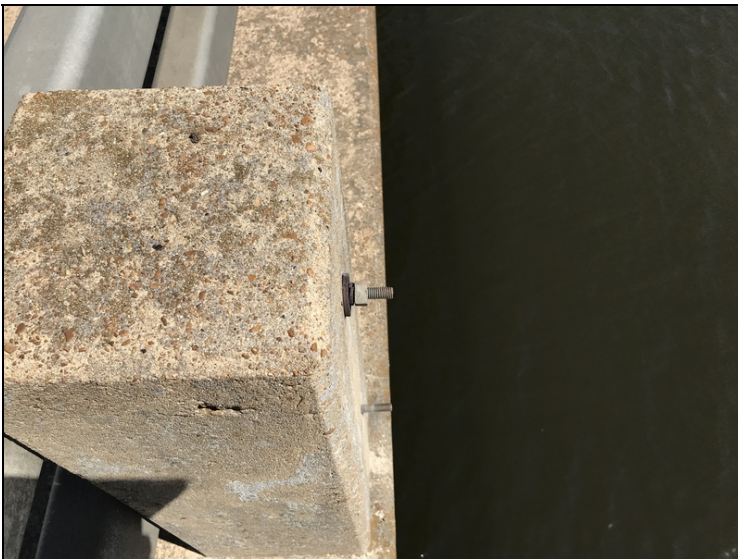
Span #4 right rail post #2,4 connection bottom rail nuts are missing.
Span #5 right side post #5 top rail bolt missing.
Span # 5 left side post #3,5 top rail bolts missing.

Typical rail nut missing

Date Reported: 05/31/2011
Priority: D- Routine
Type of Work: Replace
Status: Monitor
Component: 330 - Metal Bridge Railing

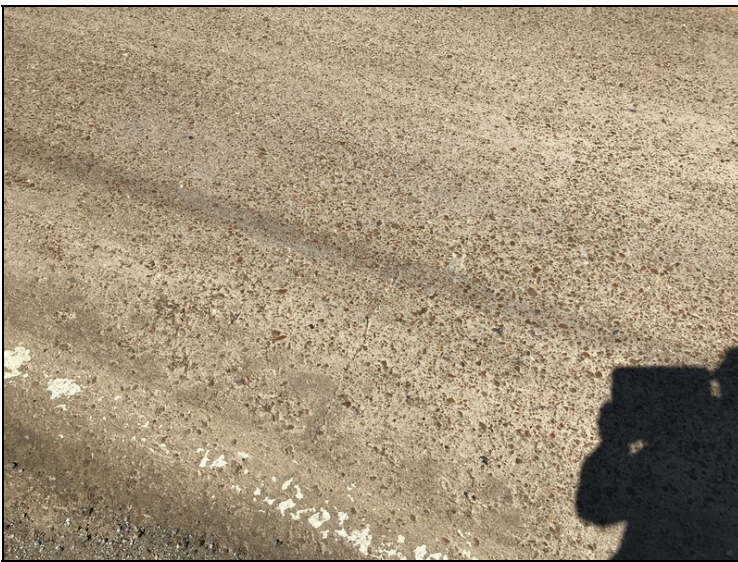
Deck surface has numerous open transverse cracks each span spaced four feet apart.

Typical deck crack.

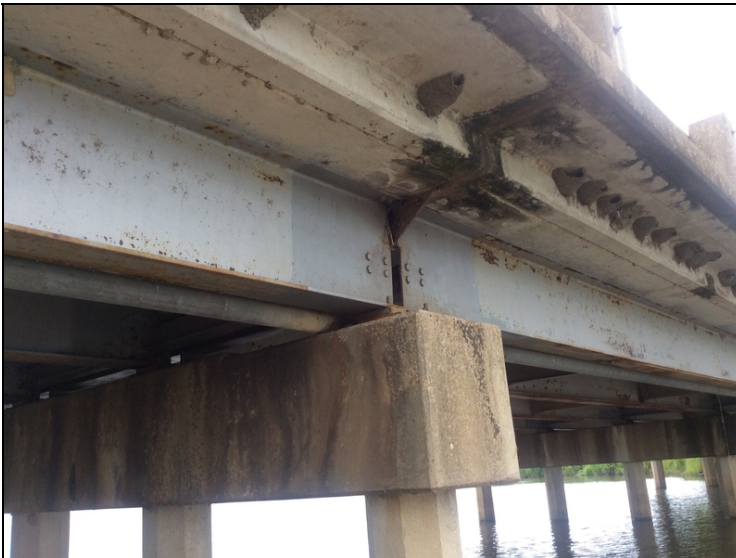
Bearings at bent #3 span #2 girders #3,5 right side has missing nuts.
Bent #5 span #4 girder #1,2,4 right anchor nuts missing.
Bent #5 span #5 girder #5 right anchor nut missing.
Bent #5 span #4 girder #5 left anchor nut missing.
Abutment #2 girder #4 both anchor bolts missing.

Bent #3 span #2 girder #5 anchor nut missing
typical of other locations.

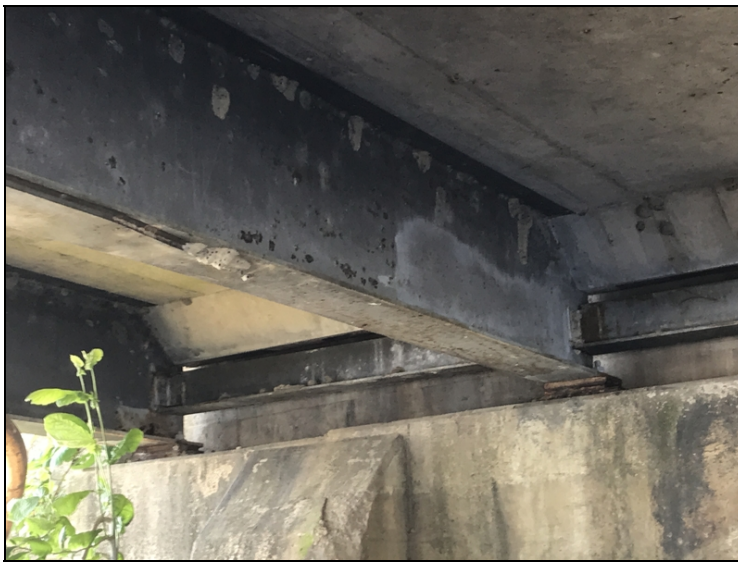
Girders have surface rust full length and ends of girders are corroded with up to 50% section loss unless other wise noted. Girder have 20% bare steel with rest of paint chalky and little effectiveness.

2017 Girder ends have had some cleaning and painting since last inspection.

Typical girder ends that have been painted

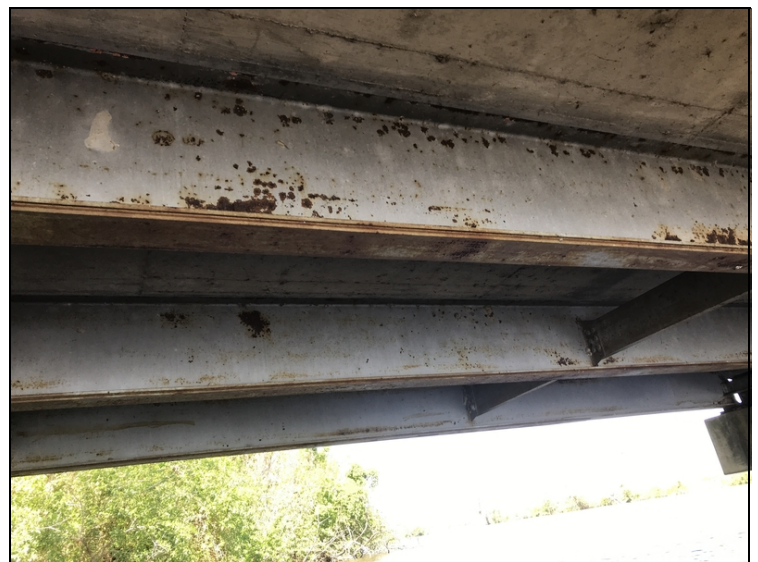
Typical paint condition

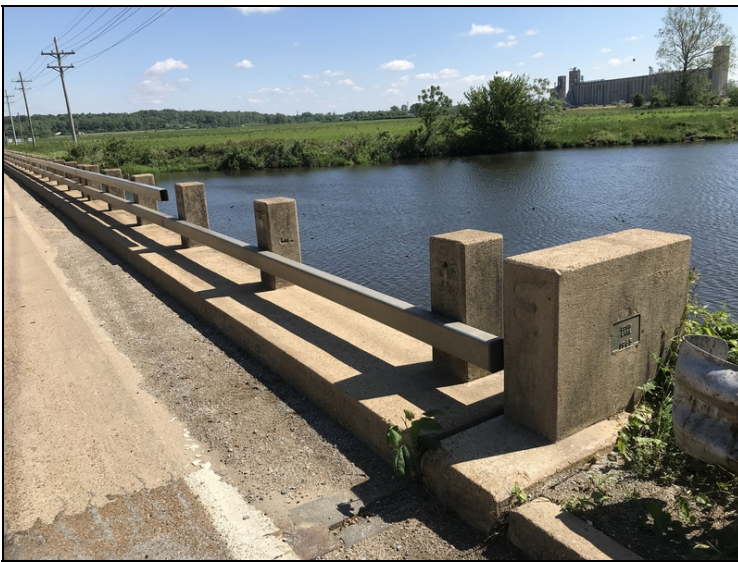
Span #1 right side first segment of top rail is missing.

Span #1 right rail missing

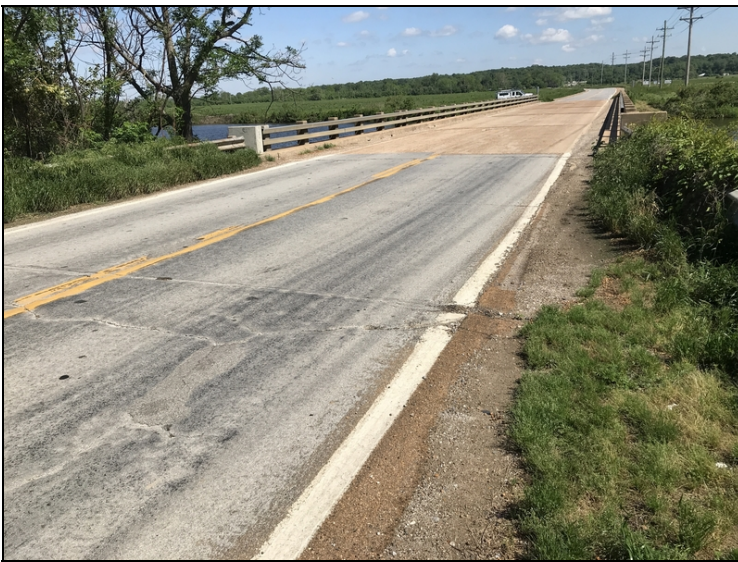
Abutment #1 approach gutters

Gutters have dirt and debris in them.
Approach gutters, both abutments, have dirt, debris and vegetation growing in them.

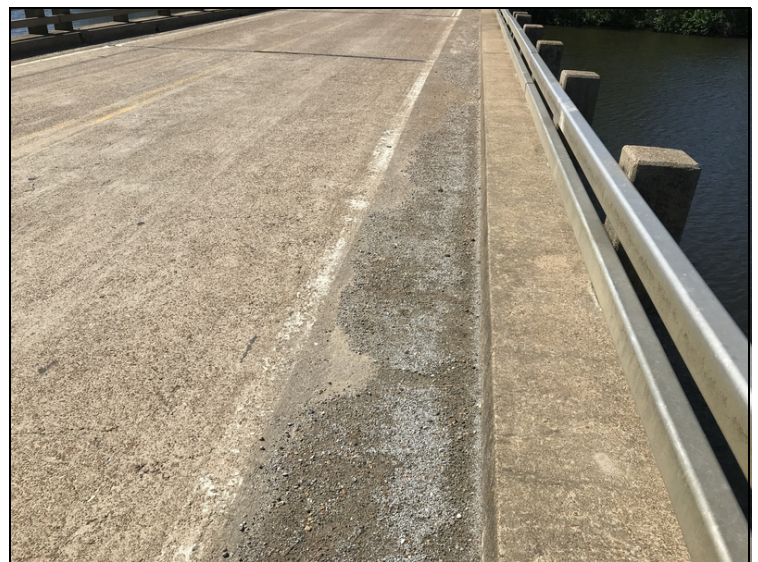
Typical gutters

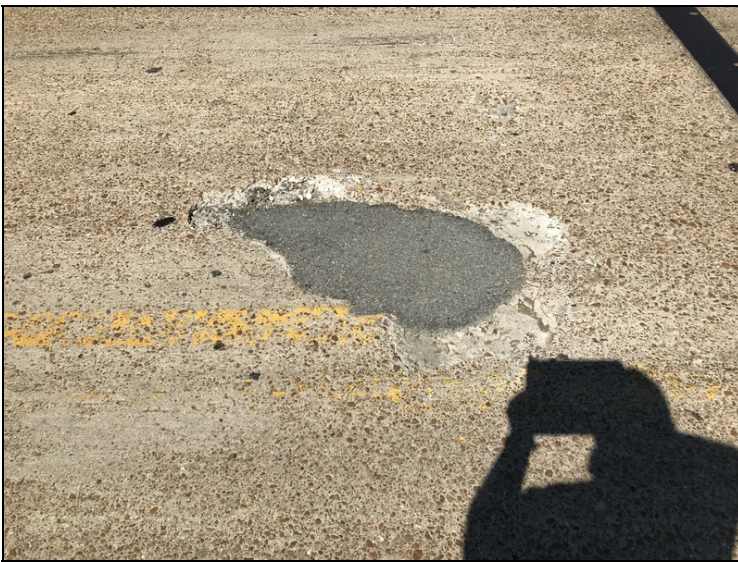
Span #1 deck, left lane, at centerline. at bent 2 has 1 1/2' x 2 1/2' x 1 1/2" deep spall with a asphalt patch that is failing.

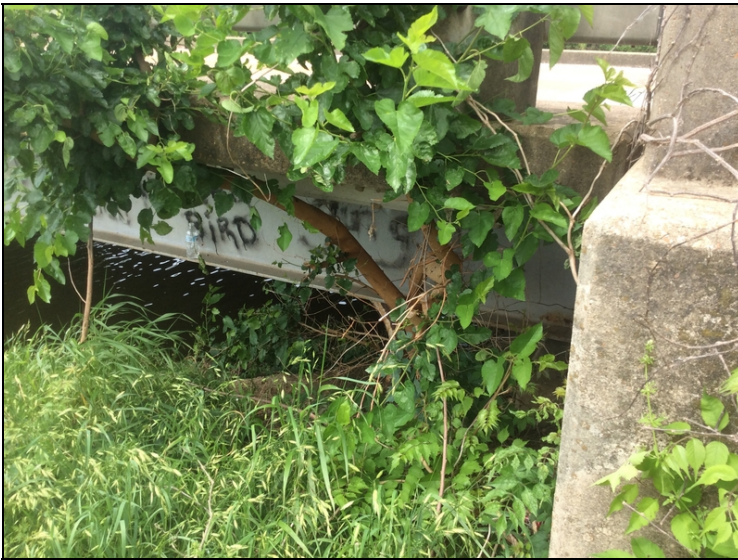
Small tree growing under bridge at abutment 2 right side.

Tree growing under bridge at abutment 2 right side.

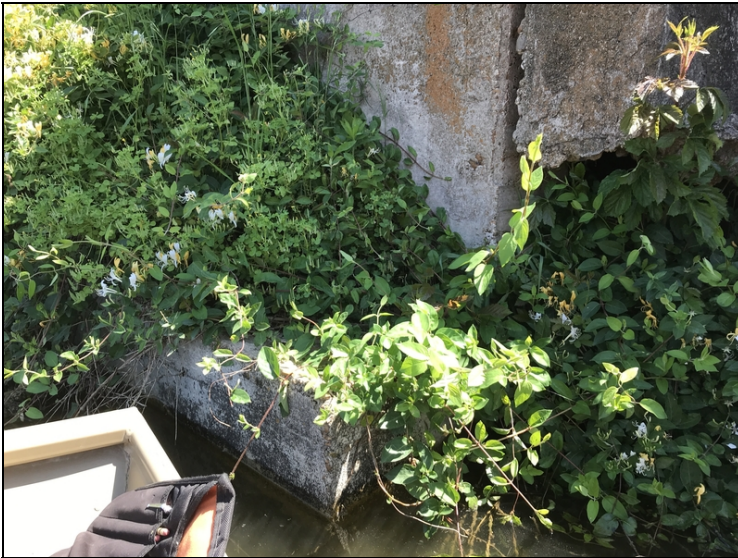
Abutment #2 left wing footing is exposed full length.

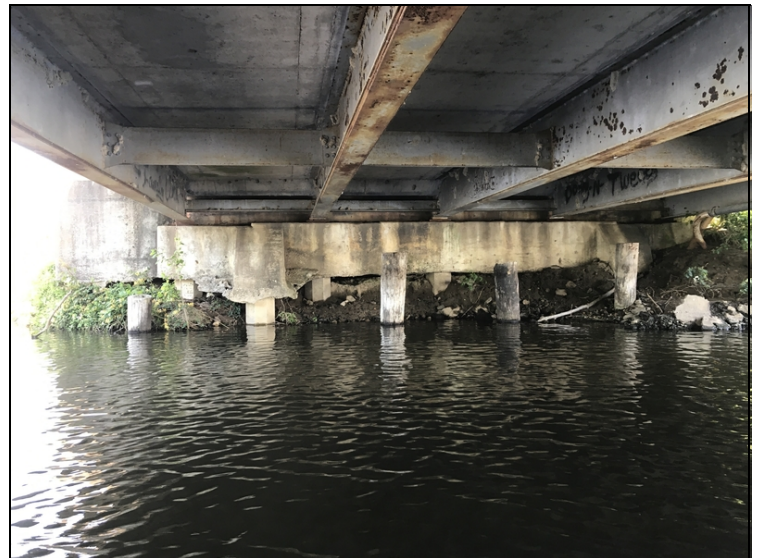
Abutment #1 undermined 2' under cap exposing piles.
Abutment #2 left side pile #1,2,3 4 exposed and cap is undermined 2' on left first 12'.
Abutment #2 left wing footing is exposed full length.

05/01/2017 Lowered substructure from 7 to 6 due to undermining of abutments.

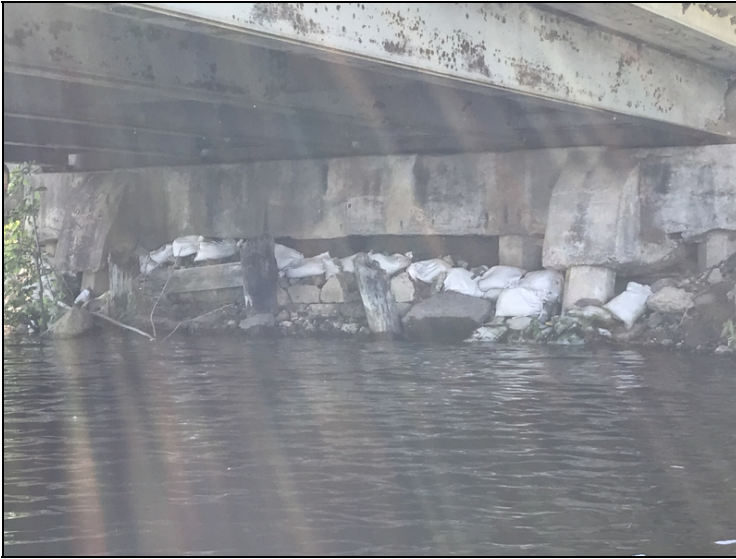
Abutment #1

2017 Some sand bags have been placed since last inspection abutment #1 only.

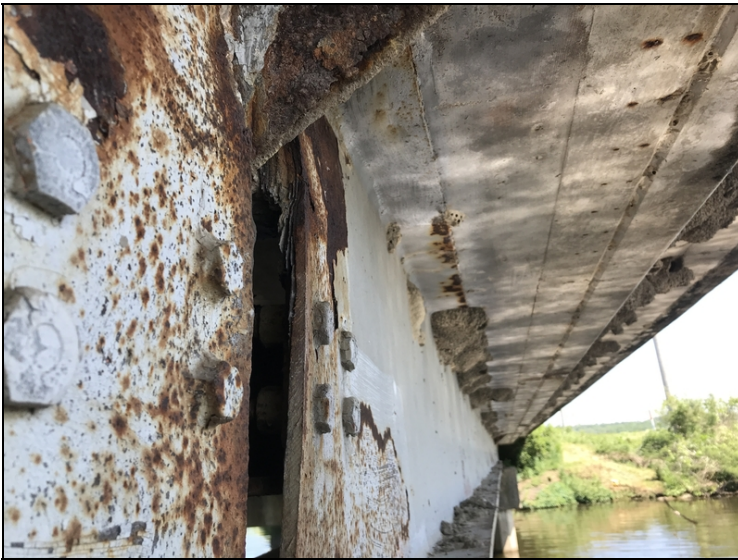
All outside girder webs are bowing outward at top due to pack rust between girder and concrete haunch.

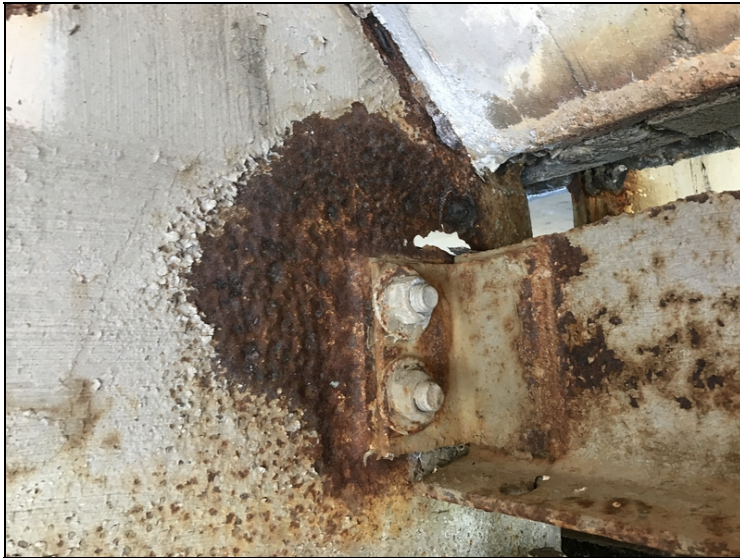
Span #4 bent #5 girder #4 web at diaphragm connection has large section loss with a three inch hole and a pin hole.

05/05/2021 lowered superstructure from 5 to 4 due to girder webs on ends having large section loss and holes.

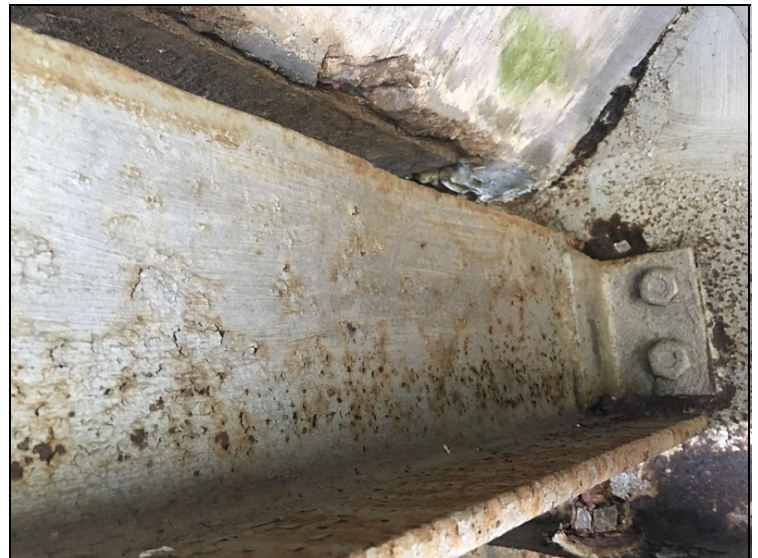
Span #2 bent #3 girder #3 has large section loss around diaphragm with a one inch hole in web.

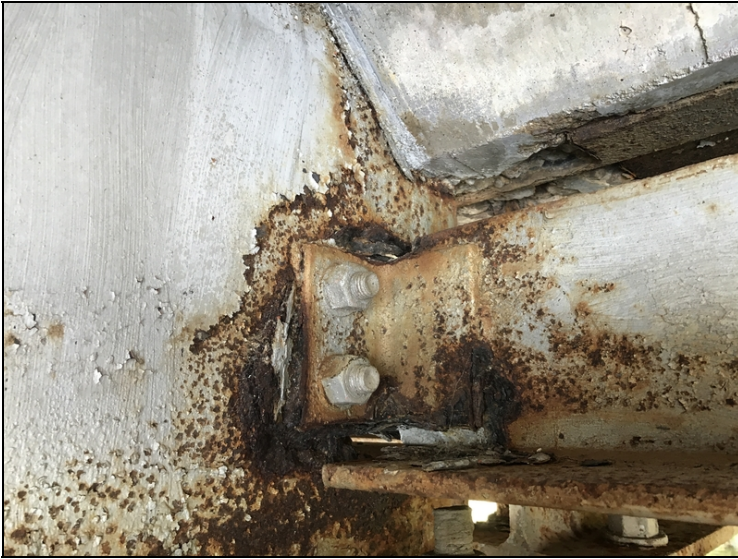
Bent #2 span #2 girder #3 has area around diaphragm condition with a three inch hole above and below diaphragm.

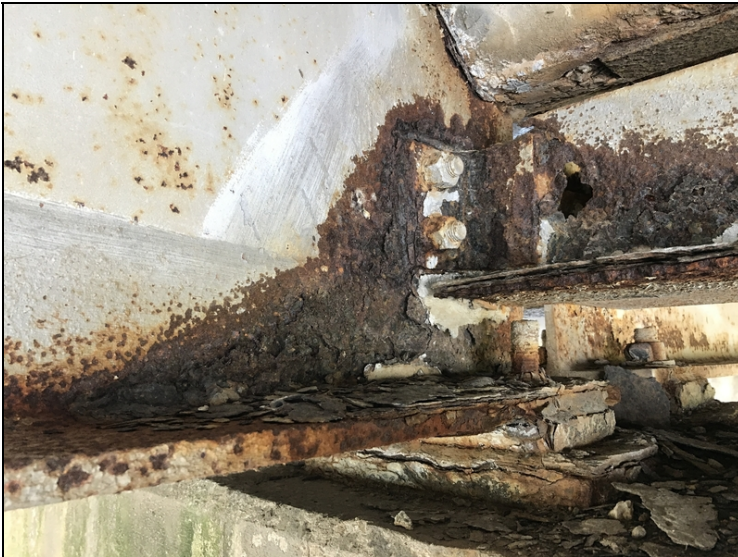
Span #4 bent #5 girder #3 web around diaphragm connection and lower flange first foot has section loss up to 75%.

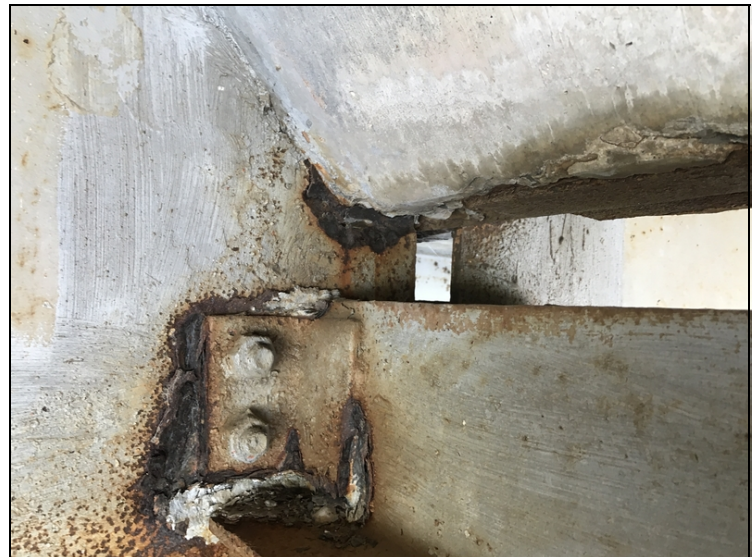
Span #3 bent #4 girder #3 has one inch hole in web at haunch and up to 75% section in web around diaphragm connection.

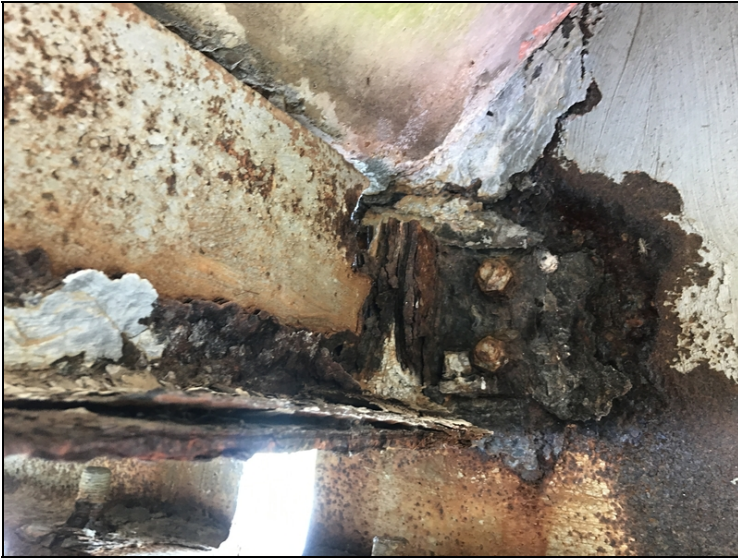
Span #3 bent #4 girder #5 web at diaphragm connection has up to 80% section loss.

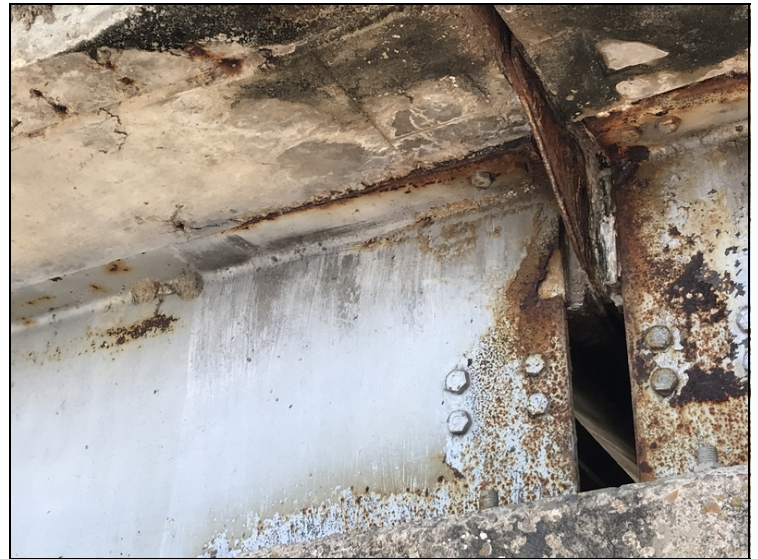
Span #2 bent #3 girder #5 web at top on end has a three inch area on outside that is rusted off.

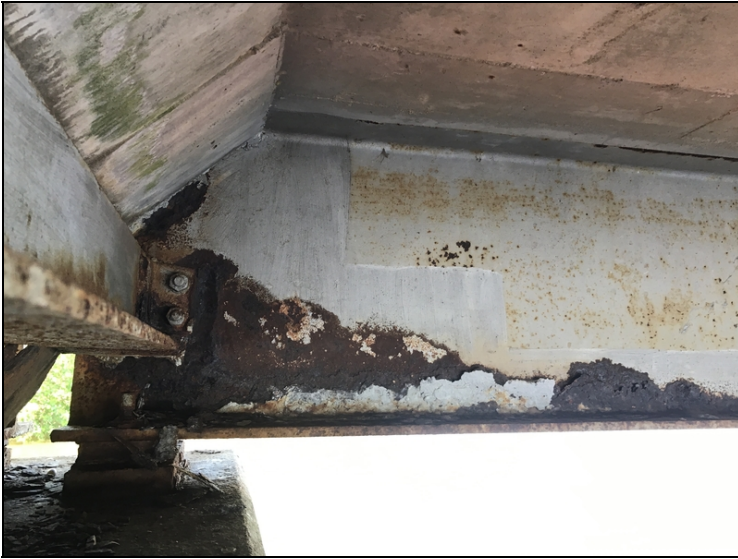
Bent #2 span#2 girder #1 first three feet of girder web has up to 75% section loss.

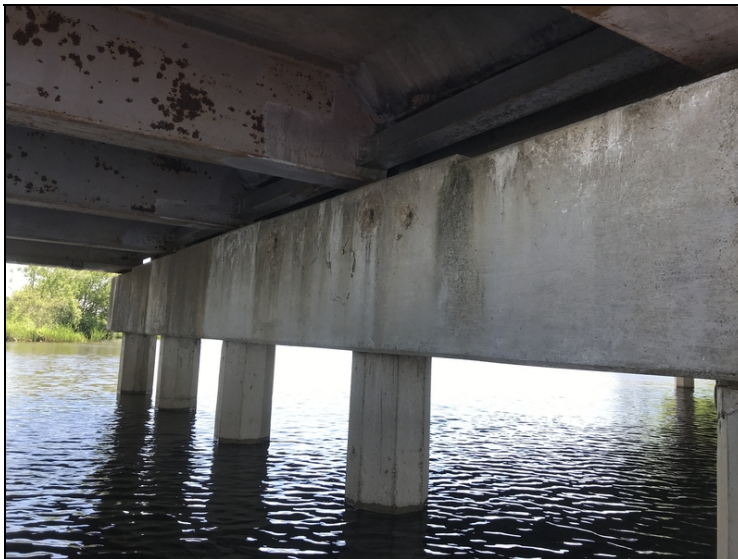
Bent #5 cap ahead face has 2' of delaminations and four 1' spalls with exposed rebar with no section loss.

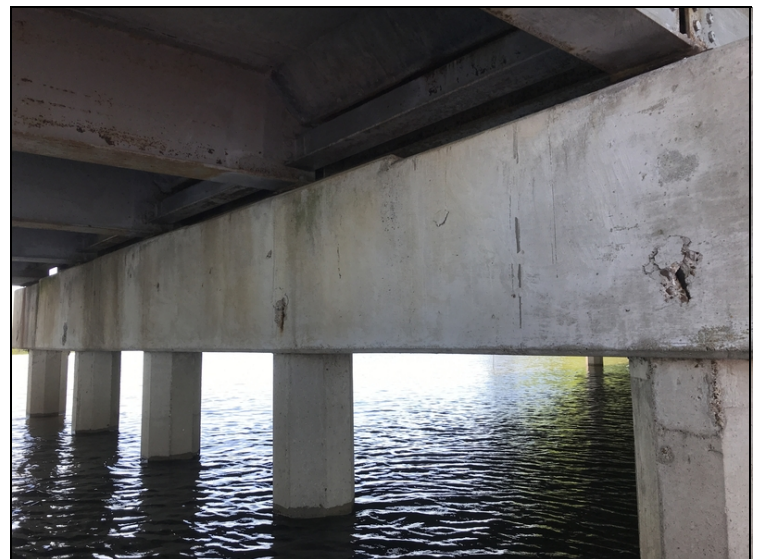
Bent #4 cap has four 1' spalls on ahead face with exposed rebar with 5% section loss.

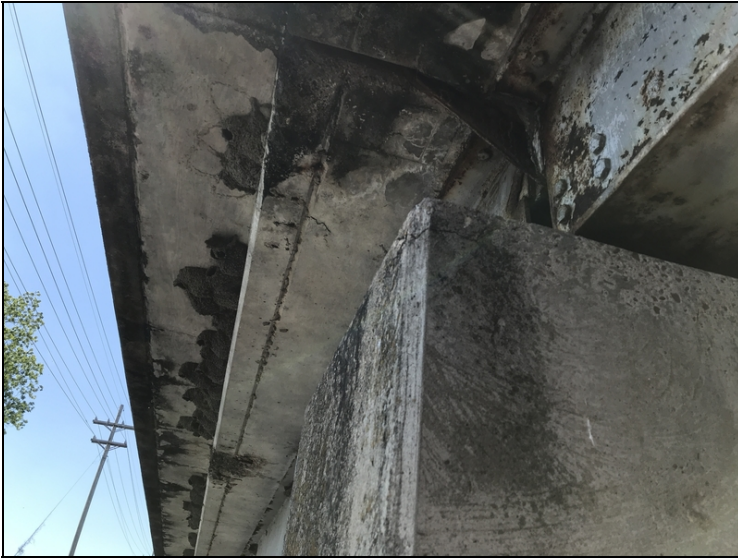
Bent #3 ahead face right top corner is cracked.

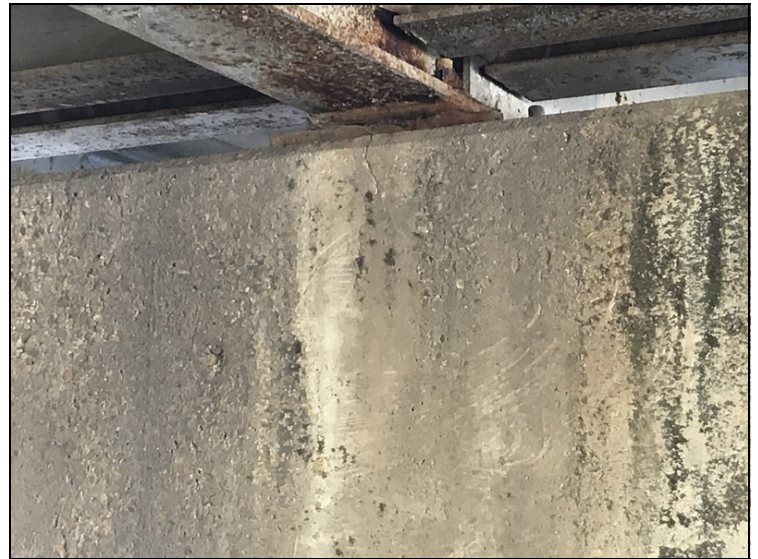
Bent #3 cap back face under girder #2 has vertical crack one foot long.

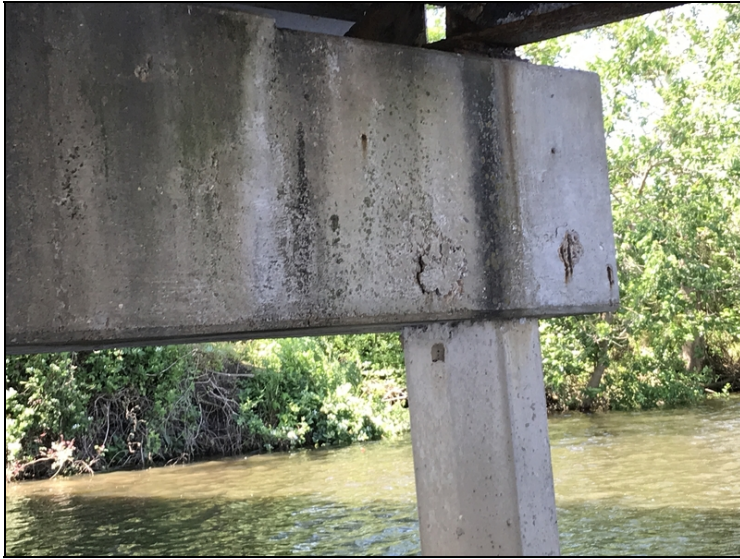
Bent #2 cap has 2 small pop outs on ahead face left end above pile #1 with exposed rebar no section loss.

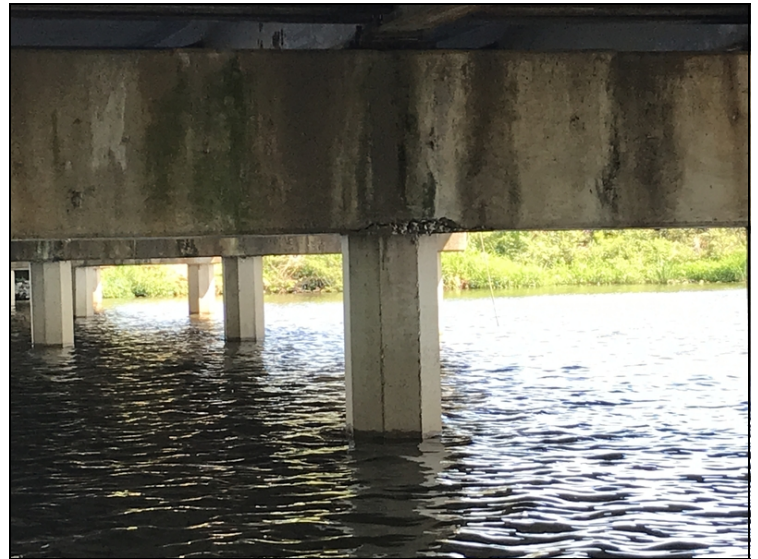
Bent #2 back face above pile #3 at bottom has 1' honey comb and 2' of delamination and cracking.

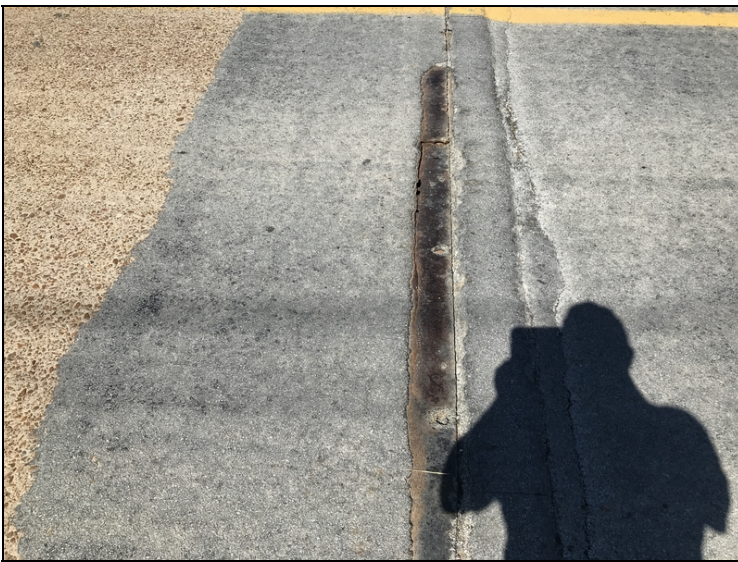
Abutment #2 right lane joint top plate is cracked,
broken and noisy for five feet.

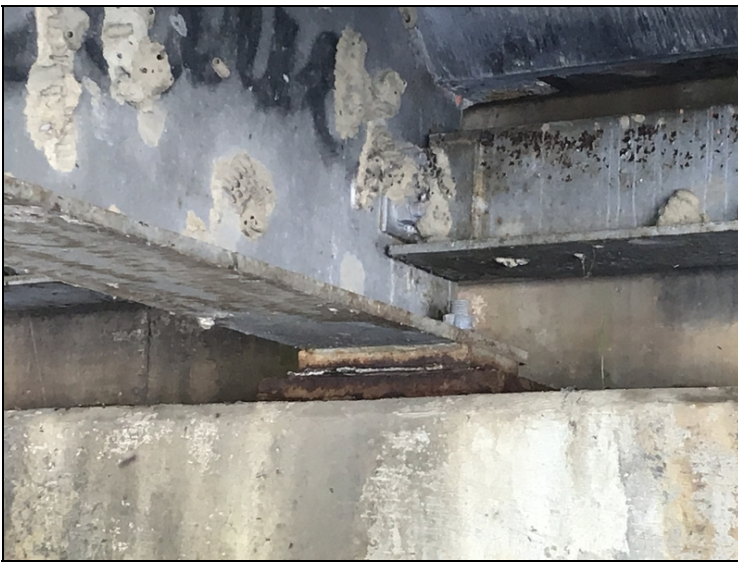
Bearings have corrosion with laminations with up 10% section loss.

Typical abutment bearing.

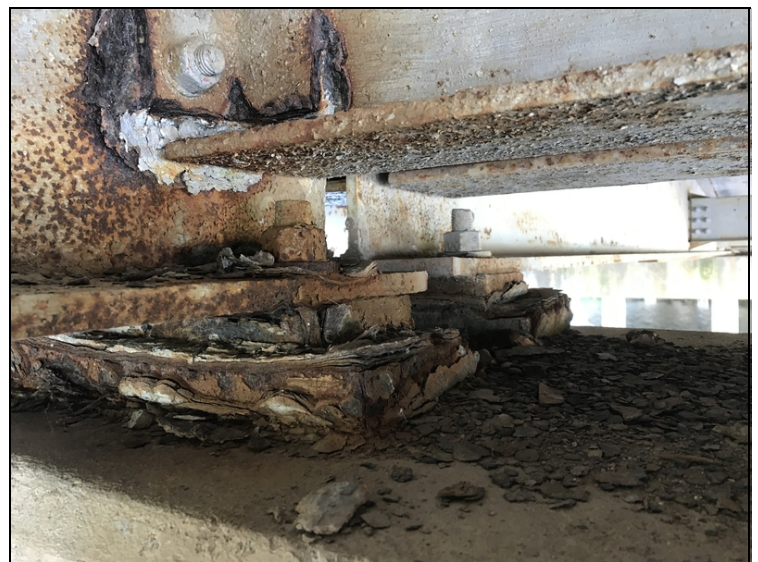
Typical bent bearings
