Bridge #03053(Routine)
Sh-44/Sec-3/L10.21 over Yellow Bank Bayou

Location: .3 Mi South Of Ratio, Ark

Team Lead: Myron Futrell Inspection Date: November 30, 2020

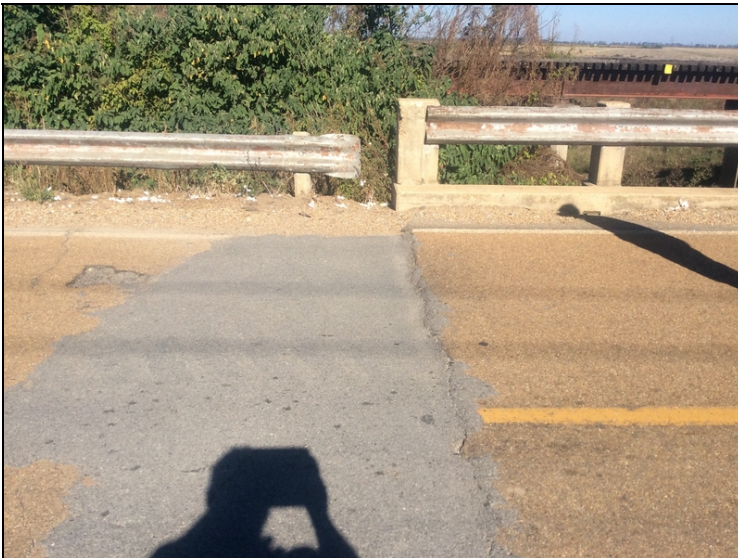
Approach roadway abutment #1
has settled two inches increasing impact loading on bridge.

Abutment #1 approach roadway settled left lane

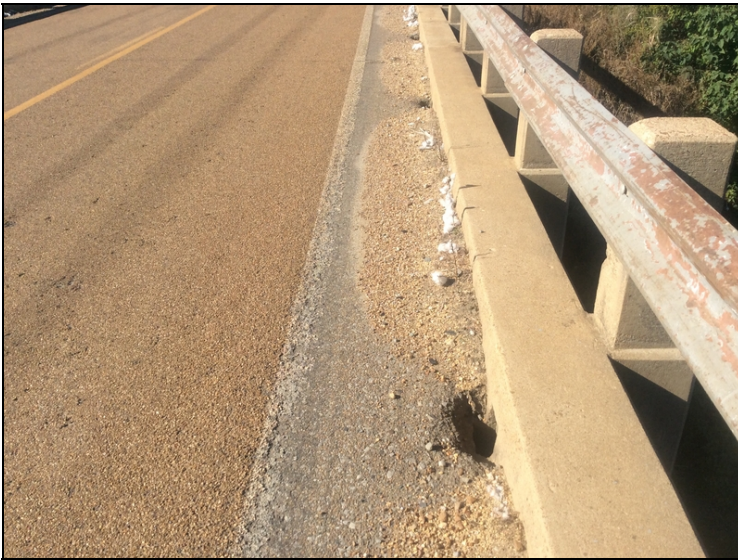
Gutters have dirt and debris in them with vegetation growing.

Gutters full of dirt and debris

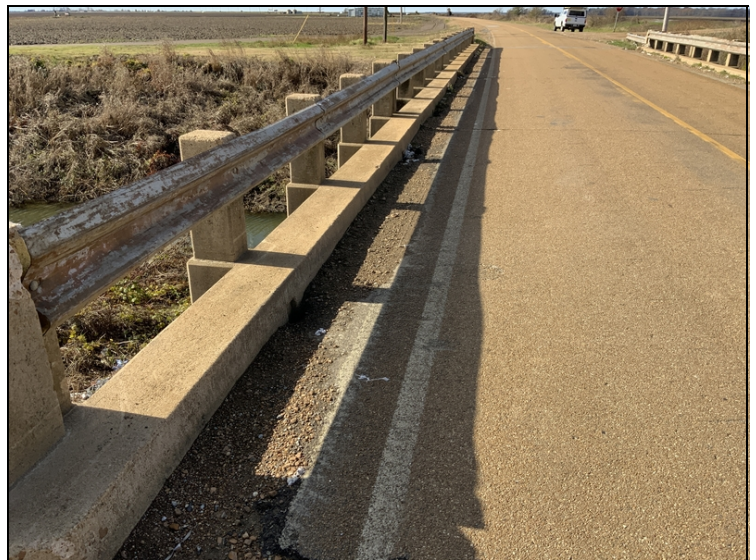
Dirt and debris in gutters.

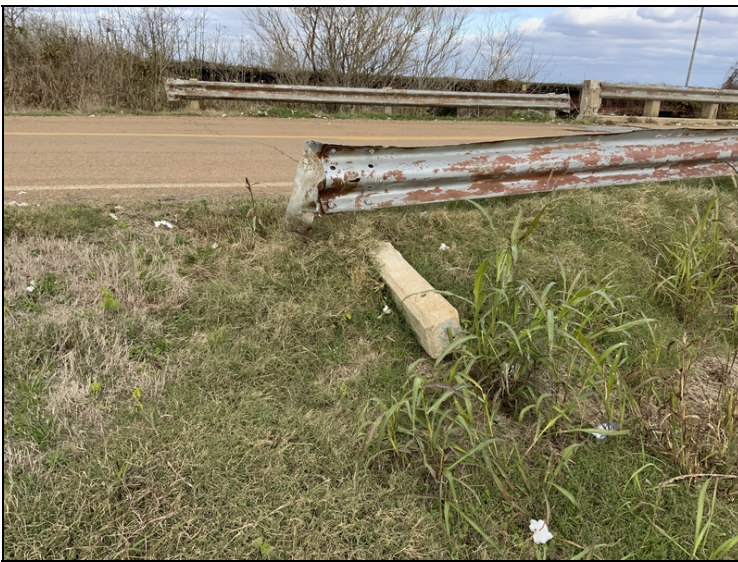
Approach rail abutment #1 right side at first post connection is loose and post is broken.

Abutment #1 right approach rail first post broken.

Abutment #1 right approach rail, first post broken.

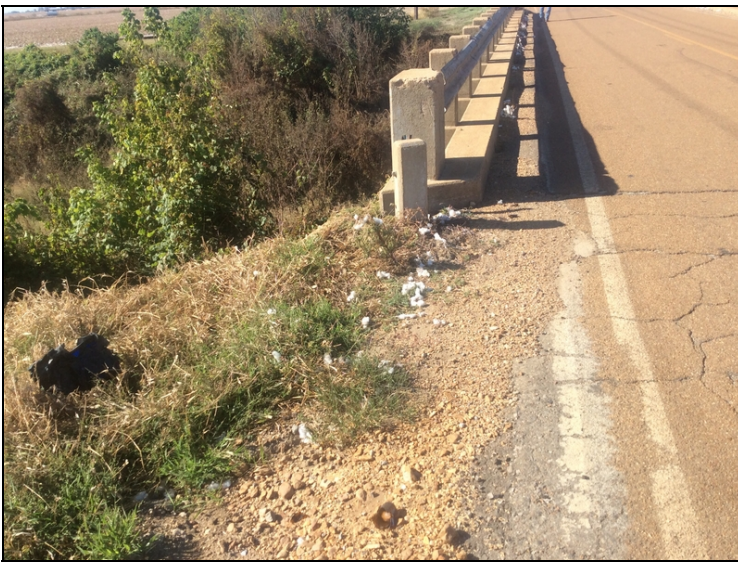
Approach rail abutment #2 right side is gone.

Abutment #2 right approach rail gone

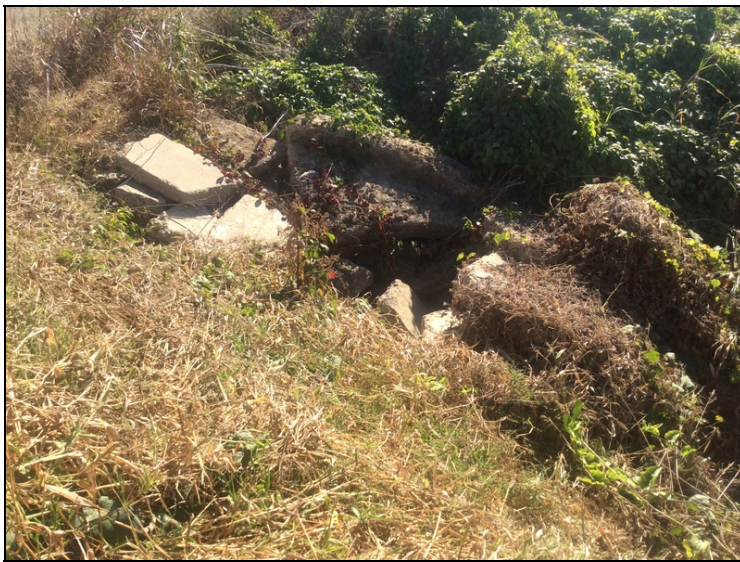
Slope at abutment #2 right side of bridge is eroded underneath concrete rubble.
Side slope eroded at abutment #2 right side 10' +/- from bridge end.

Abutment #2 right side erosion under rubble

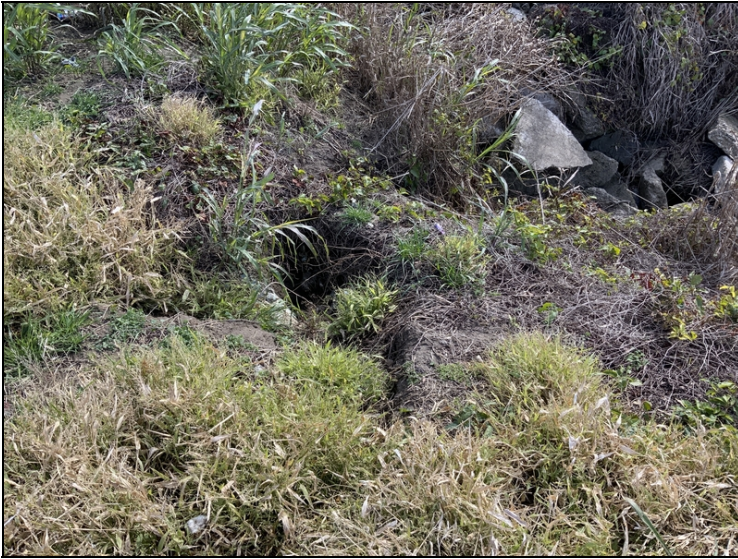
Slope erosion at abutment #2 right side 10' +/- from bridge end.

Abutment #2 right side sloe 10'+- from end of bridge eroded.

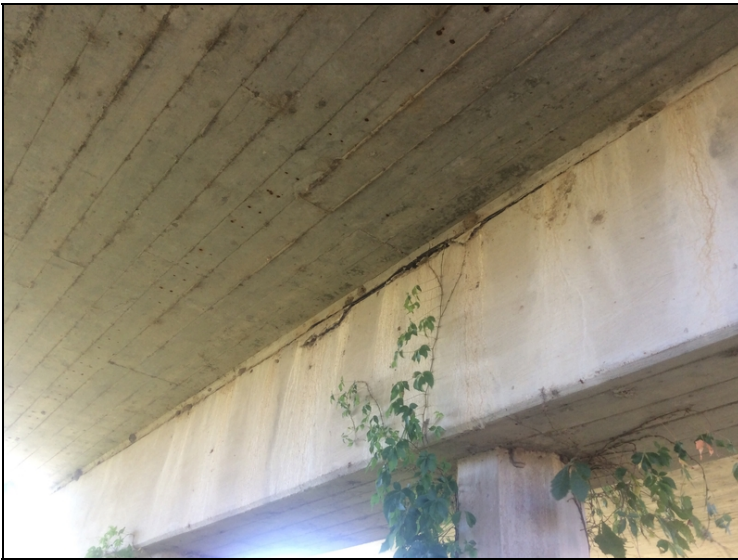
Bent #4 cap ahead face at centerline

(234)							
Bent #4 cap left end has several hairline cracks.							
Bent #4 cap ahead face at top has a one foot delamination in center.							
Abutment #2 cap has one vertical crack near center.							
Abutment #1 cap has vertical cracks every two feet.							
301	Pourable Joint Seal	LF	80	0	0	80	0
2350	Debris Impaction	LF	80	0	0	80	0

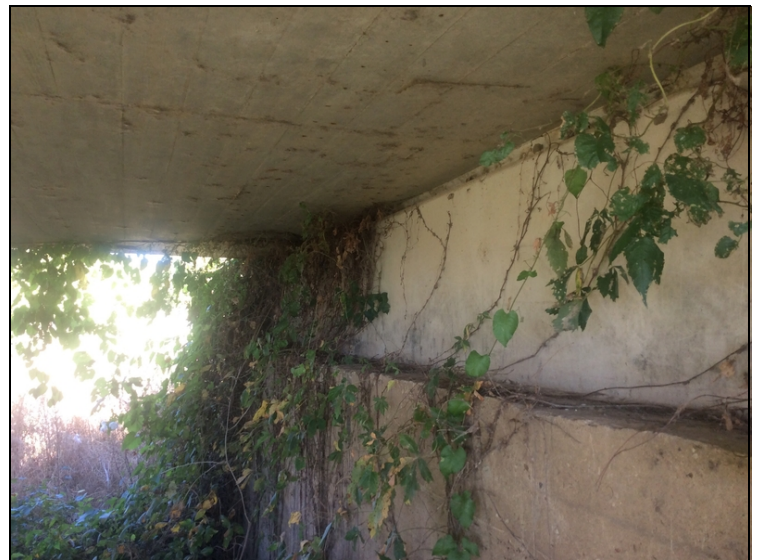
Vegetation growing under bridge and up piles and abutments

Vines growing onto both abutments

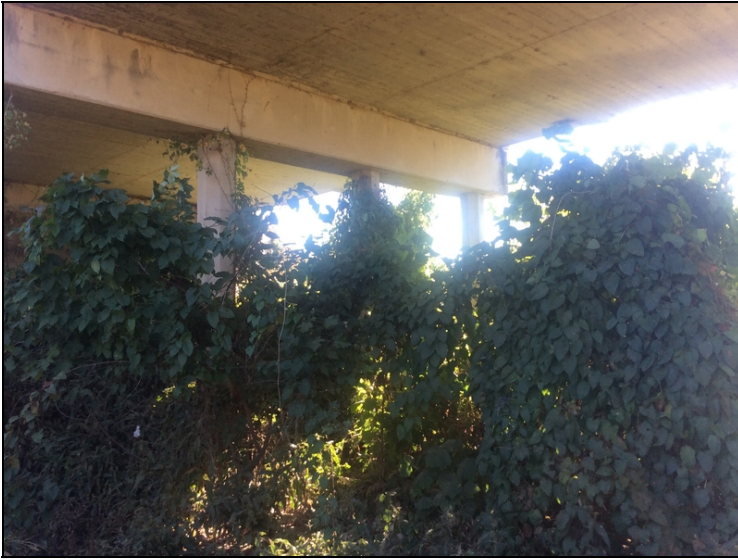
Vegetation growing under bridge and up piles bent
#4

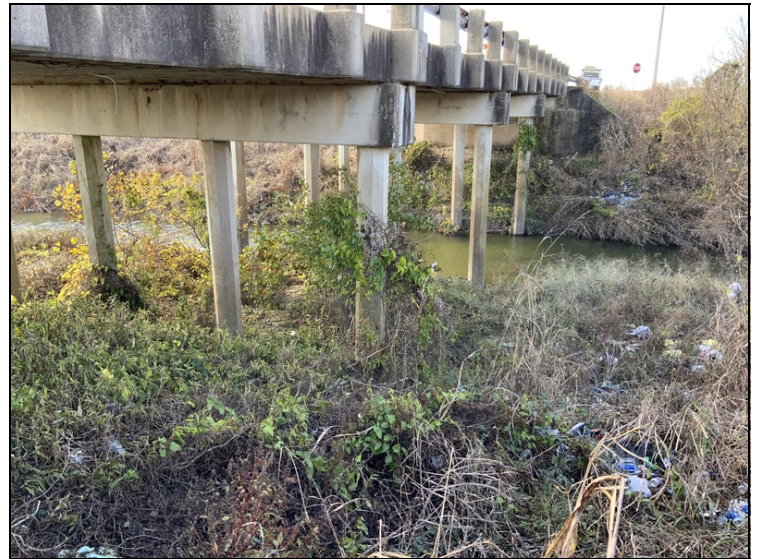
Small trees and vegetation growing beside and
under bridge.

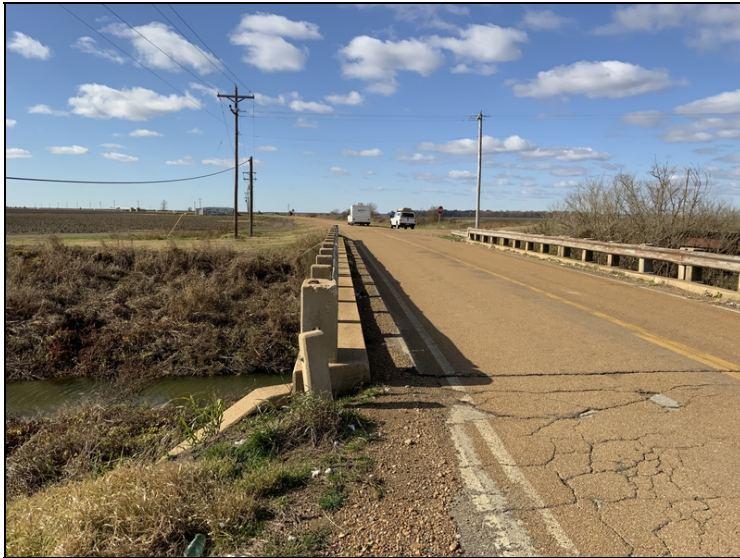
Abutment #1 left flair board knocked down.
Abutment #1 right flair board and log mile sign knocked.
Abutment #2 right flair board missing.

Abutment #2 right flair board missing.

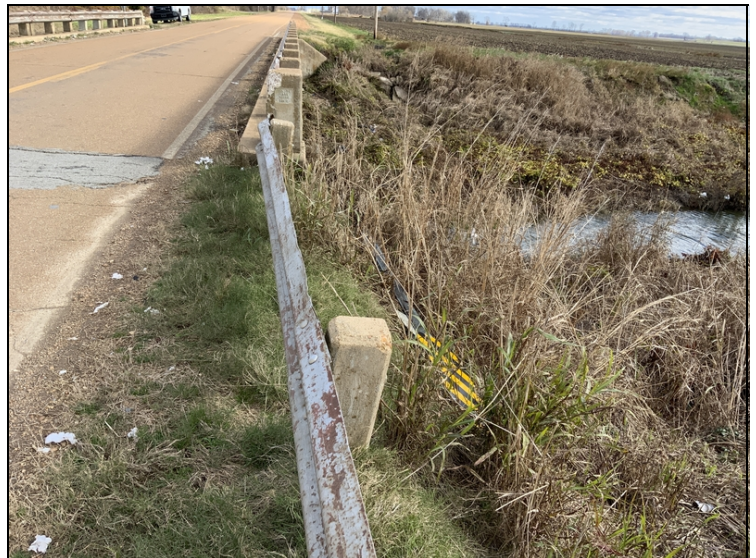
Abutment #1 right flair board and log mile sign knocked.

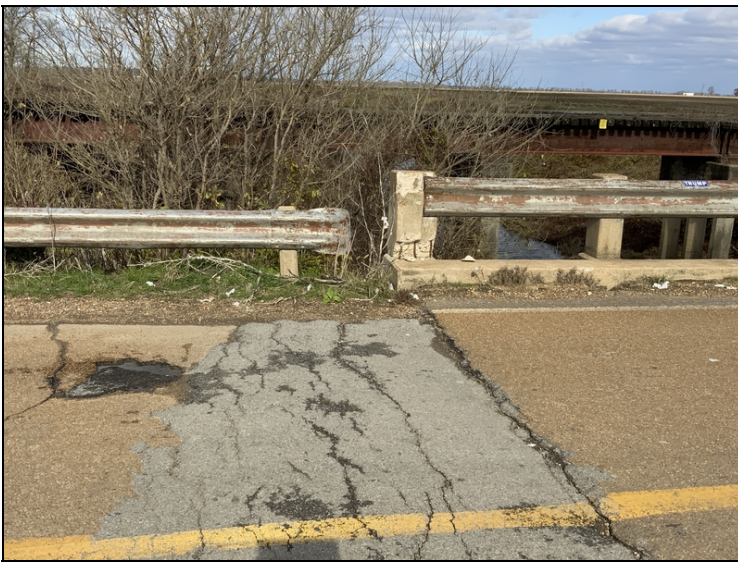
(330)							
End posts are spalled on tops due to collision damage.							
Abutment #1 left end post spalled with exposed rebar.							
Paint has primer showing full length with some areas of rust.

Abutment #1, left rail, end post spalled with exposed rebar.

Abutment #1 left end post spalled with exposed rebar.
