Bridge #M3972(Routine)

Sh-44Sec-2/L-6.67 over Indian Bayou

Team Lead: Myron Futrell Inspection Date: August 06, 2020

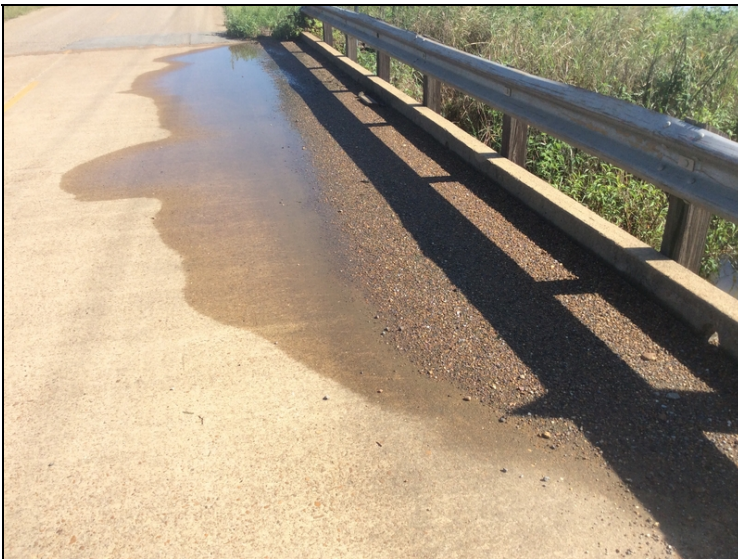
Gutters have dirt and debris.

8/10/2020-No noteworthy changes since last inspection.

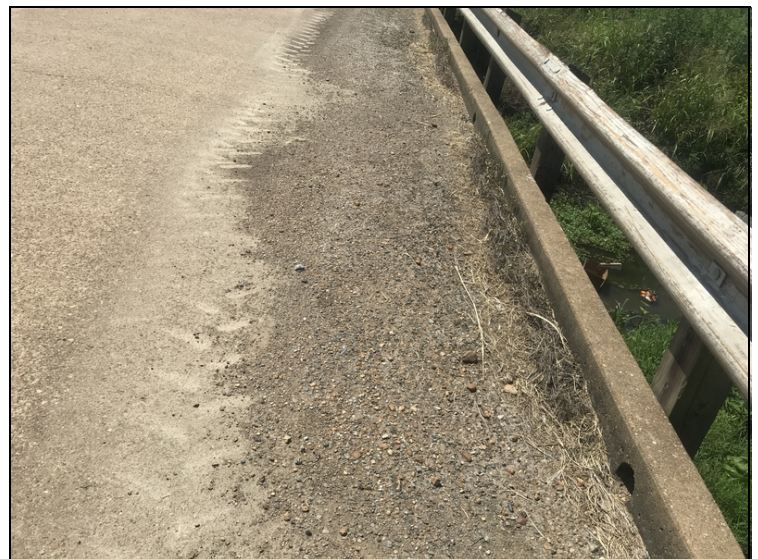
Dirt and gravel in gutters.

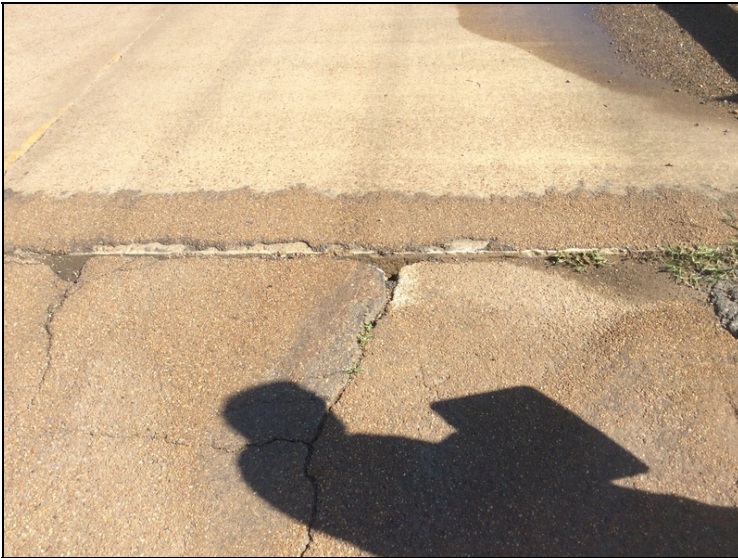
Abutment #1 approach roadway has settled up to 1 1/2" with small void underneath increasing impact loading on bridge.

Abutment #1 approach roadway has settled with small void underneath increasing impact loading on bridge.

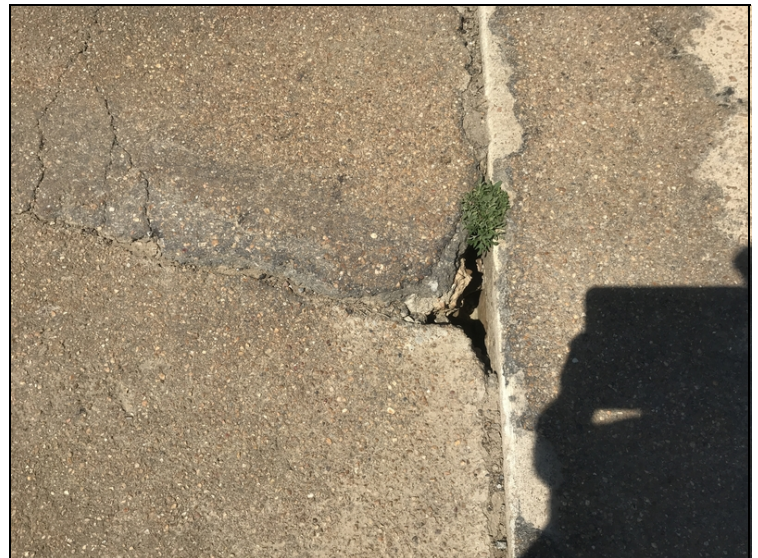
8/10/2020-Small hole in roadway has developed at bridge end.

Abutment #1 approach roadway right lane has hole with void underneath.

Abutment #1 and 2 approach roadways have settled up to 1 1/2".
Abutment #1 approach roadway right lane has small hole at bridge end.
Abutment #2 left shoulder at bridge end has small hole with a void at bridge end.
Vegetation growing beside, under and onto bridge.
Gutters have dirt and debris.

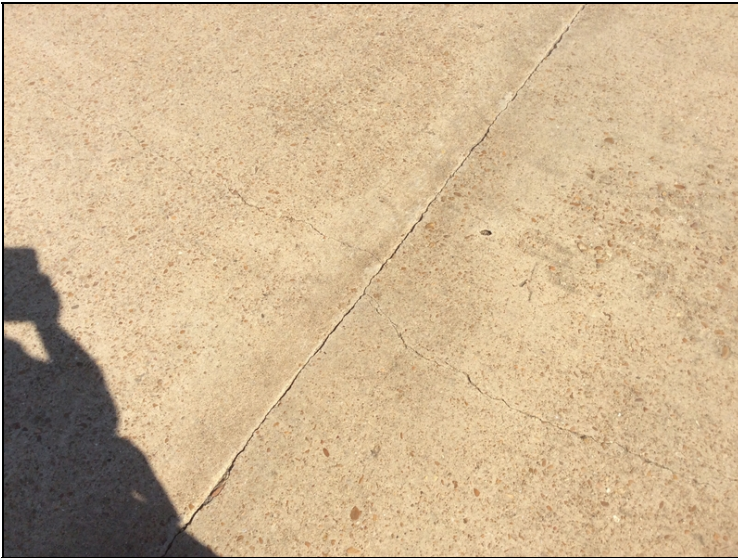
(28)	Bridge deck has a few open transverse cracks.						
107	Steel Open Girder/Beam	LF	180	150	30	0	0
1000	Corrosion	LF	30	0	30	0	0
515	Steel Protective Coating	SF	990	0	840	132	18
3440	Effectiveness (Steel Protective Coatings)	SF	990	0	840	132	18

Bridge deck has a few open transverse cracks.

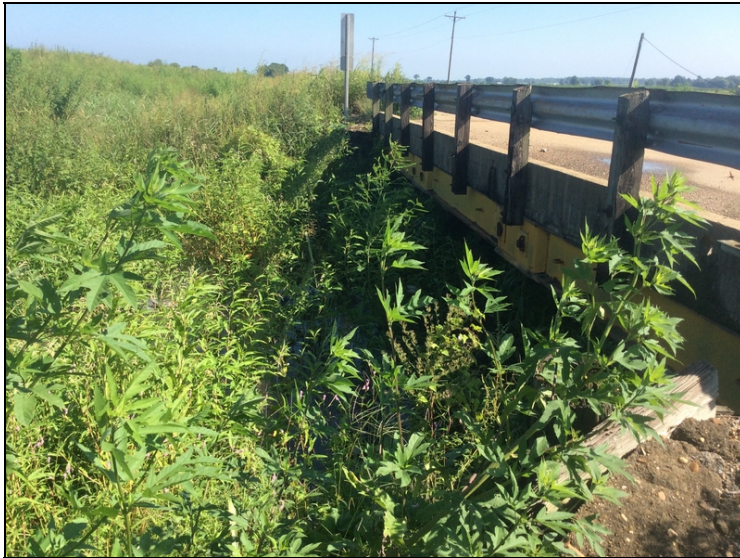
Vegetation is growing under and beside bridge.

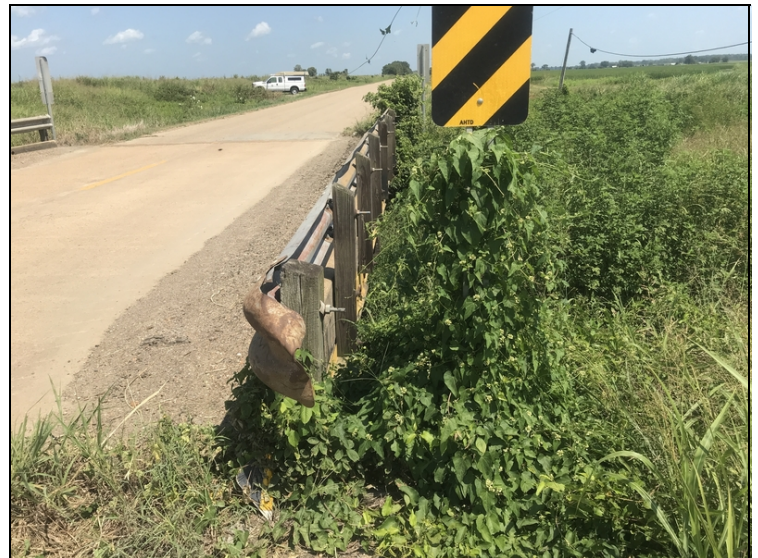
Vegetation growing beside and under bridge.

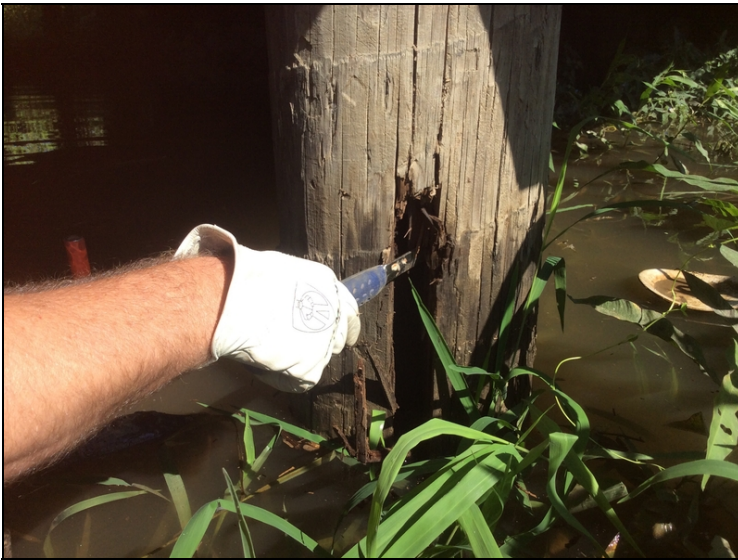
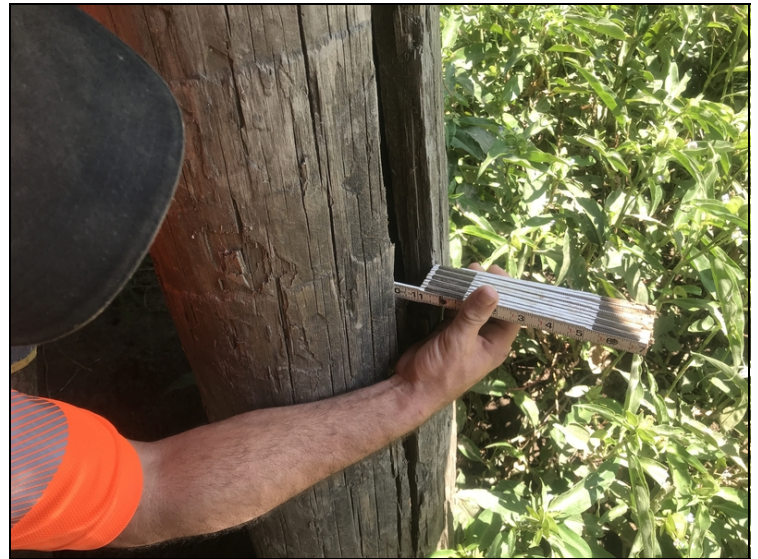
(228)	Bent #1 pile #5 has outer shell decay with 60% section loss. Bent #2 pile #1 is core decayed with 50% section loss. Bent #2 pile #5 is core decayed with 80% section loss. Abutment #2 pile #1 core decayed with 80% section loss.						
235	Timber Pier Cap	LF	84	81	0	3	0
1160	Crack (Timber)	LF	3	0	0	3	0

Bent #1 pile #5 is core decayed with 60% section loss.
Bent #2 pile #5 is core decayed with 80% section loss.
Abutment #2 pile #1 core decayed with 80% section loss.

8/10/2020-Lowered substructure from 5 to 4 due to pile condition.

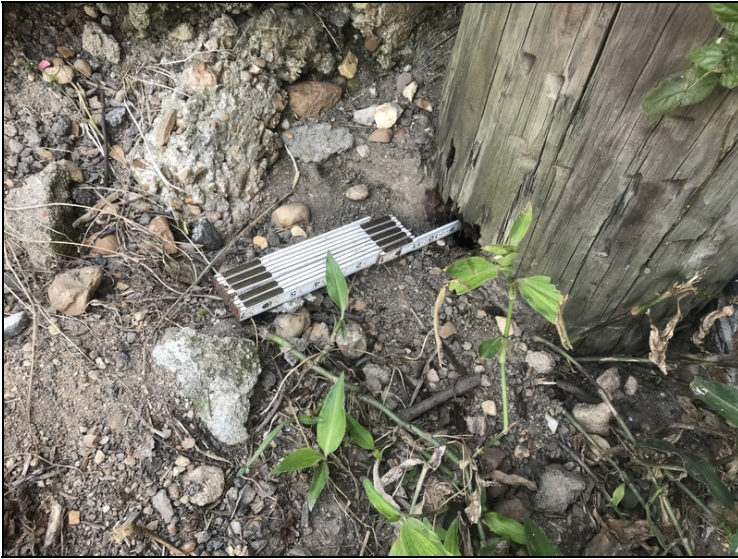
Abutment #2 pile #1.

8/10/2020-Reopened maintenance need due to addition of abutment #2 pile #1.

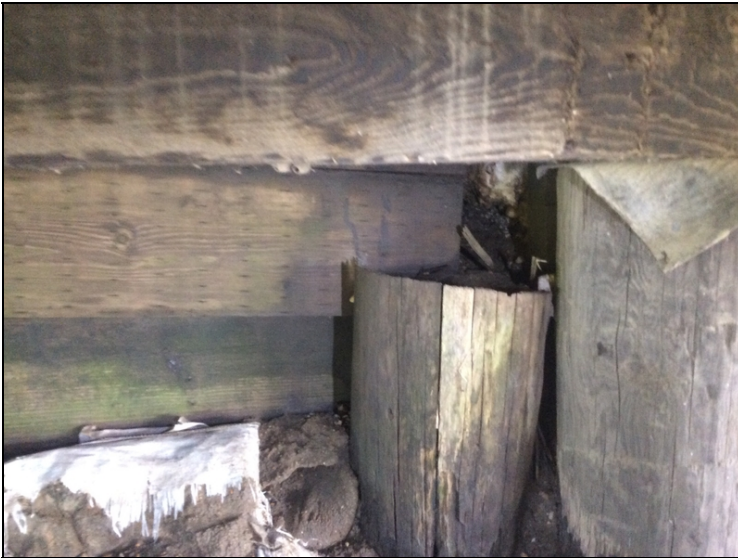
Abutment #2 behind pile #3

(216)	Abutment #2 back wall behind pile #3 has a six inch void. Timber abutments are cracked and weathered.						
228	Timber Pile	EA	15	11	0	2	2
1140	Decay/Section Loss	EA	4	0	0	2	2

Abutment #2 back wall behind pile #3 has a six inch void.

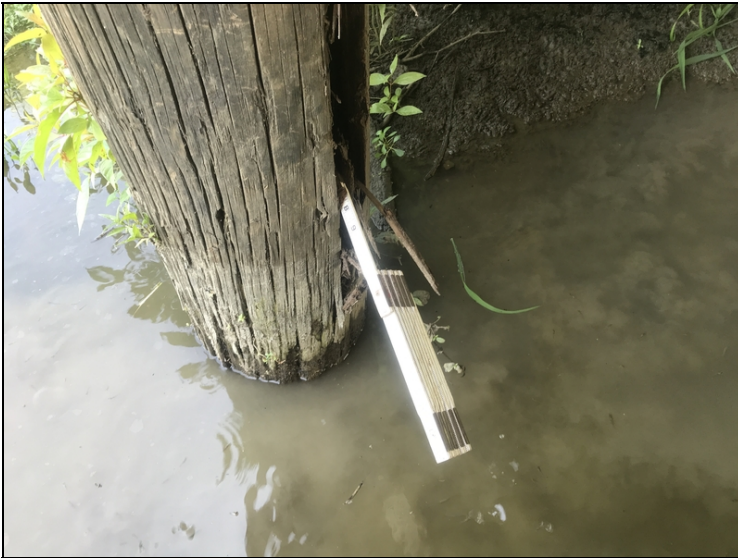
Bent #2 pile #1.

Bent #2 pile #1 is core decayed with 50% section loss.

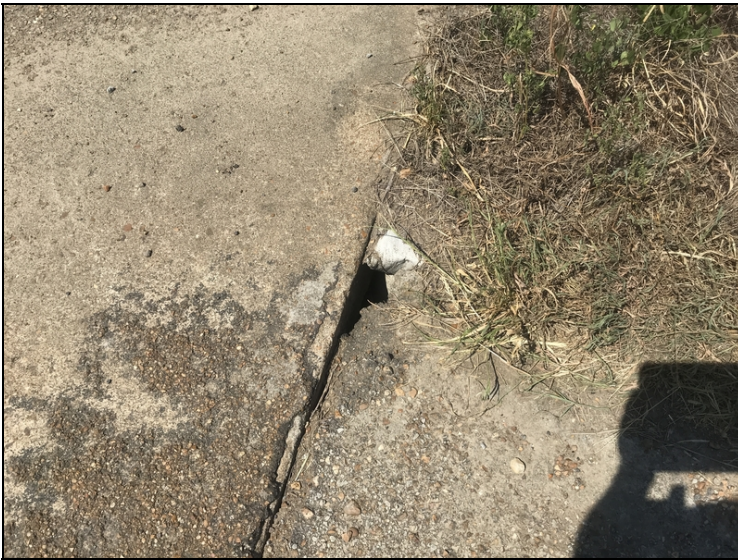
Abutment #2 left shoulder has small hole in roadway with small void behind back wall.

Hole in abutment #2 left shoulder with void.
