Asset #05854(Routine)

Sh-1/Sec-6/L-1.24 over White River Relief

Location: 1.63 Mi E Of White River

Team Lead: Drew Melton, Inspection Date: 09/06/2022

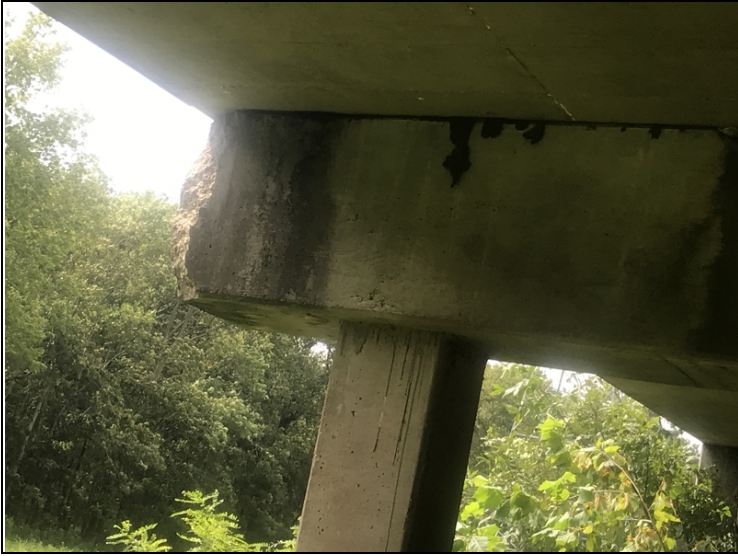
Bent #7 cap ahead face above pile #1,2,5 at top each area has a one foot spall no rebar exposed.
Bent #7 cap right end front corner spalled off rebar exposed no section loss.
Bent #10 cap left end back face top corner has a six inch crack with delamination.
Bent #14 cap right end at top has a six inch delamination.
Bent #17 cap ahead face has shallow 10" spall above pile #2.
Bent #22 cap ahead face in center at top has a one foot spall with no rebar exposed.
Bent #23 cap back face near right end has a one foot spall with no rebar exposed, and right end is spalled full height with exposed rebar with minor section loss.

Bent #7 right end.

Date Reported: 10/22/2018
Priority: D- Routine
Type of Work: Repair (General)
Status: Monitor
Component: Element

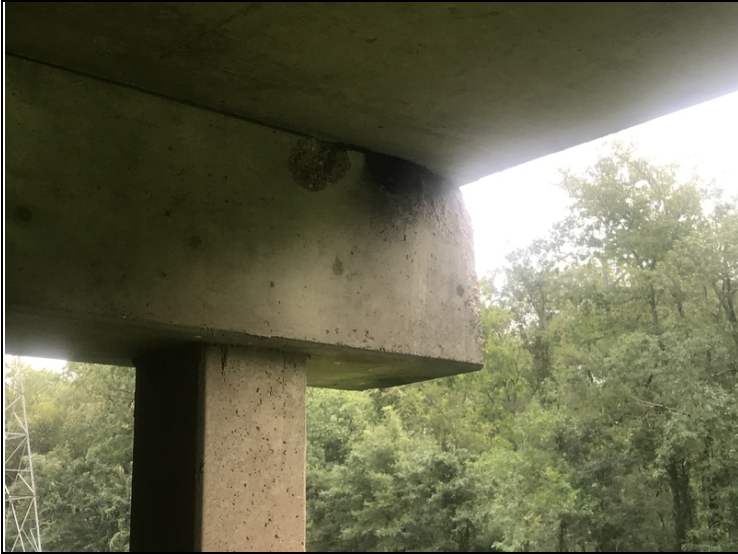
Bent #23 cap back face, right end.

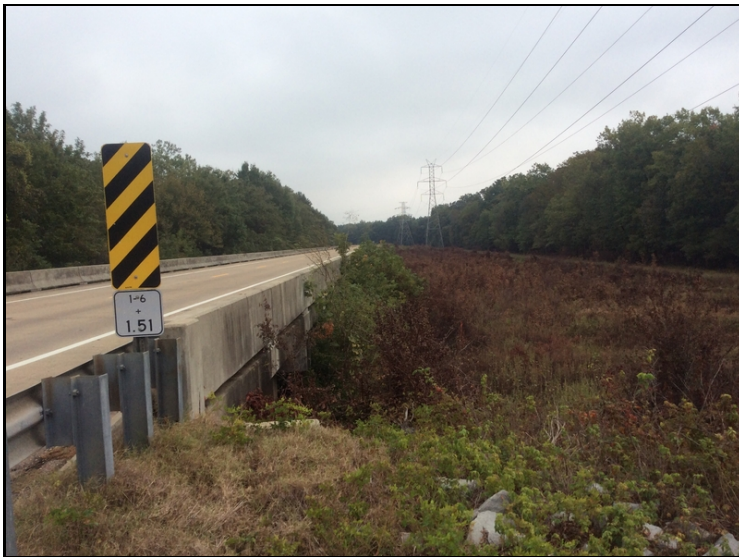
Small trees and vegetation are growing beside and under bridge.

Vegetation right side of the bridge

Date Reported: 10/30/2012
Priority: C - Important
Type of Work: (Inactive) (Inactive) 1 - Clean
Status: Monitor
Component: Miscellaneous

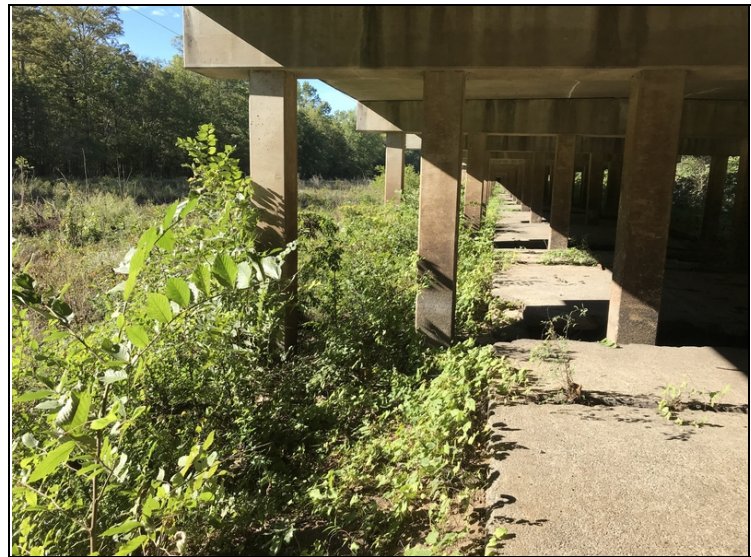
Small trees and vegetation are growing beside and under bridge.

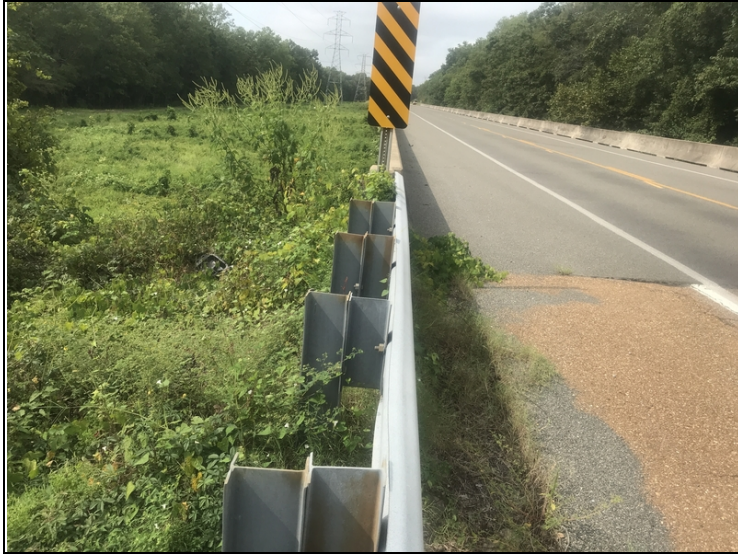
Vegetation growing beside and under and onto bridge abutment #2 right side.

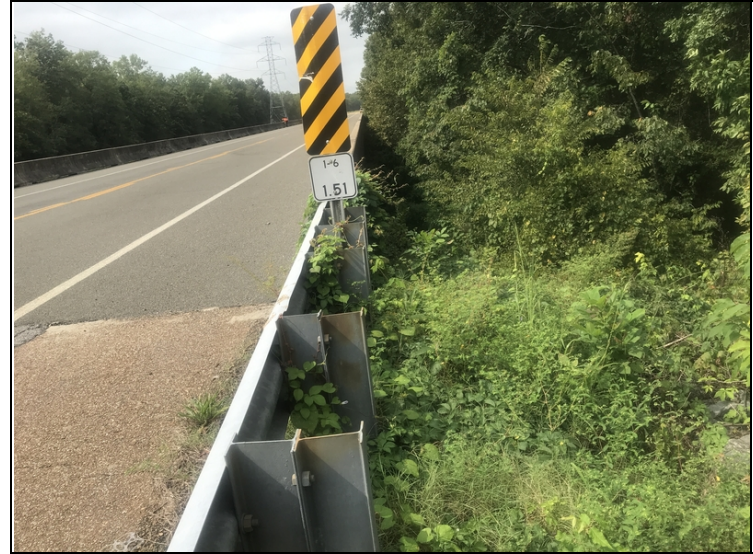
Trees and vegetation growing beside, under and onto bridge abutment #2 left side.

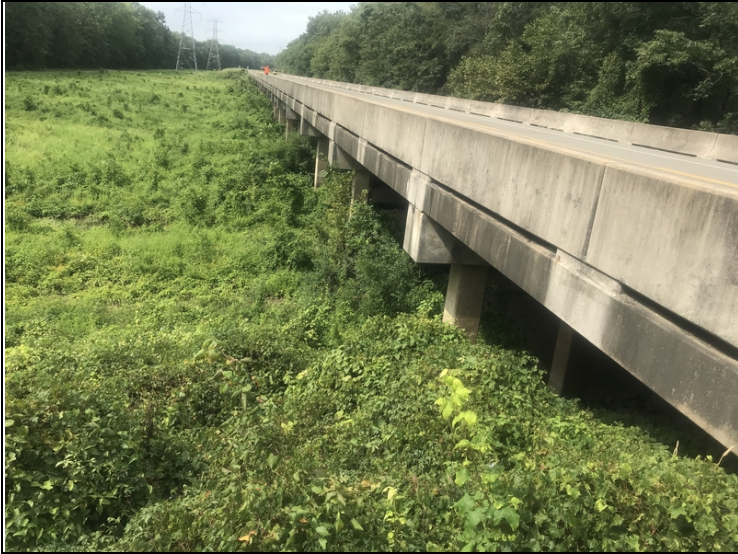
Trees and vegetation growing beside and under bridge.

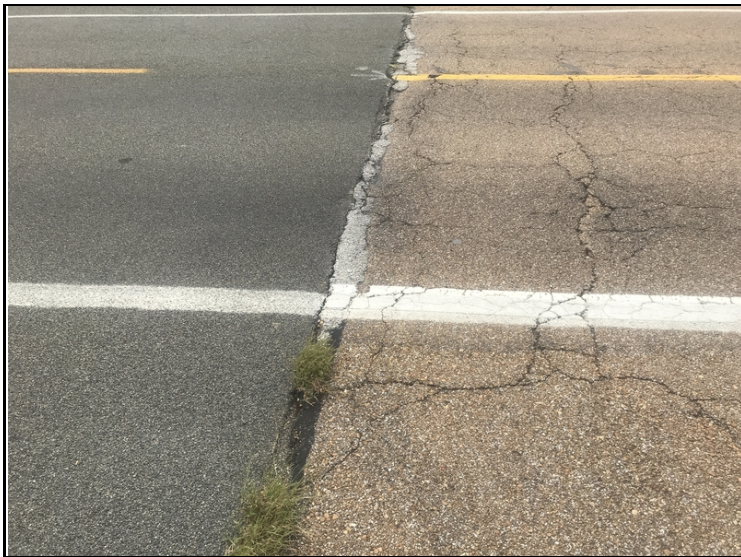
Abutment #1 approach roadway.

Abutment #1 approach roadway has settled increasing impact loading on bridge.

Abutment #1,2 approach roadways have settled increasing impact loading on bridge.

Date Reported: 10/22/2018
Priority: C - Important
Type of Work: Repair (General)
Status: Monitor
Component: Approach

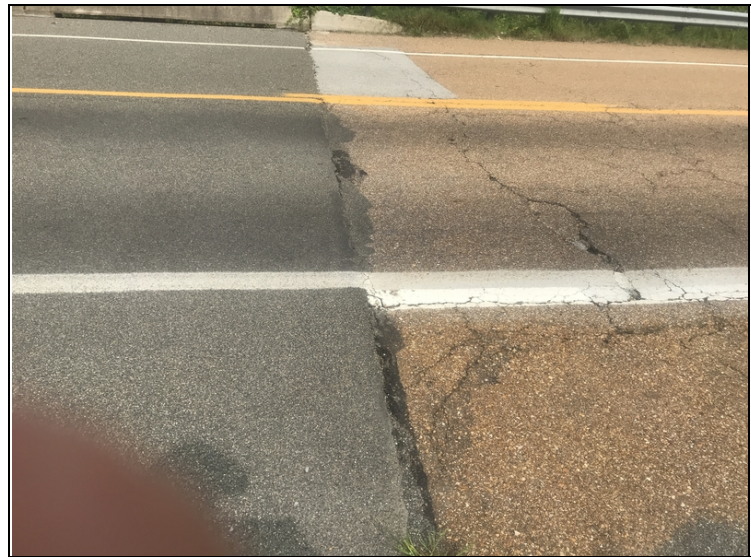
Abutment #2 approach roadway.

Abutment #2 approach roadway has settled increasing impact loading on bridge.

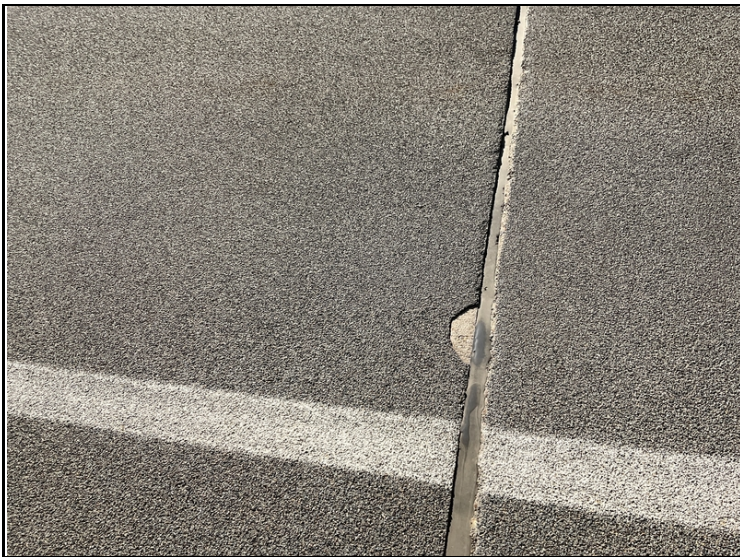
Wearing surface has a few small chipped areas near joint.

Wearing surface has a few small chipped areas
near

Date Reported: 09/06/2022
Priority: D- Routine
Type of Work: Repair (General)
Status: Open
Component: Element
