Asset #05855(Routine)

Sh-1/Sec-6/L-2.97 over Waters Bayou

Location: 3.1 Mi E Of White River

Team Lead: Drew Melton, Inspection Date: 10/19/2022

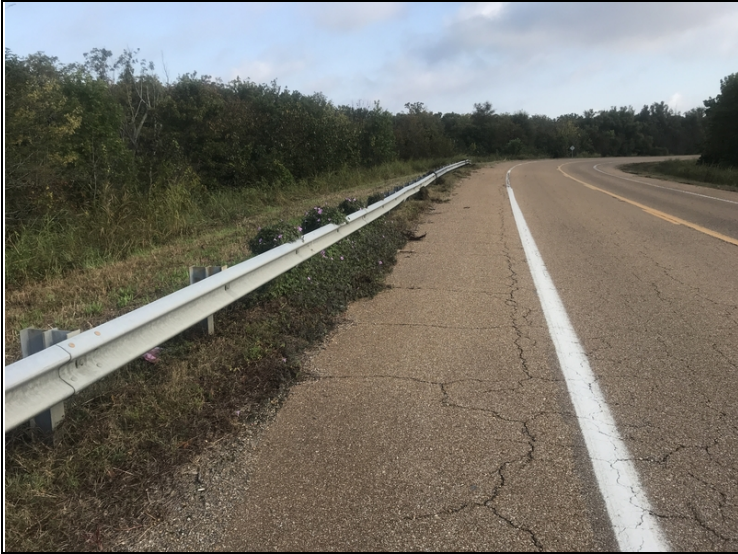
Approach rail abutment #1 right side and abutment #2 left side has minor collision damage.

Abutment #2 left side approach rail has minor collision damage 70' from bridge end.

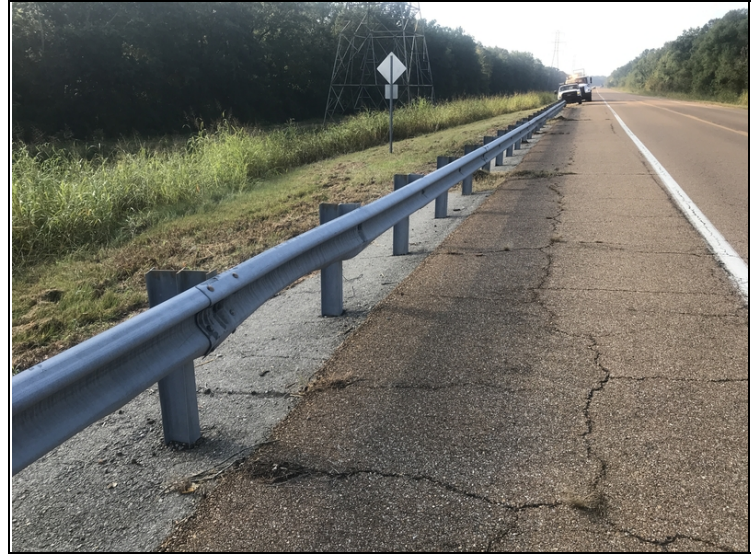
Abutment #1 right approach rail has several areas of minor collision damage.

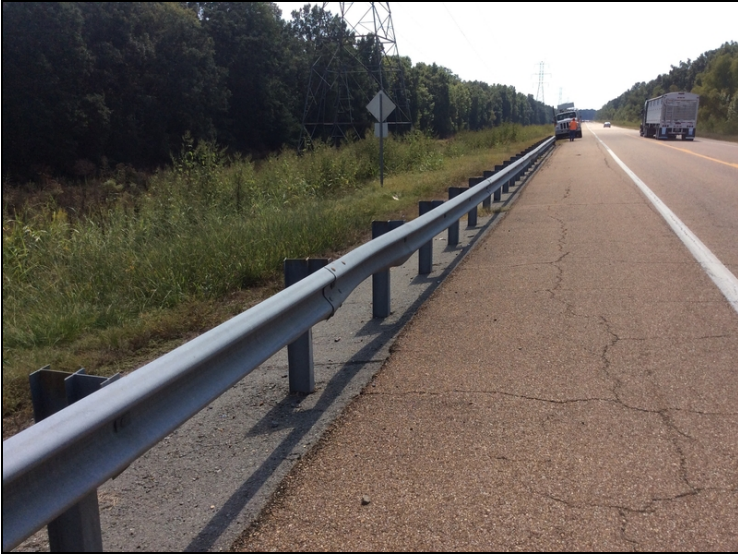
Abutment 1 right approach rail damage.

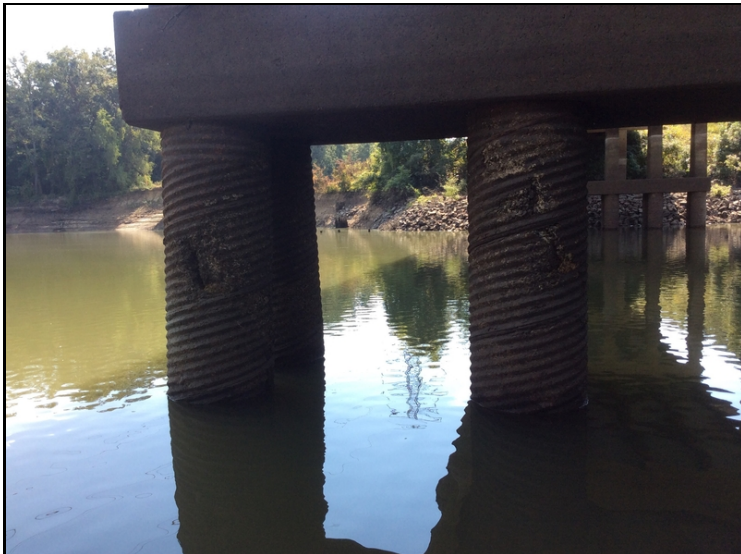
Bent #3 column #11 has areas of 100% section loss to steel encasement with a two to three foot void in concrete encasement at water line exposing steel H beam.

Bent #5 column #8 has areas of 100% section loss in steel encasement with a two foot void in concrete encasement at water line.

Bent #5 column #7,10,12 all have areas of 100% section loss in steel encasement with a three to four foot void in concrete encasement at water line exposing steel H beam.

Typical voids in concrete surrounding piles.

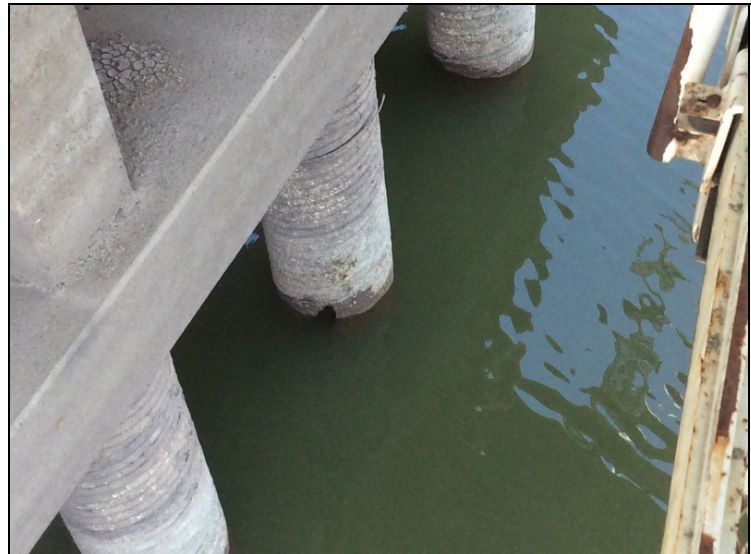
Void in concrete bent 6 pile encasement.

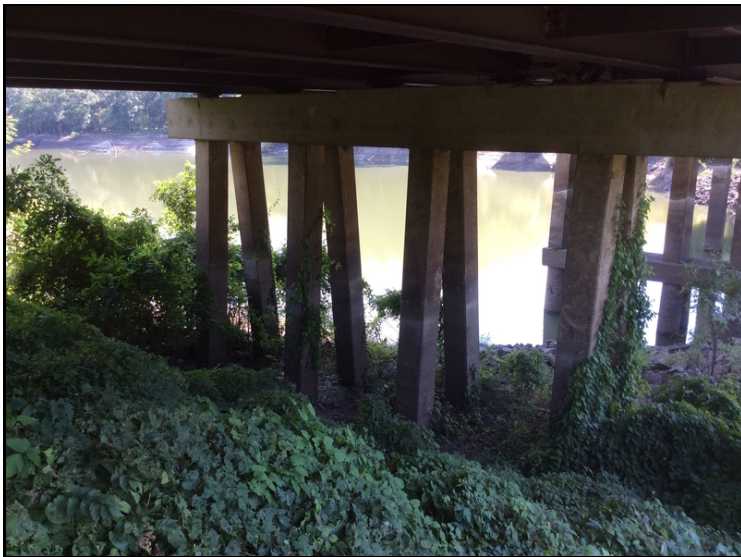
Small trees and vegetation are growing under and beside bridge.

Typical vegetation.

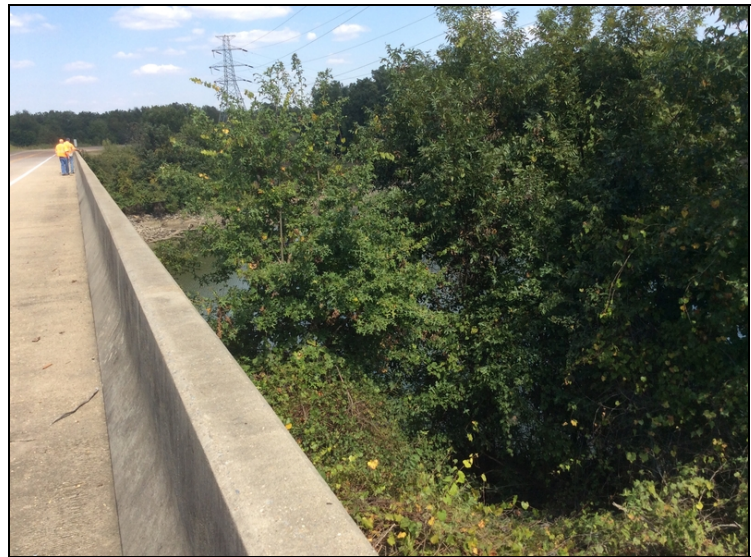
Typical vegetation.

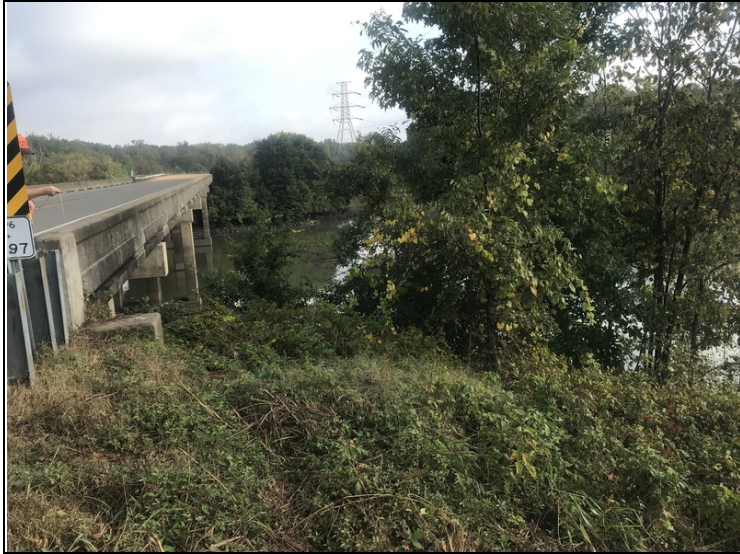
Trees and vegetation growing beside and under bridge abutment #1 right side.

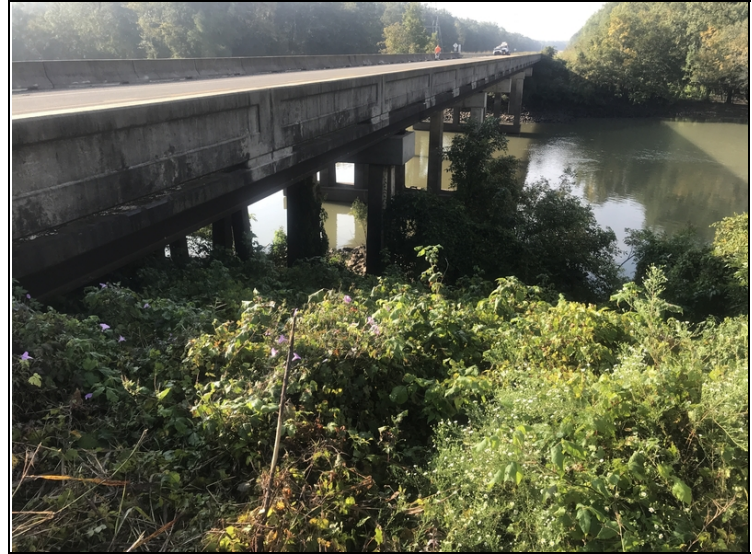
Trees and vegetation growing beside and under bridge abutment #2 left side.

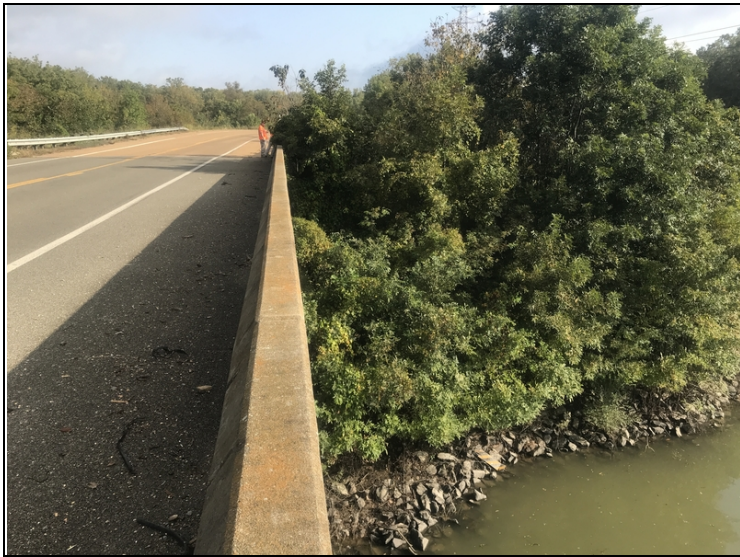
Trees and vegetation growing beside, under and onto bridge abutment #2 right side.

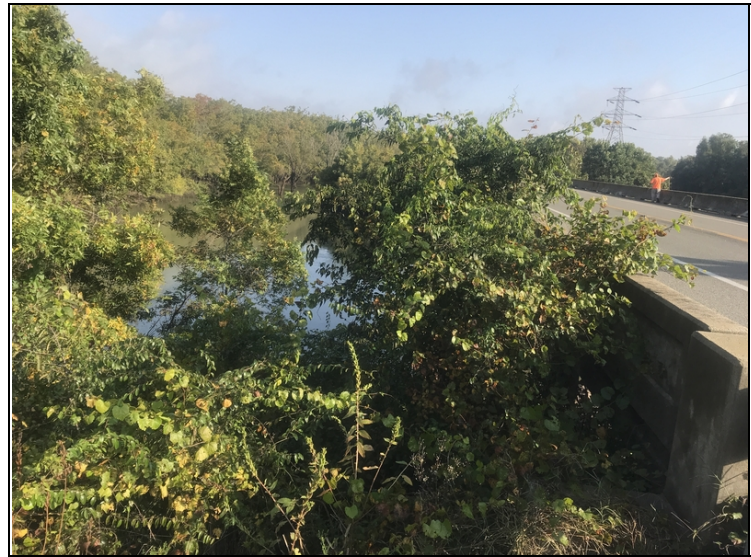
Trees and vegetation growing beside and under bridge abutment #1 left side.

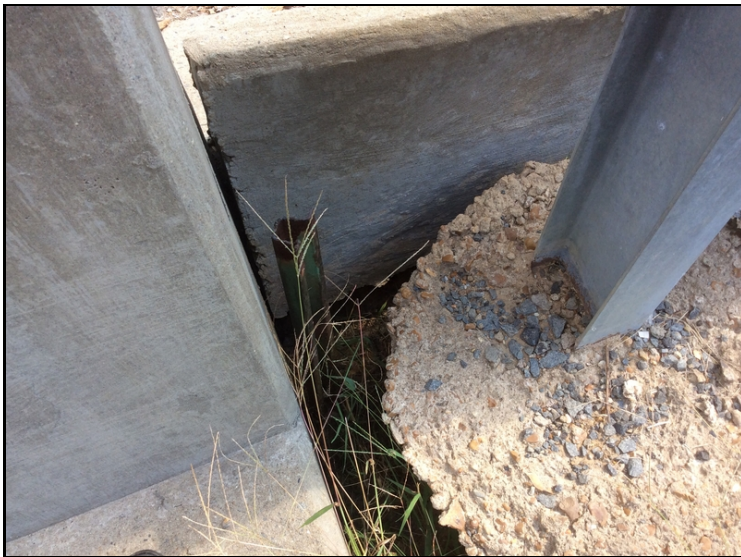
Abutment 1 left side approach gutter at bridge end  
has void 2' x 2'.

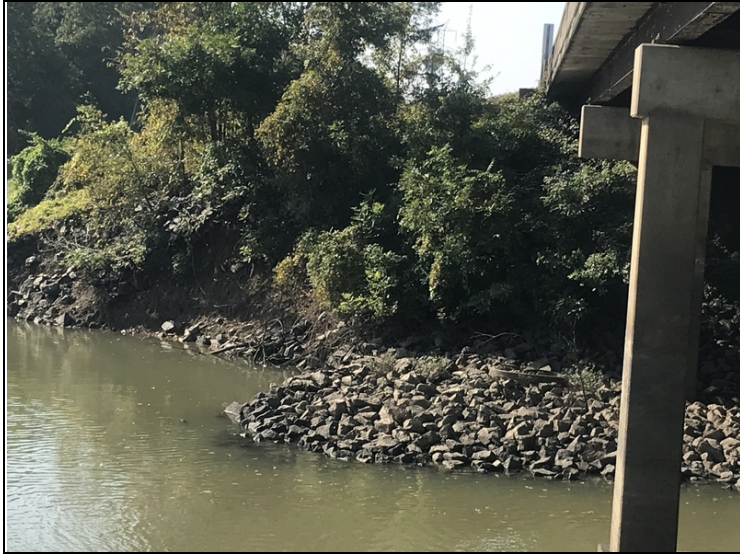
Abutment 1 right side bank is eroding within 30' of bridge.  
Abutment 2 right bank 60' from abutment 2 is eroding.

Slope erosion at abutment #1 right side.

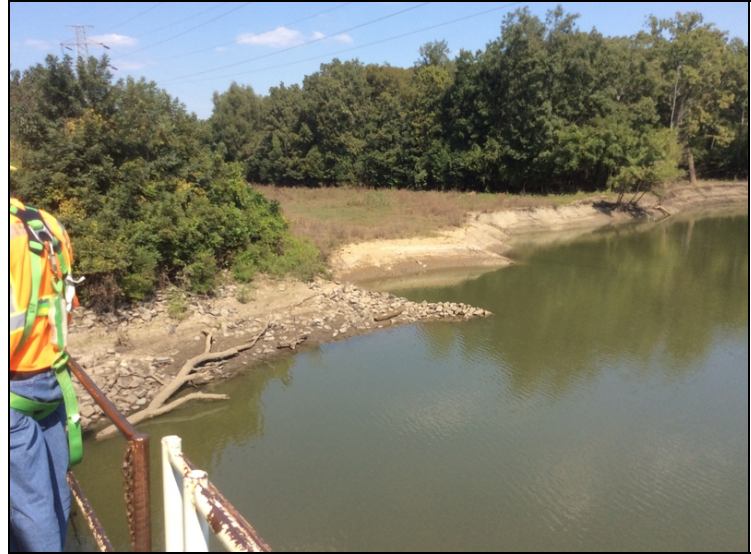
Comment: 10-3-2016 lowered channel from 8 to 6 due to Abutment 2 right bank 60' from abutment 2 is eroding.  
10/19/2022 lowered channel from 6 to 5 due to erosion on each end of bridge beside structure.

Abutment 2 right bank 60' from abutment 2 is eroding.

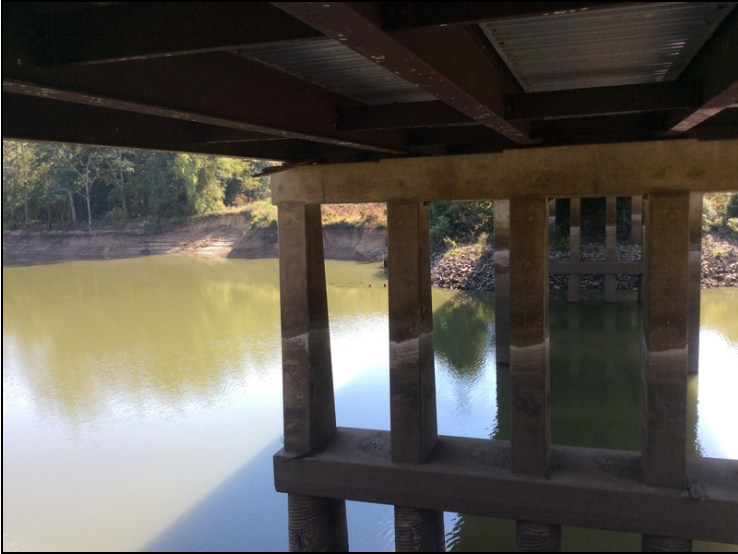
Abutment 1 right side bank is eroding within 50' of bridge.

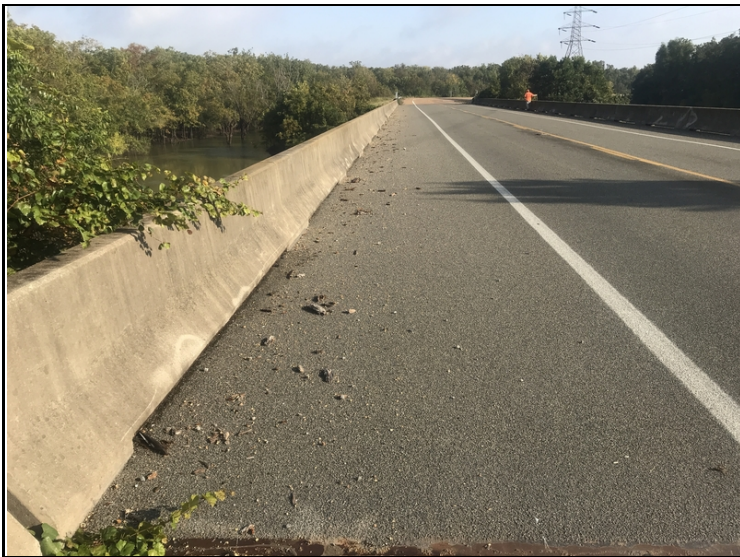
Debris in gutters.

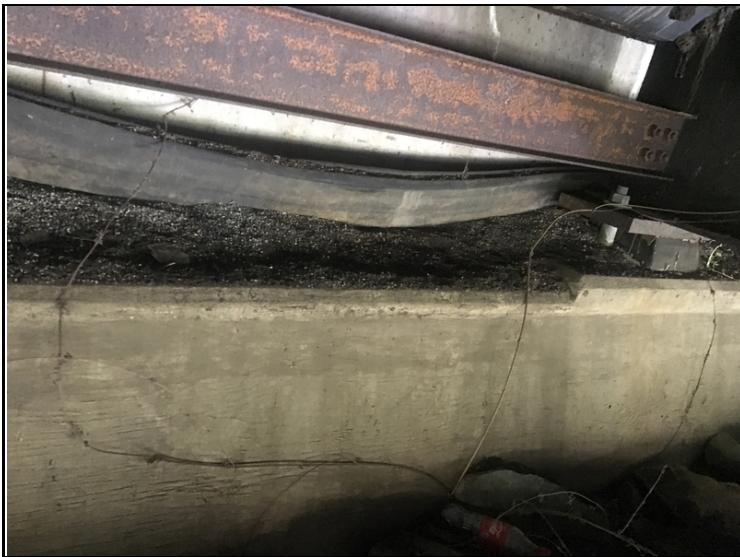
Dirt and debris on abutment #2 cap, typical of abutment #1.

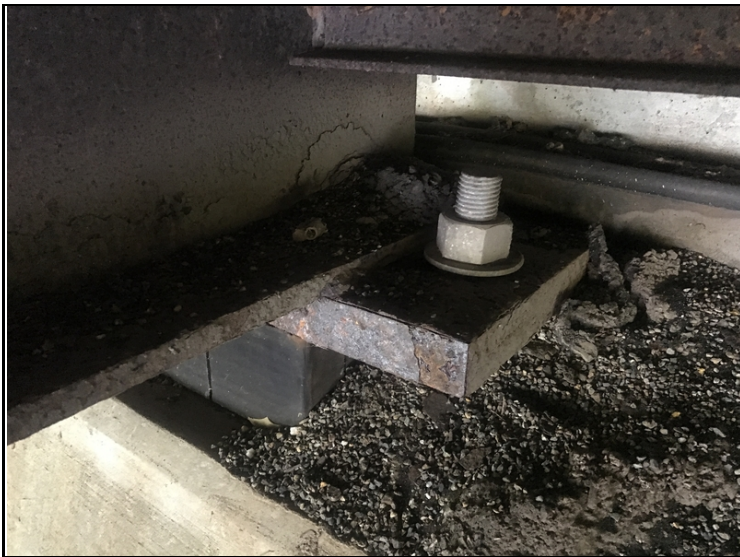
Abutment #1 bearings #2, 3, 4 and 5 have corrosion with laminations.

Abutment #1 bearings have corrosion with laminations.

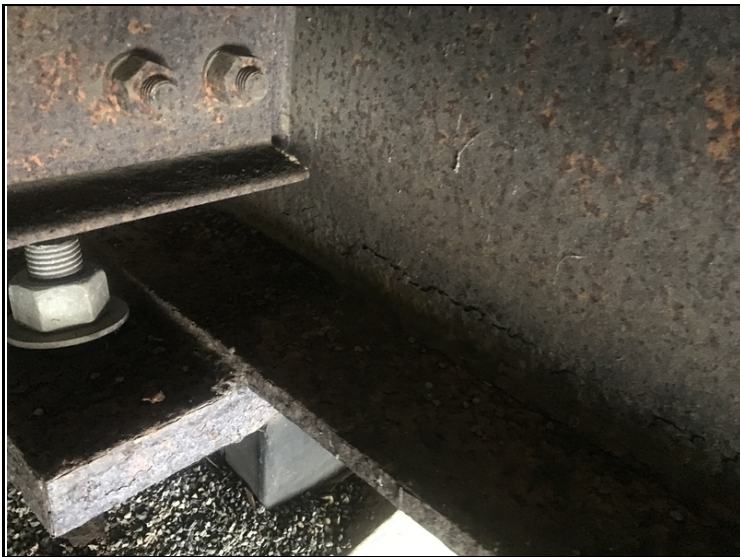
Comment: 10/12/2020-Lowered superstructure from 8 to 7 due to scaly rust on girder ends at abutment #1.

Abutment #1 girders Nos. 2, 3, 4 and 5 have scaly rust last 4' on bottom flanges and lower web.

Span #1 abutment #1 girders have scaly rust first 4'+- on bottom flanges and lower web.
