Asset #05856(Routine, Underwater type 2)

Sh-1/Sec-6/L-3.45 over Indian Bayou

Location: 3.45 Mi E Of White River

Team Lead: Drew Melton, Inspection Date: 09/20/2021

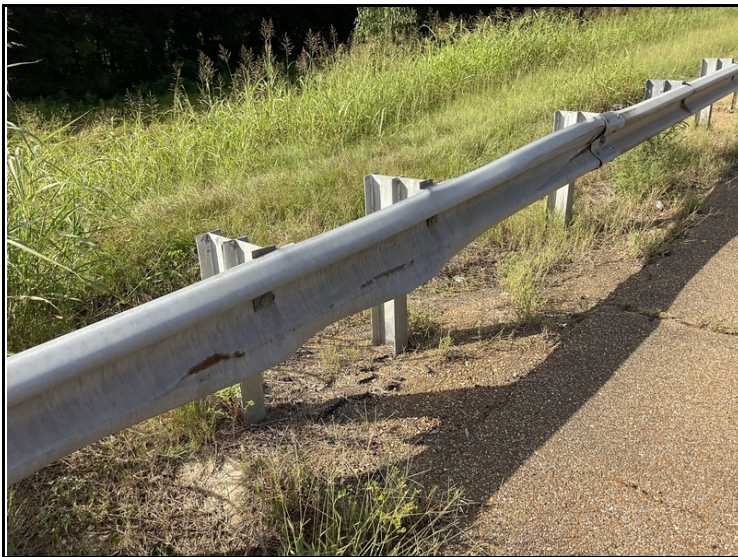
Abutment #1 right approach rail has impact damage.

Abutment #1 right approach rail collision damage

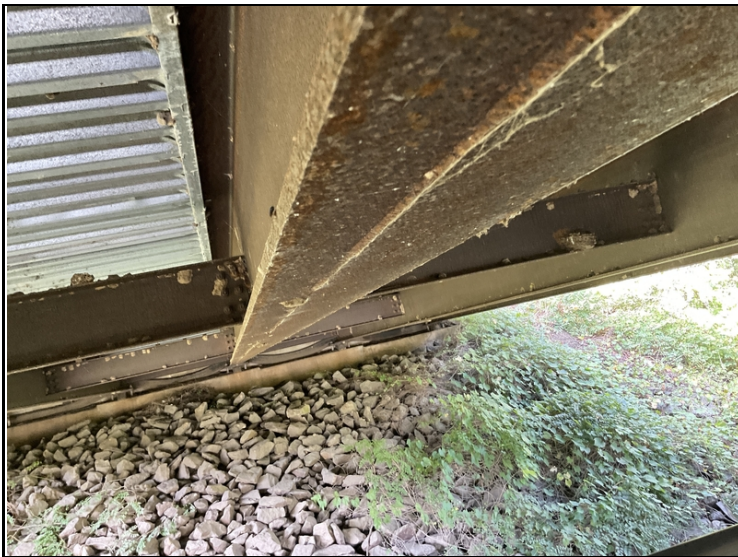
Span #1 girder #3 bottom of bottom flange has a thin sliver of steel hanging down 1/4" full length of girder.

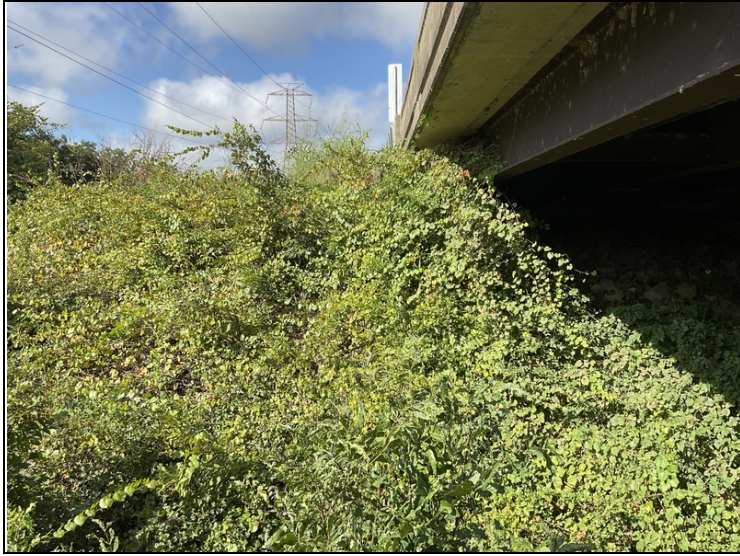
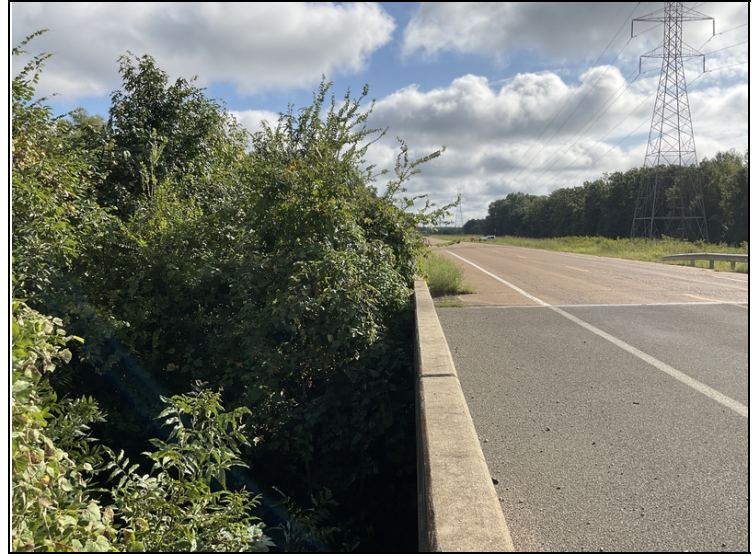
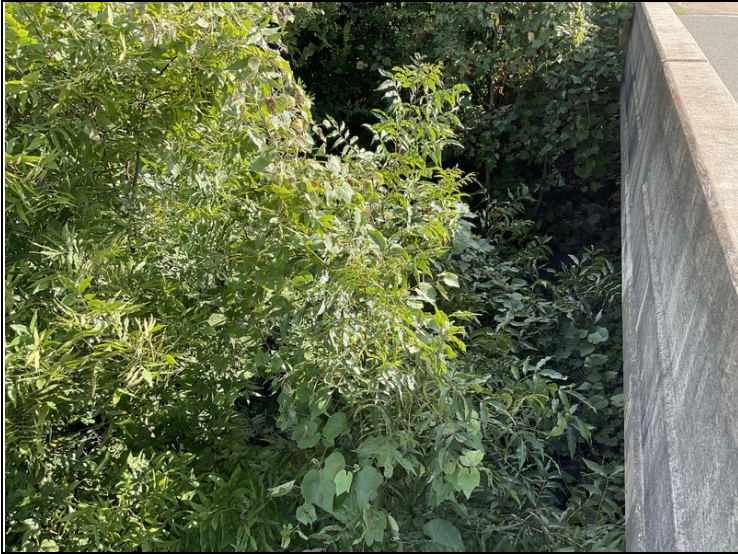
Vegetation is growing under and beside bridge and onto roadway.

Typical vegetation

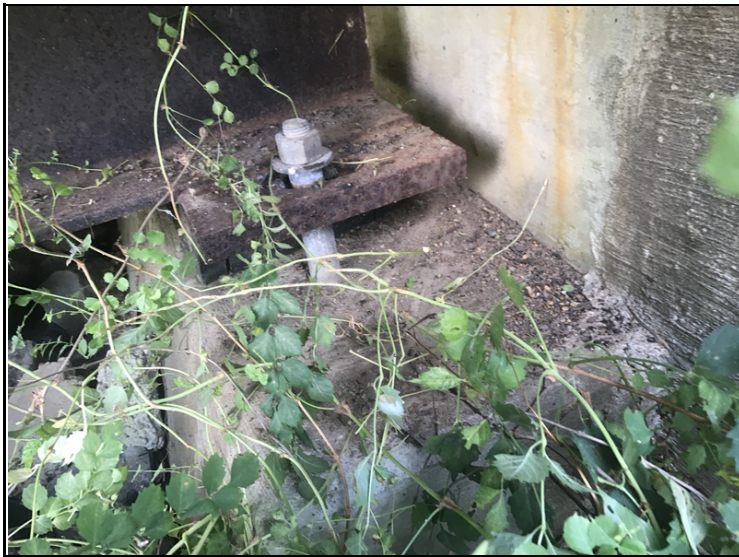
Bent #6 girder #4 right anchor nut loose.  
Abutment #1 girder # 1 left anchor nut loose.

Abutment #1 girder #1 left anchor nut has been tightened.

Tightened anchor bolt nuts.

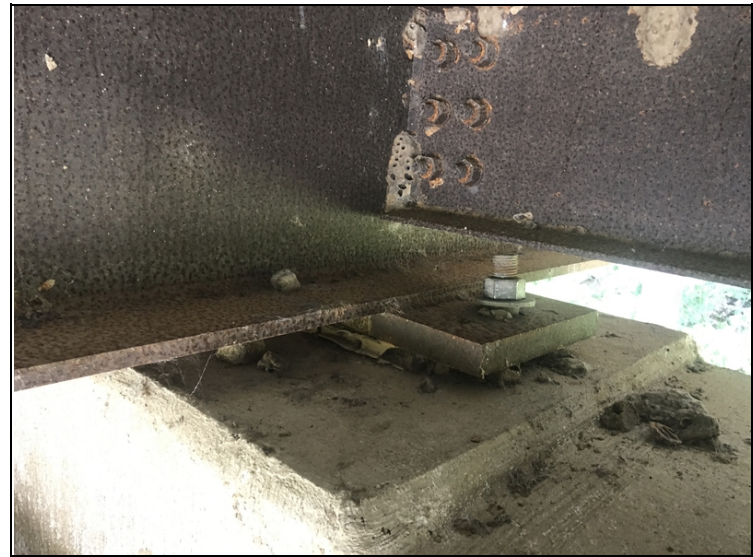
Span #6 girder #4 right anchor nut has been tightened.

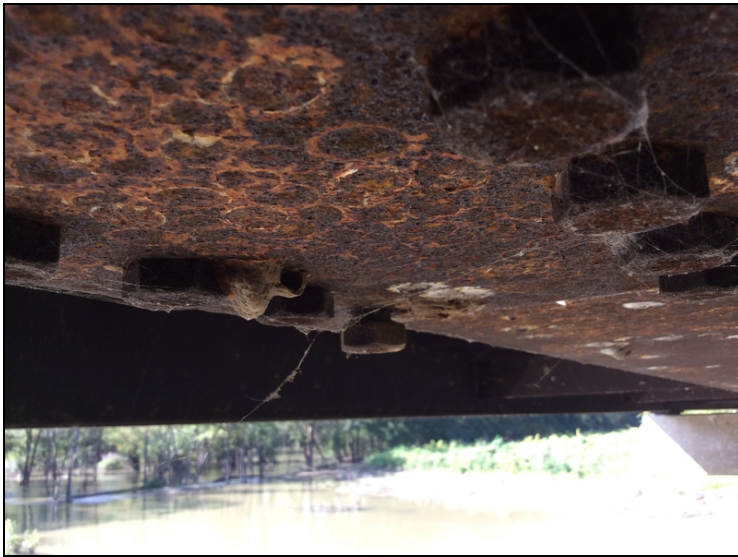
Span #5 girder #5 bottom field splice bolt loose and backed out.  
Span #6 girder #3 bottom field splice bolt loose and backed out.

Span #5 girder #5 bottom splice bolt loose and backed out.

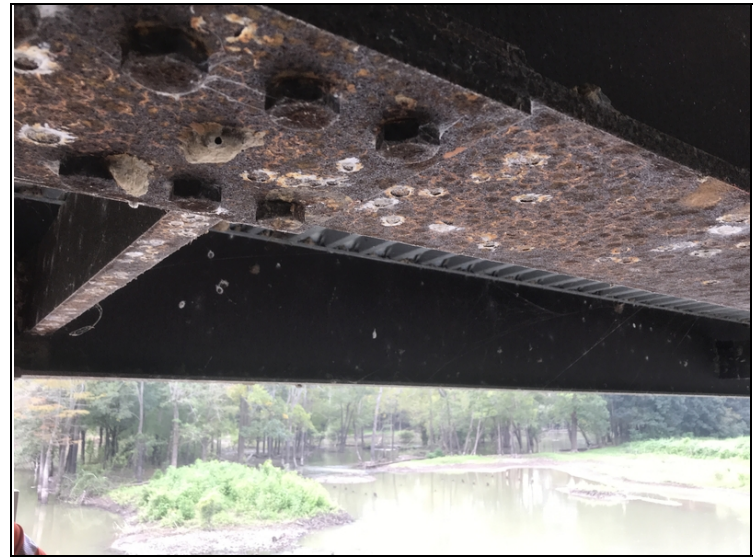
Span #5 girder #5 splice bolt has been tightened.

Tightened field splice bolts.

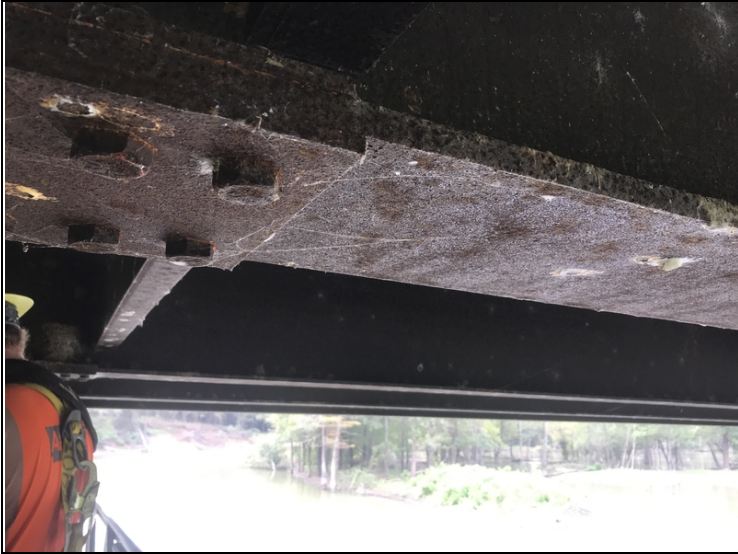
Span #6 girder #3 splice bolt has been tightened.

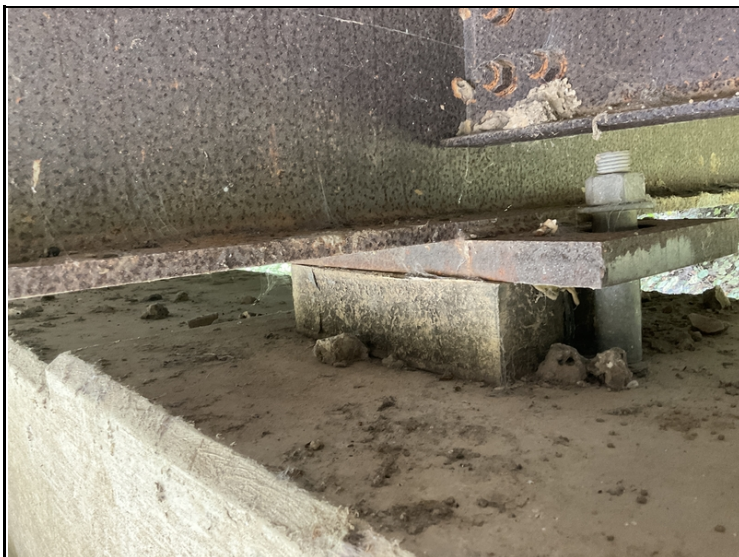
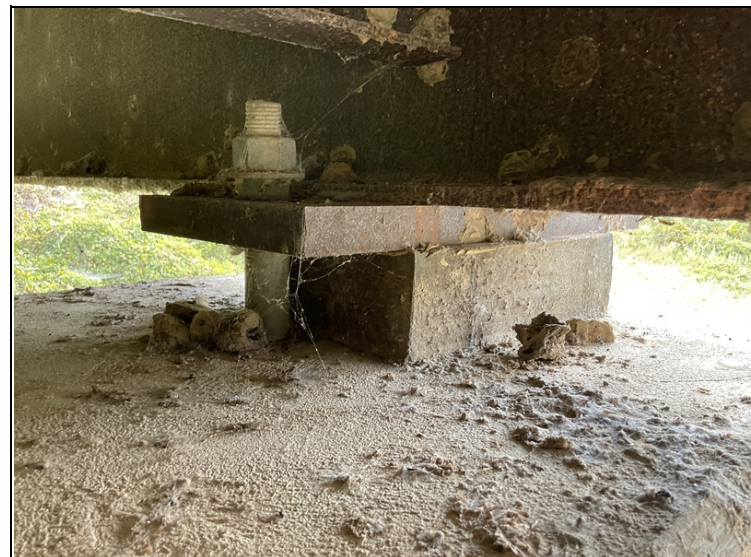
ELEMENTS	DESCRIPTION	UNITS	TOTAL	CS1	CS2	CS3	CS4
2220	Alignment	EA	2	0	0	2	0
(310) Bent #7 girders #3,6 bearing material has come unglued and has slid 1".							
331	Reinforced Concrete Bridge Railing	LF	758	758	0	0	0

Bent #7 girders #3 & #6, elastomeric bearing pad material has debonded from the load plate and has slid approximately 1".

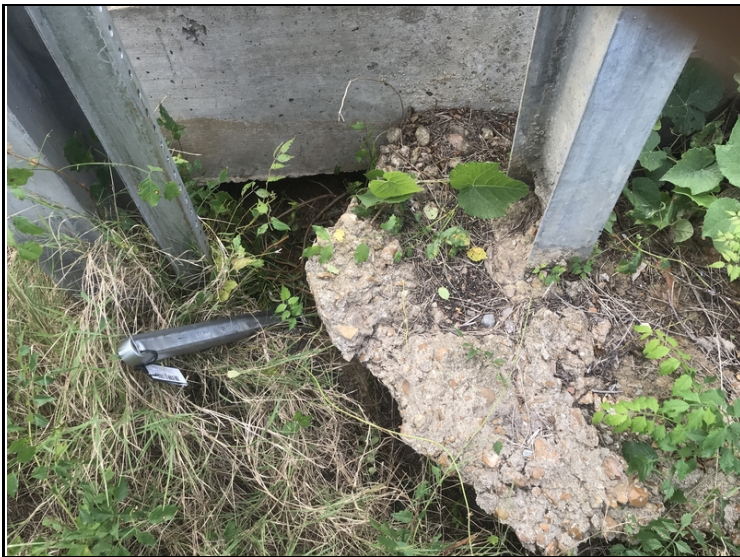
Abutment #2 left approach gutter undermined at bridge end.

Small void under abutment #2 left approach gutter.

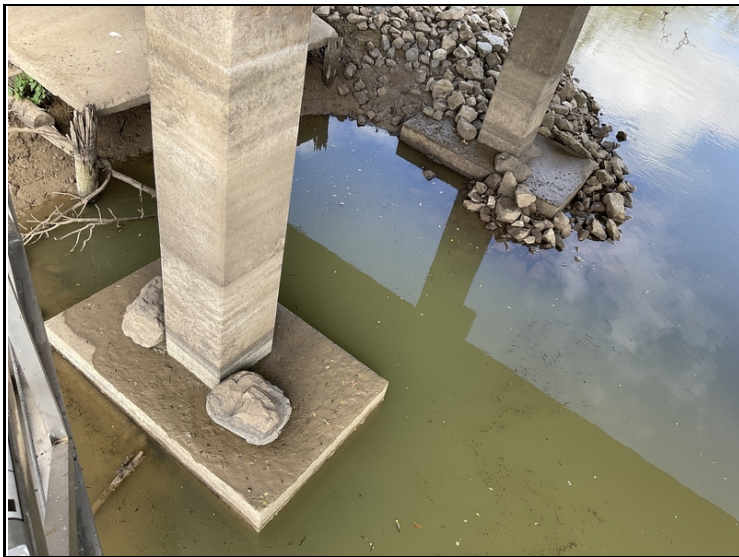
Bent #3 ahead face footings

Bent #3 left footing is exposed 1' on all sides of columns.

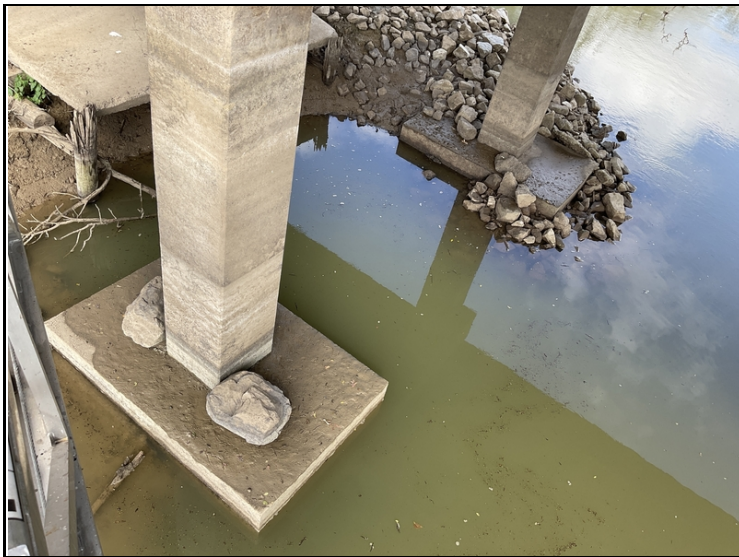
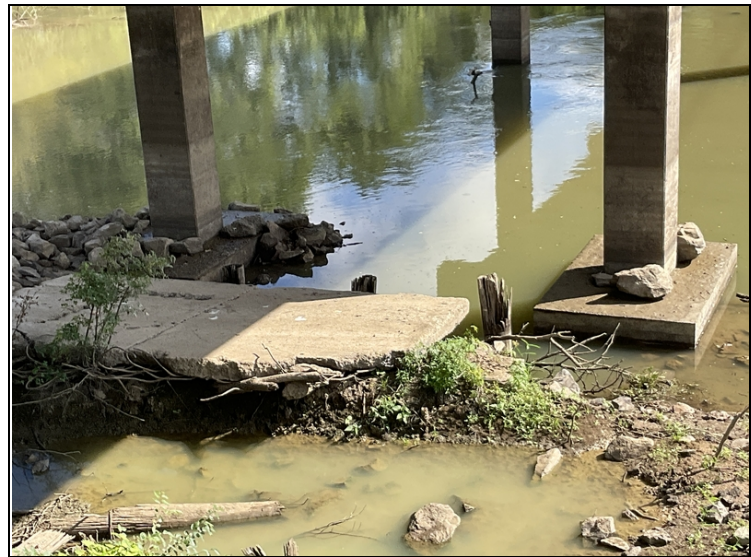
Bent #3 right footing west and north side is exposed five and a half feet one foot other two sides  
Bent # 4 footing is exposed on right column 2' on south and east sides and 5' on north side and beginning to undermine on north east corner.

Bent #3 ahead face footings

Bent #3 footing back face

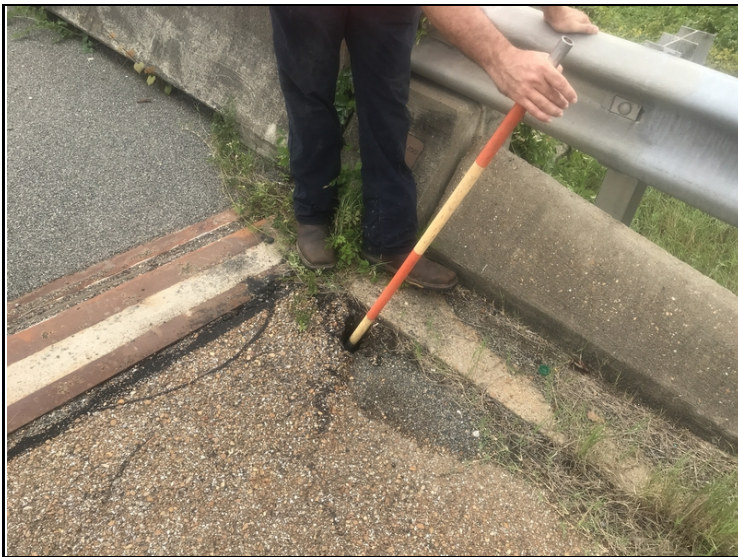
Abutment #1 right approach gutter has small hole and small void at bridge end.

Small hole in abutment #1 right gutter at bridge end.

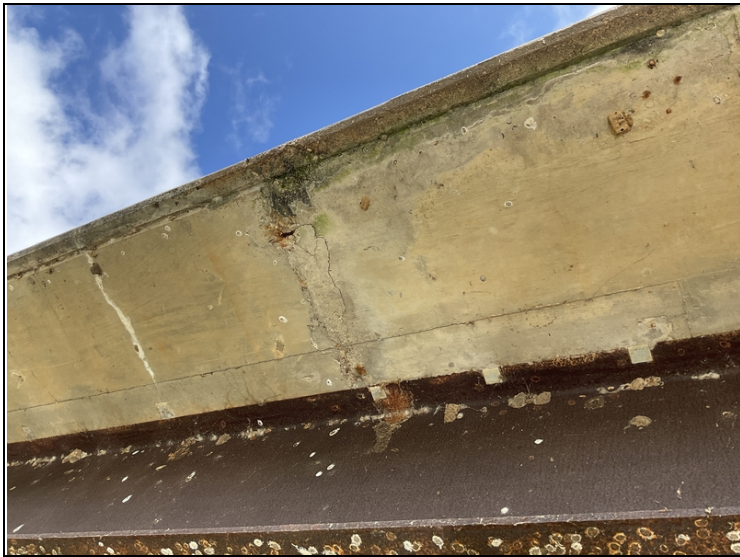
Span #4 right side soffit-under surface overhang  
3/4 span.

Span #4 right side soffit-under surface overhang has six inch spall with exposed rebar no section loss at 3/4 span.  
Span #5 right soffit-under surface overhang has six inch spall with exposed rebar no section loss at 1/4 span.  
Span #6 right soffit-under surface over hang has six inch spall with exposed rebar no section loss at 1/4 span.
